**Chemical Data Summary Report
Santa Susana Field Laboratory
Ventura County, California**

U.S. Department of Energy
EM Consolidated Business Center
Contract DE-EM0001128
CDM Smith Task Order DE-DT0003515

January 2017

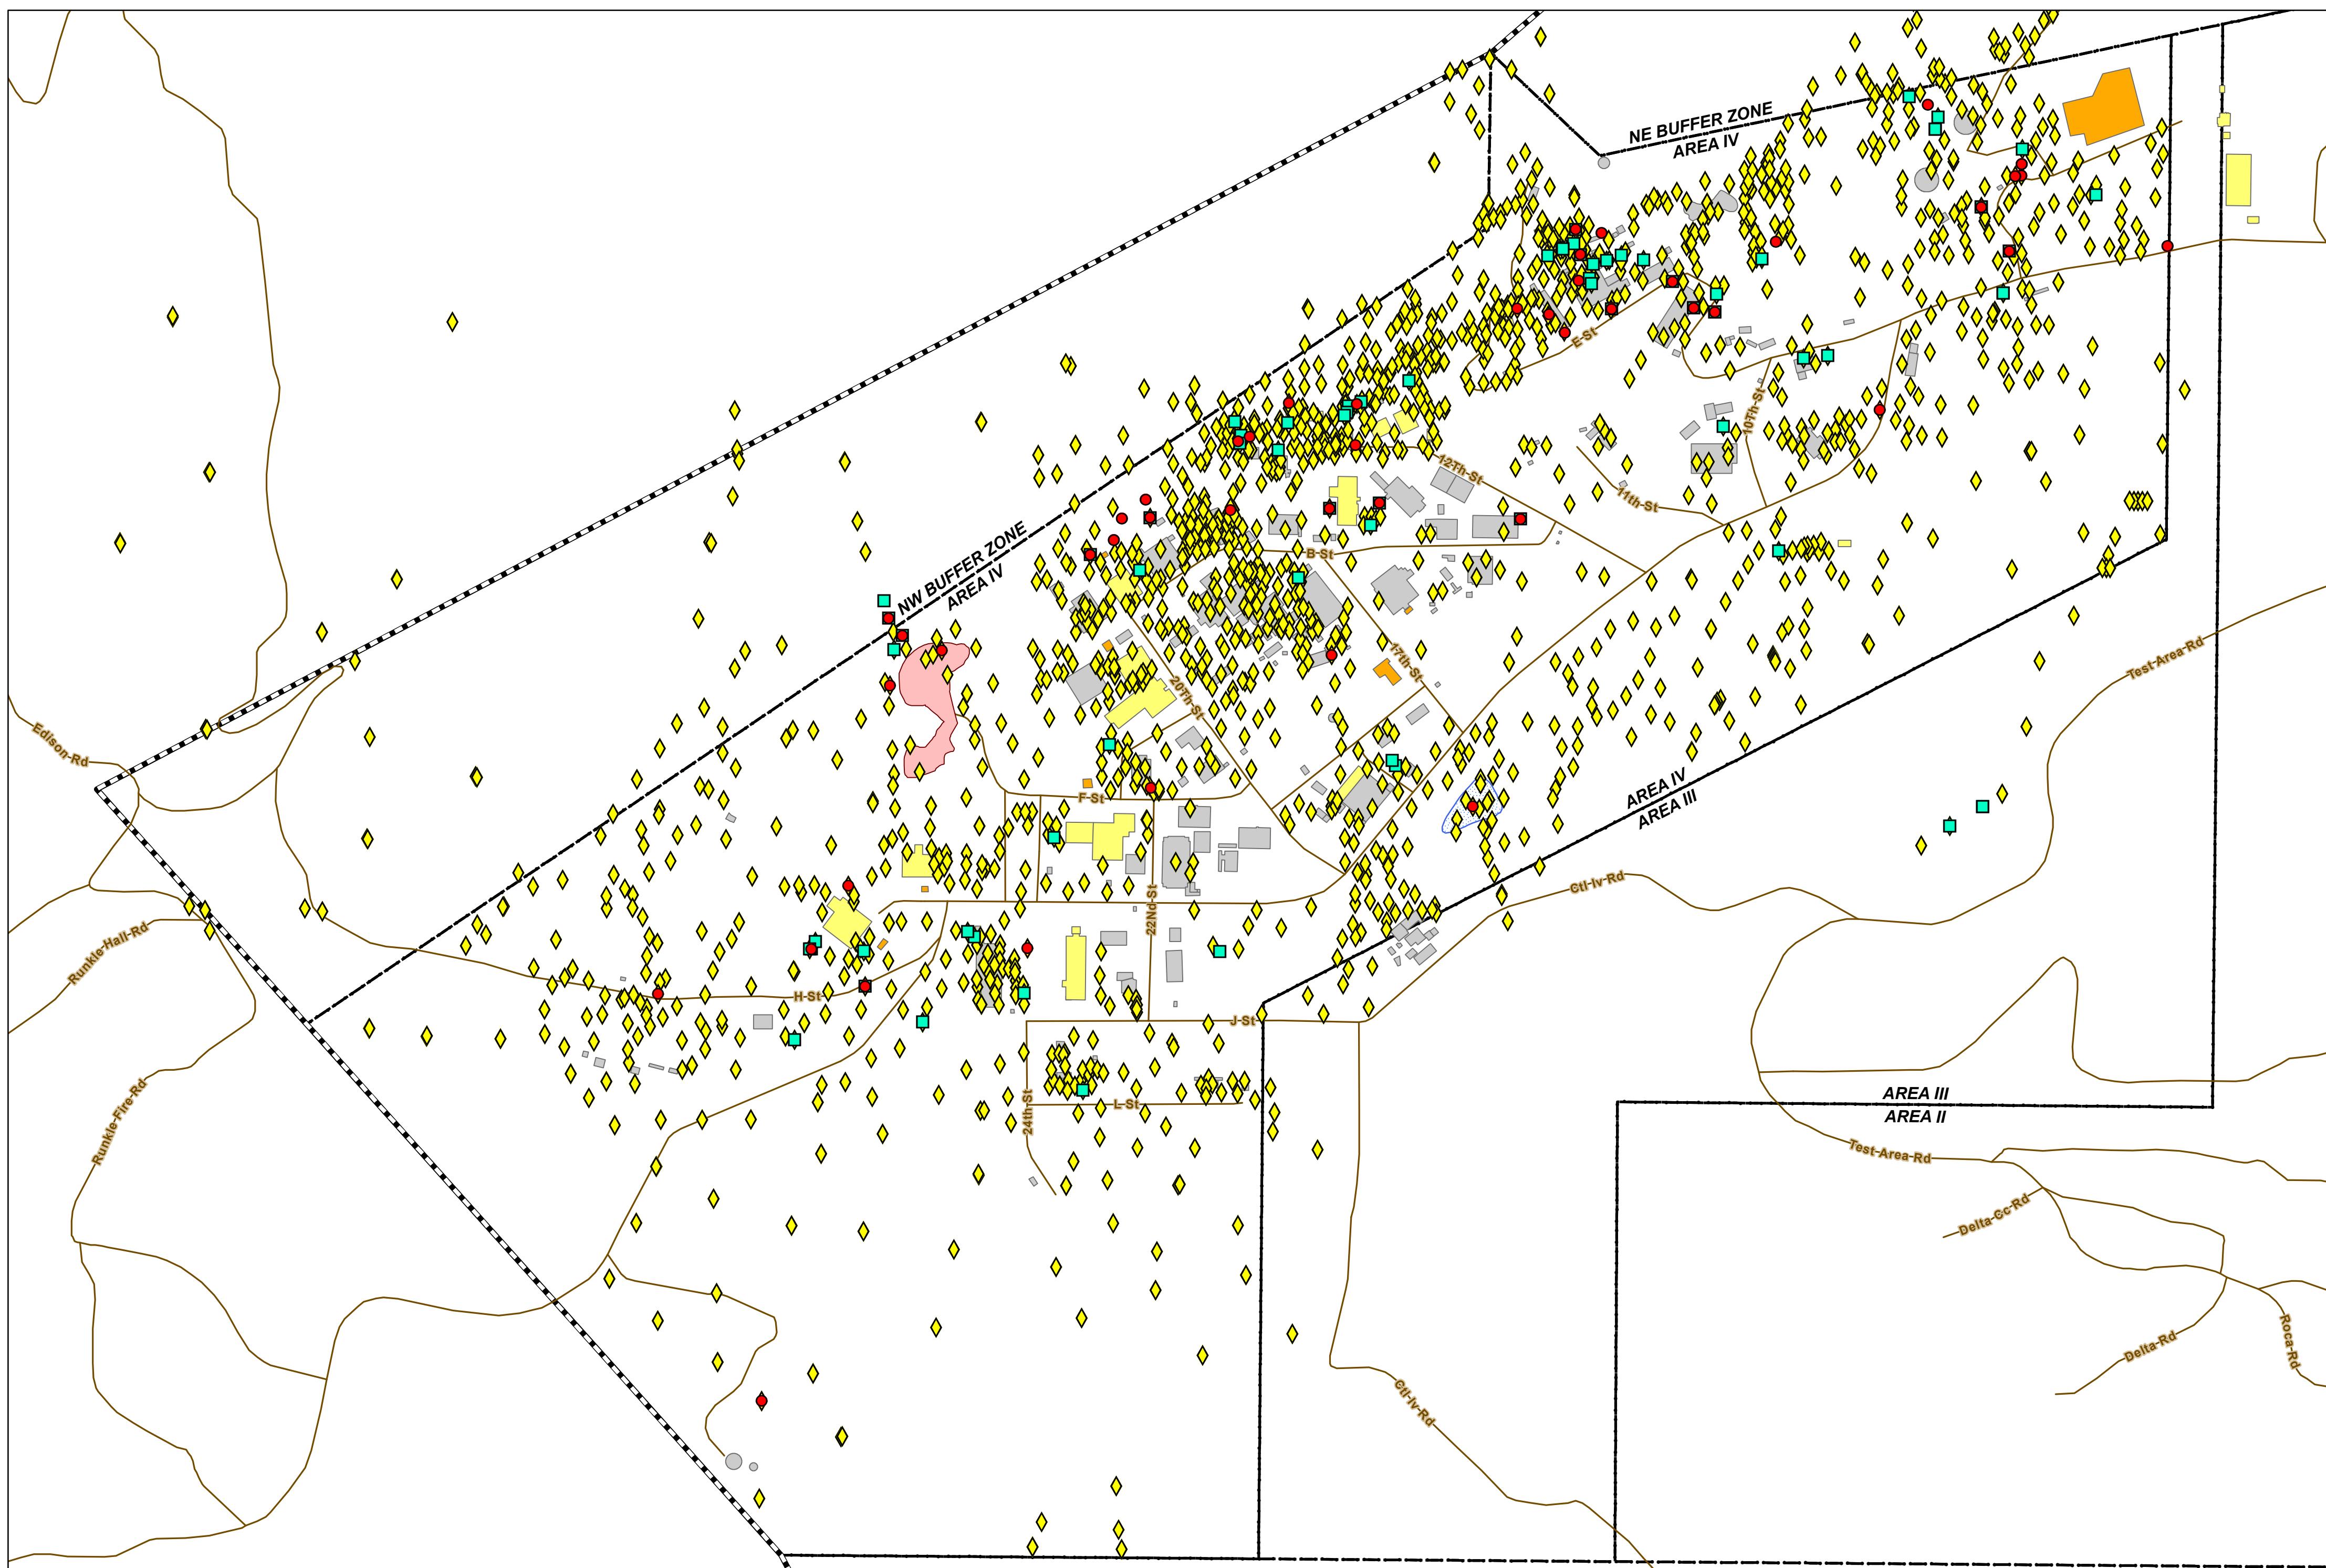
Figure 4-31 illustrates the distribution of medium carbon range TPH (C15-C20) above the LUT value of 5 milligrams per kilogram (mg/kg). There were very few exceedences above 500 mg/kg. Figure 4-32 illustrates the distribution of heavier carbon range TPH (>C20) above the LUT value of 5 mg/kg.
