*Final Environmental Impact Statement*  
*Thacker Pass Lithium Mine Project*

*Appendix M*

Visual Simulations

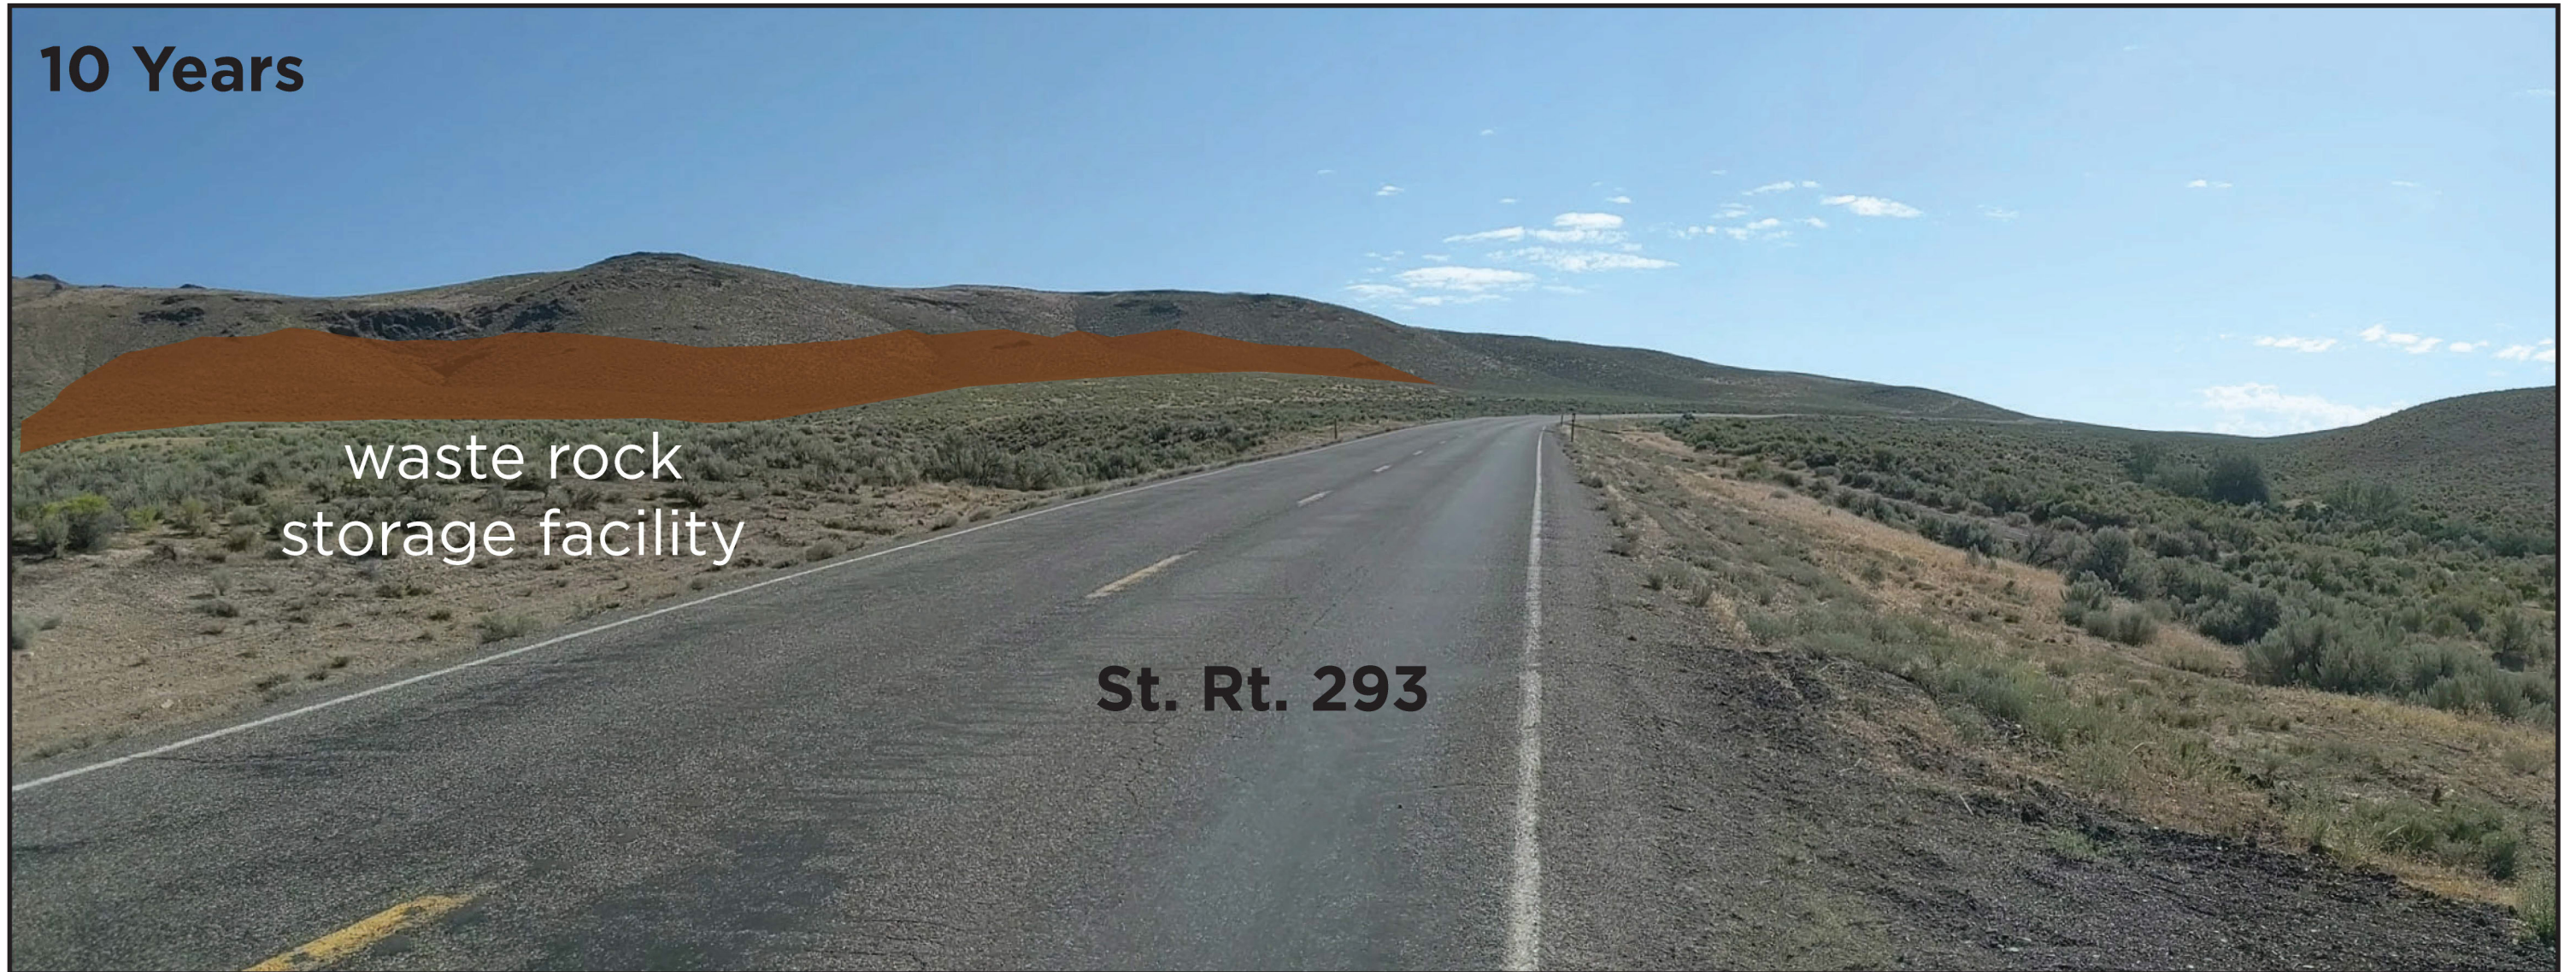
## Thacker Pass Project KOP 2

**10 Years**

waste rock  
storage facility

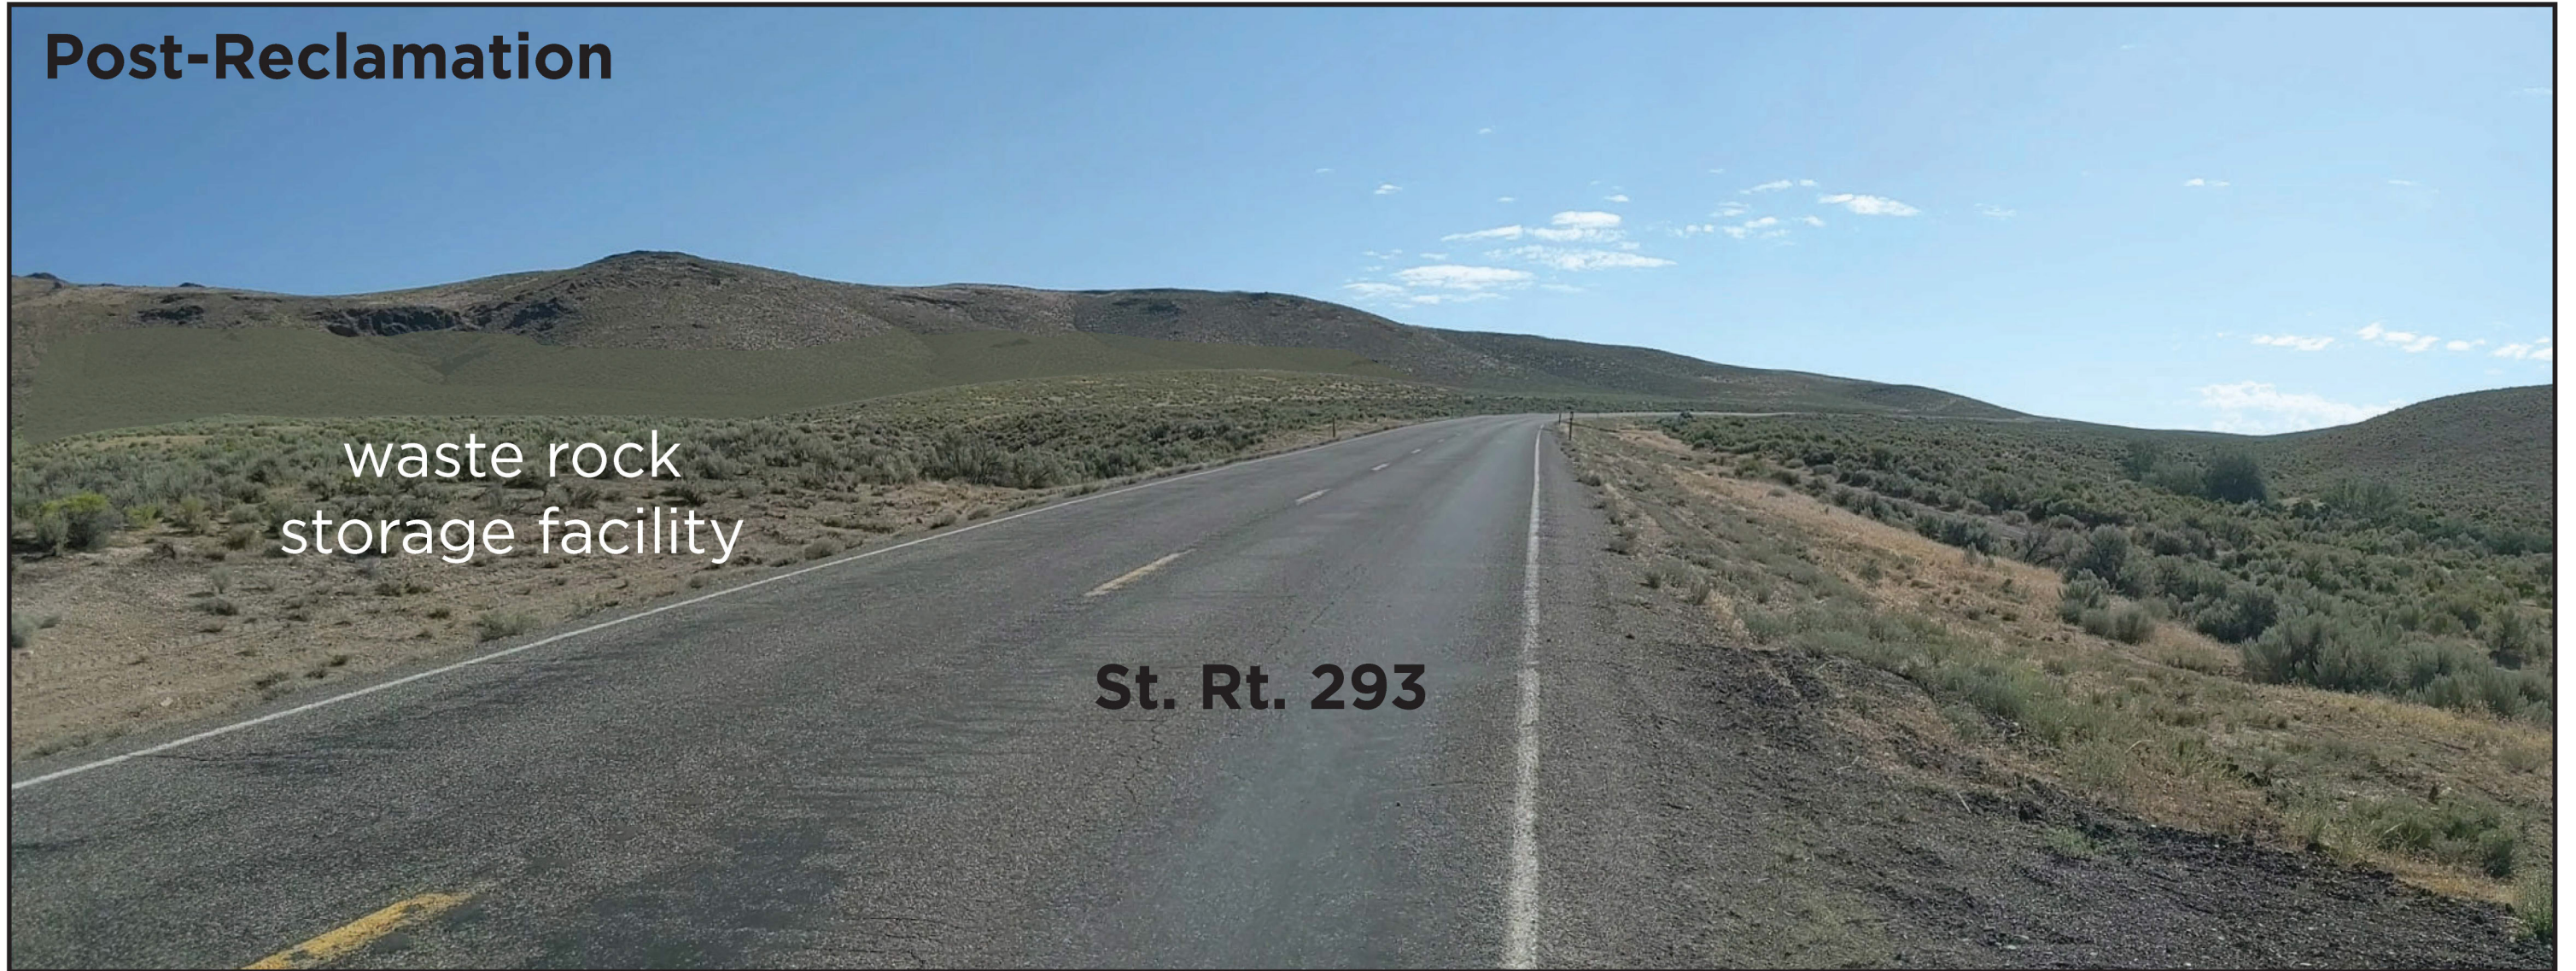
## Thacker Pass Project KOP 2

### Post-Reclamation

waste rock  
storage facility

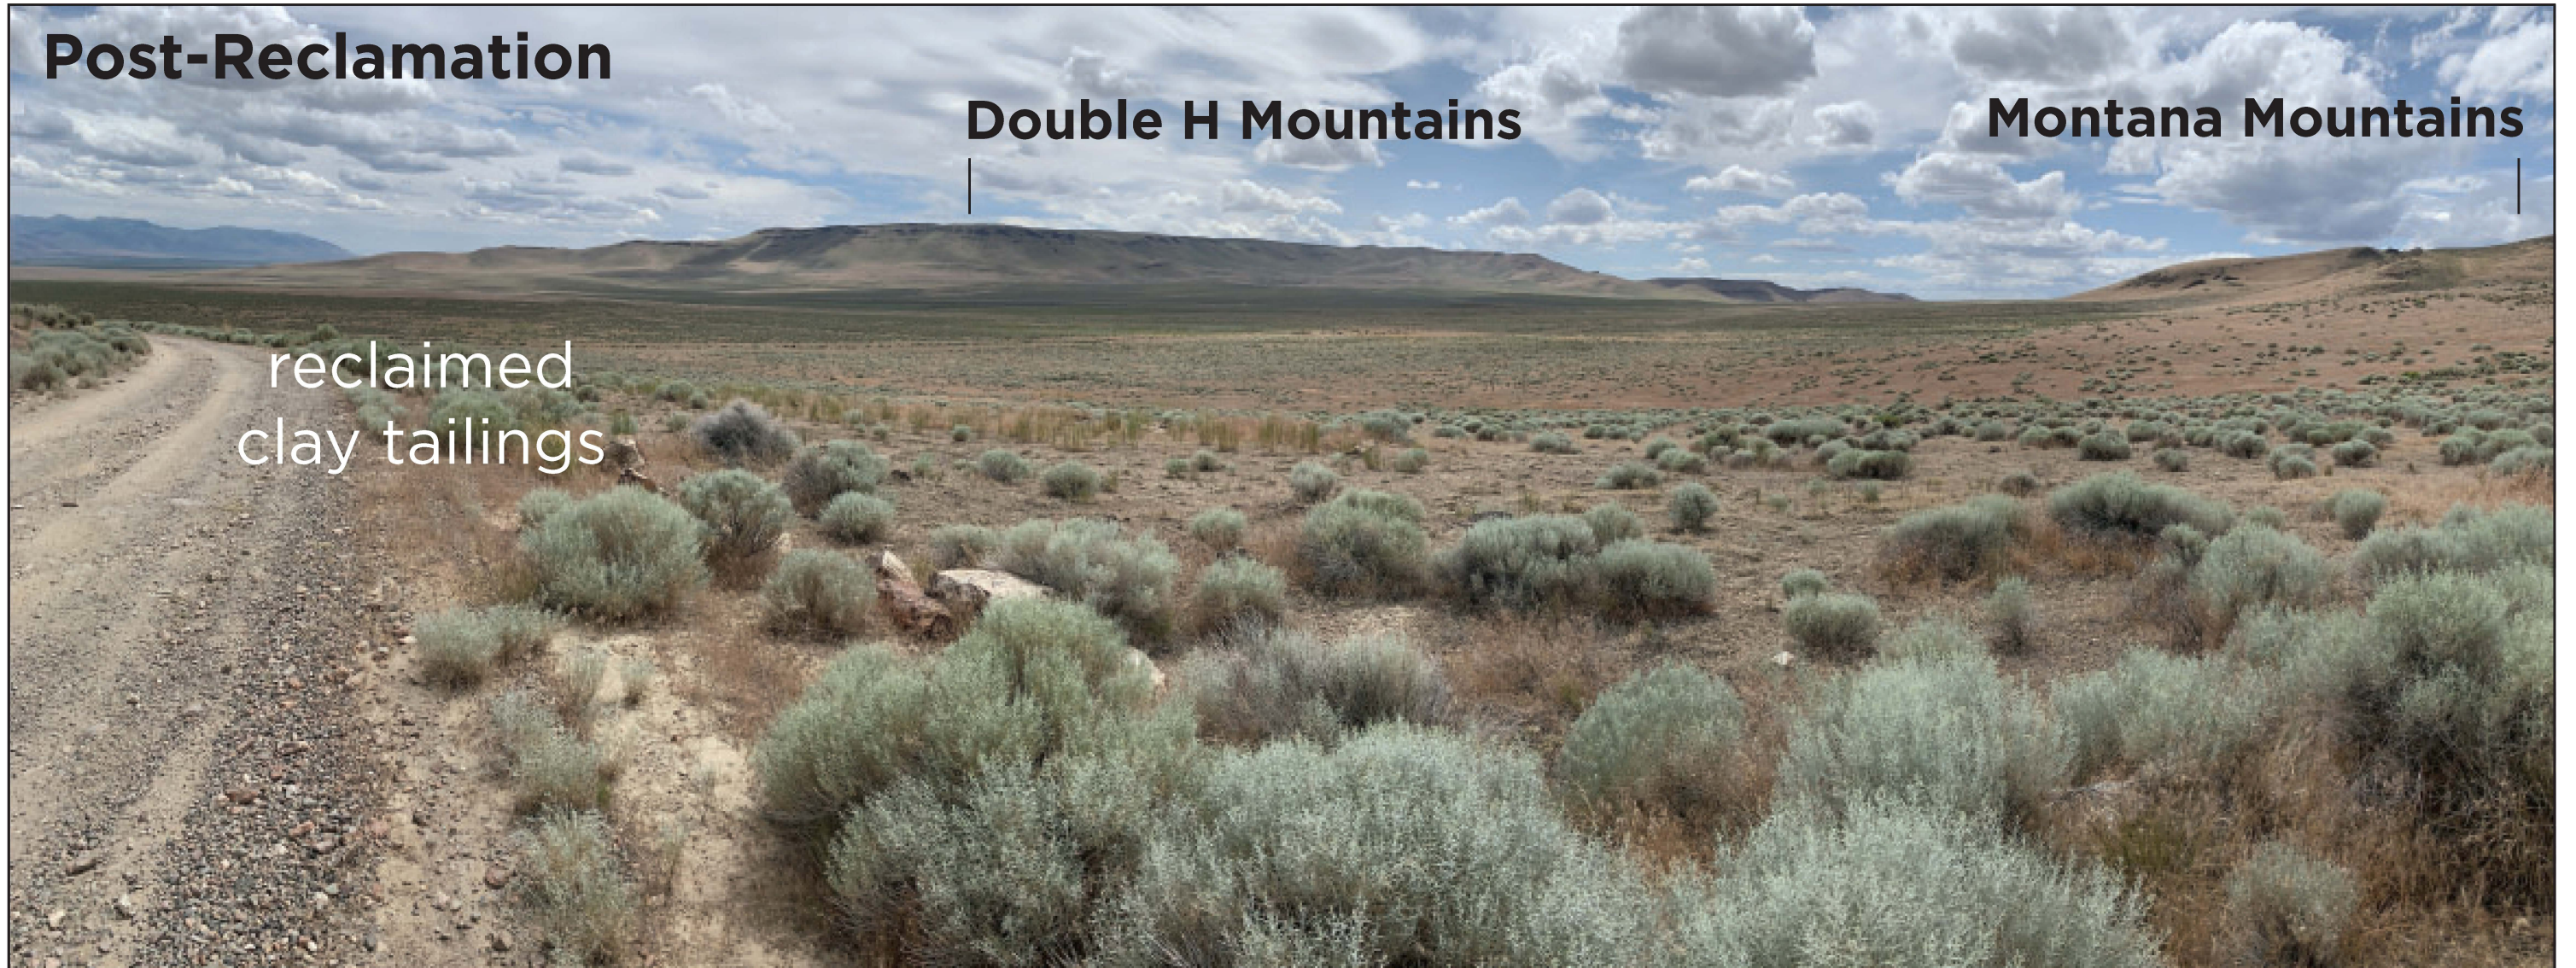
## Thacker Pass Project KOP 3

**Post-Reclamation**

reclaimed  
clay tailings

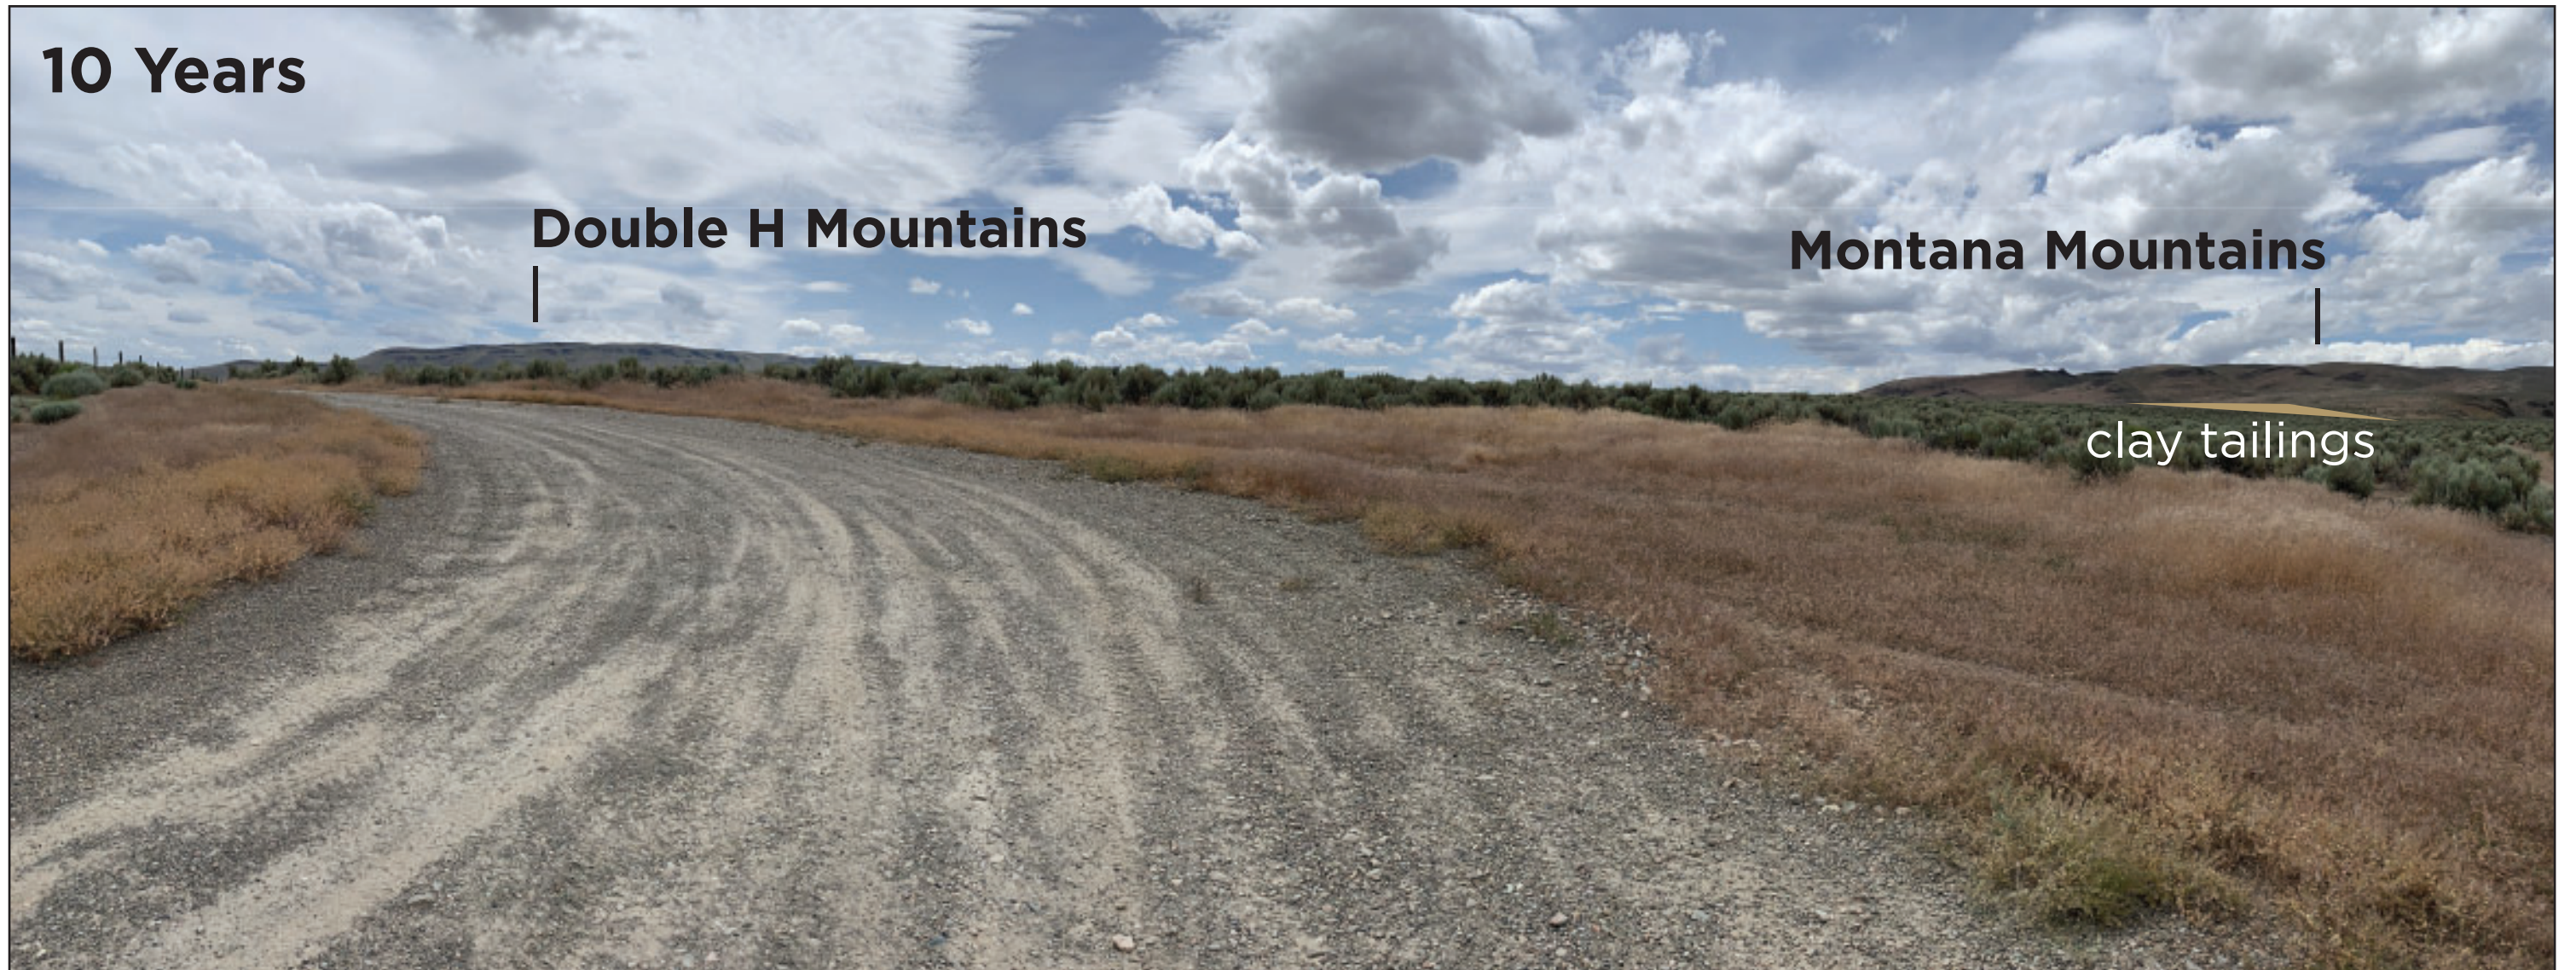
## Thacker Pass Project KOP 6

**10 Years**

clay tailings

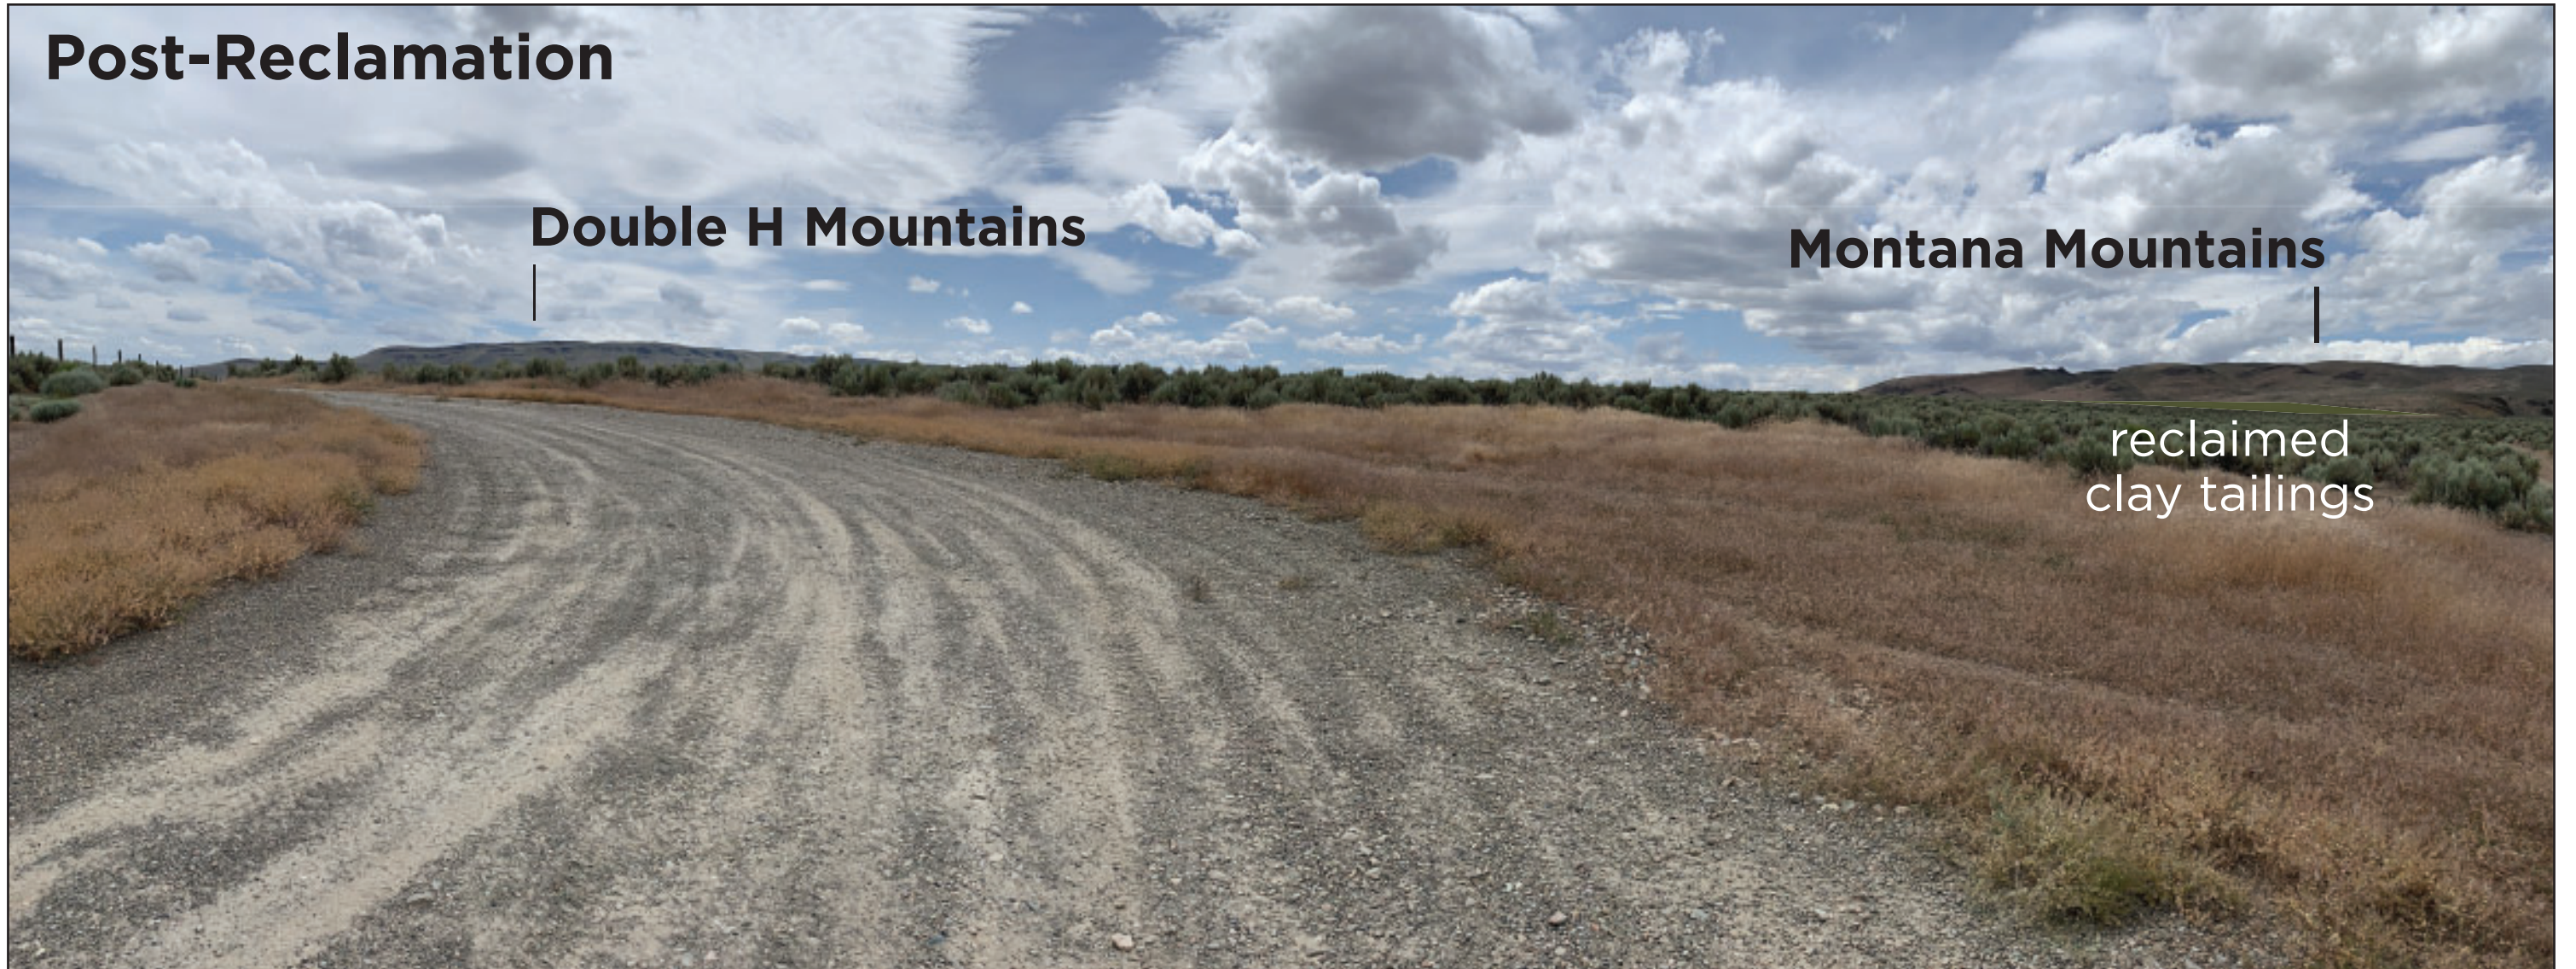
## Thacker Pass Project KOP 6

# Post-Reclamation

reclaimed  
clay tailings
