*Final Environmental Impact Statement*  
*Thacker Pass Lithium Mine Project*

*Appendix P, Part 8 of 8*

Water Information

| Location Map | |
|---|---|
| PROJECT: | Thacker Pass Hydrologic Baseline |

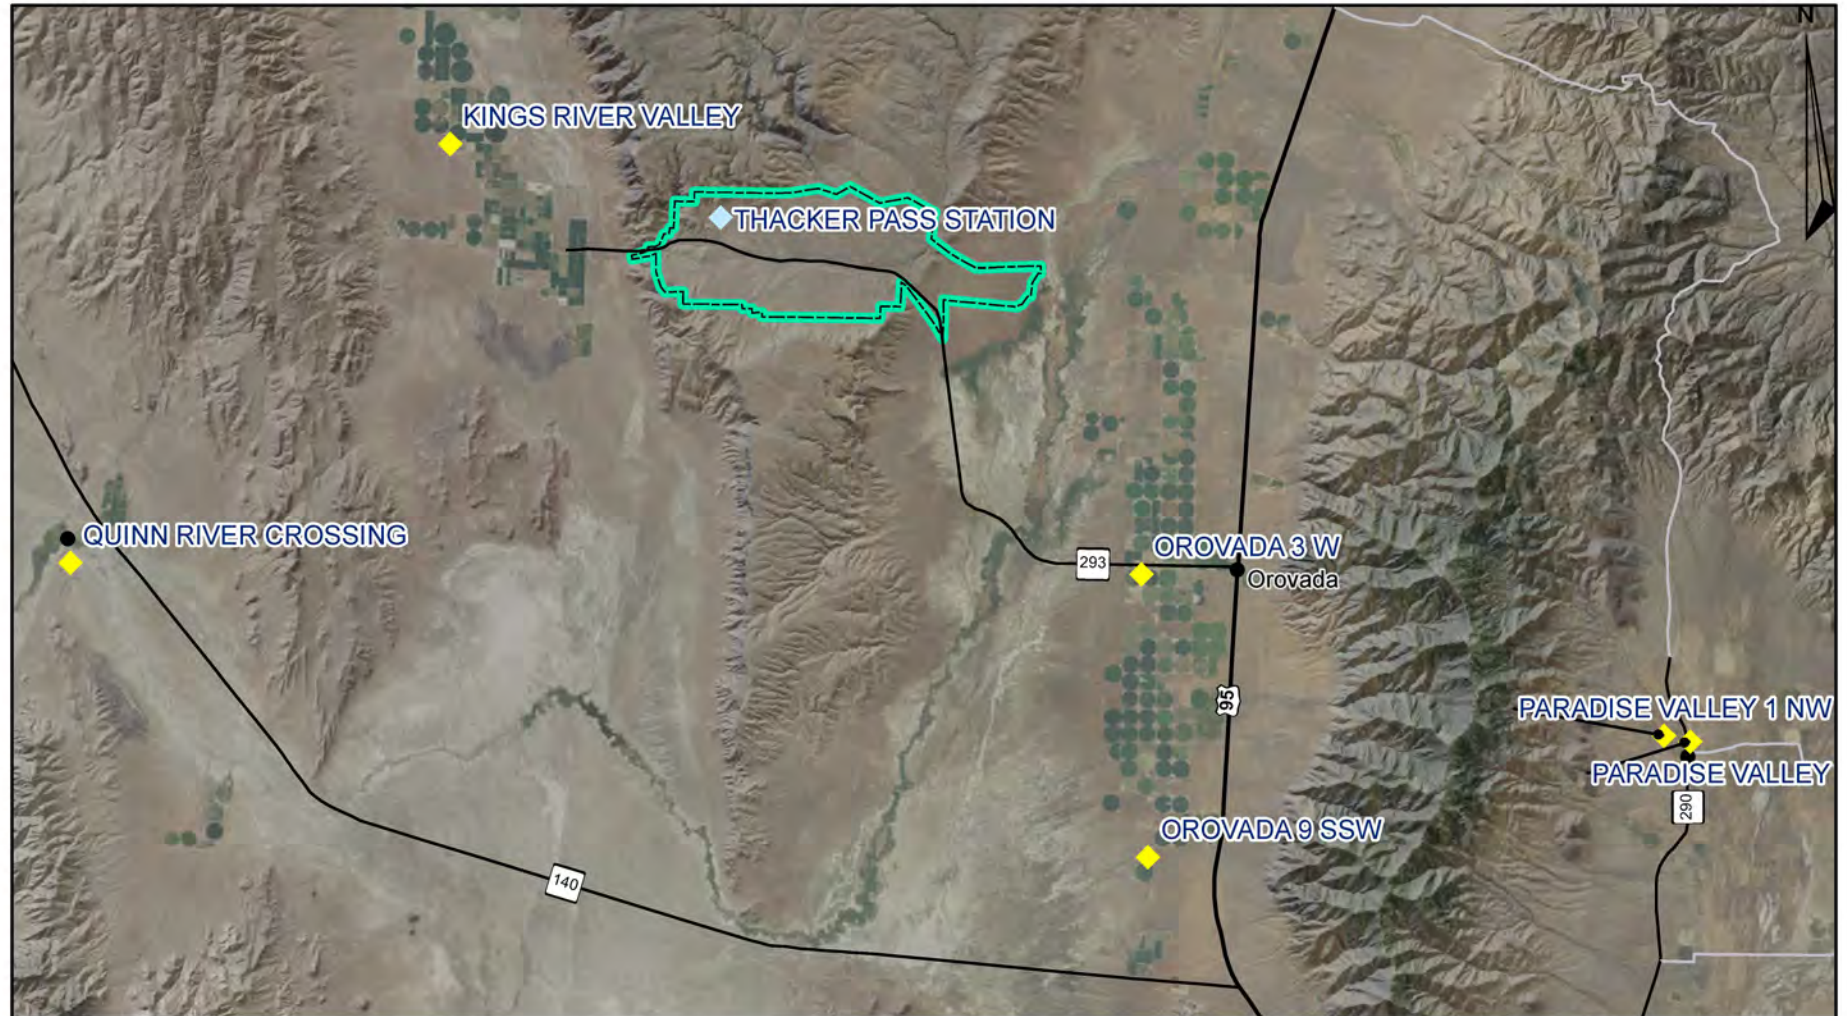
| FIGURE: | 2.2 | |

## Meteorological Station Locations

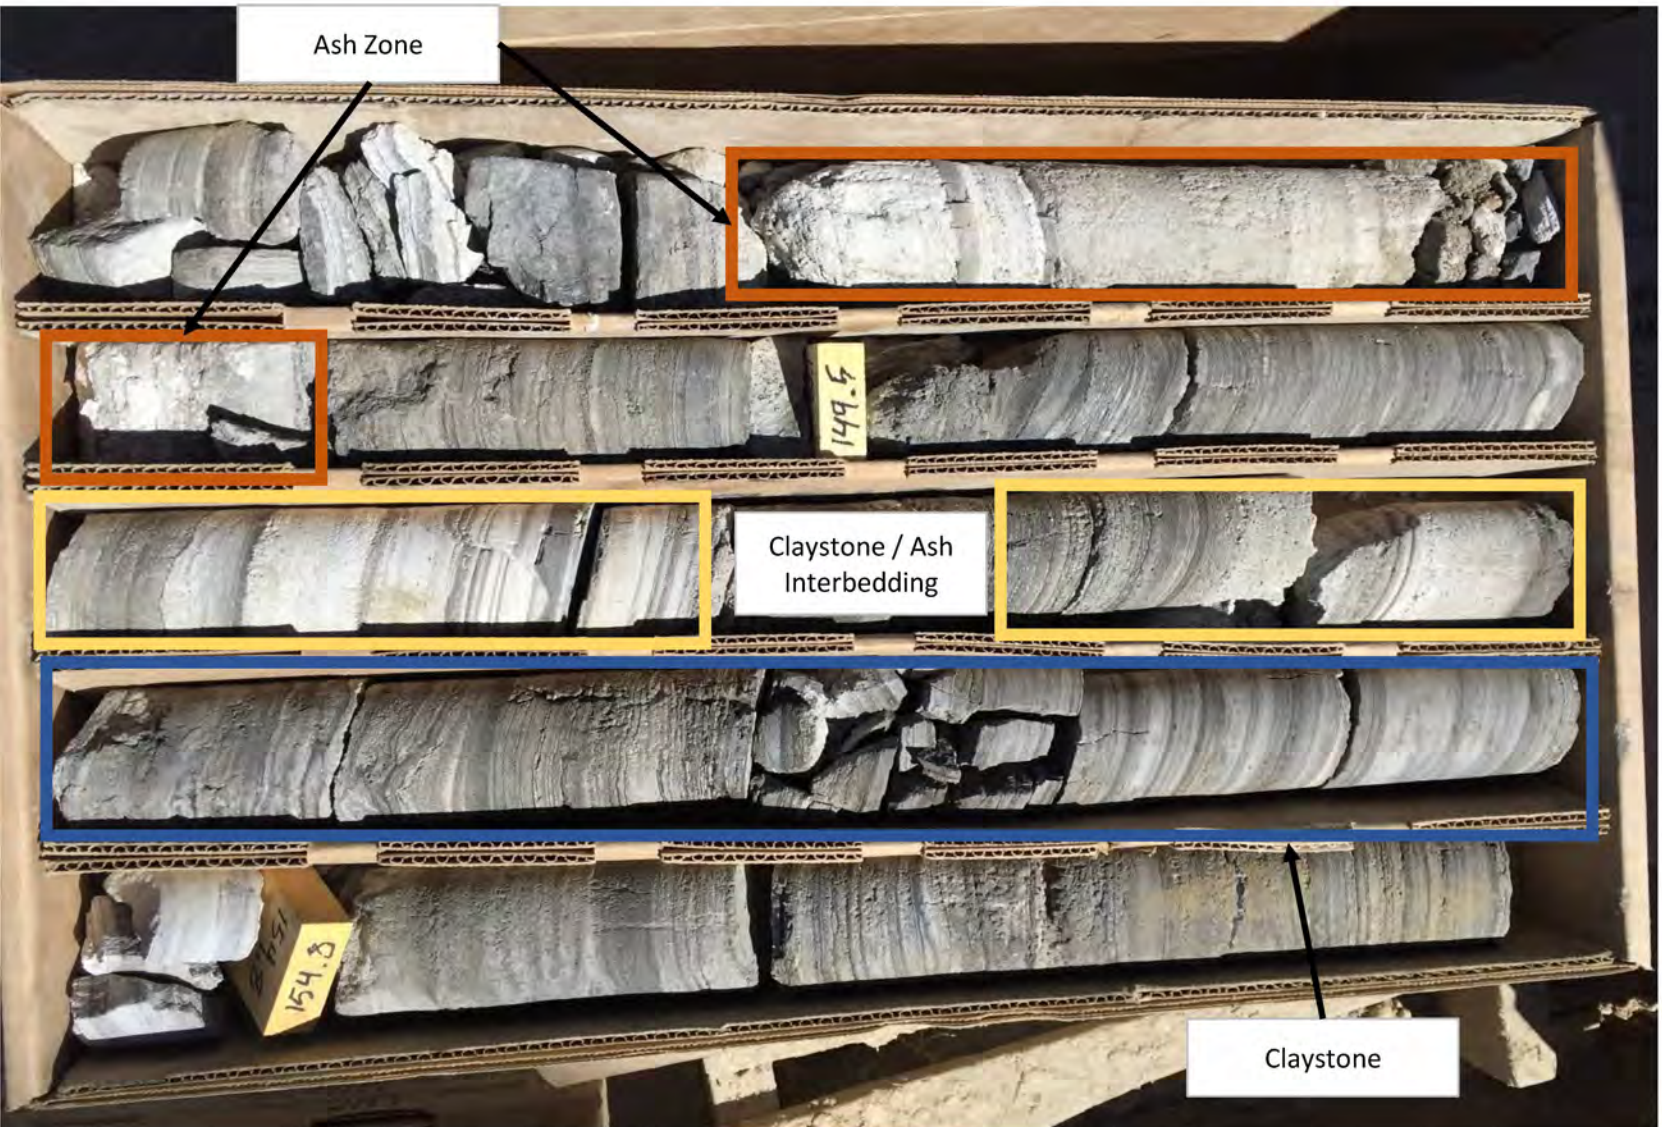
| DATE: | AUGUST 2019 | FIGURE: | 2.11 |

Core Photos: Claystone / Ash Units

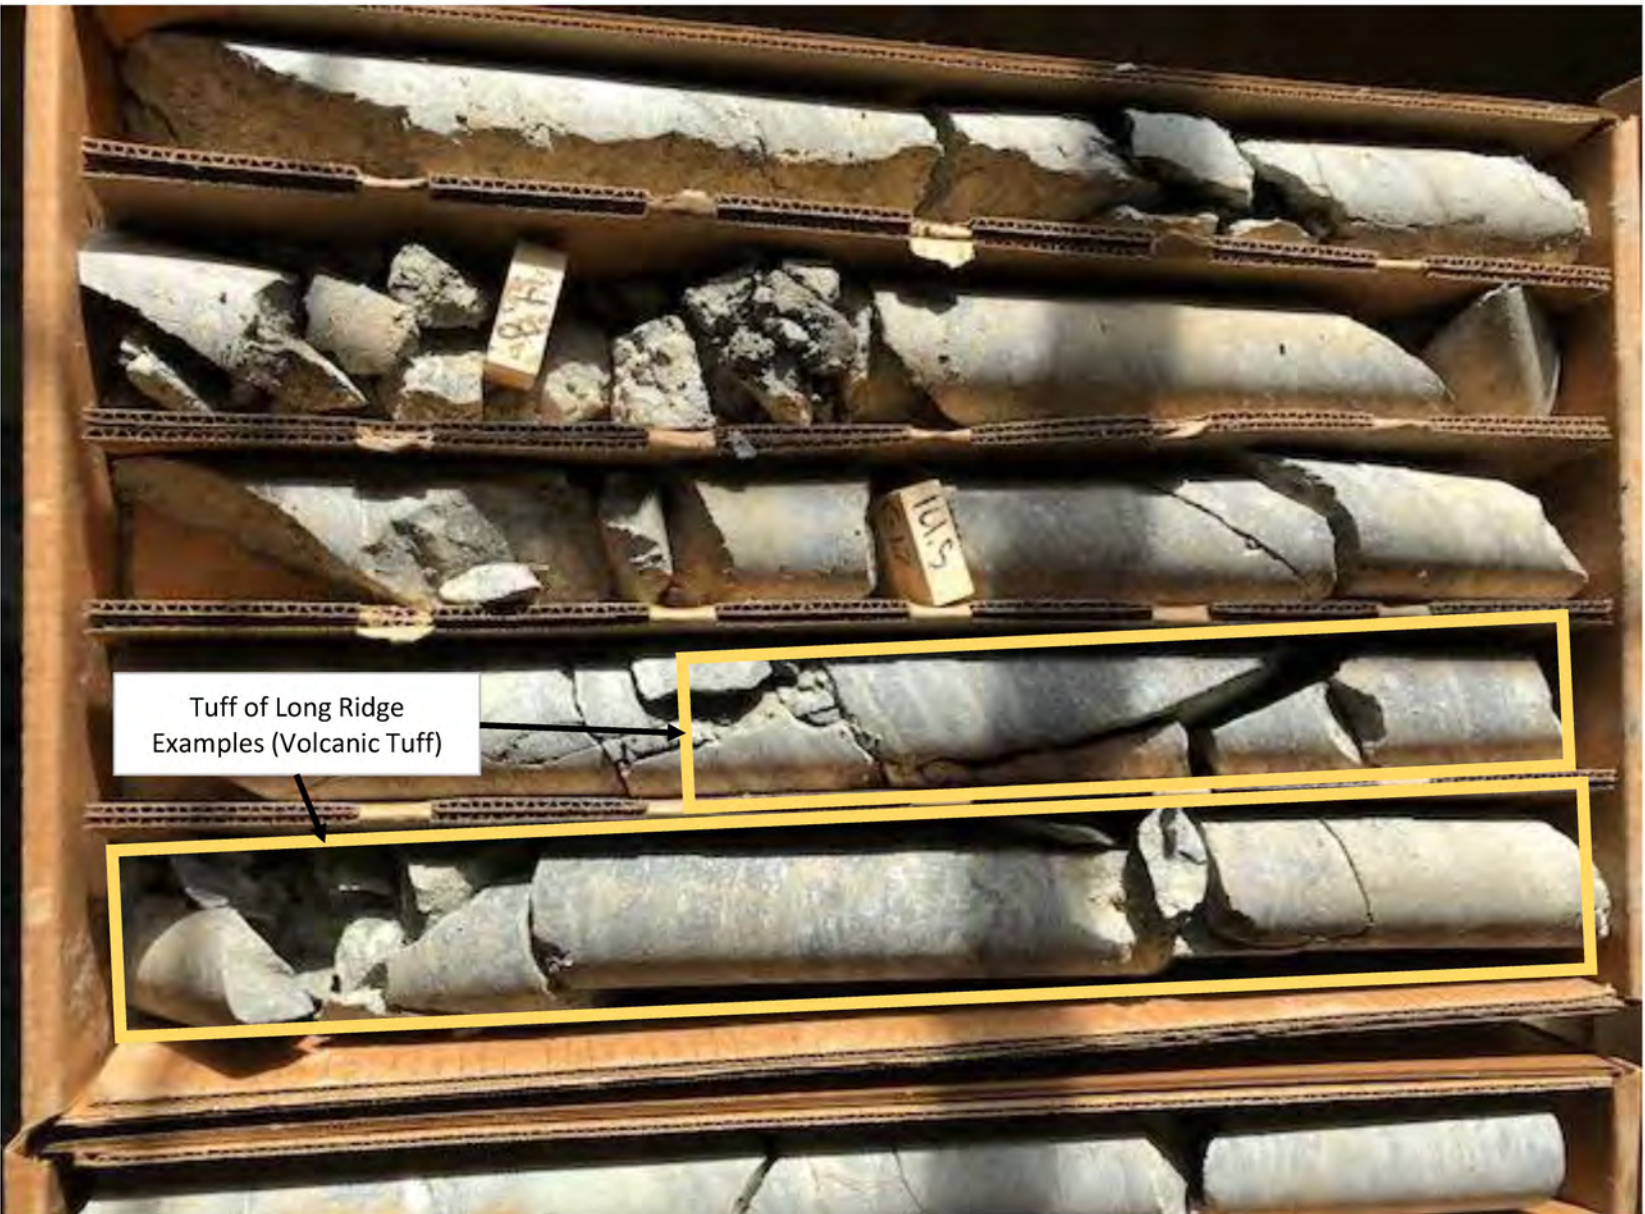
FIGURE: 2.13

Core Photos: Tuff of Long Ridge (Volcanic Tuff)
