RMDF LEACH FIELD

DECONTAMINATION

FINAL REPORT

Rockwell International

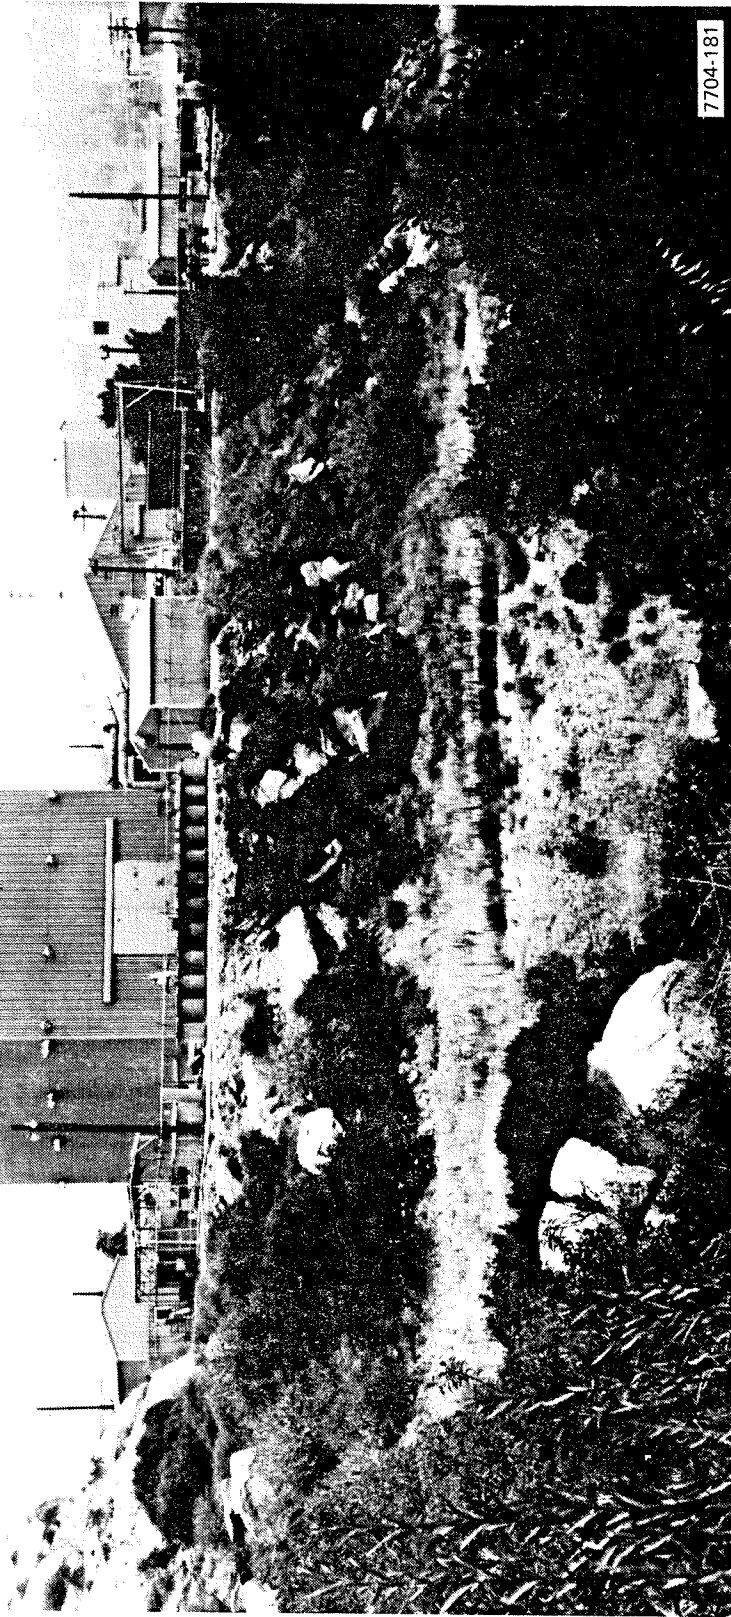
surface at the conclusion of the project in 1978. This protected the area from wind and water erosion. It was graded and contoured to pass surface water to the west, and erosion control was provided by seeding rye grass on all of the disturbed soil areas. Figure 4 is a photograph of the leach field as it exists today.

Figure 4. RMDF Leach Field Looking South

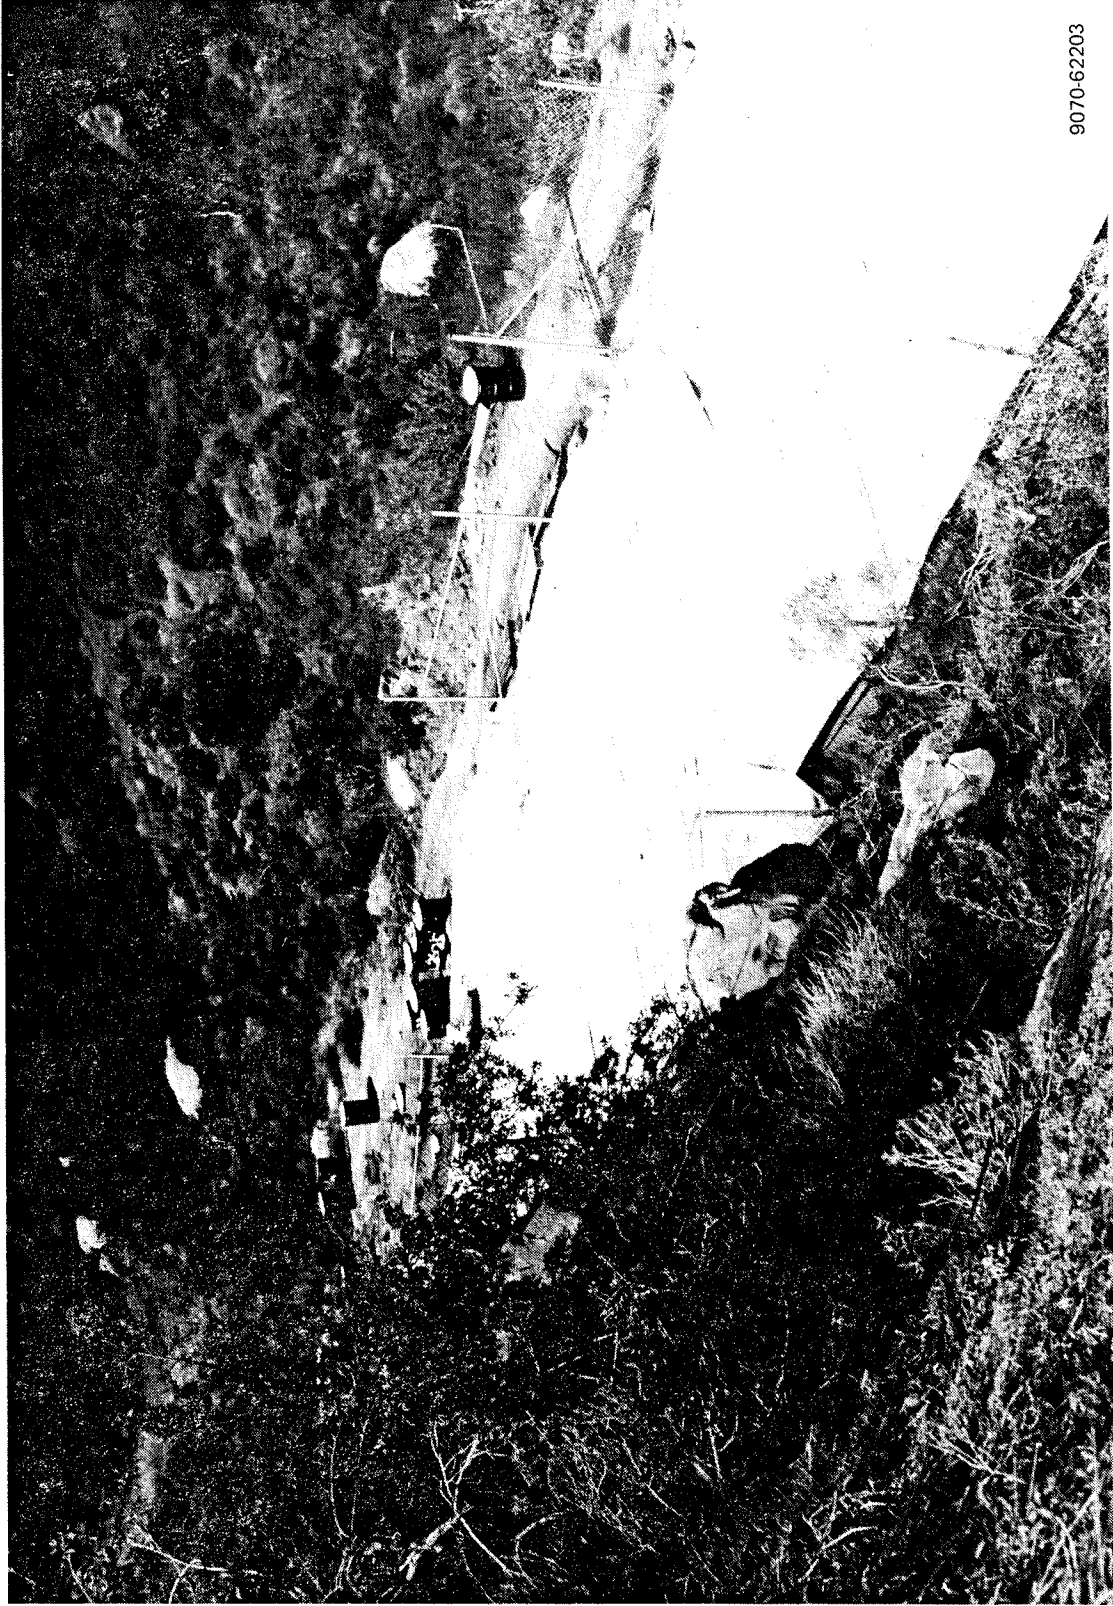
9070-62203

Following the survey, the field was covered with plastic and plywood to protect the area from surface water that could percolate or run into the test holes and cause further migration of the radioactive materials.

Figure 12. Protective Plywood and Plastic Sheeting Covering Leach Field

The decontamination progressed over several years of intermittent activity. The contamination was uncovered in 1975 by the exploration of the distribution box. The removal of all plant materials from the site followed. The site was fenced, posted, and protected from any further activity. During 1976, the decontamination plans were prepared, and the test holes were bored. The field, perforated with the test holes, was protected from rainwater and storm runoff during the intense winter rainfall of 1977/1978 by the plywood and sheet plastic protective cover shown in Figure 12. Early in 1978, the cover was removed and salvaged.

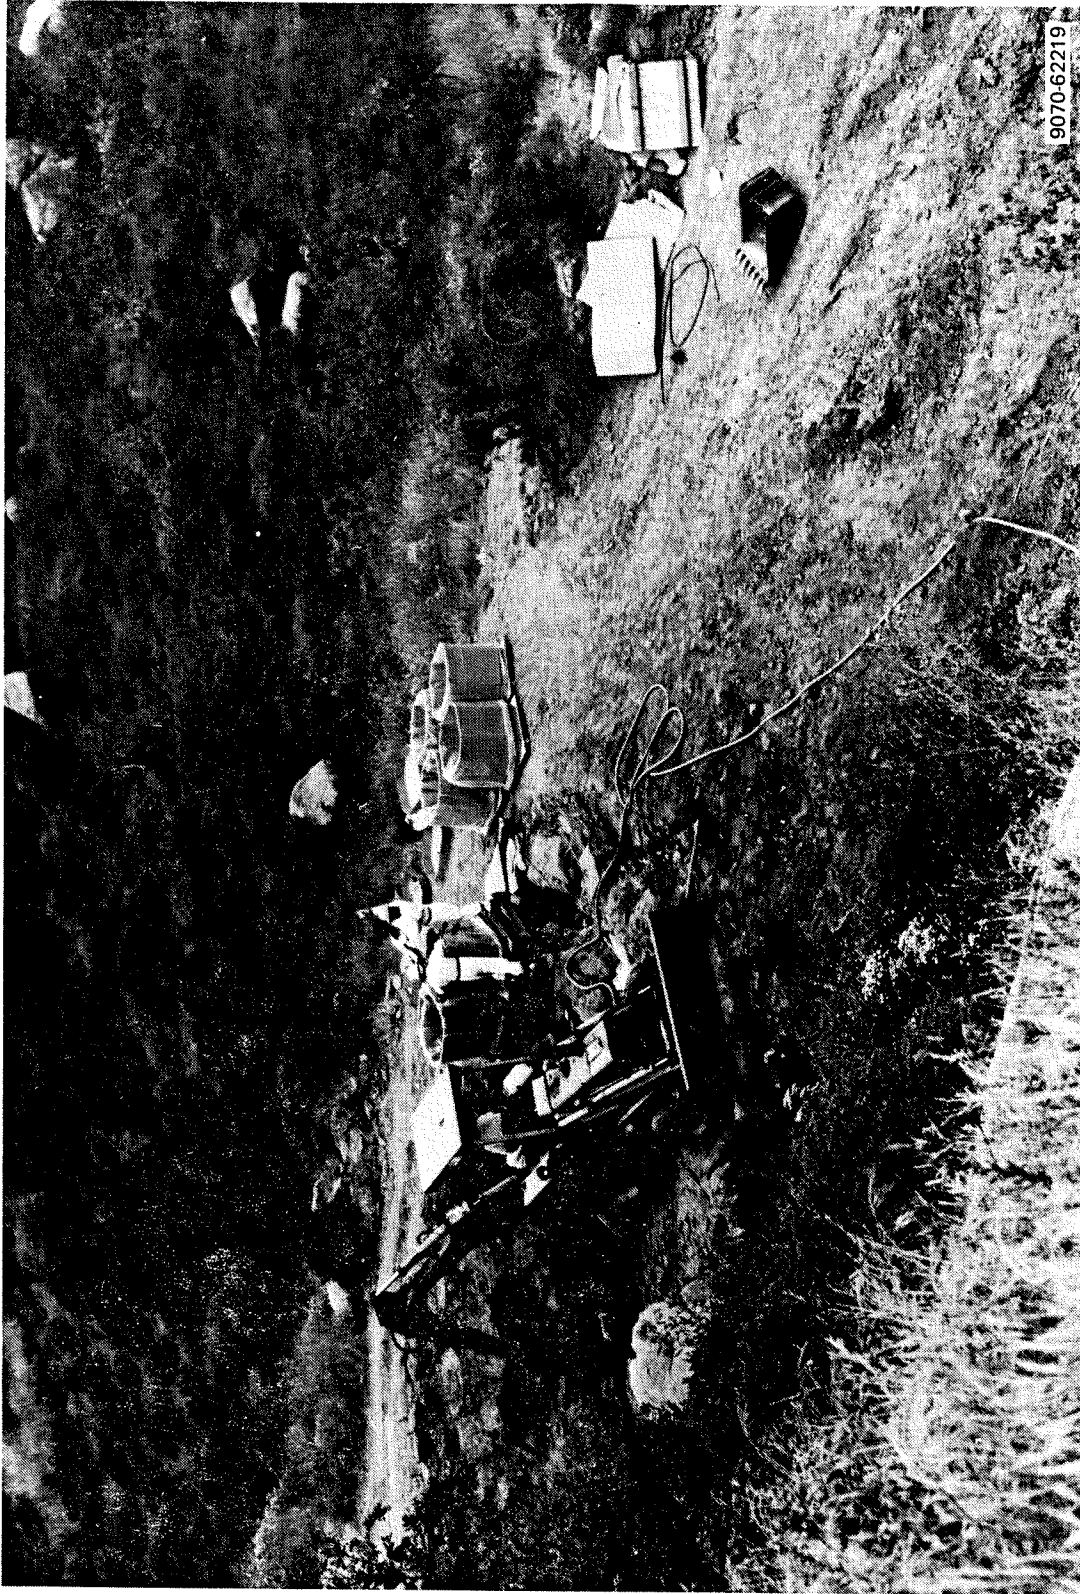
Figure 13. Initiation of Leach Field Excavation

Excavation of the noncontaminated overburden started in mid-1978 at the west end of the field and progressed easterly using a conventional backhoe (shown in Figure 13). The material having the highest level of radiation was removed next to reduce the radioactive background at the site and to eliminate the possibility of spreading this material, since the only working access to the other end of the field was across this area.

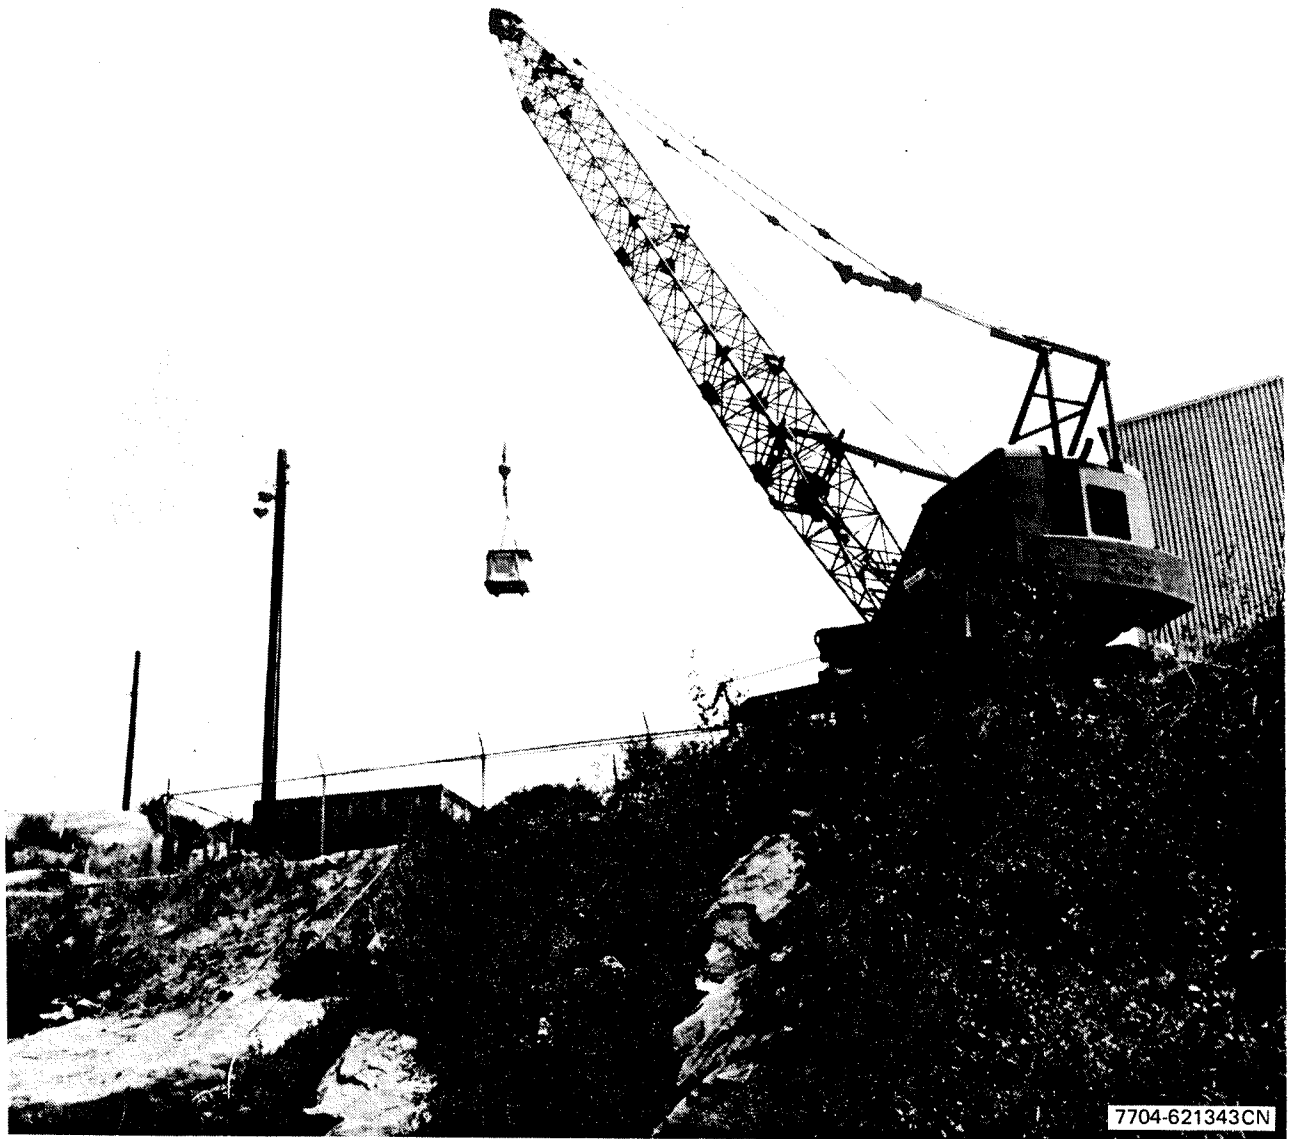
Figure 16. Crane Hoisting Soil Container from Leach Field

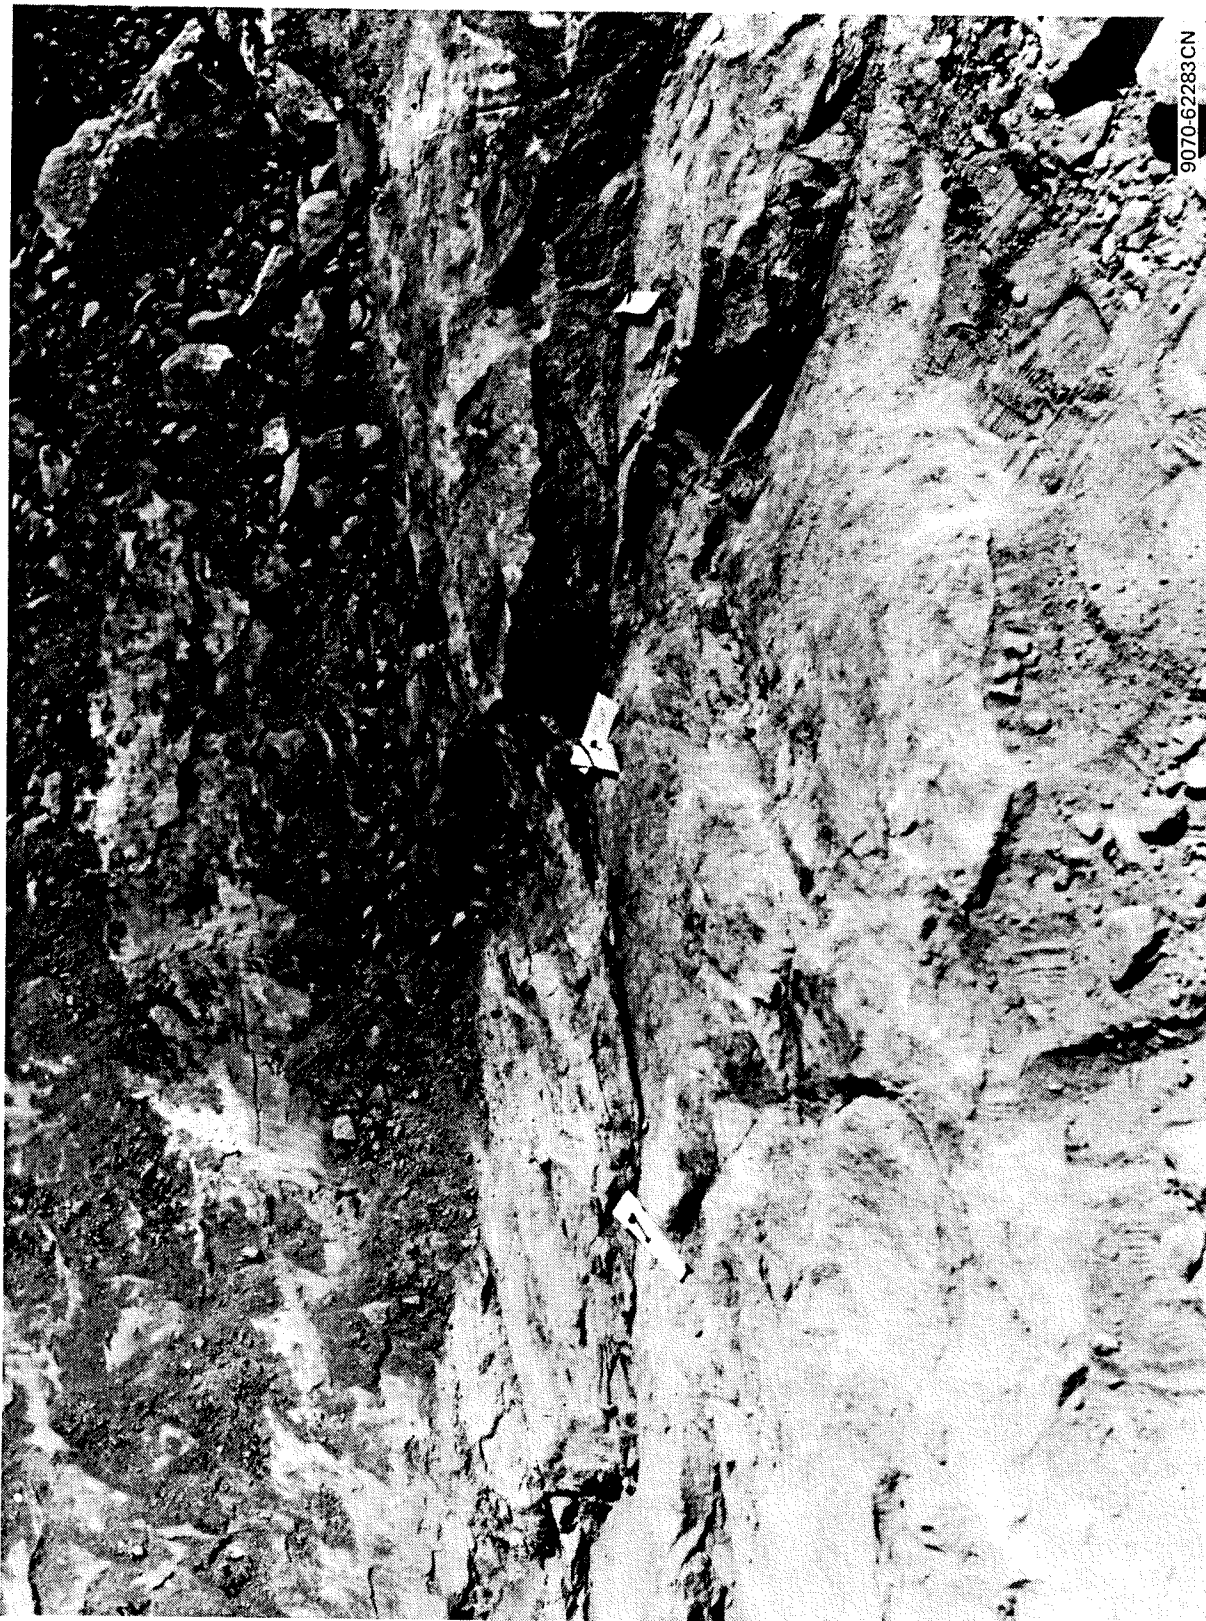
Several small areas continued to show radioactive material in loosely cemented fractures and relatively uncemented cracks (illustrated in Figure 18). This contamination was followed using the same rock removal techniques, except more localized, which resulted in mining out holes up to 10 ft deep (illustrated in Figures 19 and 20). Figure 21 illustrates the protective covering used at this stage of the project to protect the workings from a summer rainstorm.

Figure 18. Contaminated Rock Fractures

The remaining loose gravel and soil left by the backhoe was removed with hand shovels to the underlying sandstone rock surface. Radiological surveys indicated that some radioactive material had penetrated the pores and fractures in the rock. A Hy-Ram* was used to crush and split off the surface of the rock about 6 in. deep in each pass. This material was scraped up and removed with a skip loader. The final scraping was done by hand to ensure complete removal. All remaining contaminated areas were processed with the same techniques to ensure complete removal of radioactive materials.

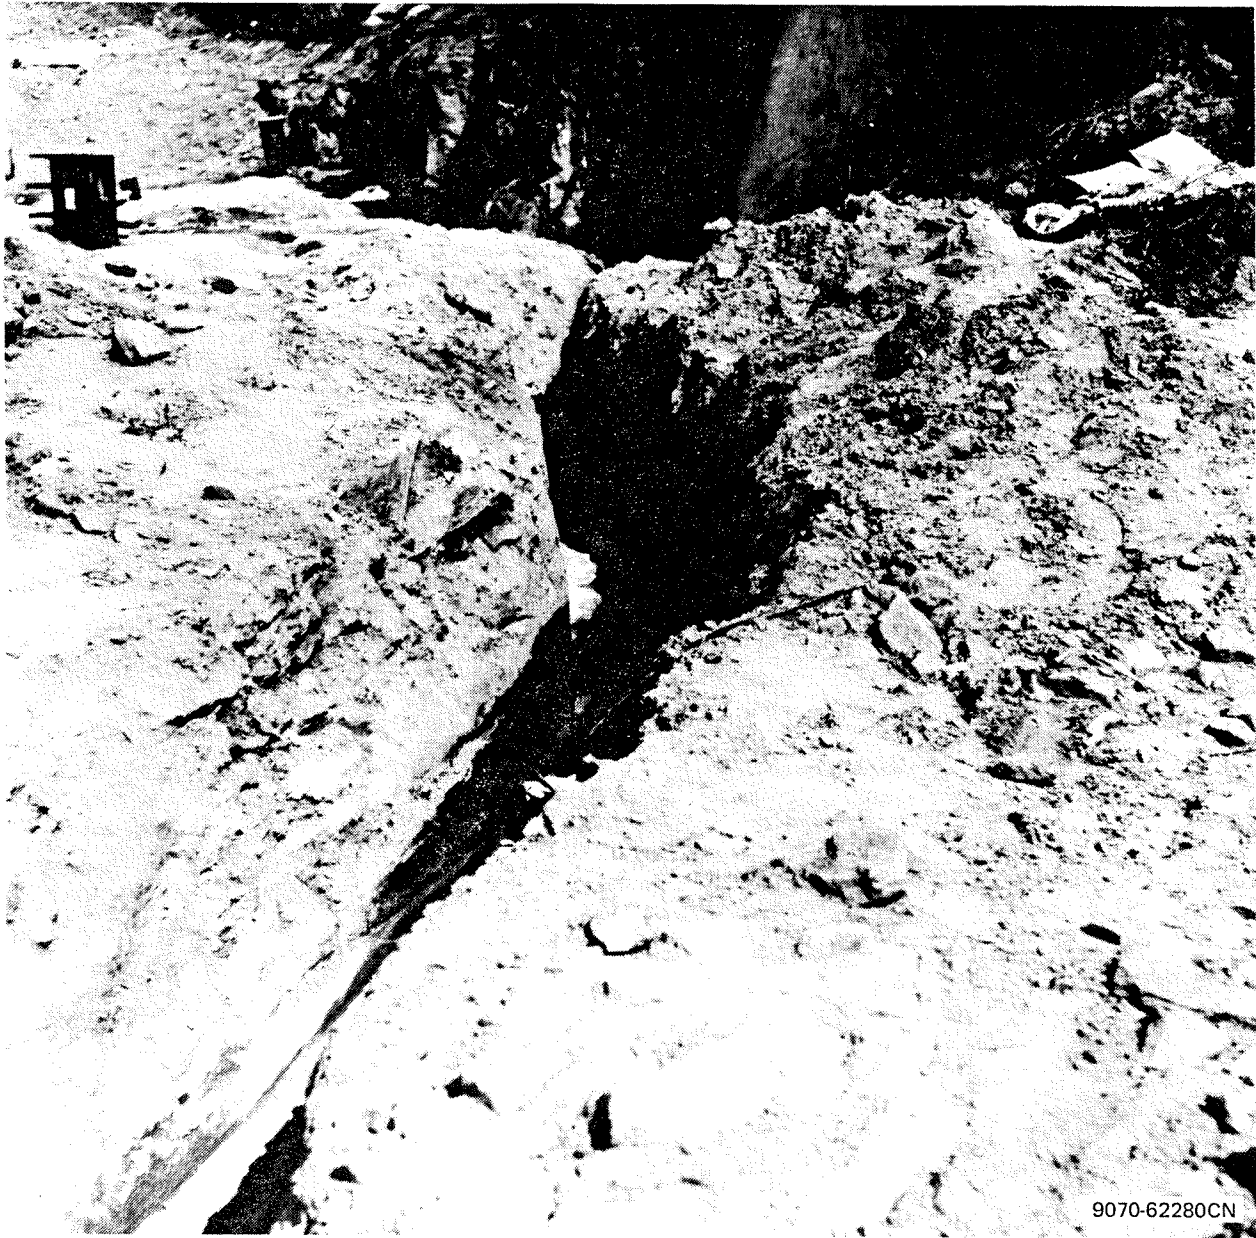
Figure 19. Contamination Removal from Rock Fracture

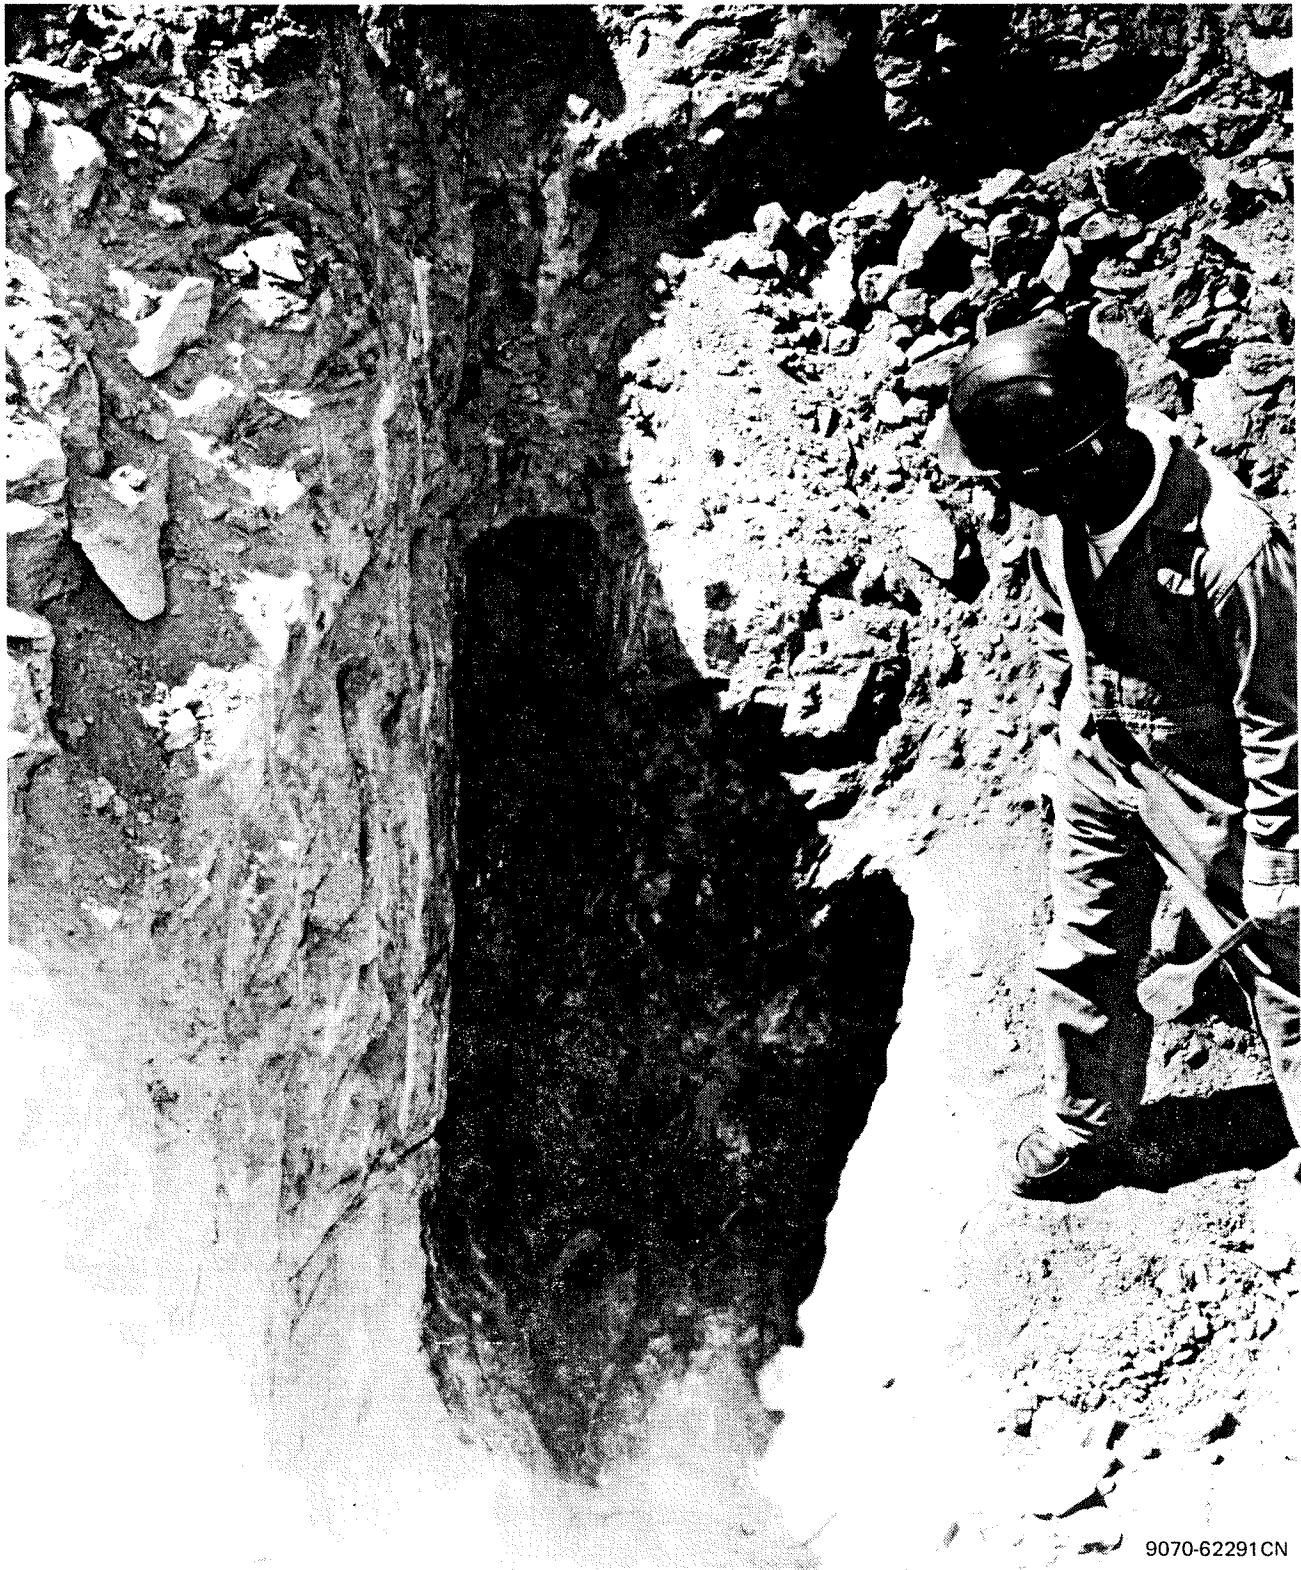
9070-62291CN

Figure 20. Close-up Photograph of Contamination Removal from Rock Fracture

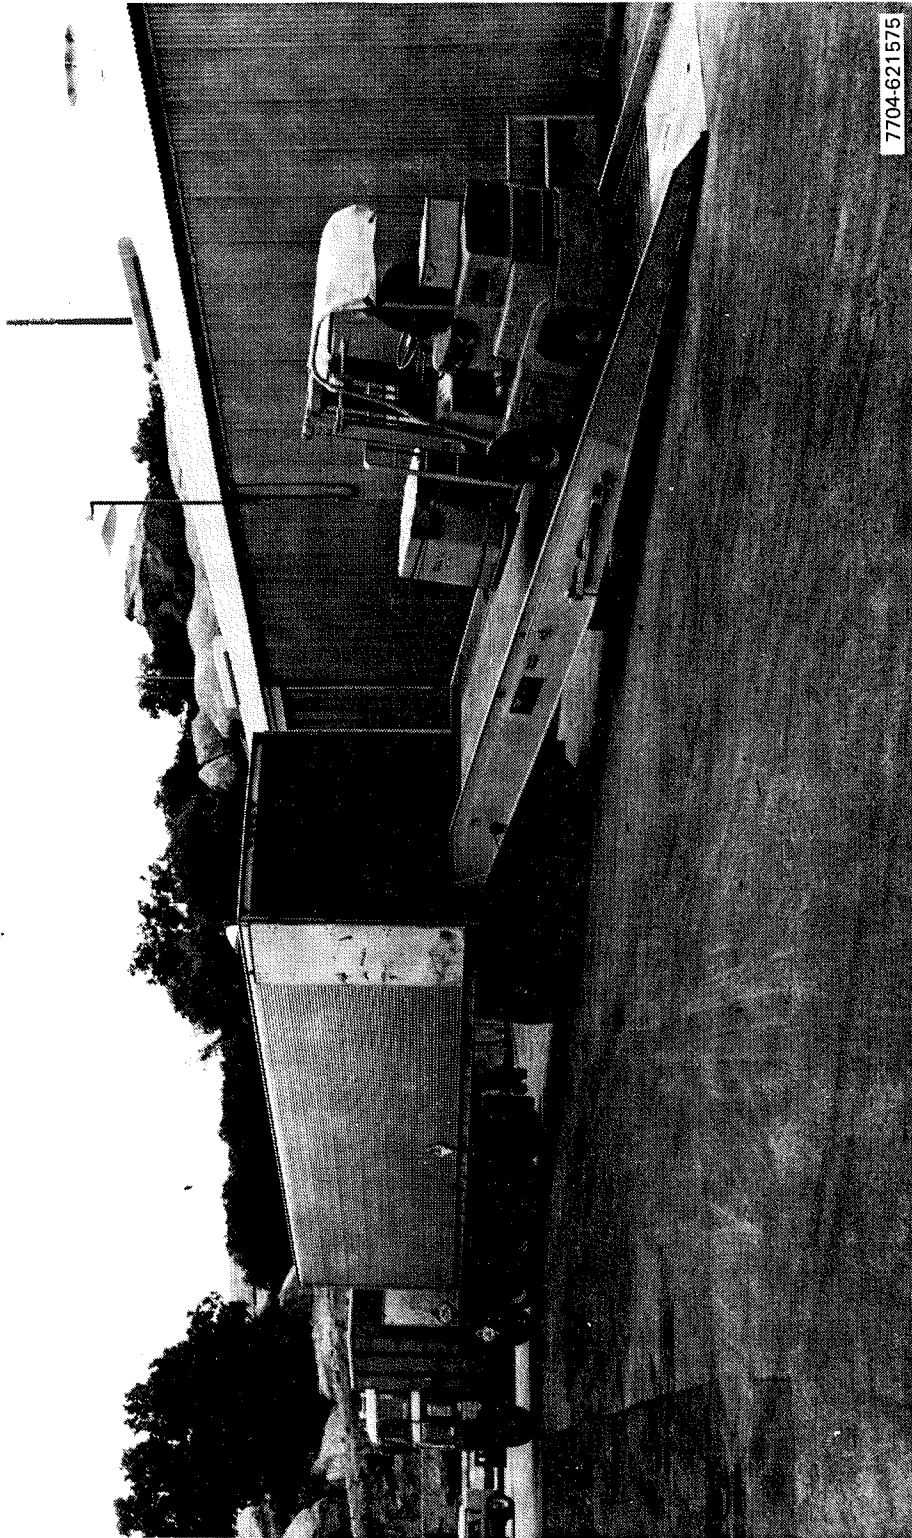
The boxes were transported in a closed van-type truck. The loading operation is shown in Figure 27. Only one layer of boxes could be placed in the van without exceeding its weight limit.

Figure 27. Loading of Soil Containers into Closed Van

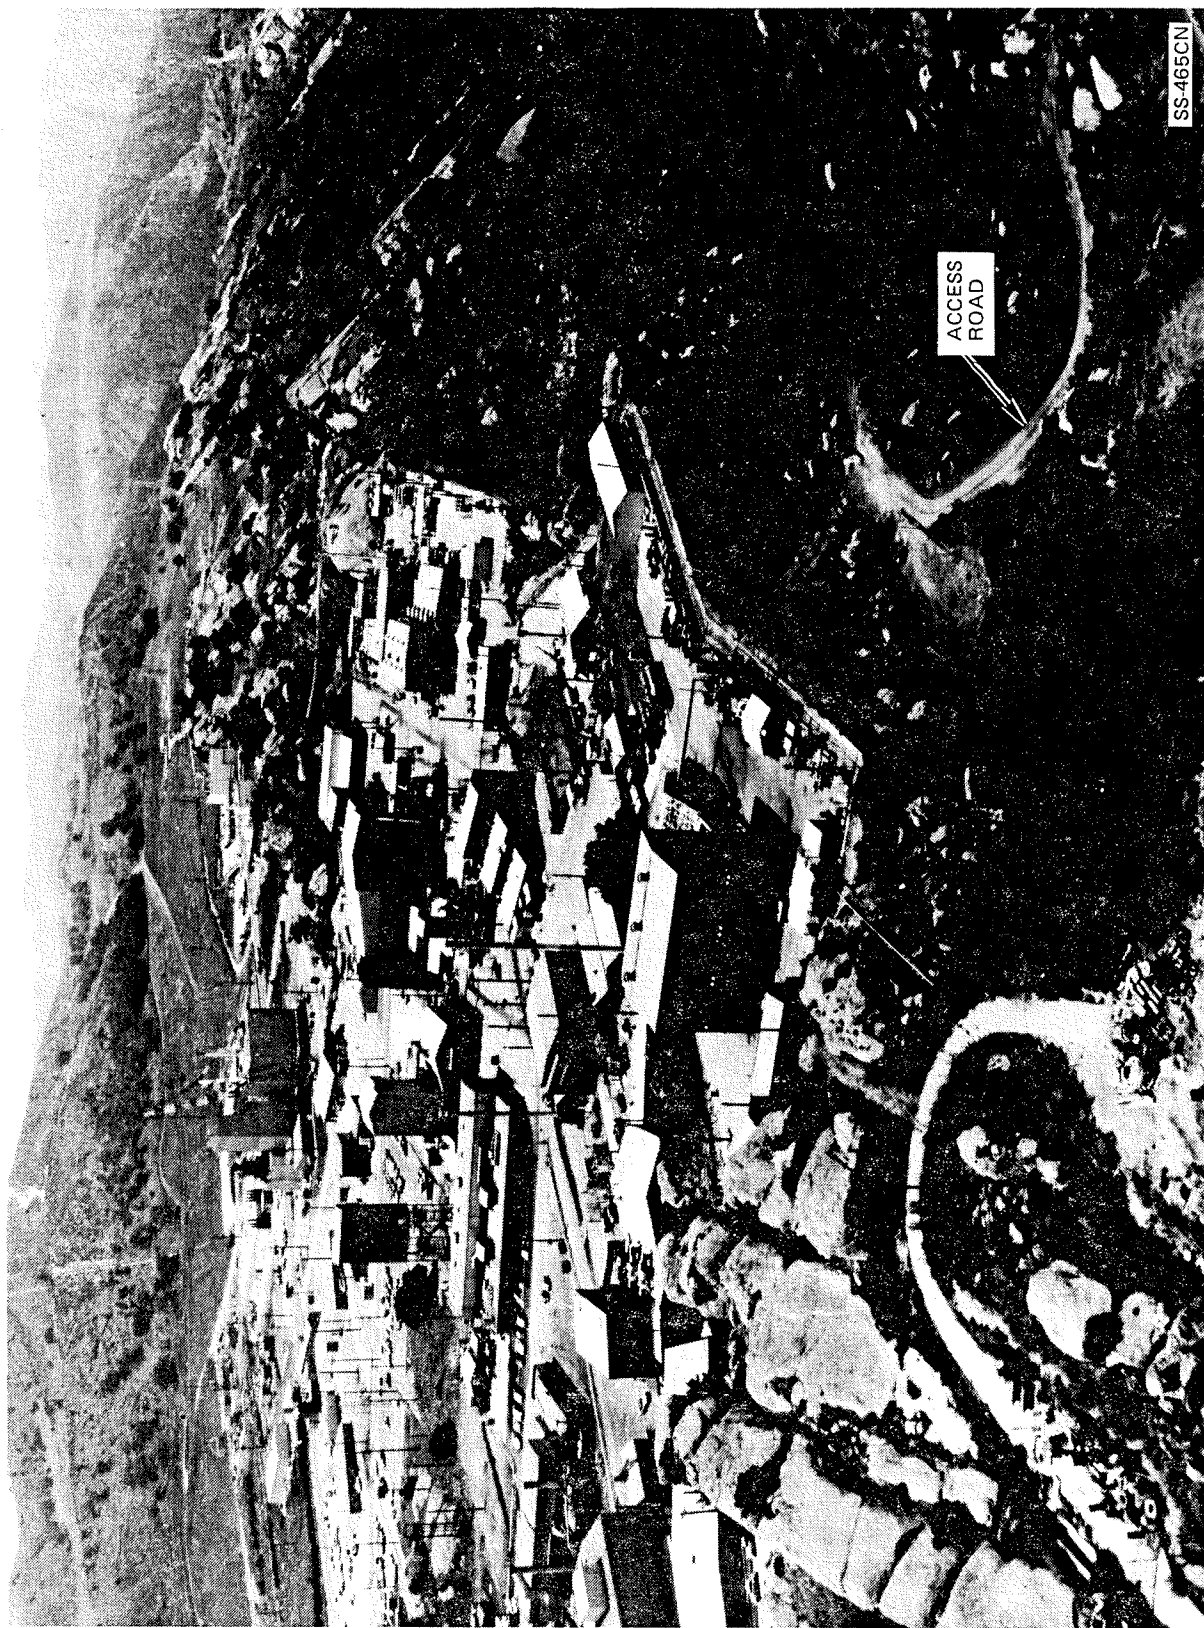
SS-465CN

The leach field was at the base of a steep bank, and it was located about 50 ft north and 30 ft below the RMDF storage yard. It was not feasible to cut a road in the bank; therefore, vehicle access was provided by a steep bulldozed dirt road in the canyon to the north-east. This road is shown clearly in Figures 28 and 29. The travel distance to this road from the gate of the RMDF, near Building 034, was 1 mile. The mobile crane positioned in the RMDF yard at the top of the bank moved boxed soil and equipment directly between the leach field and the RMDF, avoiding the difficult surface transportation. Personnel and light equipment used the road for access.

Figure 28. Access Road to RMDF Leach Field
