Quarterly Progress Report  
January, February, March, 1956

#### Environmental Surveys

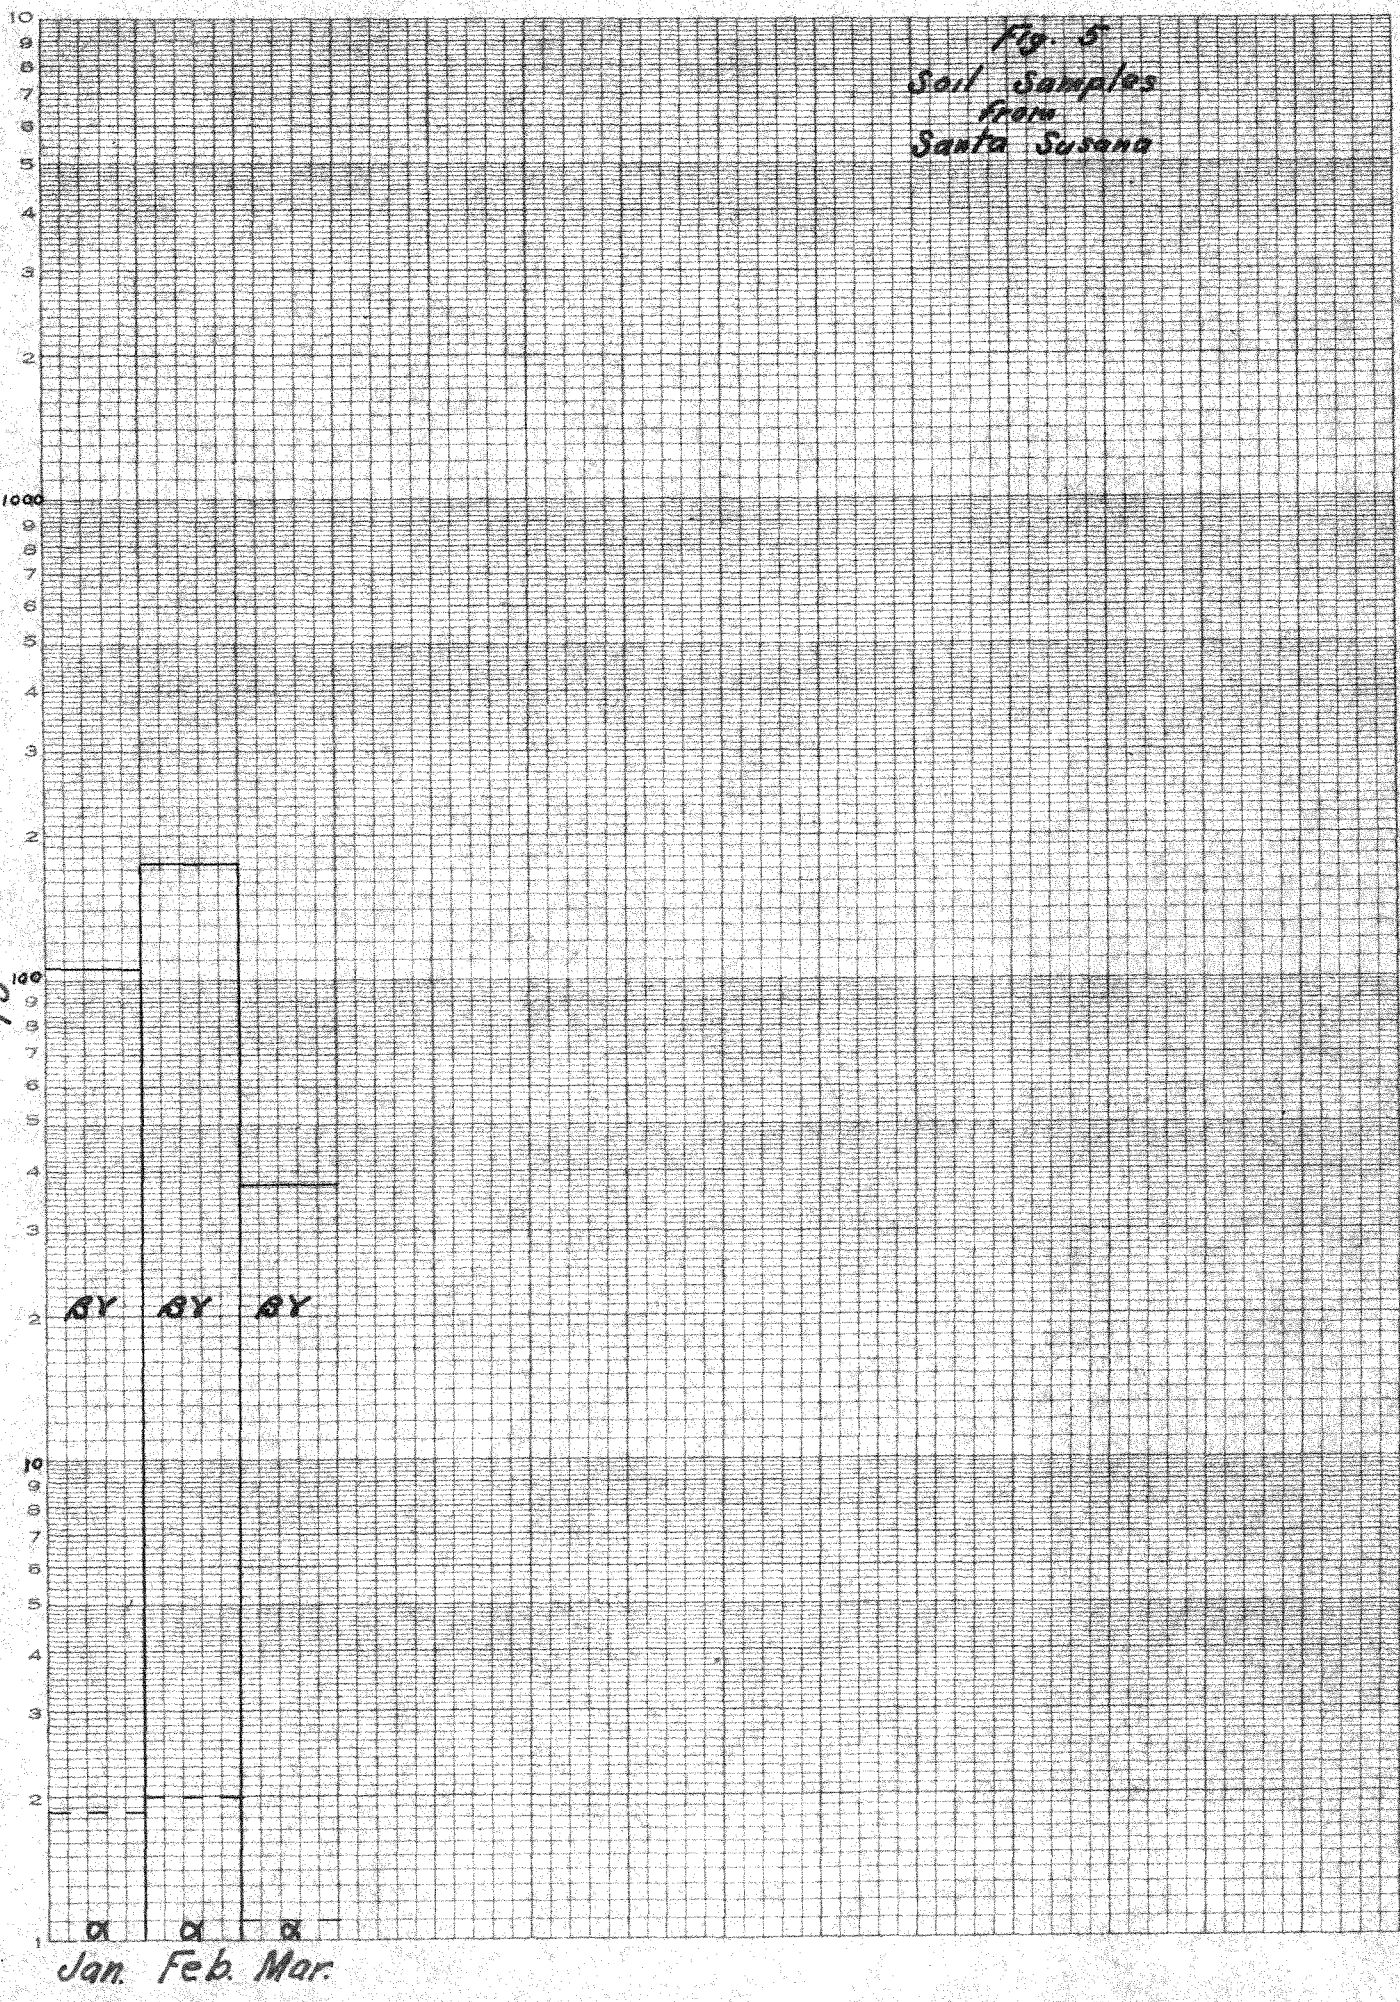
Fig. 5  
Soil Samples  
from  
Santa Susana

The water samples at the reactor site showed a maximum activity of  $197 \times 10^{-9}$   $\mu\text{c/cc}$   $\text{Bx}$  and  $11.6 \times 10^{-9}$   $\mu\text{c/cc}$  of  $\text{L}$ . Other results are given in Figs. 1 through 8.

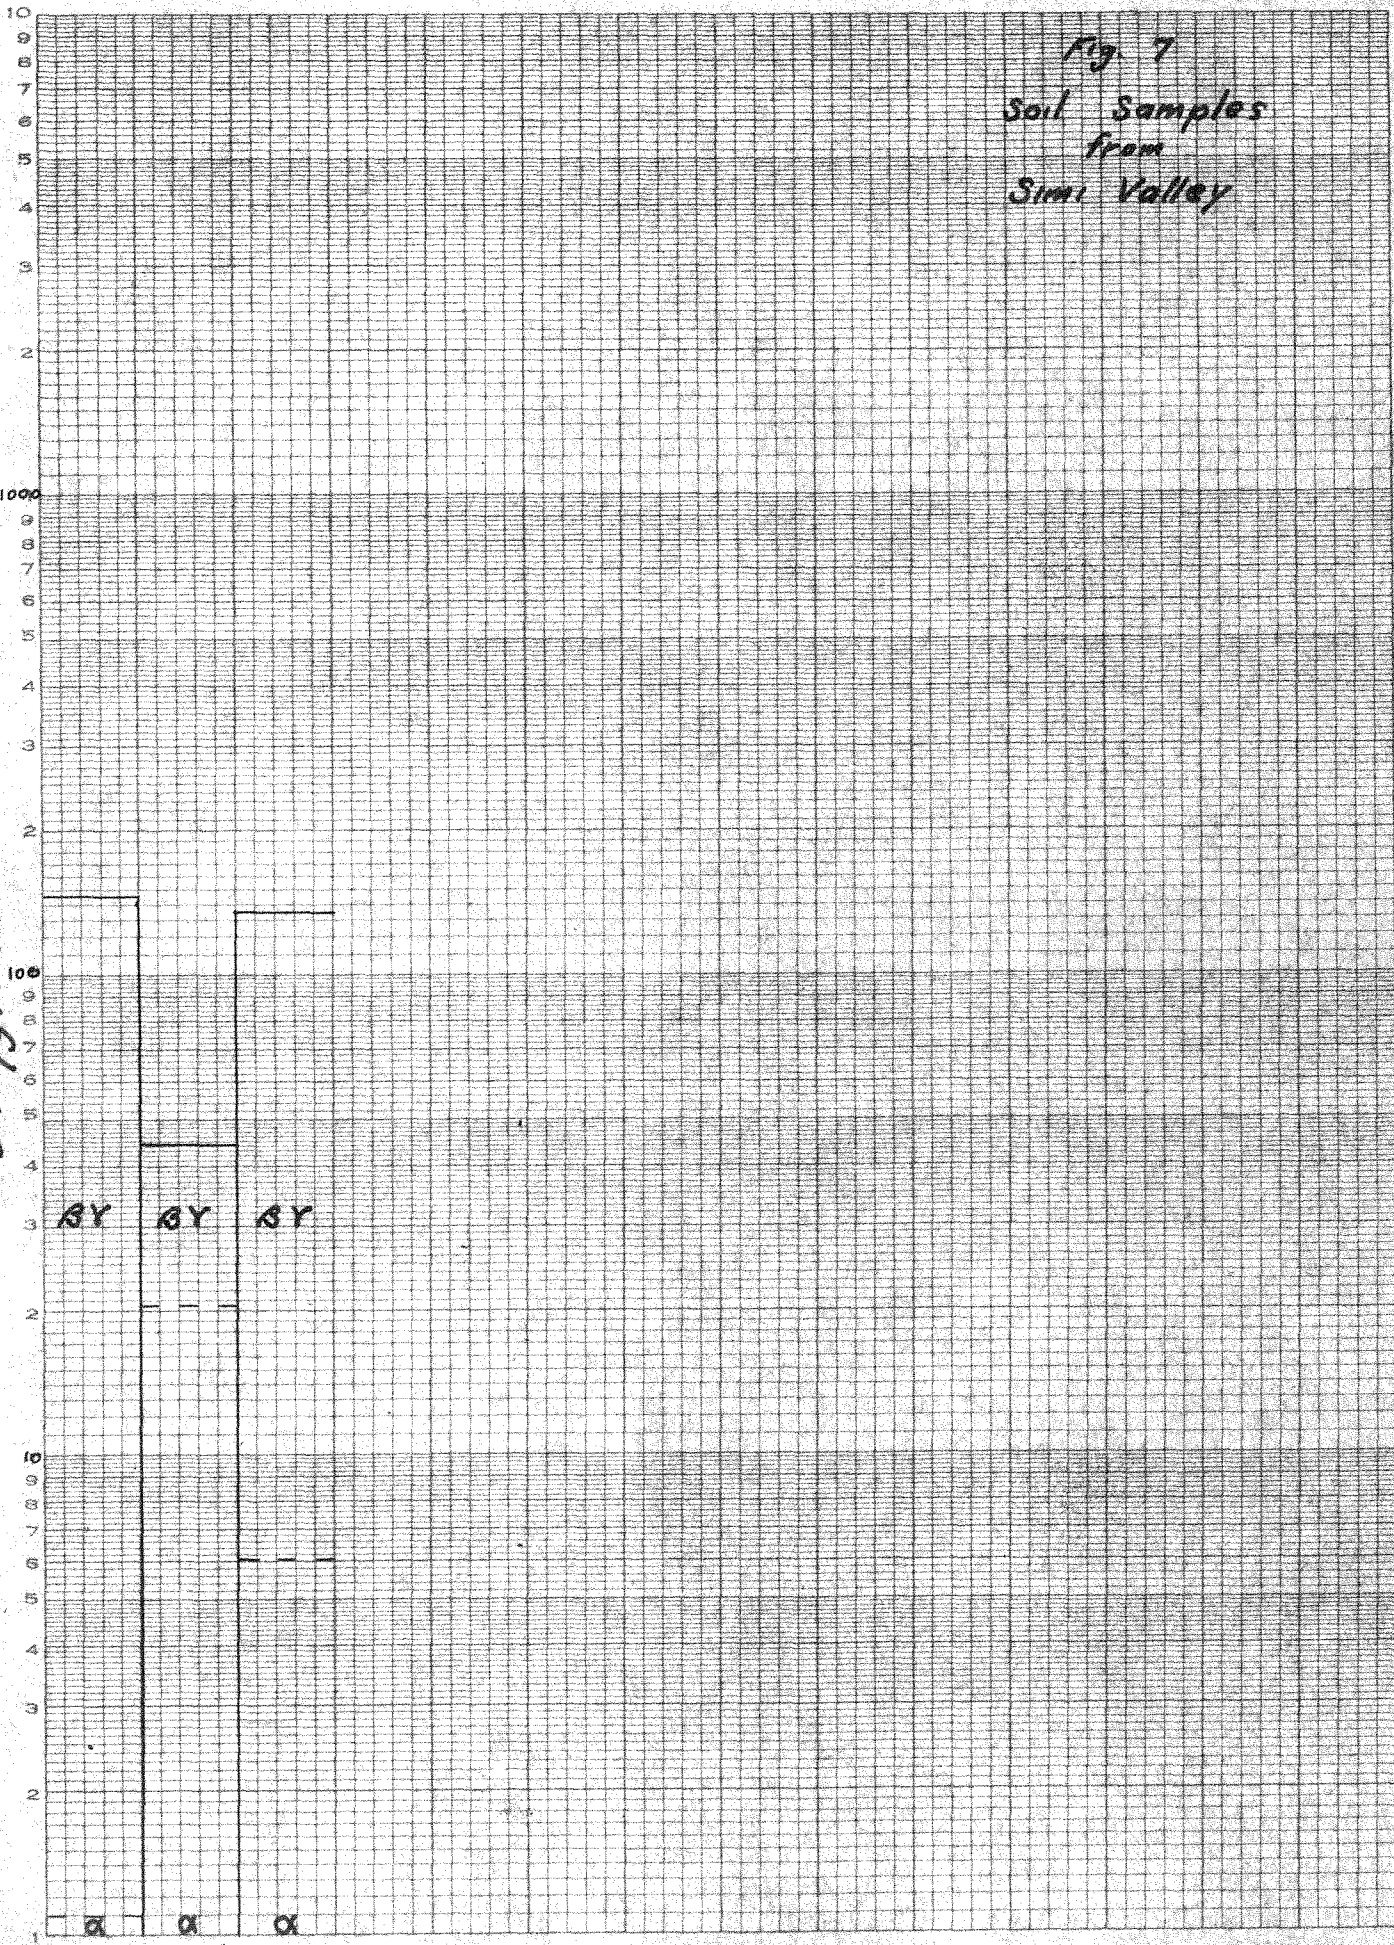
Fig. 7  
Soil Samples  
from  
Simi Valley
