**GROUP 8 – WESTERN PORTION OF AREA IV  
RCRA FACILITY INVESTIGATION REPORT  
SANTA SUSANA FIELD LABORATORY  
VENTURA COUNTY, CALIFORNIA**

***VOLUME III – RFI SITE REPORTS***

***EMPIRE STATE ATOMIC DEVELOPMENT AUTHORITY AREA (SWMU 7.9)***

**September 2007**

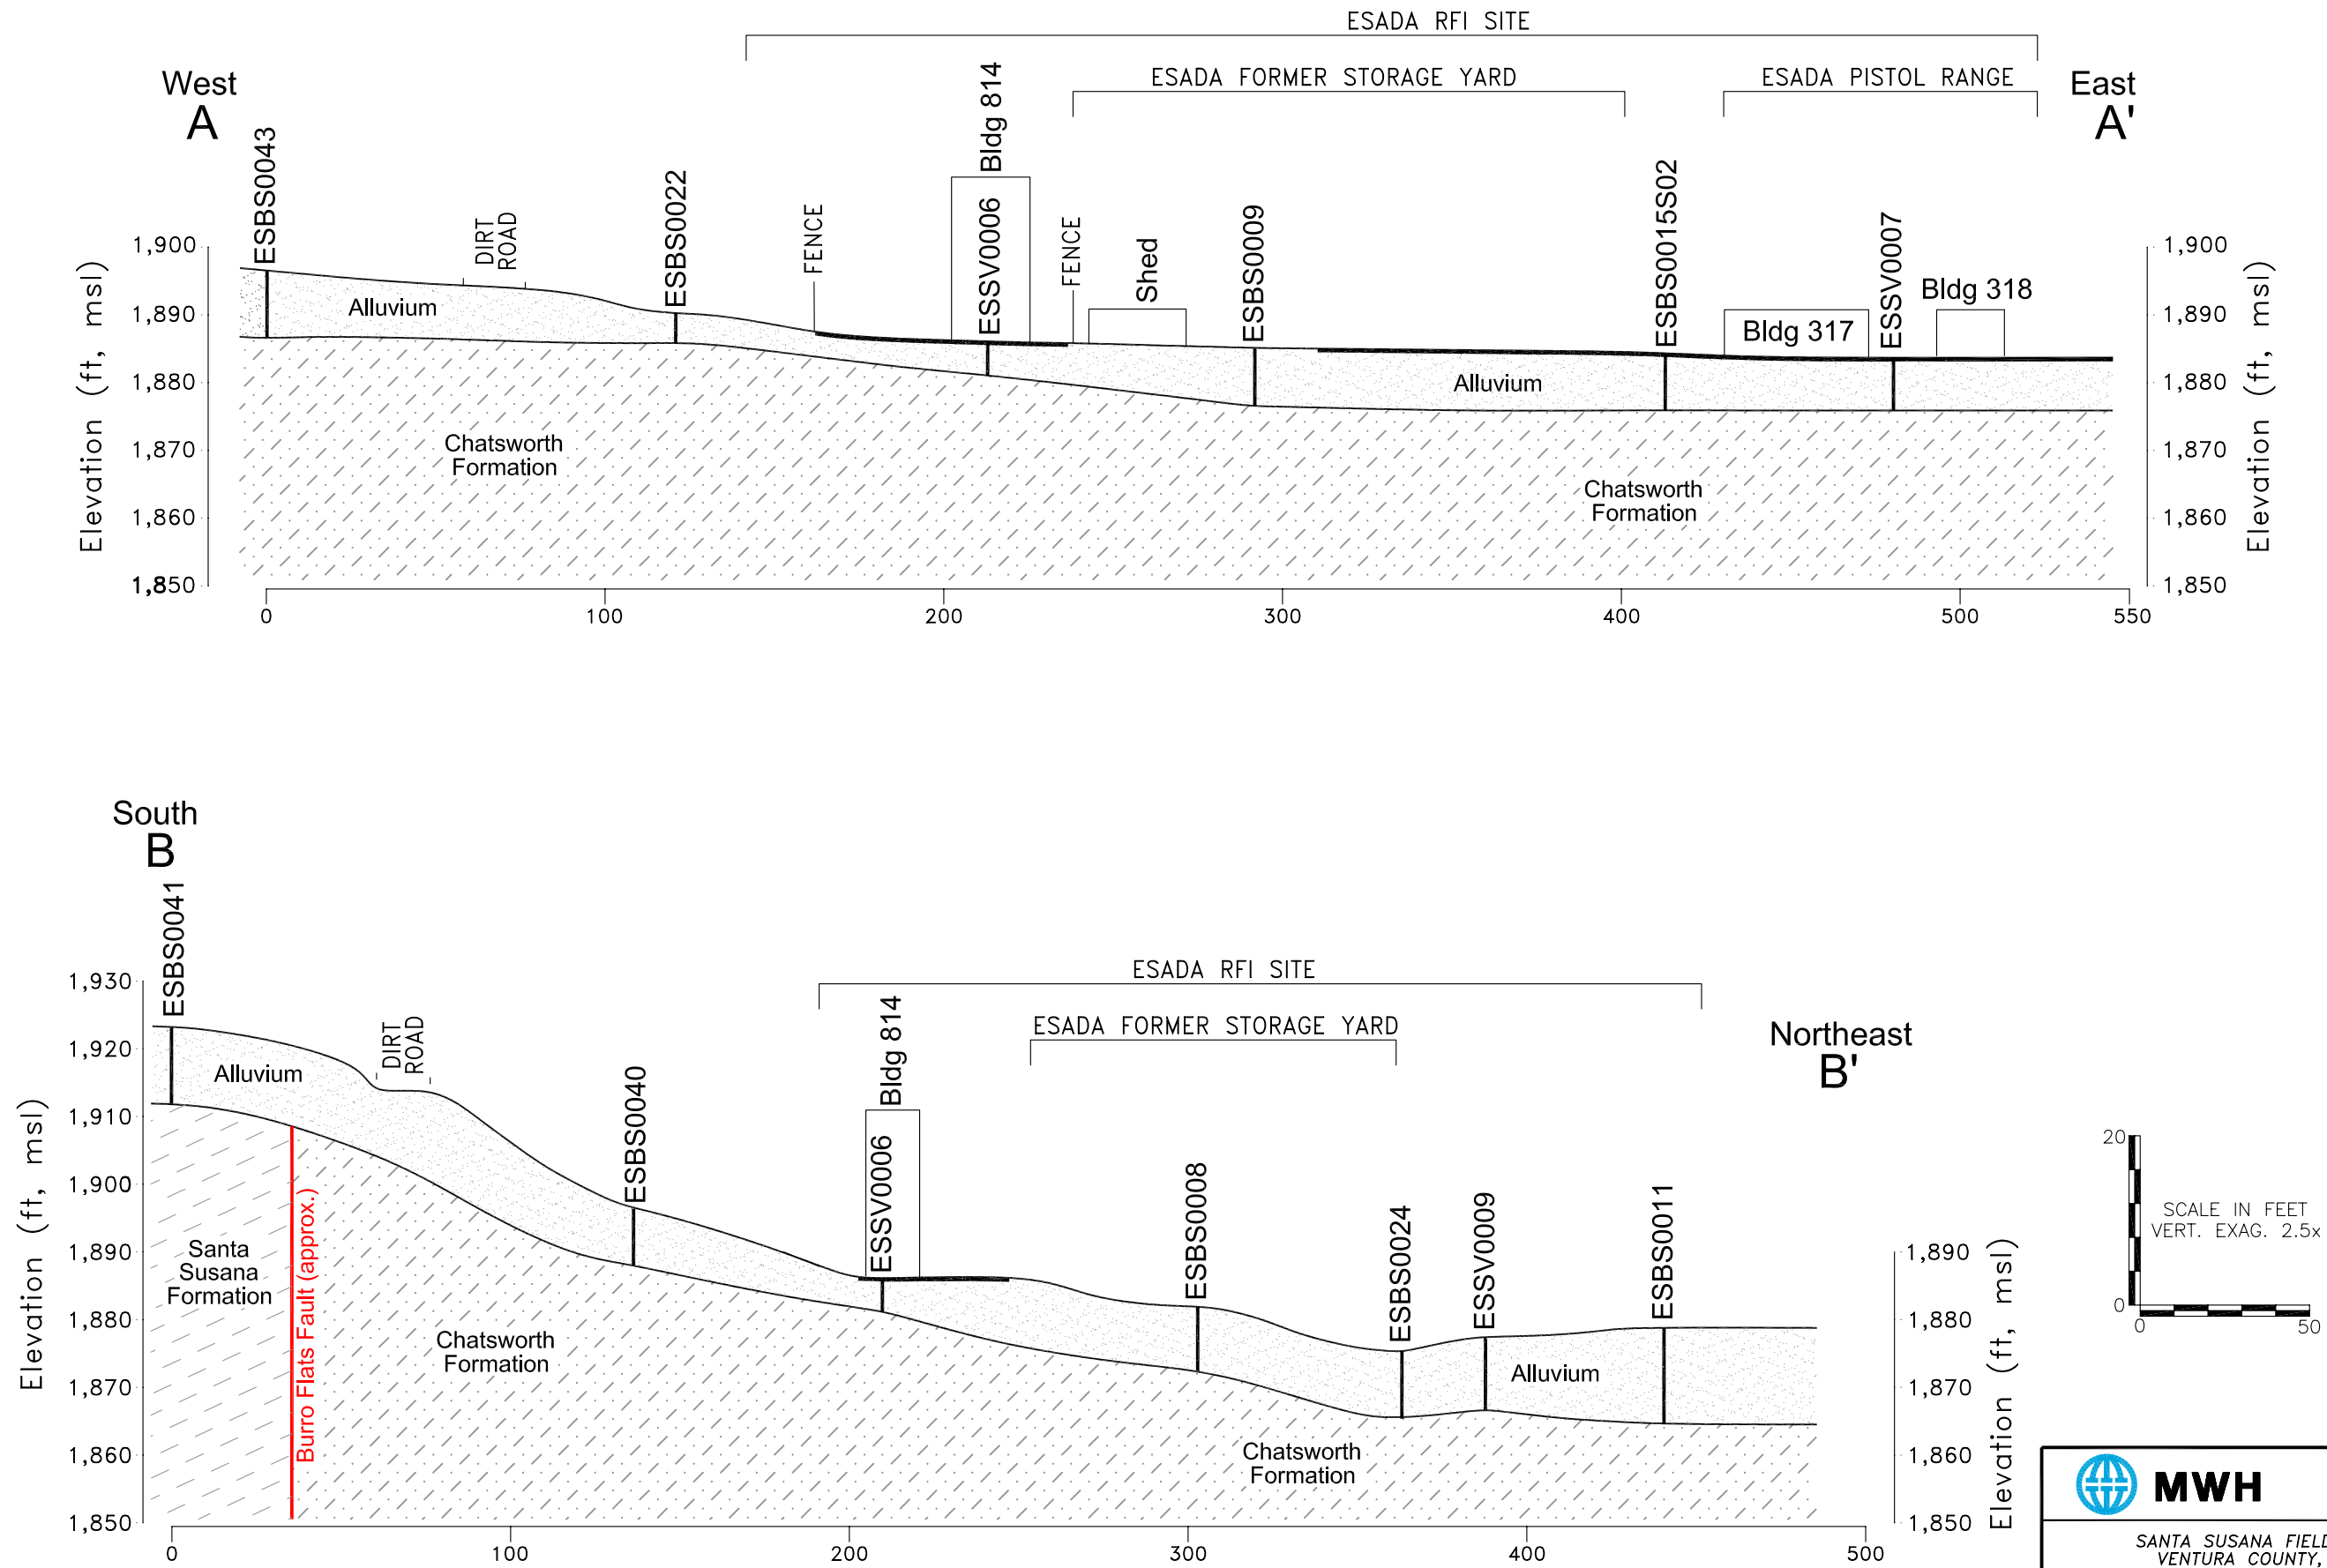
SANTA SUSANA FIELD LABORATORY  
VENTURA COUNTY, CALIFORNIA  
SEPTEMBER 2007  
**SURFICIAL CROSS SECTIONS**  
**A-A' & B-B'**  
**ESADA RFI SITE**  
FIGURE C.2-3

Note: Dip and orientation of the Burro Flats fault is approximate due to limited fault exposures.

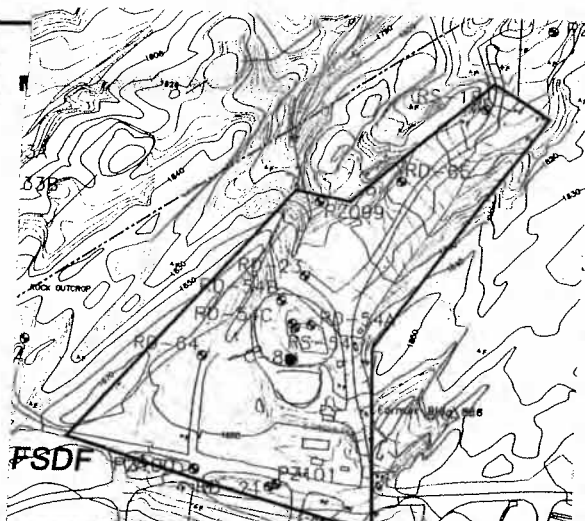
Boring #: ESSV0003

PID/OVA	Sample Interval	Recovered (in.)	Blow Counts / 6 in.	Retained for Analysis	Casing Type & Size	Annulus Filler	Depth (Feet)	USCS Soil Type	Soil Description	Estimated % Of				
										Gravel	Sand			Silt/clay
											Coarse	Medium	Fine	
									Surface: Vegetation					
							1		NO Samples / No logging					
									Install Vapor probes					
							2							
							3		benseal 0-2.5					
									3.5' Brown probe 2.5-3.5					
							4		benseal 3.5-6.5					
							5							
							6							
									sand 6.5-7.5					
							7		7.5' Yellow probe 6.5-7.5					
							8		Bedrock @ 7.5' Refusal					
							9							
							10							
							11							
							12

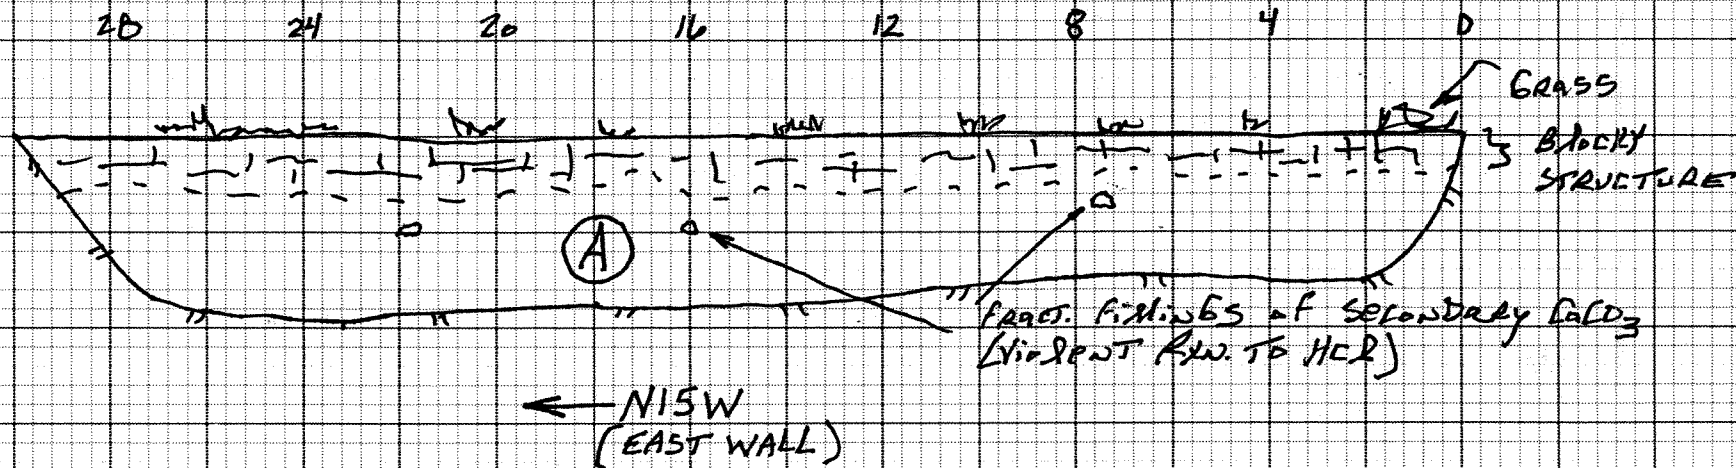
UNIT **A**: CLAYEY SAND (SC); DAY-MAIST; DR. YEL. BAN (10 YR HL);  
V. STIFF-HARD; BLOCKY STRUCT. IN UPPER 0.5-1';  
SL. MORE ORGANIC (i.e., DARKER-COLORED) IN UPPER 0.5';  
[NATIVE SOIL]; NO EVID. OF STAINING OR DISCOLORATION

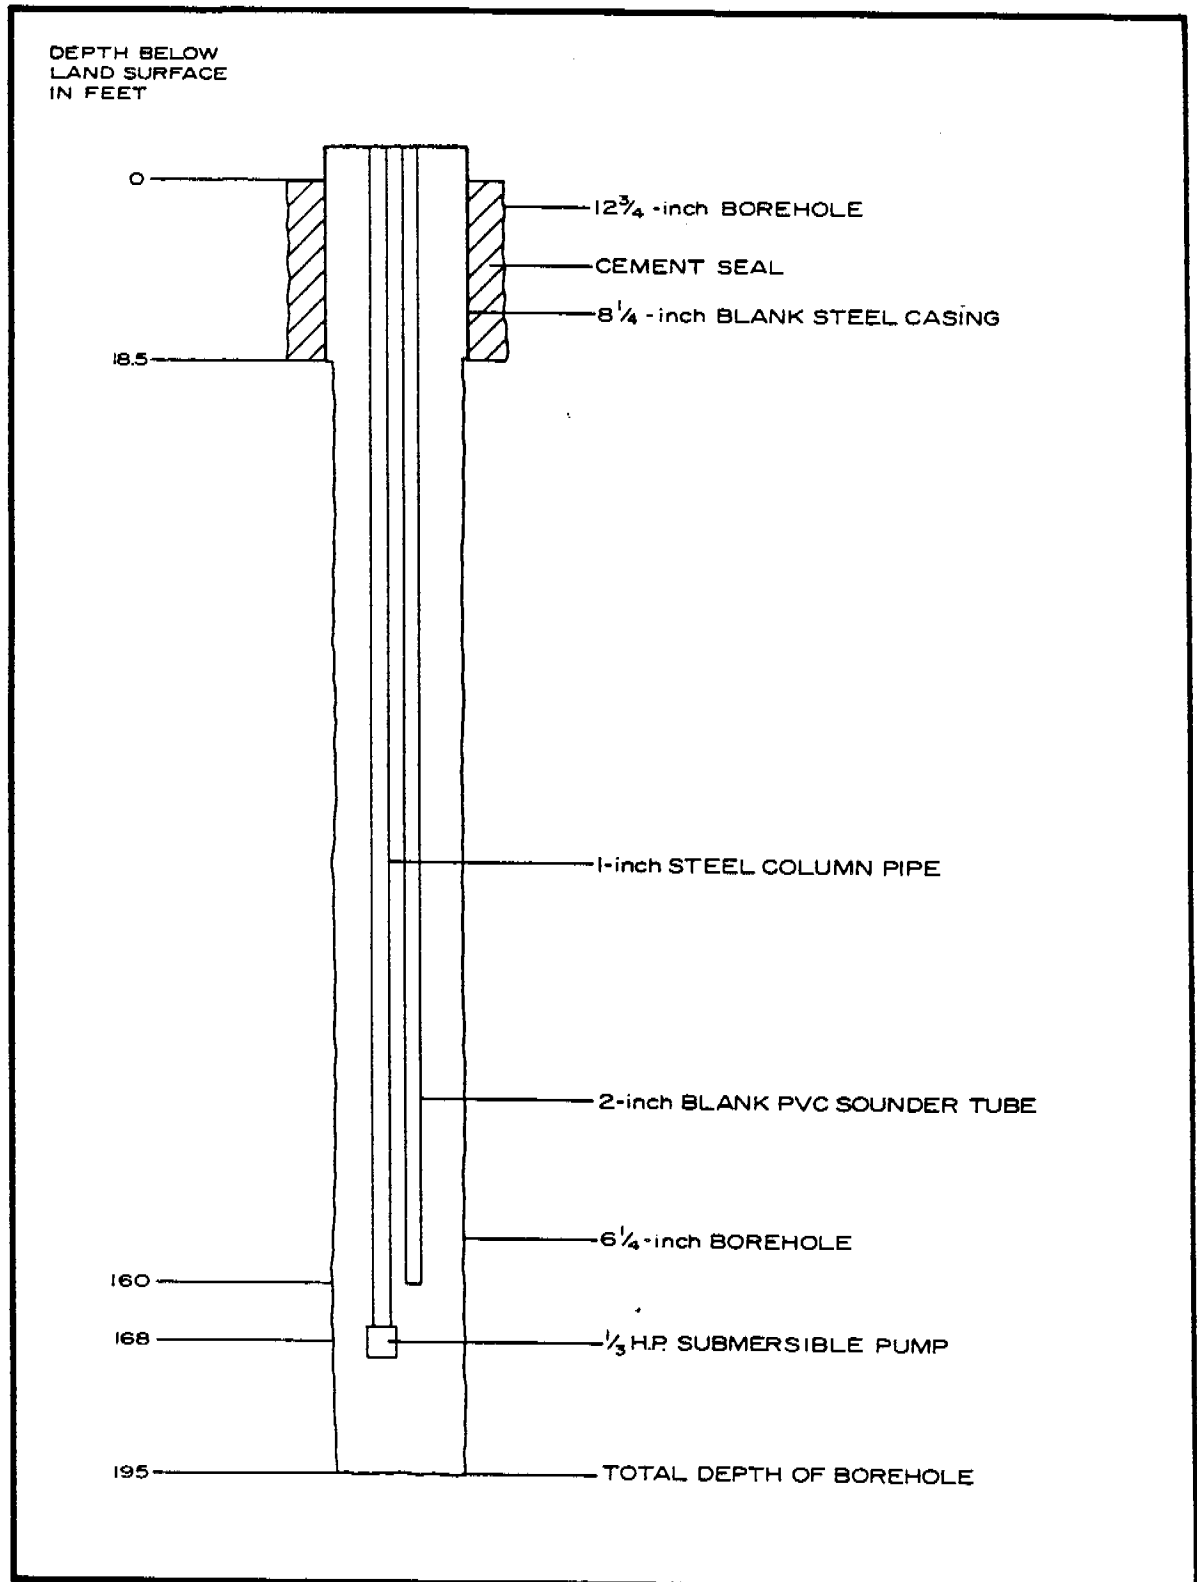
FIGURE E-68  
SCHEMATIC DIAGRAM OF MONITOR WELL RD-50

DEPTH INTERVAL (feet)	DESCRIPTION OF MATERIAL	
0 - 6.5	SILTY CLAY	Light brown, low plasticity, soft, slightly moist.
6.5 - 10.0	SILTY CLAY	Mottled light brown and light grey, moderately plastic, firm, slightly moist.
10.0 - 13.0	SILTY SAND (WEATHERED CHATSWORTH FORMATION)	Very light brown, cementation increasing with depth, slightly moist.
At 13.0 feet, Chatsworth Formation.

TOTAL DEPTH OF BOREHOLE: 13.0 FEET
