GROUP 7 – NORTHERN PORTION AREA IV RCRA FACILITY INVESTIGATION REPORT SANTA SUSANA FIELD LABORATORY VENTURA COUNTY, CALIFORNIA

VOLUME II – RFI SITE REPORTS

BUILDING 4029 REACTIVE METALS STORAGE YARD (SWMU7.11)

June 2009

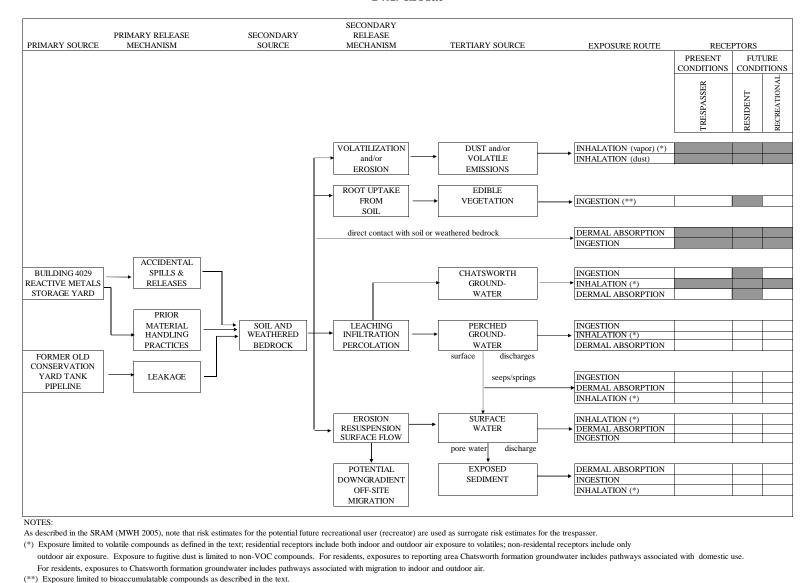
Figure A.4-1

Human Health Risk Assessment Conceptual Site Model
B4029 RFI Site

- complete and potentially complete exposure pathways evaluated in this risk assessment

incomplete exposure pathways not evaluated in this risk assessment

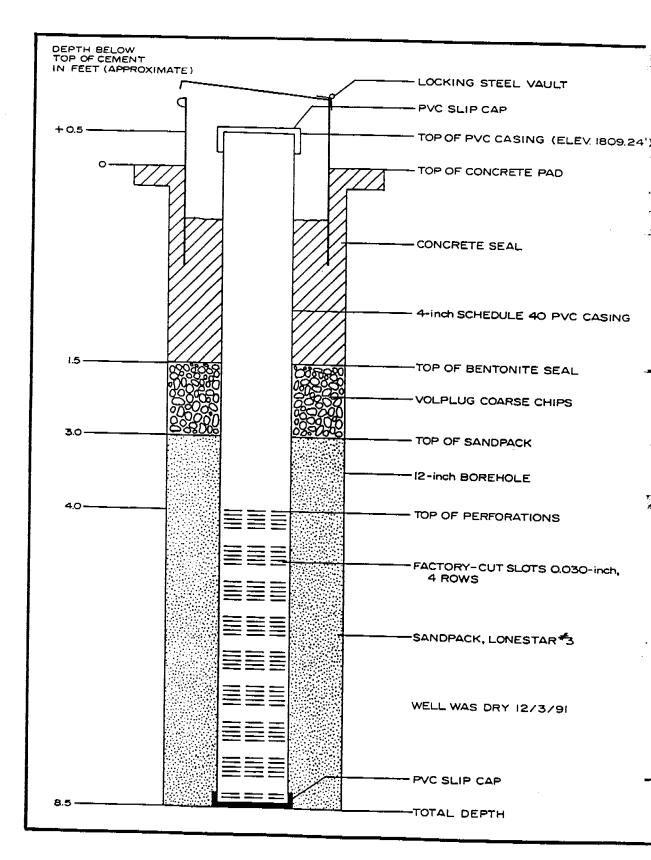
FIGURE C-24 SCHEMATIC DIAGRAM OF SHALLOW ZONE MONITOR WELL RS-24

DEPTH INTERVAL (feet)	DESCRIP	TION OF MATERIAL
0 - 6.0	SANDY CLAYEY SILT	Brown, low plasticity, soft, dry.
6.0 - 7.0	SILTY SAND (WEATHERED CHATSWORTH FORMATION)	Light brown, loose, moist.
7.0 - 8.5	SILTY SANDSTONE (CHATSWORTH FORMATION)	Light brown, well cemented, moist.

TOTAL DEPTH OF BOREHOLE: 8.5 FEET
