2023 Monitoring Report, Dolores River Restoration on Lease Tract C-SR-13

May 2024

Legacy
Management

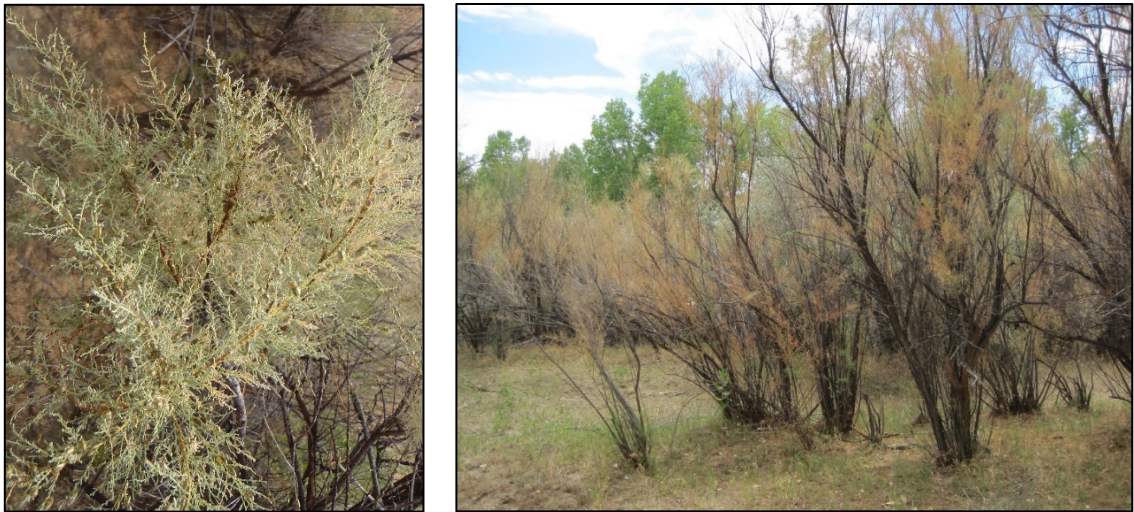
Note: The stand is 90% defoliated.

Figure 3. Defoliation of Tamarisk with Numerous Adult Beetles (Left) and Widespread Defoliation on a Tamarisk Stand (Right) (Photos Credit: CDA)

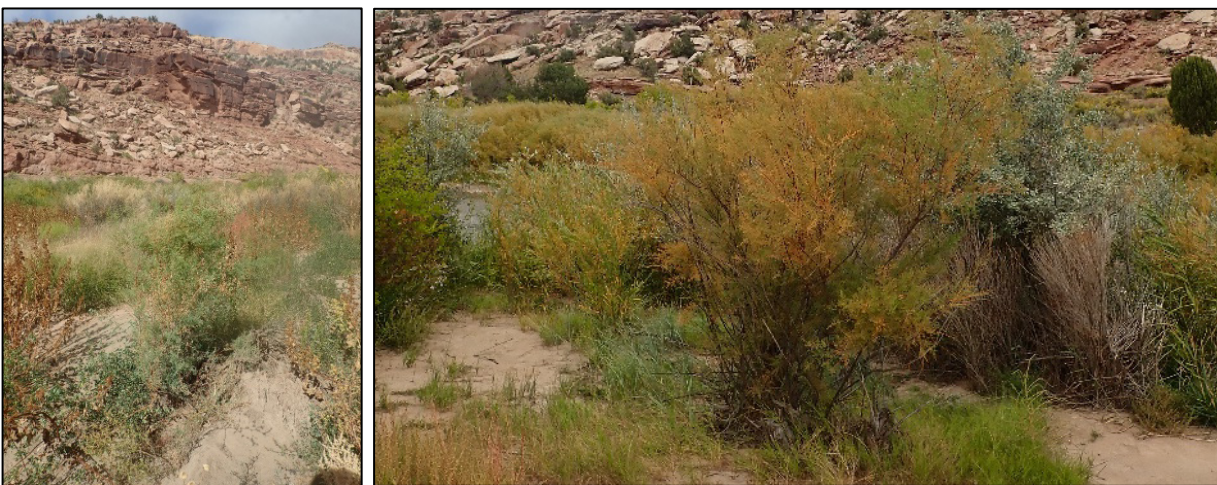
Tamarisk trees were surveyed at monitoring points 26 and 14N (Figure 6). At monitoring point 26, one sweep point was taken on one small and one medium tree. No tamarisk leaf beetles were found in the sweep samples. One tamarisk weevil adult, two green leafhoppers, and other insects (flea beetles and earwigs) were observed in the sweep net. The trees had 0% to 1% flowers; the canopy foliage was mostly green with a low percentage of brown foliage, which indicates that feeding damage is most likely due to the weevils and leafhoppers. Neither tree had deadwood.

Figure 6. Feeding Damage Caused by Tamarisk Weevils and Green Leafhoppers Evidenced by the Brown and Senesced Foliage on the Tamarisk at Monitoring Point 26 (Left) and Monitoring Point 14N (Right)

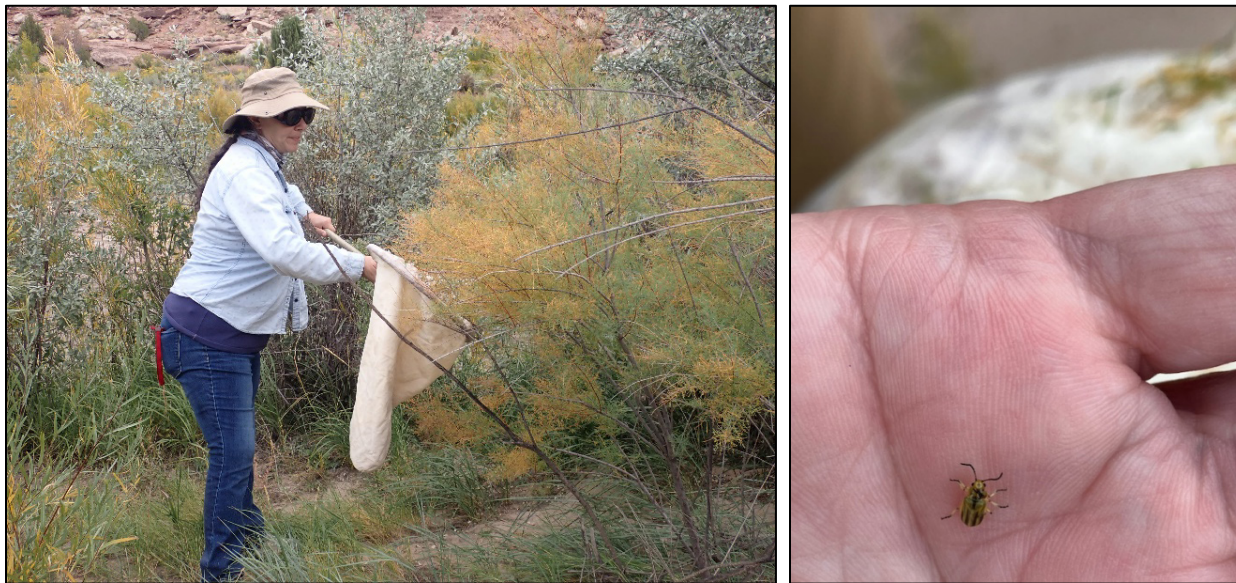
At monitoring location 14N, a sweep point was taken on one small tree and one medium to large tree. One male tamarisk leaf beetle was found in the sweep net (Figure 7). The sweep sample also contained 12 tamarisk weevils, eight tamarisk leafhoppers, and other insects (ants, lacewings, spiders, flea beetles, true bugs, and parasitoids). Deadwood was higher on the medium to large tree than the small tree. The canopy foliage on the trees had a higher percentage of yellow feeding damage caused by green leafhoppers (Figure 7). There were few flowers on the trees. Zero percent brown foliage on the trees indicated that most tamarisk leaf beetles were overwintering for the season, or a low population of beetles was present in the area.

Figure 7. Sweep Net Survey Performed on Tamarisk Tree (Left) and Male Adult Tamarisk Leaf Beetle Collected During Sweep Sample at Monitoring Point 14N (Right)

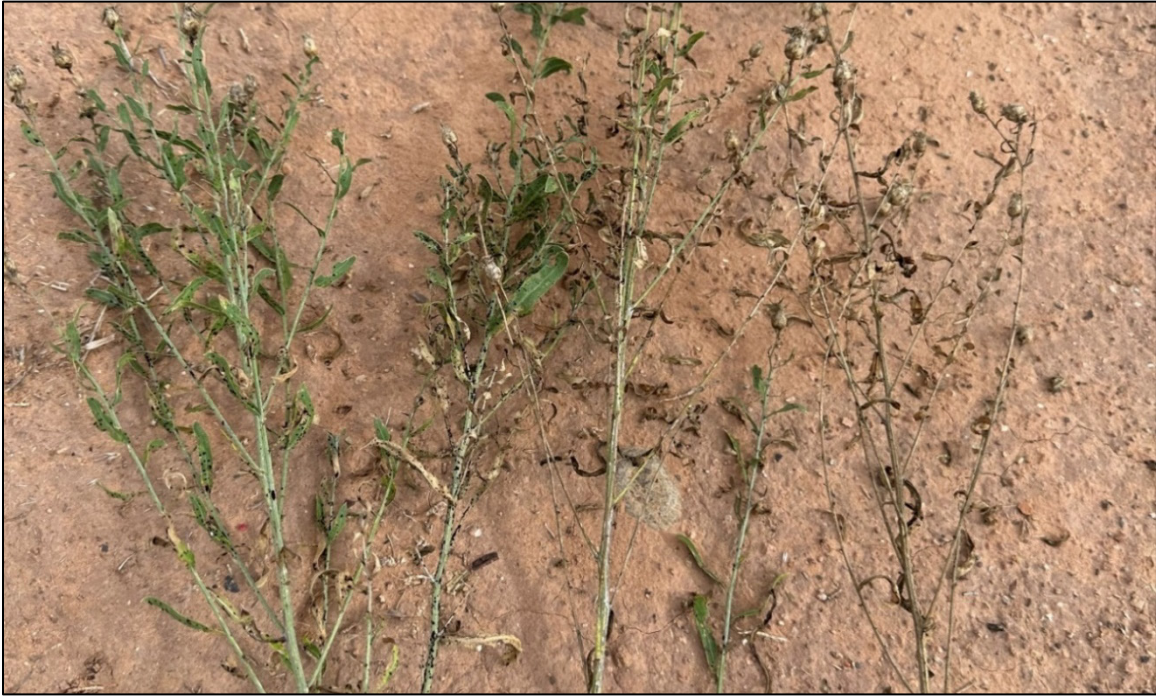
Figure 8. Rust Fungus Damage Progression from Left to Right

Two of the three Russian knapweed agents were found at two monitoring points along the lease tract: rust fungus and midge galls. Russian knapweed rust fungus was found to be infecting most of the plants at point 14N. Some of the plants showed more advanced fungus damage than other newly infected plants. The advanced plants looked highly stressed, or senesced, by the fungus. The newly infected plants were still green and showing signs of early leaf dieback (Figure 8).

Note: The plants on the left are newly infected compared to the last plant on the right, which displays advanced damage with total dieback, and there is intermediate rust fungus damage on the plants in the center.

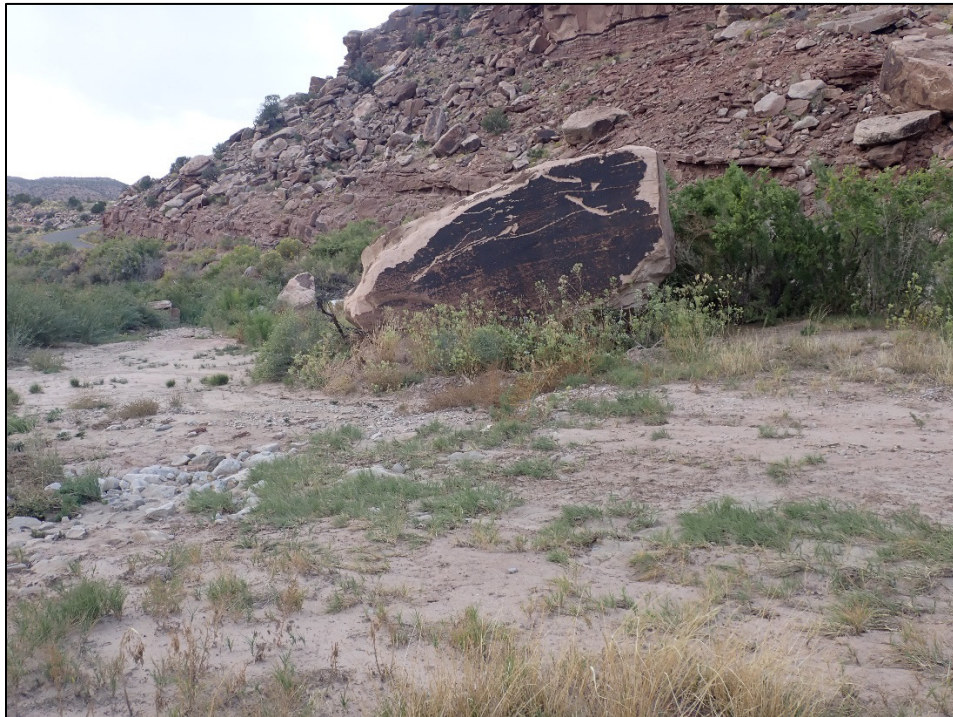
Figure 10. DA1 with Patches of Native Vegetation and Bare Ground

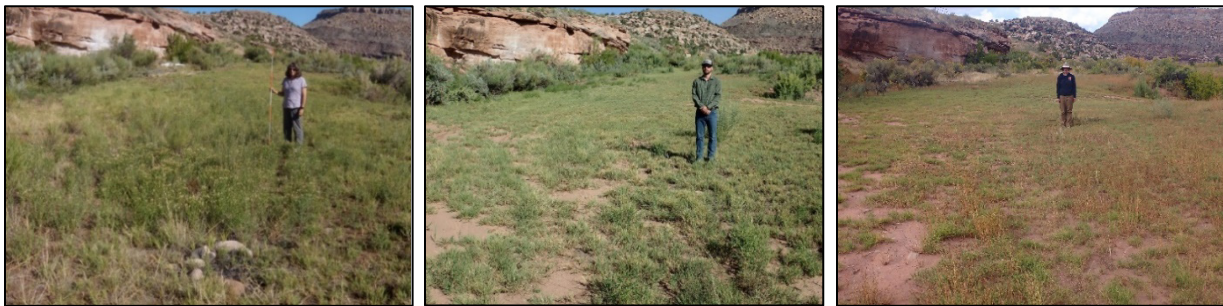
Photographs taken at the same points over time suggest several trends. A significant reduction in the cover of noxious weeds, especially Russian knapweed, is evident, and native vegetation has become established in its place. Figure 11 shows the major reduction of Russian knapweed and the establishment of native vegetation, mainly saltgrass, over the last 10 years at monitoring point 14N. Russian knapweed was dominant in the understory at many points in 2012, but it has been reduced to a minor component through weed control efforts; less bare ground was visible in the understory in 2023 than in previous years.

Figure 11. Photomonitoring Point 14N in 2012 (Left), 2022 (Center), and 2023 (Right)

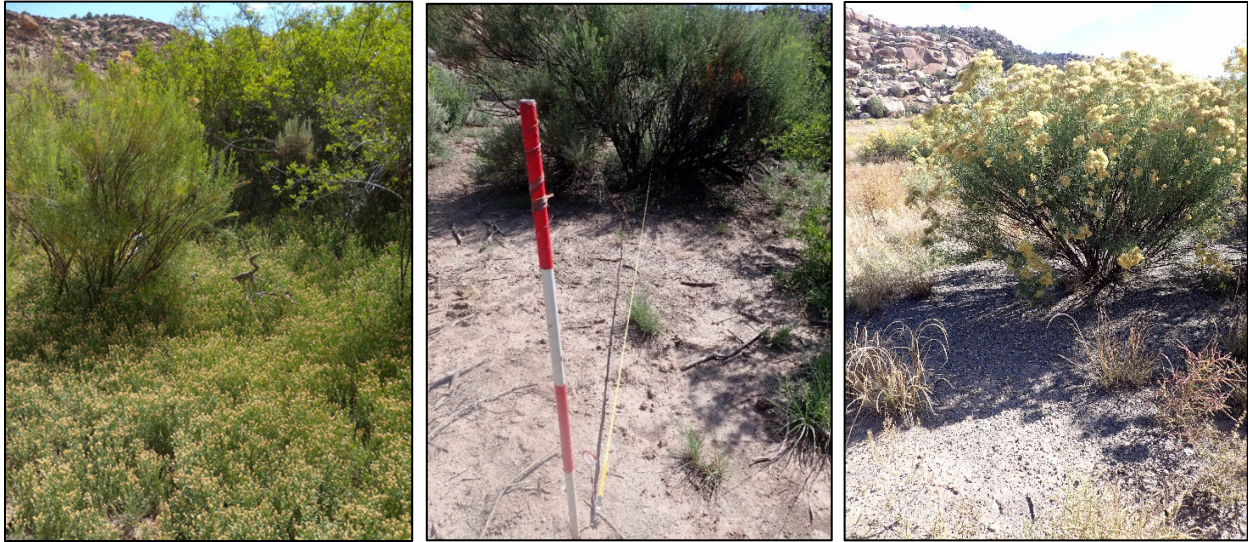
Figure 12 shows monitoring point 11B, an area where Russian knapweed has been successfully eliminated by herbicide treatment. In 2012, before the herbicide treatment, Russian knapweed was dominant throughout the understory and had formed a monoculture. This noxious weed has an allopathic root system, which sends toxins into the soil and prevents native vegetation from growing. After eradication, large patches of bare ground were present throughout the understory. Seasonal flooding events along the Dolores River watershed help to remove toxins, deposit nutrients into the soil, and aid in soil health recovery while reducing the impact from livestock grazing along the lease tract. Sand dropseed (*Sporobolus cryptandrus*) and other native grasses have begun to establish at the monitoring point and were more abundant in 2023 than in 2022.

Figure 12. Photomonitoring Point 11B Dominated by Russian Knapweed in 2012 (Left), Showing Large Amounts of Bare Ground After Knapweed Eradication in 2022 (Center), and Showing Native Grasses Beginning to Establish in the Understory in 2023 (Right)

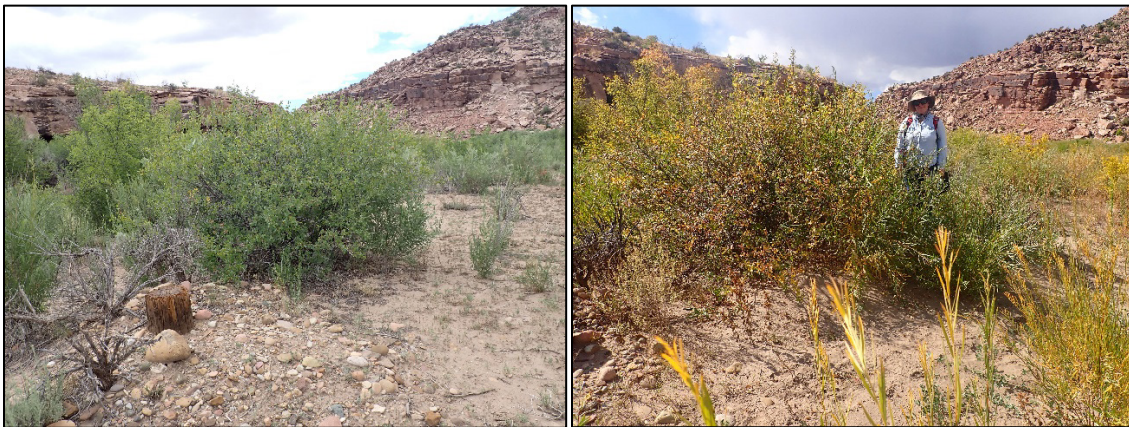
Visual comparisons showed that photomonitoring point 25P had more bare ground in 2022 compared to 2023 (Figure 13). This area was also affected by seasonal flooding, which prevented livestock access and grazing for a portion of the growing season. Narrowleaf willow (*Salix exigua*), a desirable native tree, and other native plant species were beginning to establish at the monitoring location.

Figure 13. Photomonitoring Point 25P in 2022 (Left) and 2023 (Right), Showing the Natural Establishment of Narrowleaf Willow After Weed Eradication
