OE-3: 2024-03

Moving HVAC Parts Pose Amputation Risk - 2024

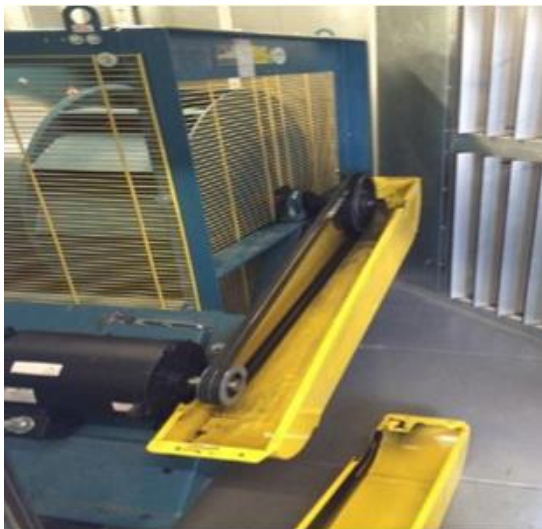
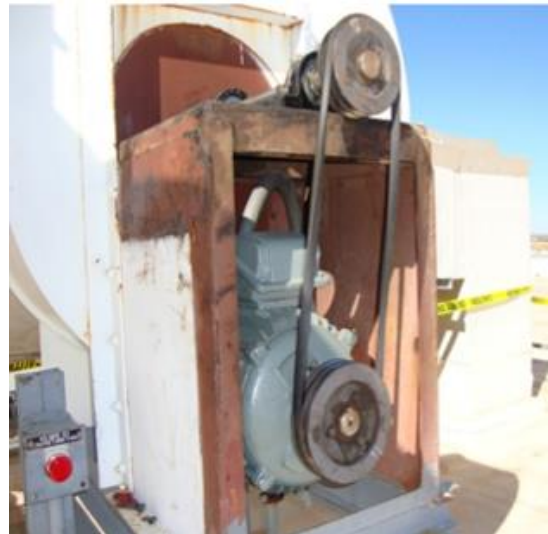
The pictures below are examples of air handling units with the guarding removed showing the exposed belt and pulley which can create an in-running nip point.

1. DOE contractors should utilize this OE-3 and the 2017 OE-3 as operational awareness tools for all personnel working on HVAC systems. They can be used to train new workers and as periodic refreshers as often as necessary to ensure that workers are adequately trained and informed.
2. Ensure all equipment is properly locked out consistent with the requirements of OSHA's performance-based standard "The Control of Hazardous Energy (lockout/tagout)" found in 29 CFR 1910.147 which is incorporated in DOE's Worker Safety and Health Program 10 CFR 851.23.
3. Before starting a task, management should ask the question, does the energy control procedure, provide sufficient detail and adequate guidance for an authorized worker to safely and effectively isolate all forms of energy for the HVAC system being serviced and/or maintained?
