**CJ Interim Completion Report – Addendum M
Attachment 2.**

**Geologic Characterization of the Crescent Junction
Cell Excavation Phase IV**

General Observations:

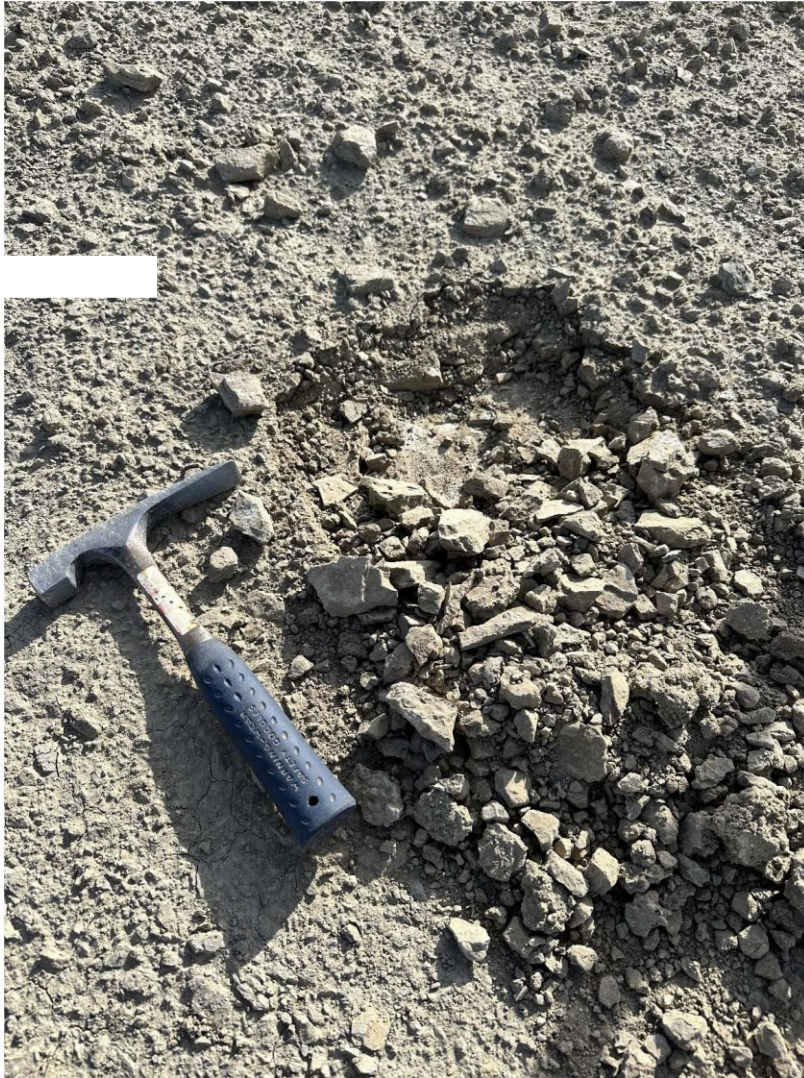
Photograph 1

Observations: Weathered Mancos Shale, north section of the phase IV excavation. Flaggy mottled bedding, fine-grained, soft, subangular, 10 YR 6/2 (brown beige), no clay content (0%), trace gypsum precipitation on bedding planes.

1: Flaggy mottled bedding present on cell floor along the north edge of cell wall.

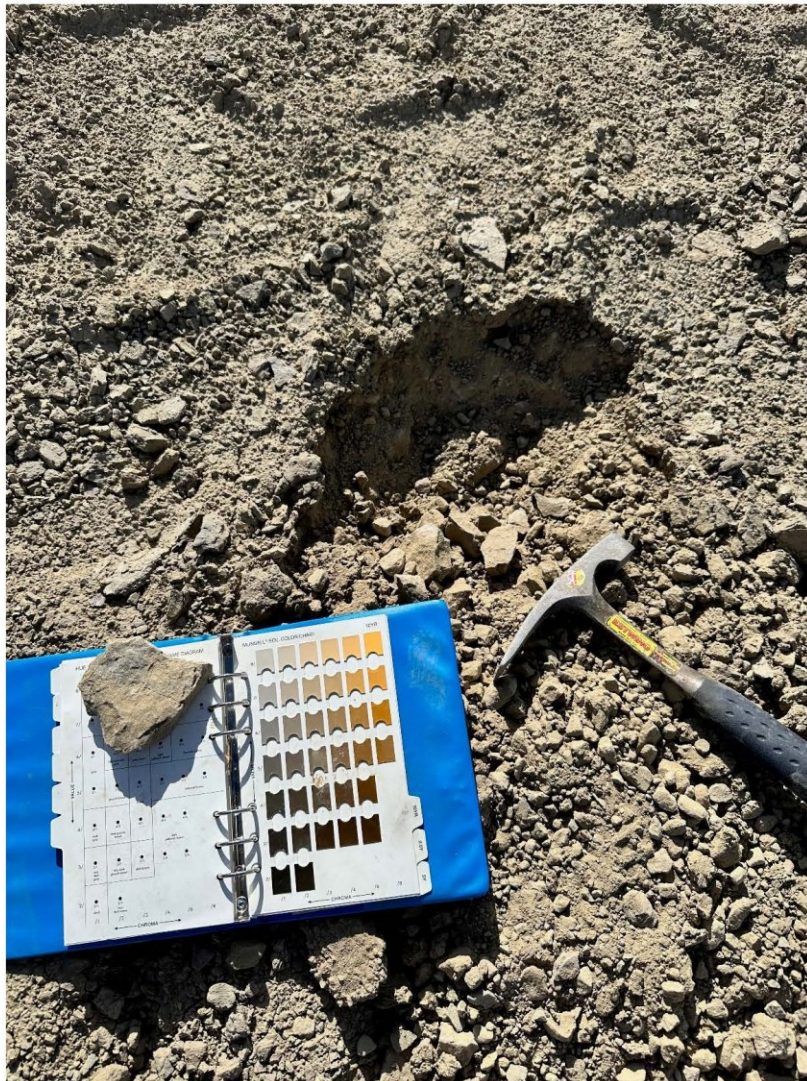
Photograph 2

Observations: Weathered Mancos Shale, northeastern corner of the phase IV excavation. Highly weathered, flaggy mottled bedding, fine-grained, subangular, 10 YR 6/2 (brown beige), no clay content (0%), trace gypsum present on bedding planes.

2: Highly weathered flaggy mottled bedding present on cell floor along the northeastern corner of cell wall.

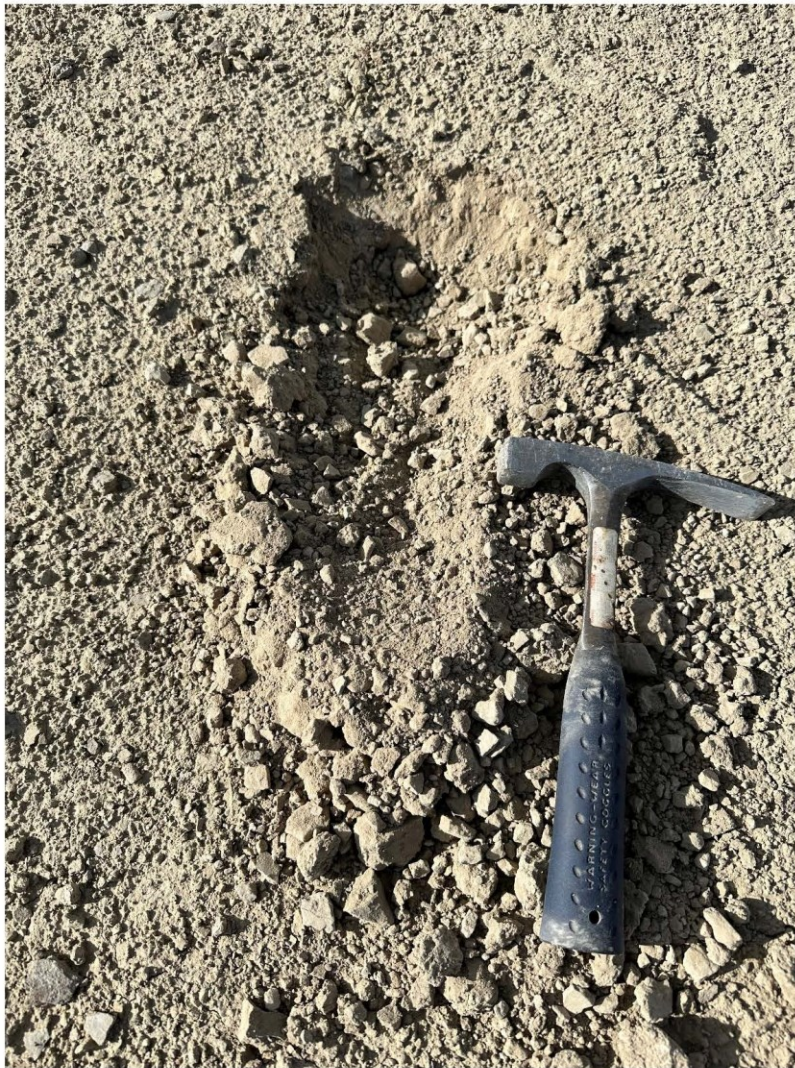
Photograph 3

Observations: Weathered Mancos Shale, northeastern edge of the phase IV excavation. Highly weathered, flaggy mottled bedding, fine-grained, thin-friable, subangular, 10 YR 6/2 (brown beige), no clay content (0%), trace gypsum present on bedding planes, trace mica.

2: Highly weathered flaggy mottled bedding present on cell floor along the northeastern edge of cell wall.

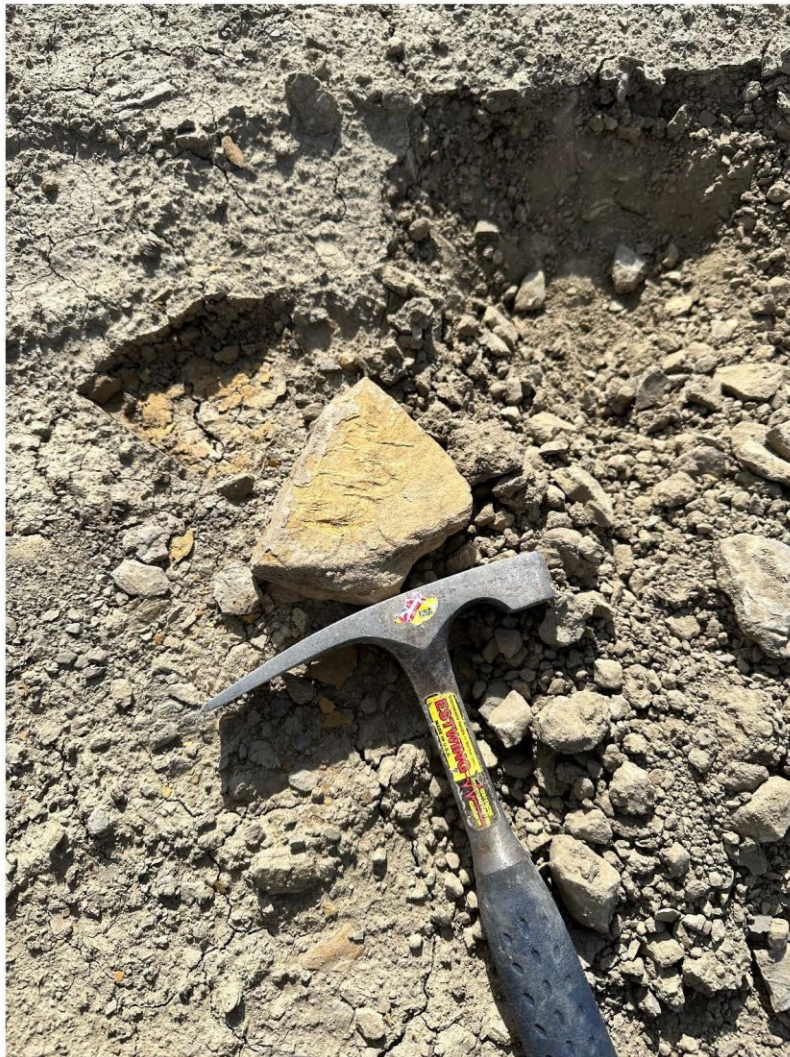
Photograph 5

Observations: Weathered Mancos Shale, east central portion of the phase IV excavation. Flaggy mottled bedding, very hard, friable bedding planes, fine-grained, subangular fragments ¼" to 2", 7.5 YR 6/6 (yellow tan), no clay content, no gypsum present.

5: Hard flaggy bedding present on cell floor along the within the east central portion of the cell.

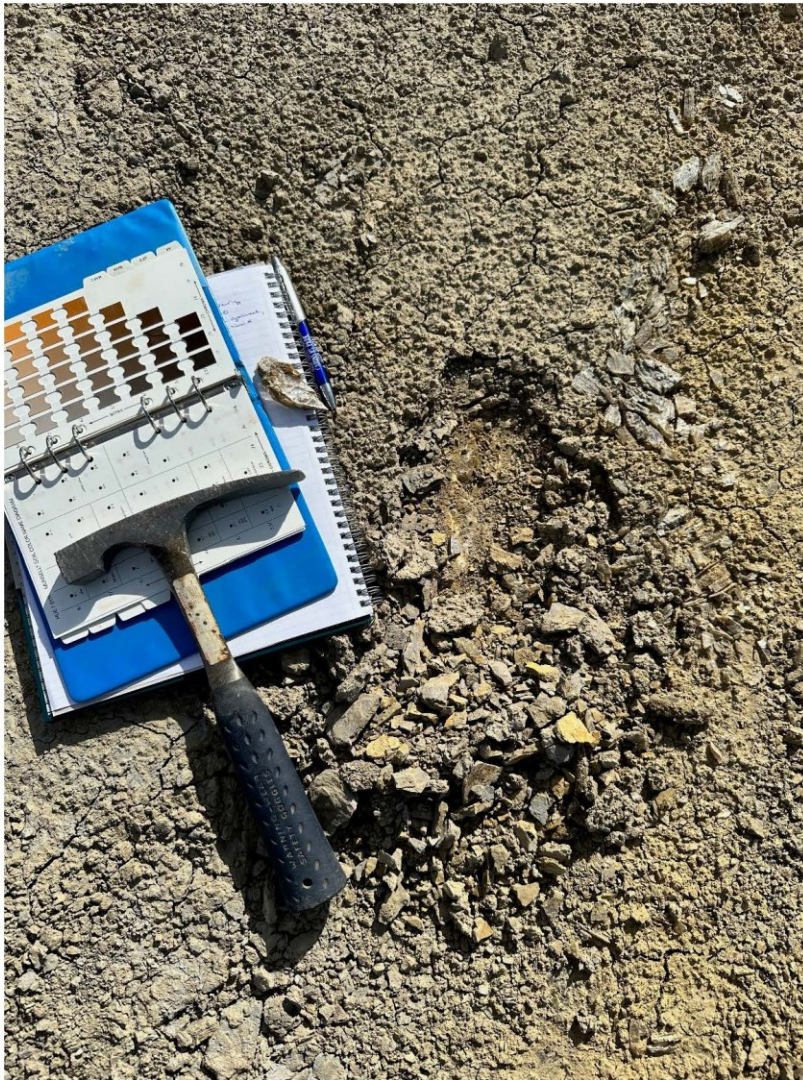
Photograph 6a

Observations: Weathered Mancos Shale, center eastern edge of the phase IV excavation, flaggy mottled bedding, hard and friable, fine-grained, angular-subangular fragments ¼" to 3", 10 YR 7/2 (beige-tan), no clay content, abundant mica and gypsum present on surface.

6a: Hard friable bedding present on cell floor along the eastern edge of the cell.

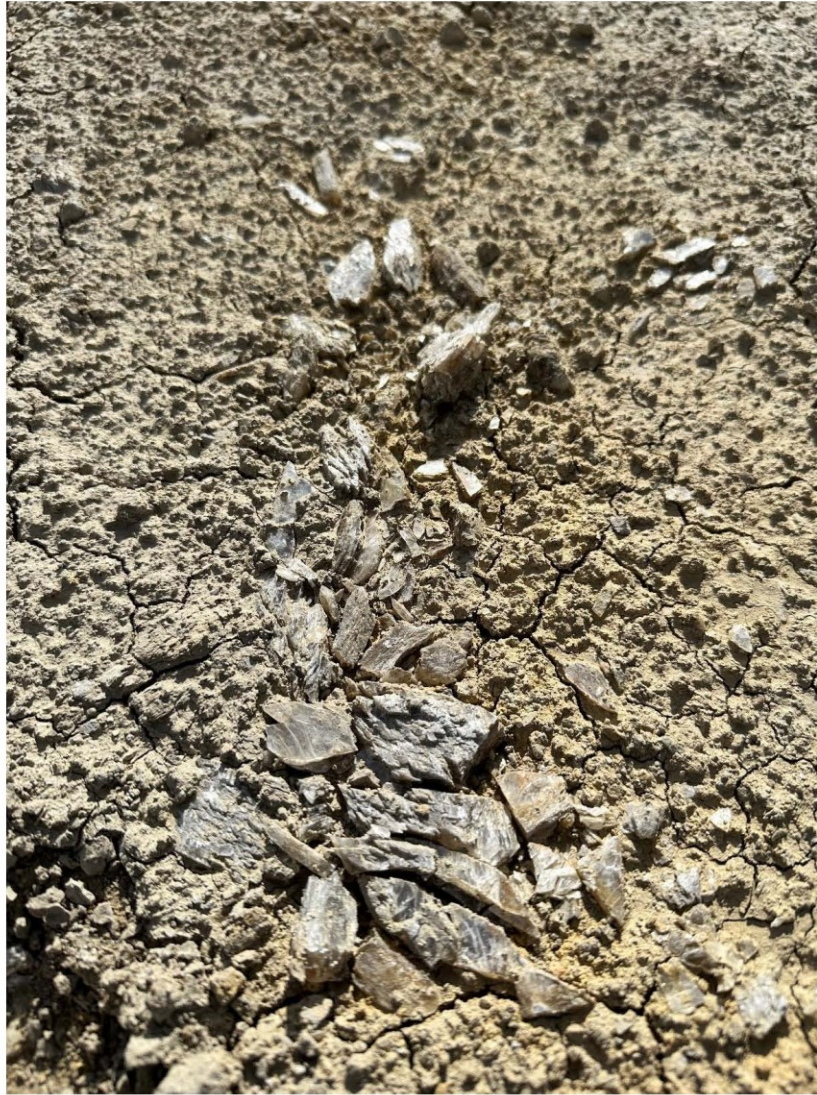
Photograph 6b

6b: Close up of mica and gypsum.

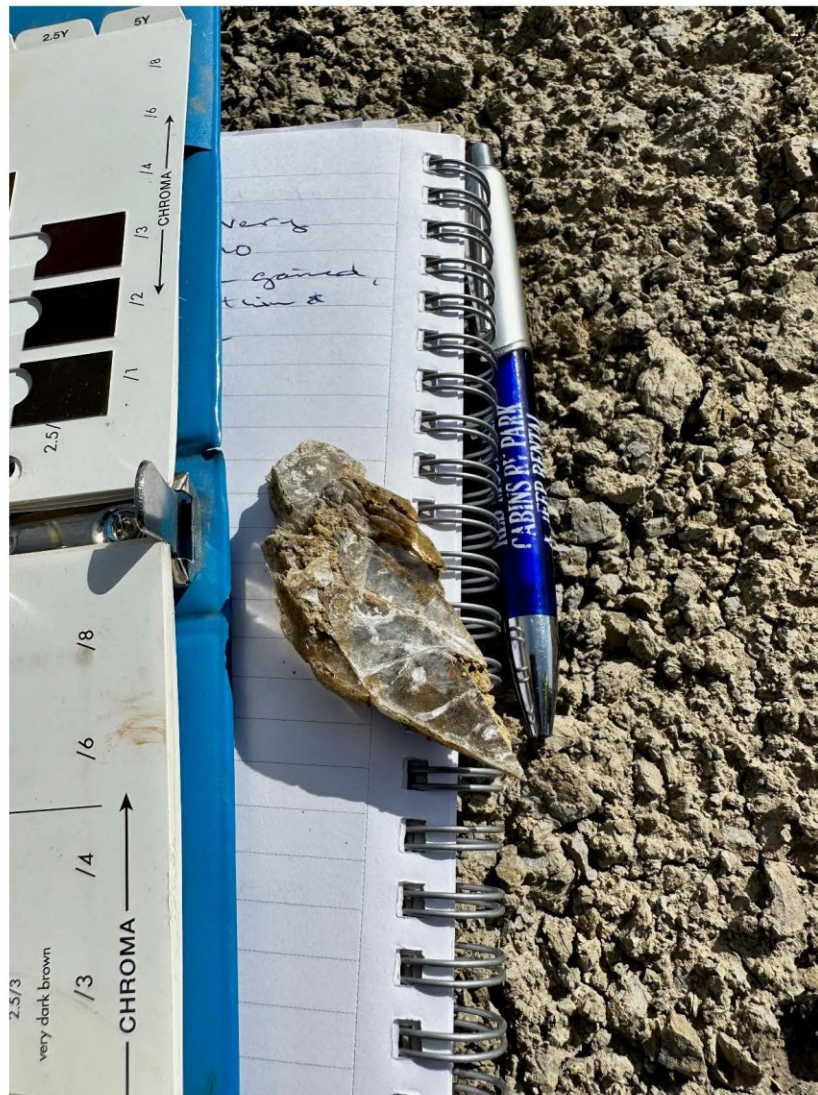
Photograph 6c

6c: Close up of mica and gypsum.

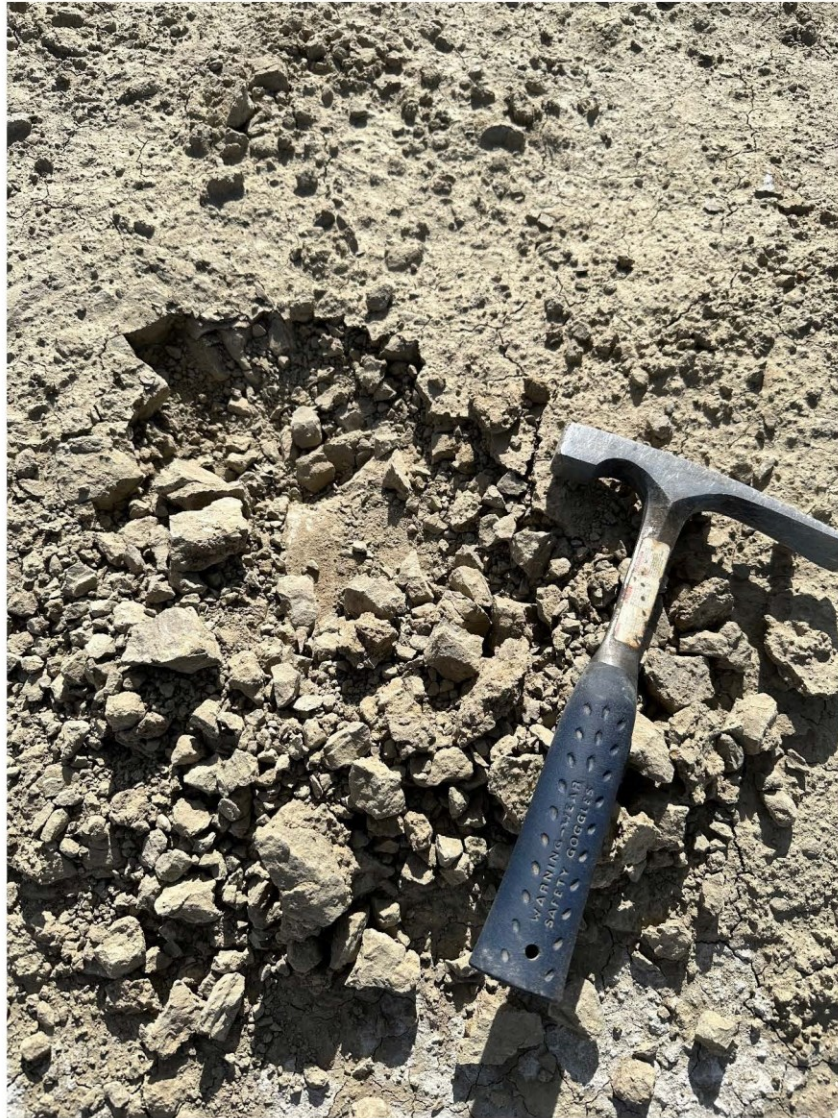
Photograph 7

Observations: Weathered Mancos Shale, central portion of the phase IV excavation. Flaggy mottled bedding, softer than previous location, fine-grained, small subangular fragments ¼" to 1" cobbles, 10 YR 6/4 (tan), partial limonite staining on some bedding faces.

7: Mottled subangular fragments present in the central portion of the cell.

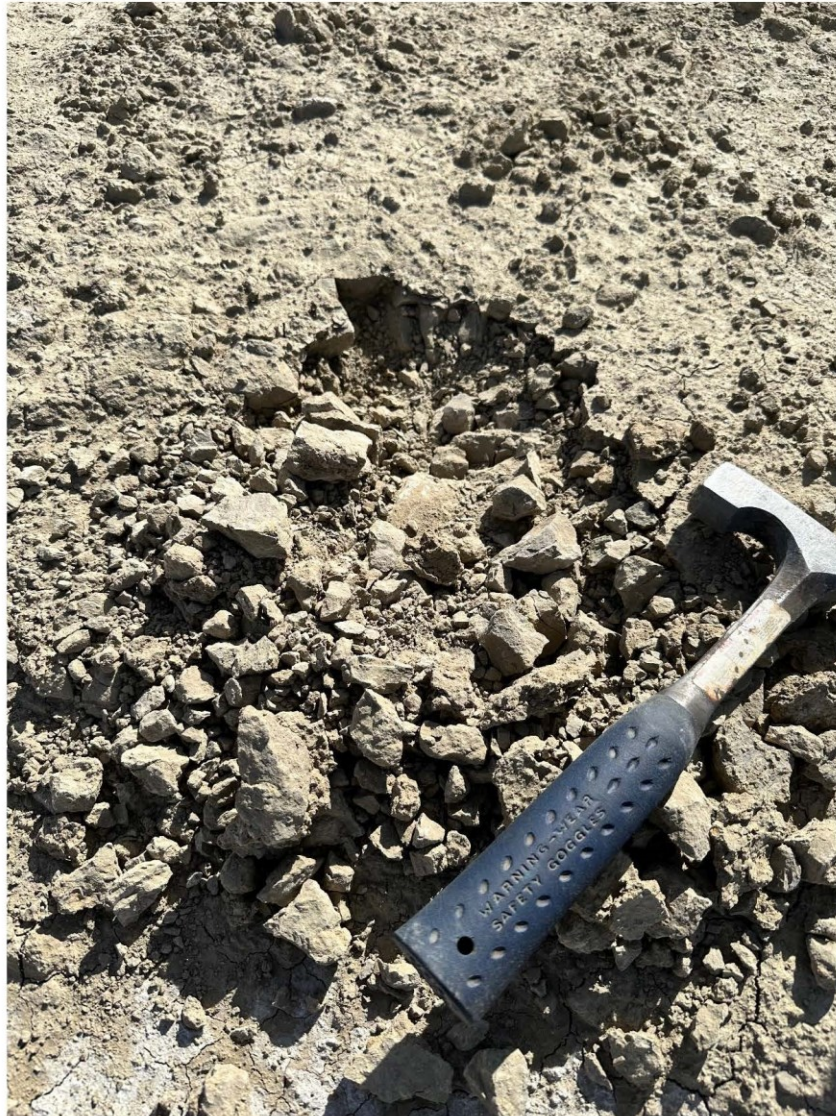
Photograph 8

Observations: Weathered Mancos Shale, east central portion of the phase IV excavation. Highly weathered flaggy mottled bedding, friable, angular-subangular fragments ½" to 2", 10 YR 5/3 (brown), limonite staining on bedding faces.

8: Close up of weathered subangular clasts present in the east central portion of the cell.

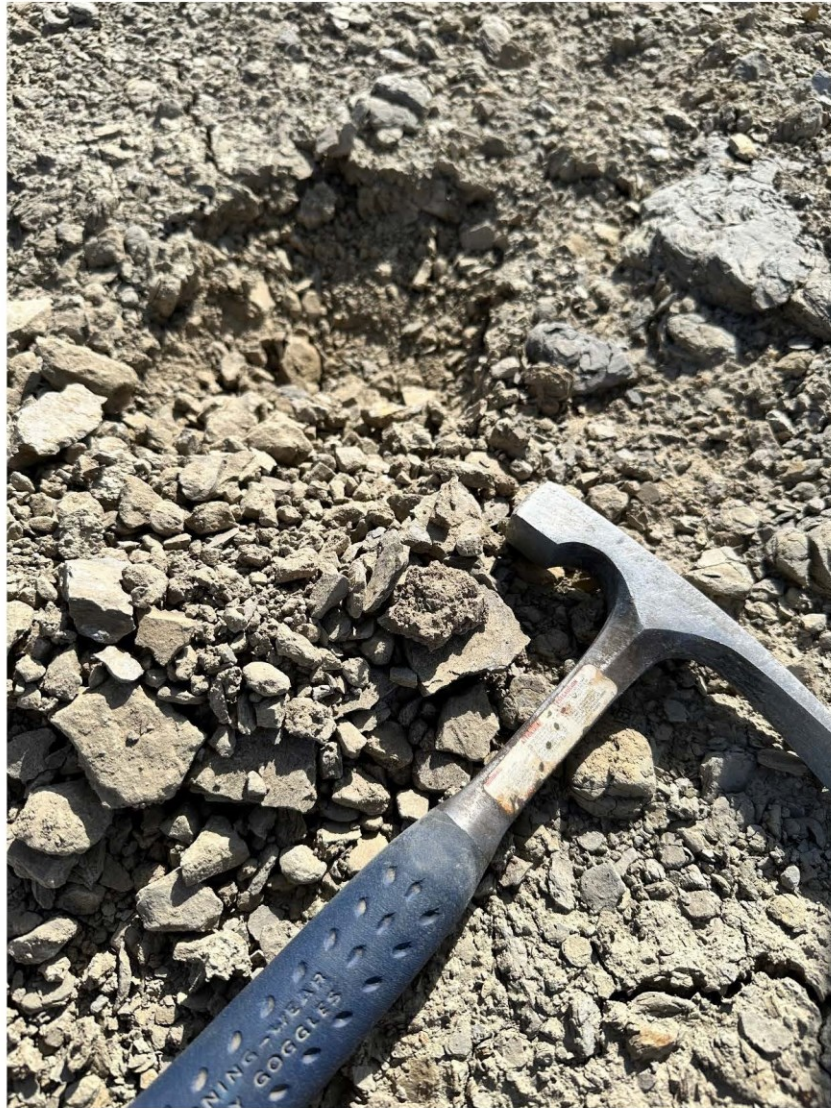
Photograph 9

Observations: Weathered Mancos Shale, east central portion of the phase IV excavation. Flaggy mottled bedding, fine-grained, hard angular fragments, 10 YR 6/4 (tan), gypsum precipitation, some iron and limonite staining.

9: Weather bedding with iron and gypsum present on cell floor in the east central portion of the cell.

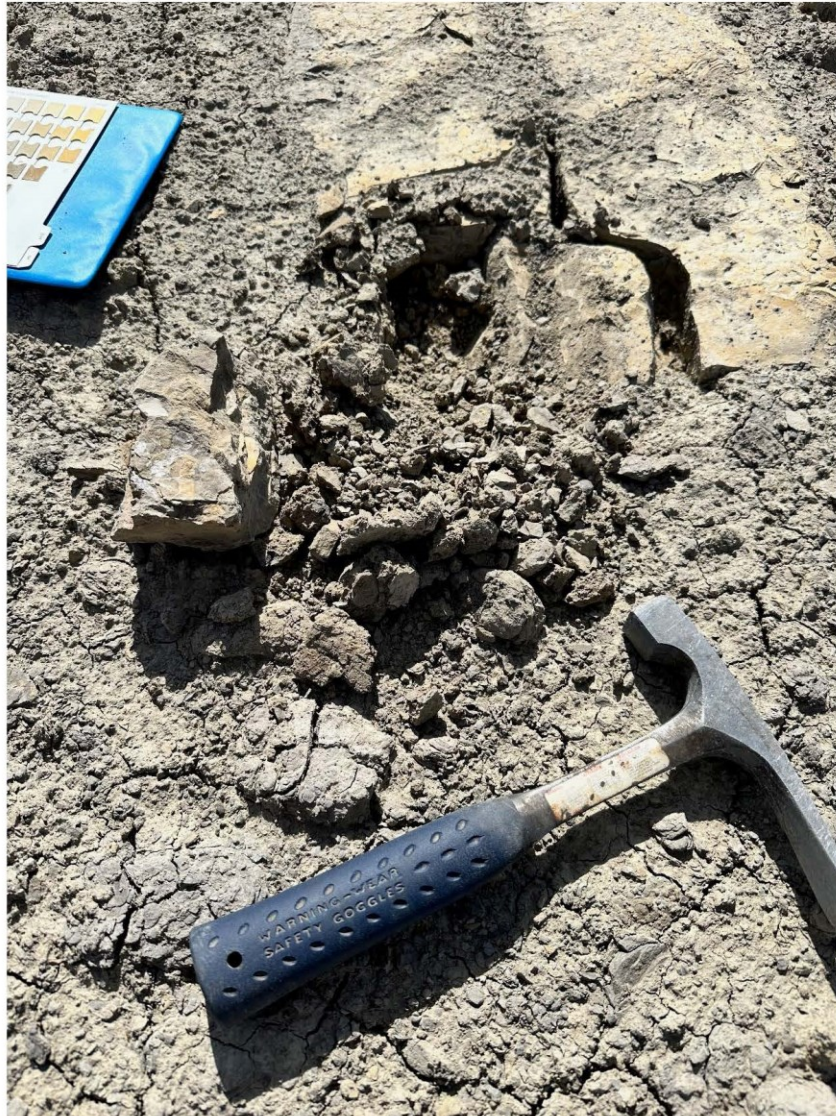
Photograph 10

Observations: Weathered Mancos Shale, south central edge of the phase IV excavation. Lightly weathered, fine-grained, hard angular fragments ¼" to 3", 10 YR 5/3 (brown), distinct bedding plane on larger fragments.

10: Lightly weathered fragments present on cell floor in the south portion of the cell.

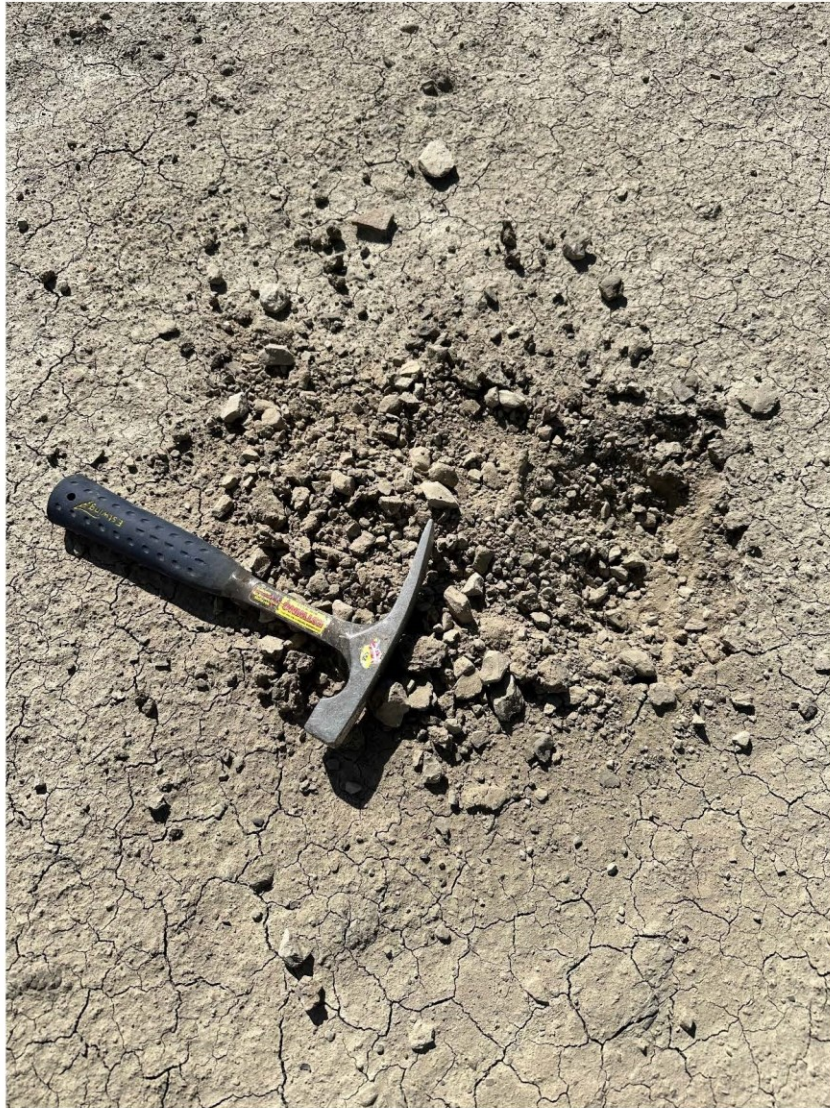
Photograph 11

Observations: Weathered Mancos Shale, south central portion of the phase IV excavation. Mottled flaggy bedding, fine-grained, round-subangular fragments ¼" to ¾", 10 YR 6/2 (tan-brown beige), trace gypsum and mica deposits.

11: Round-subangular fragments on cell floor in the south central portion of the cell.

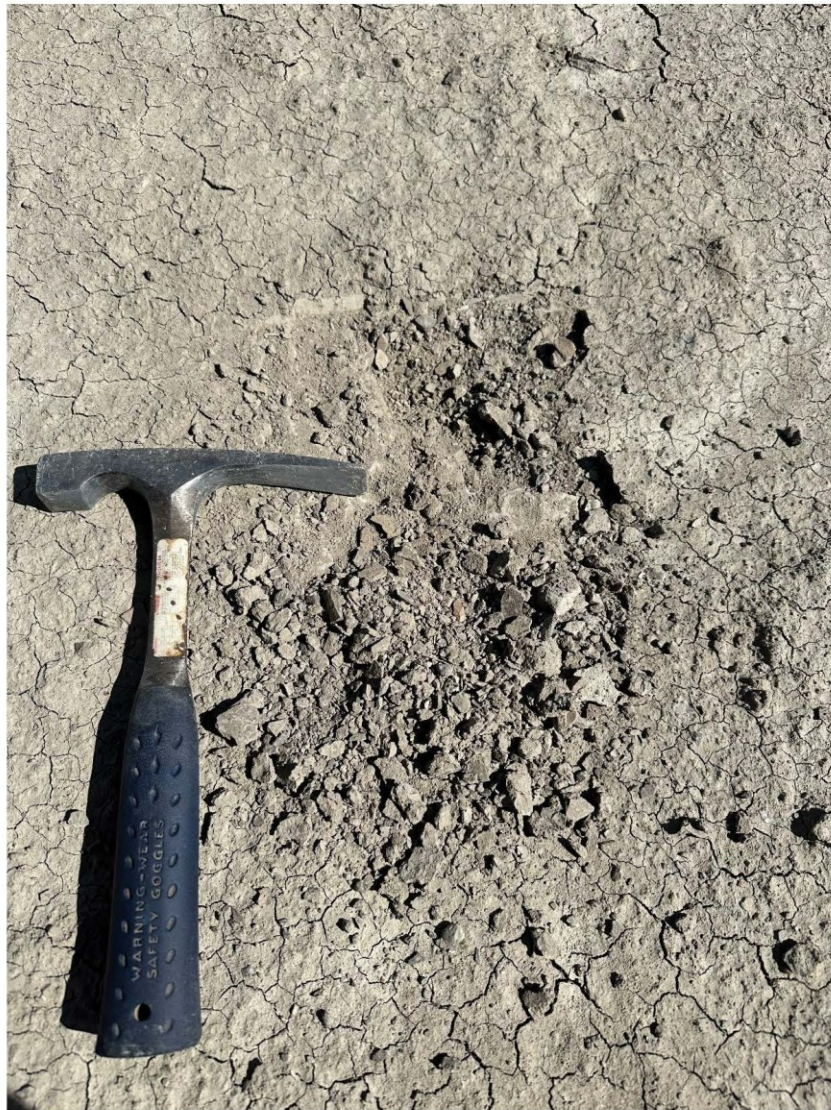
Photograph 12

Observations: Weathered Mancos Shale, southern portion of the phase IV excavation. Hard angular fragments, distinct bedding planes, 10 YR 7/2 (beige-tan), trace clay (10%) present.

12: Hard angular fragments on cell floor in the southern portion of the cell.

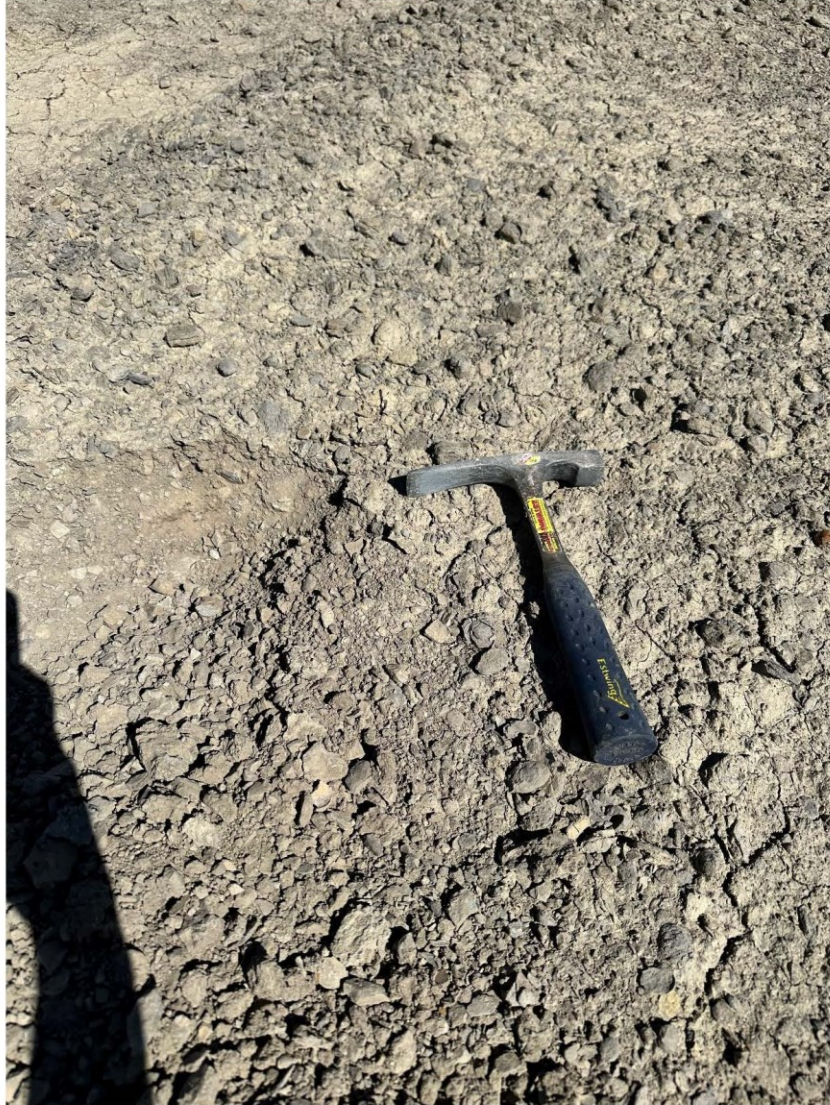
Photograph 13

Observations: Weathered Mancos Shale, southeastern corner of the phase IV excavation. Hard mottled bedding, angular fragments, friable, distinct bedding planes, 10 YR 6/2 (tan-brown beige), trace mica/gypsum present, no clay content.

13: Hard angular fragments on cell floor in the southeastern corner of the cell.
