APPENDIX E NATURAL RESOURCES ASSESSMENT REPORT

NATURAL RESOURCE ASSESSMENT REPORT

Wabash Hydrogen Energy Center Project
Vigo and Vermillion Counties, Indiana

Wabash Valley Resources LLC
444 W Sandford Ave
West Terre Haute, IN 47885
August 2024

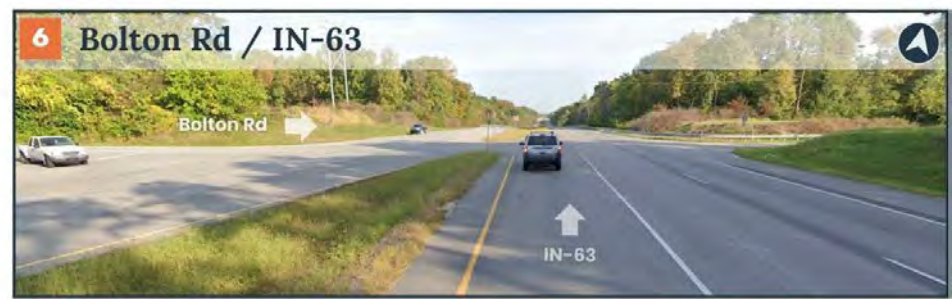
Figure3-Intersection#6

would allow for observing changing traffic patterns and potential safety hazards, thereby improving intersection safety. If congestion or safety issues arise at any intersection in the future, working with county and state transportation officials can facilitate timely investments and improvements to address these concerns effectively.

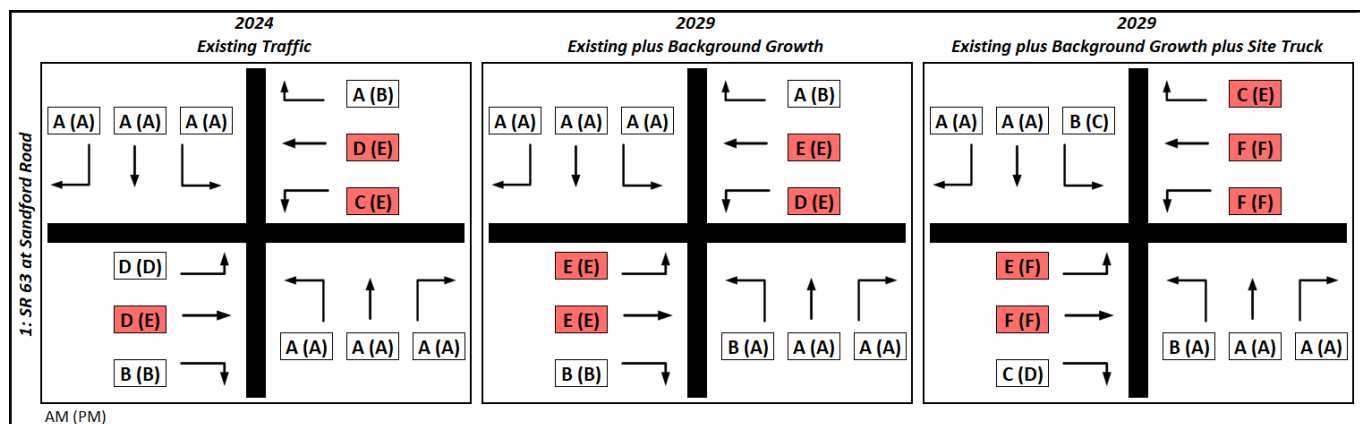
All turning movements along SR 63 are projected to operate at an acceptable level of service (LOS) during the peak hours. However, multiple turning movements at both Sandford Avenue approaches are currently operating below acceptable levels, with additional movements expected to degrade further due to background growth and the forecasted increase in site truck traffic.
