Moab UMTRA Project Flood and Drought Mitigation Plan

Revision 15

December 2025

U.S. Department
of Energy

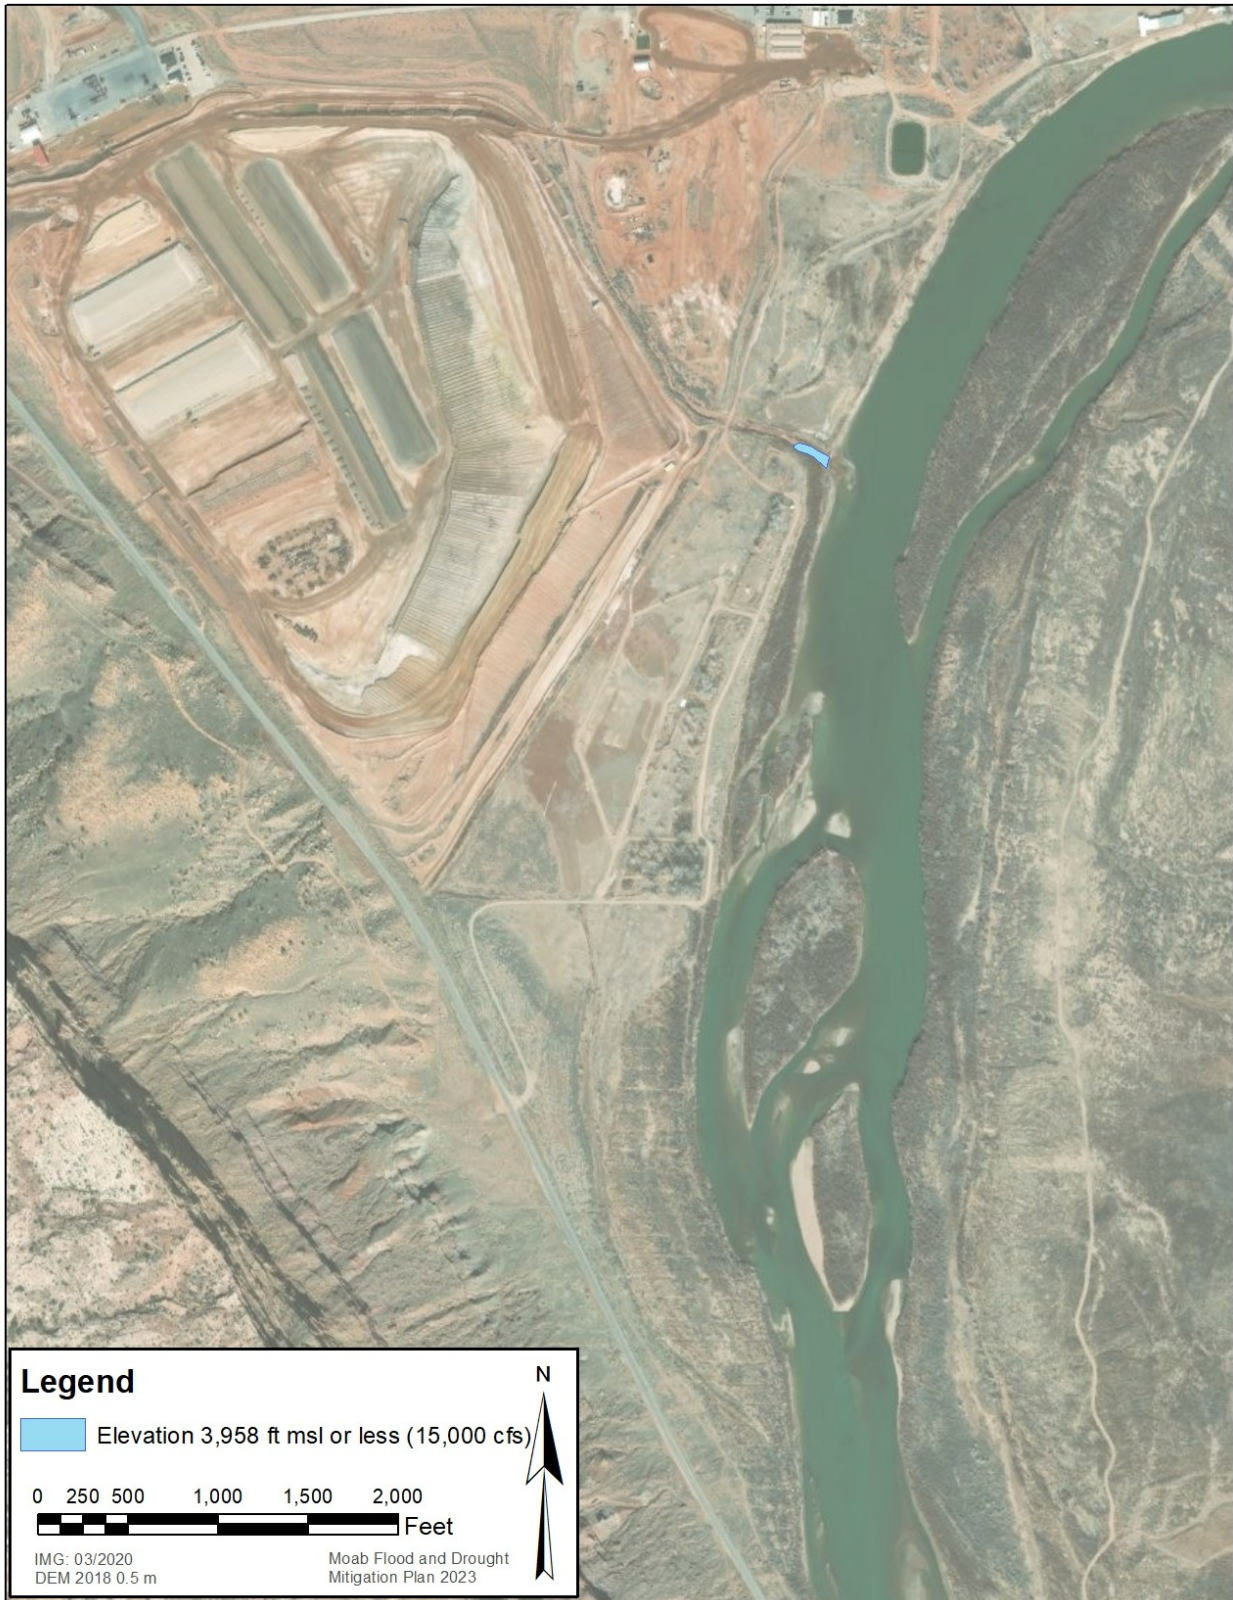
Figure A-1. Potential Flooded Areas at 15,000 cfs (Shown in Highlighted Blue Area)

These trigger points account for increases in flow rate that may occur over the weekend when site support is limited. Figures A-1 through A-4 in Appendix A show the ground elevations of the Moab Site that will be impacted by the specific river flow. Figures A-3 and A-4 (for flows of 35,000 and 40,000 cfs, respectively) were generated prior to 2025 surface remediation activities that included the removal of some berms that were once located at the base of the tailings pile and north of Moab Wash. As a result, these maps may no longer be representative of the areas actually impacted at these river flows. Surface remediation activities are on-going as the site moves towards closure, and this needs to be taken into consideration during flood preparation.

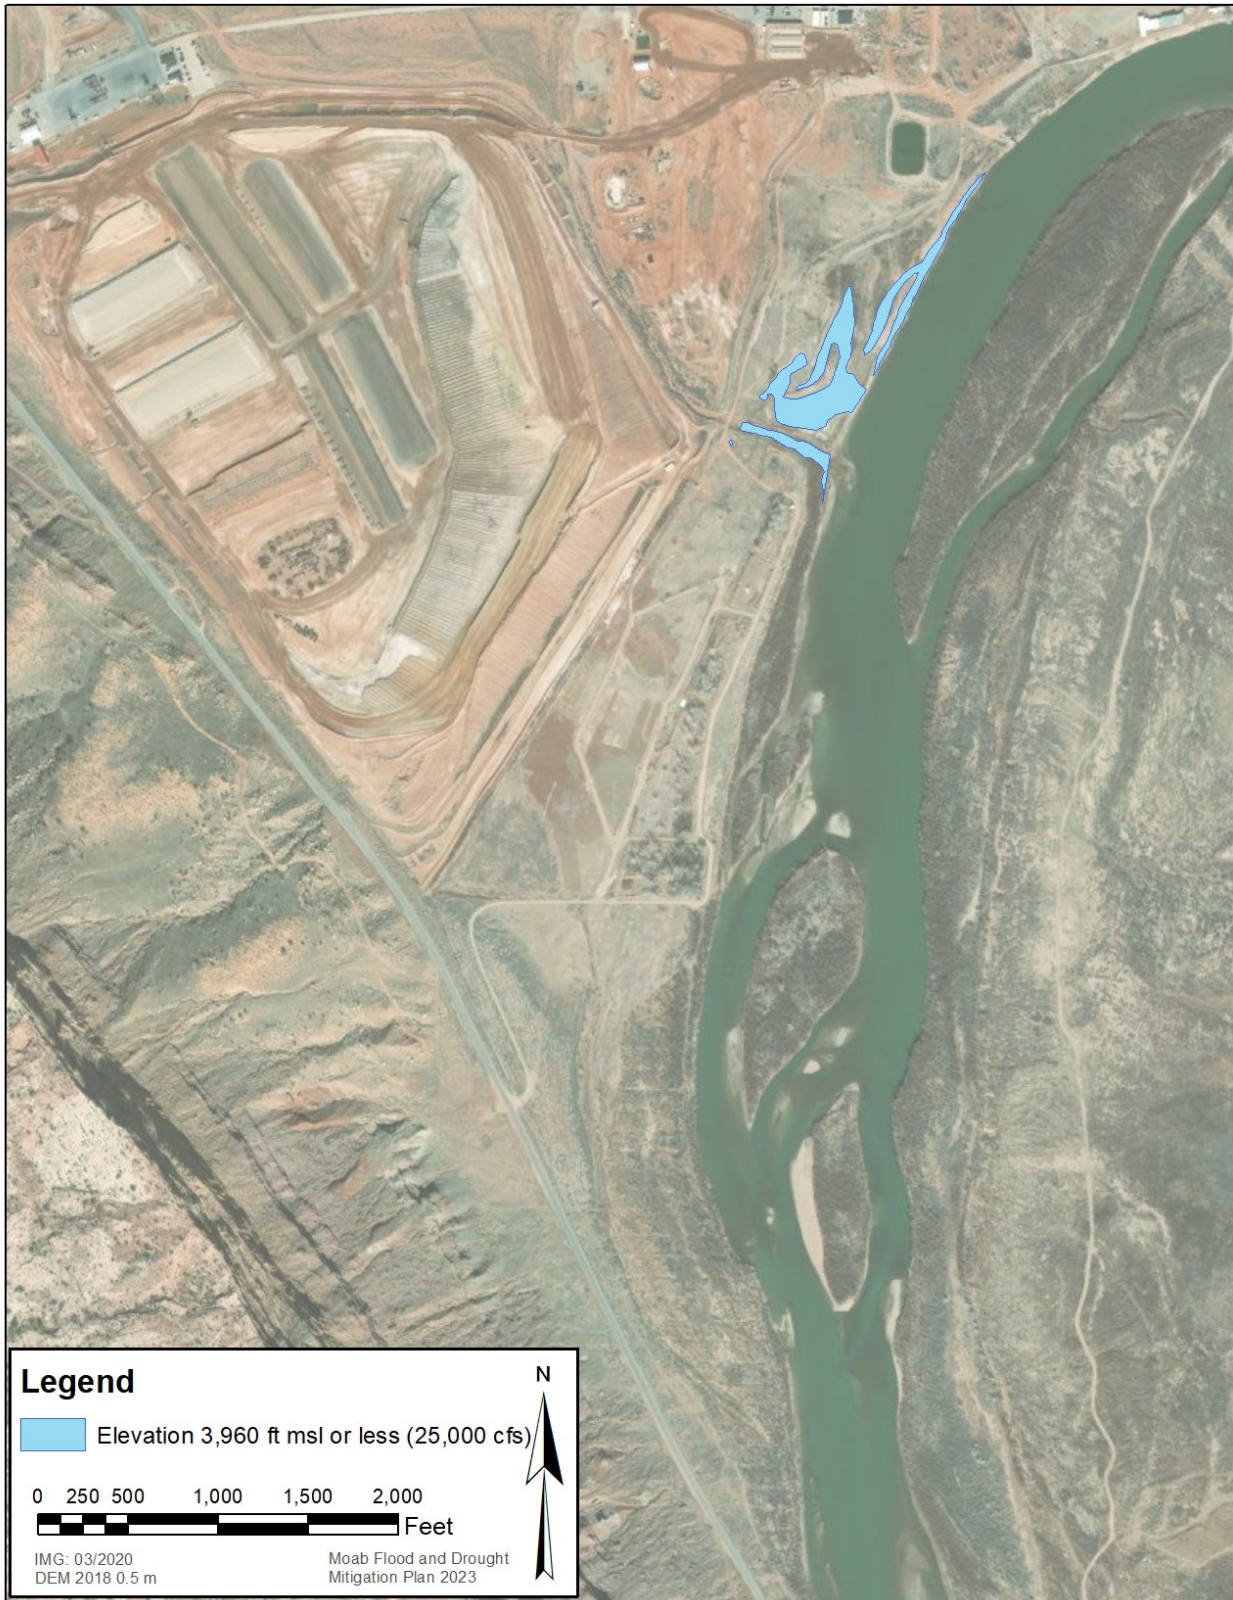
Figure A-2. Potential Impact of 25,000 cfs

At flows of just above 25,000 cfs, well field access will be impacted by surface water backing up into the Moab Wash and onto the lower Wash crossing. Once the Colorado River flows are predicted to reach 25,000 cfs at the Cisco gage, RAC personnel will perform the following tasks:
