## Building America Efficient Solutions for Existing Homes

### Case Study: Build San Antonio Green San Antonio, Texas

**Construction:** Deep energy retrofit

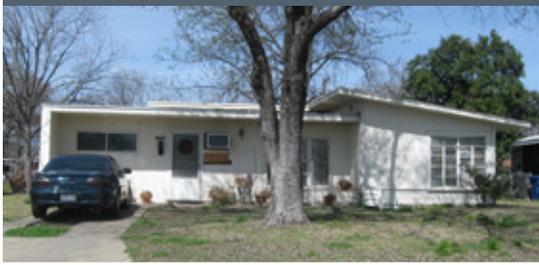
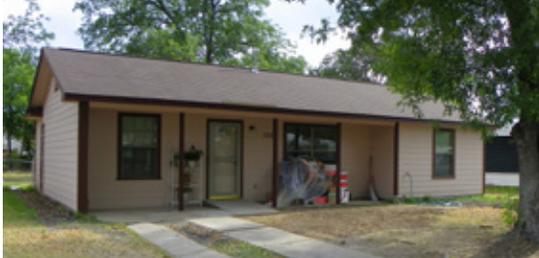
*(Photo above) Before and after photos of the 1949 retrofit.*

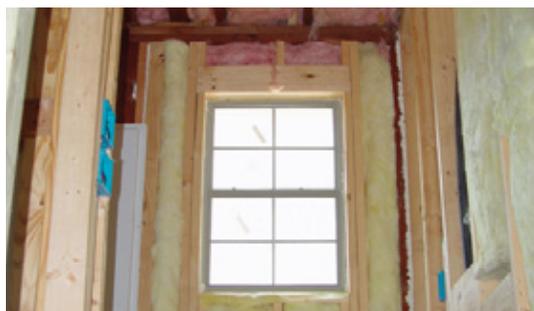
*(Photo left) Unfaced batt insulation was properly installed in wall cavities without gaps or compression*

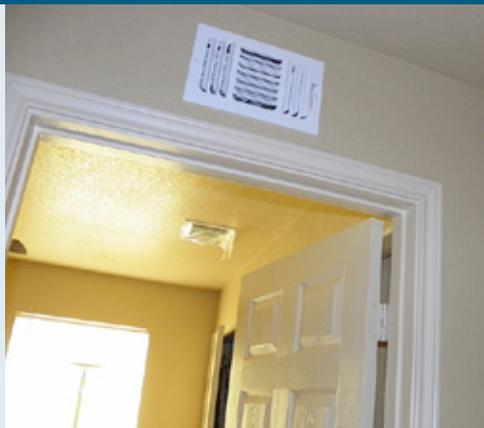
Transfer grilles (left photo) were installed to ensure good return air flow even when the bedroom doors are closed. The outside air intake is through a filter-backed grille (right) that removes dust and pollen from the ventilation air which is circulated by the new central HVAC system's air handler fan. (Photo sources: BSAG and Calcs-Plus)

- To ensure combustion safety, the gas furnace was installed in the attic and the gas water heater was installed in an exterior closet.
- A tight duct system, the transfer grilles, and the outside air ventilation system proved to be implementation challenges even with an HVAC contractor willing to learn. As a result, multiple site visits, onsite duct testing, and training were required to achieve the project goals.
- The availability of the pre-retrofit utility bills permitted the team to calibrate the analysis model, which was then used to estimate the post-retrofit savings. To better understand actual energy use and occupant lifestyle, all three project homes are being metered.
