Building America Case Study Whole-House Solutions for New Homes

Hydronic Heating Coil Versus Propane Furnace

Rehoboth Beach, Delaware

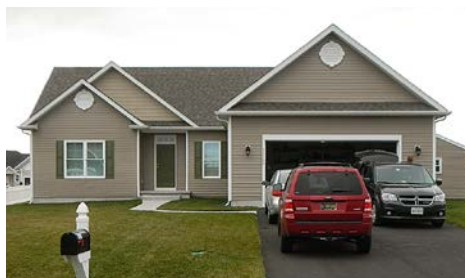
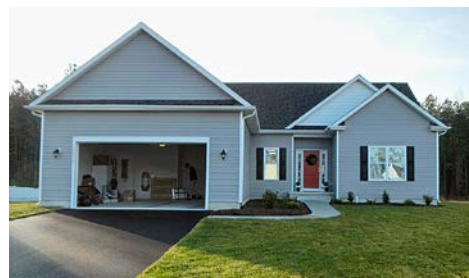
Standard house (left), and test house (right)

In 2012, Insight Homes constructed two similar homes (identical floor plans and thermal envelopes) with different heating and domestic hot water (DHW) systems in Rehoboth Beach, Delaware. Each single-story, 1,715-ft² house has three bedrooms and two bathrooms. The heating, ventilation, and air conditioning (HVAC) systems and ductwork are located in conditioned crawlspaces. The standard house, which is the builder's standard production house, uses an air source heat pump (ASHP) with supplemental propane furnace heating. The Building America test house uses the same ASHP unit, but supplemental heat is provided by a combined DHW and hydronic space heating system. Both houses were occupied during the test period.
