# WIPP Weatherization: Common Errors and Innovative Solutions

**Amy Hollander – National  
Renewable Energy  
Laboratory**

**April 30<sup>th</sup>, 2013**

# Field Case Studies for Home Energy Upgrades

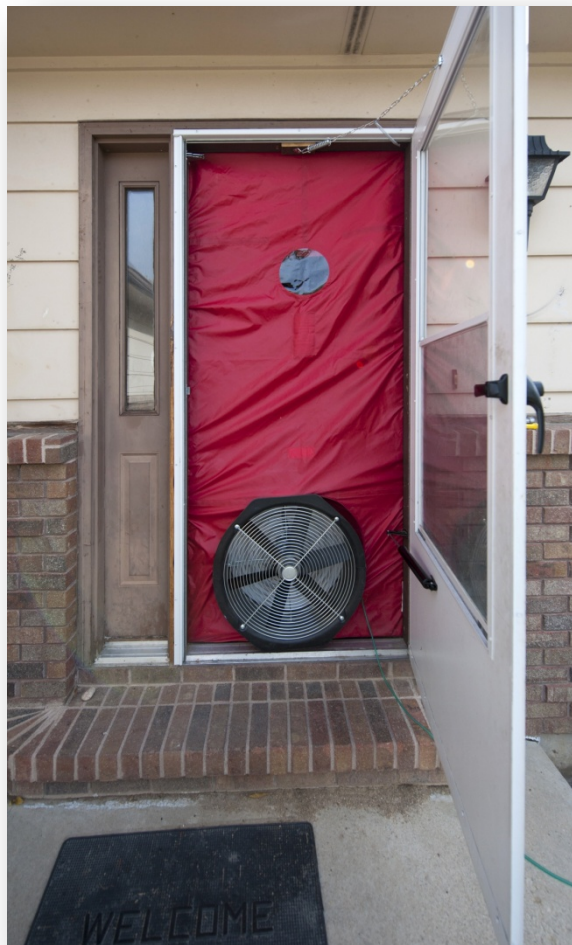
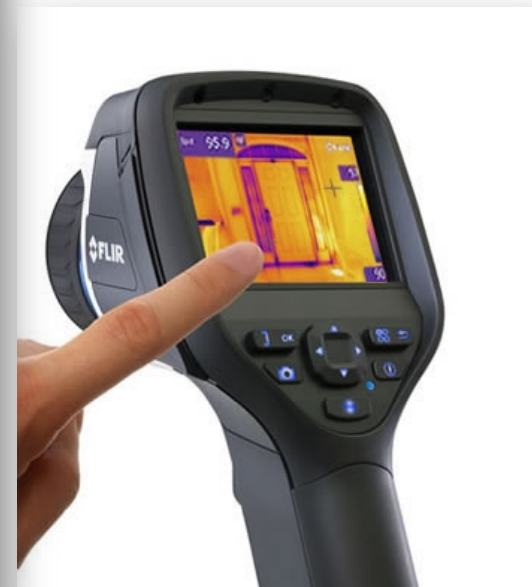
- A blower door lowers the house pressure, allowing for leak detection
- Simultaneously an infrared camera detects air leakage one cannot feel

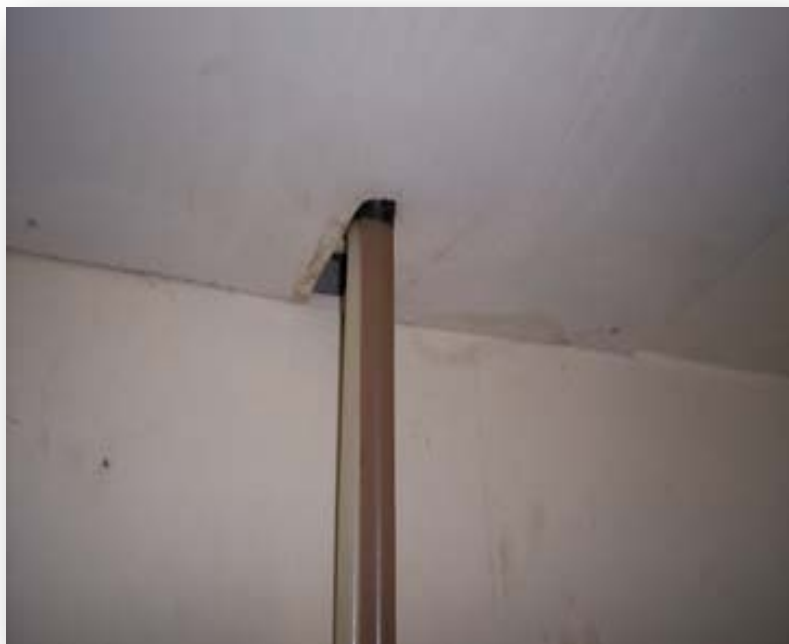
Electrical Penetrations

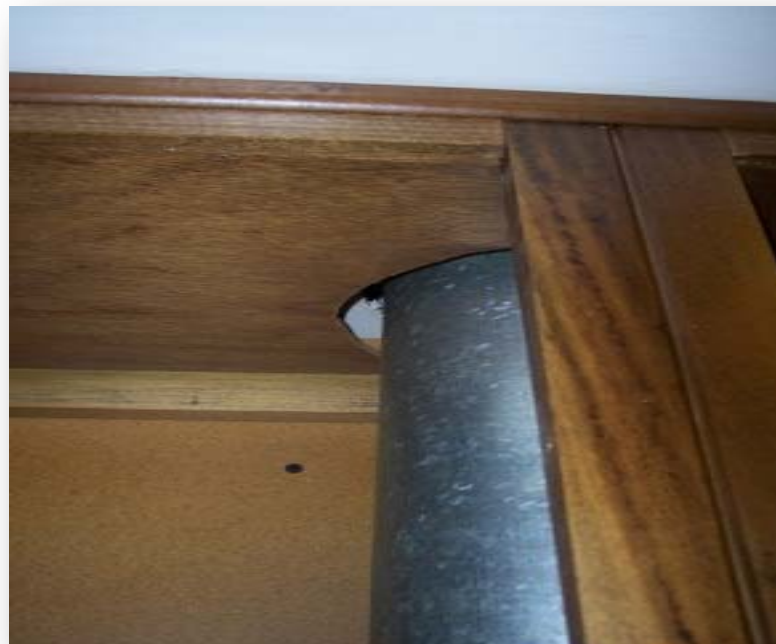
Flue Penetrations

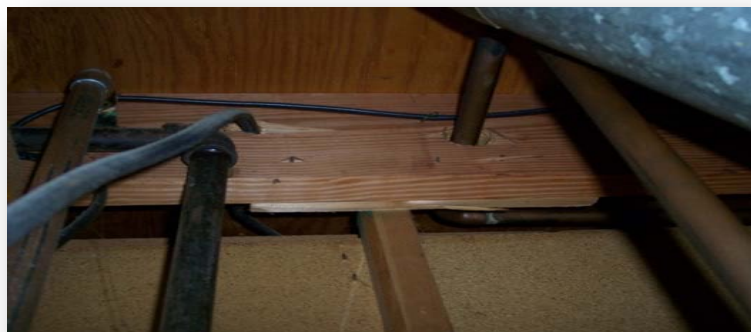
Plumbing Penetrations

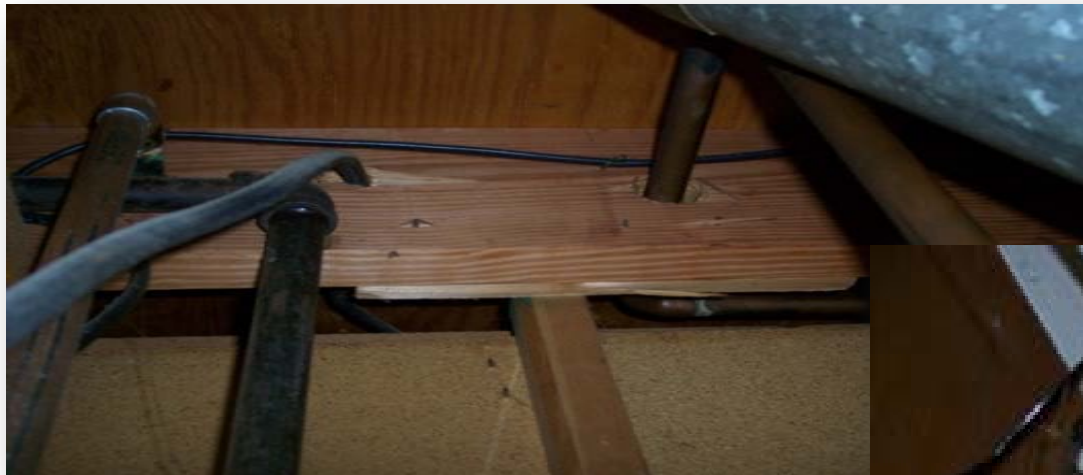
## Unsealed Penetrations

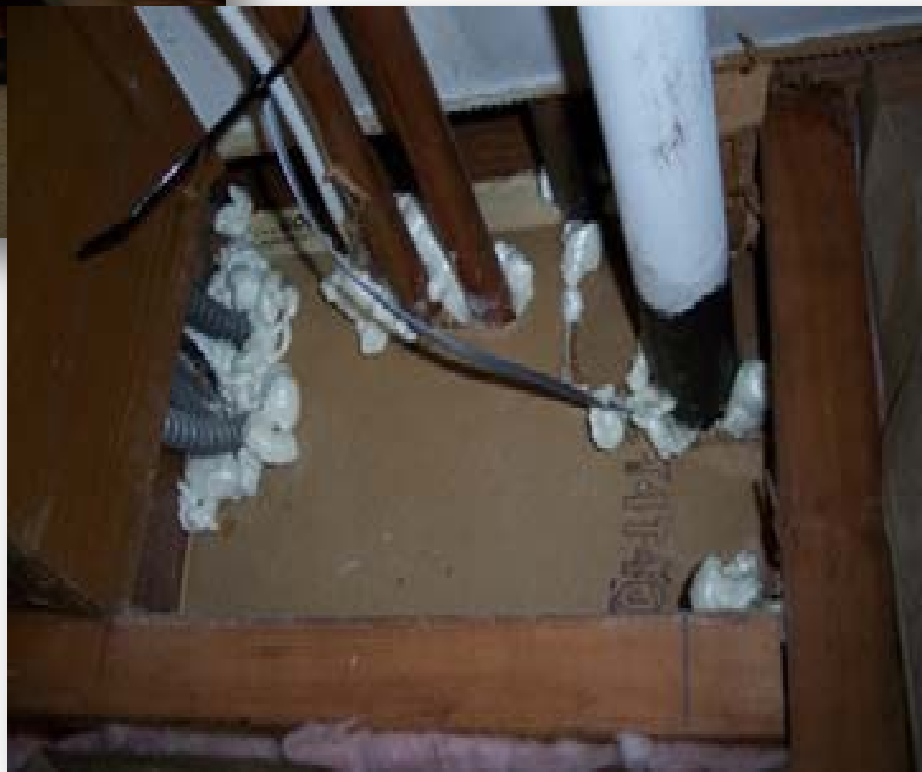
Well-sealed penetrations  
and bypasses

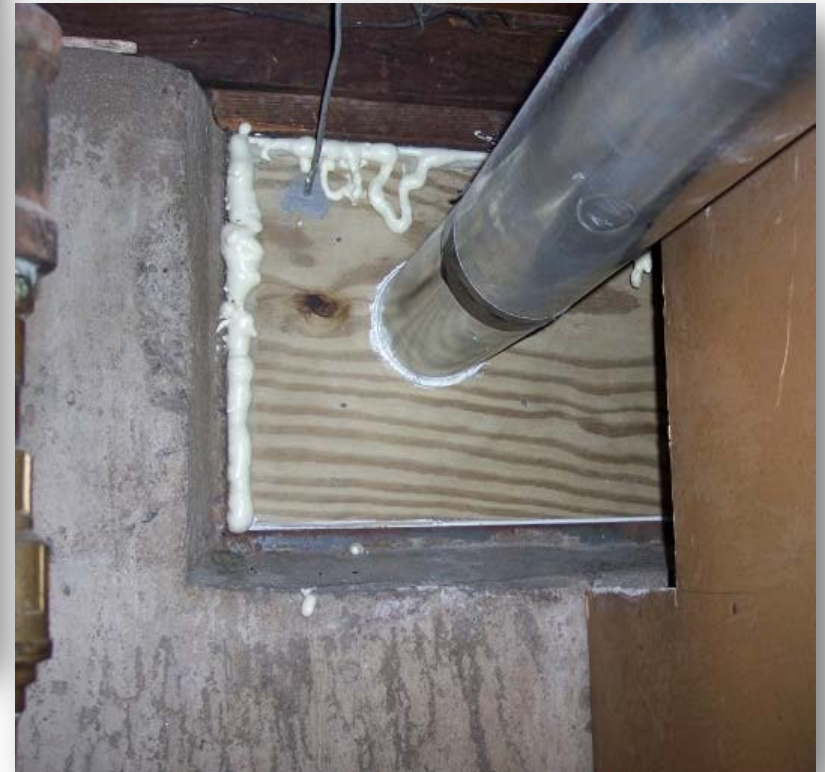
Well-sealed combustion intake through rim joist

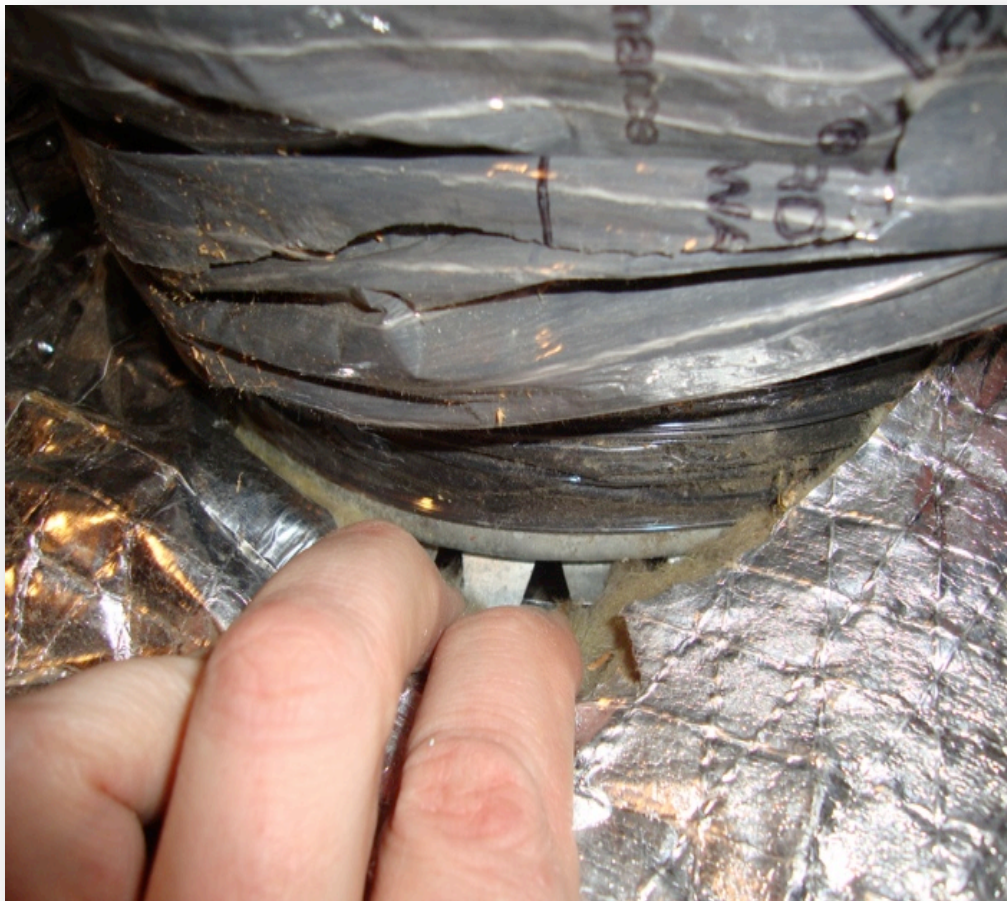
Heating ducts in the attic are nicely insulated but not air sealed.

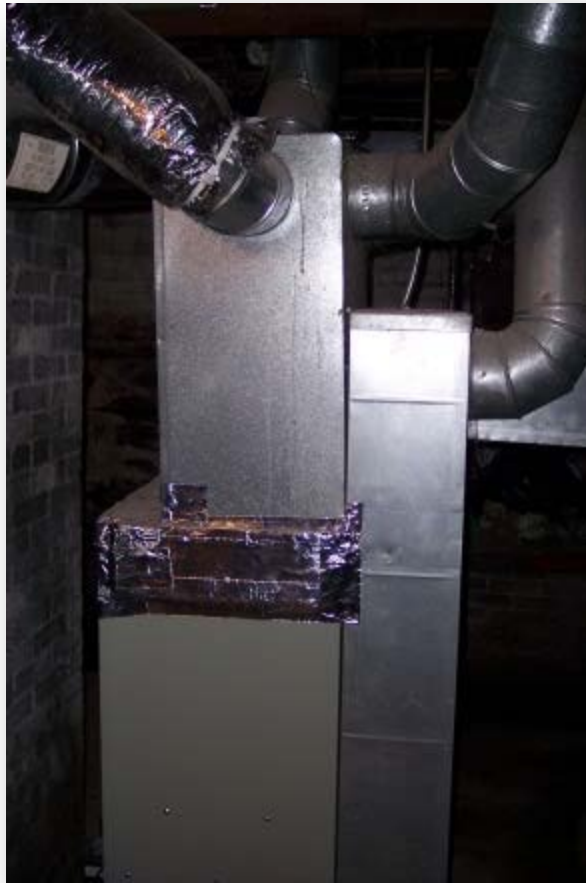
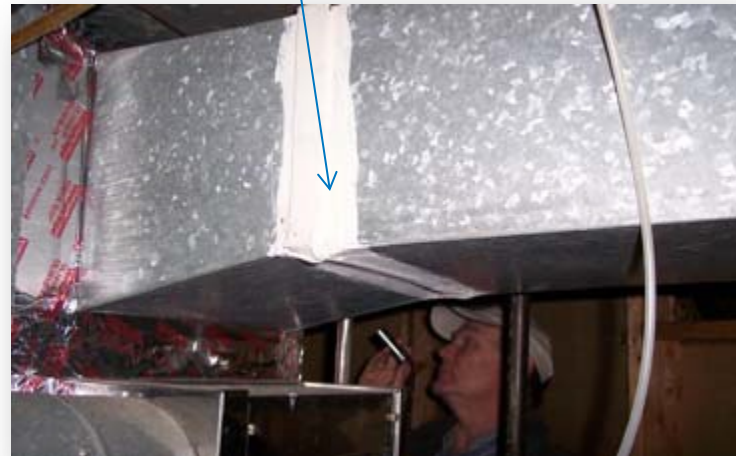
Use mastic or mesh tape, not  
aluminum tape

Mesh Tape & Mastic

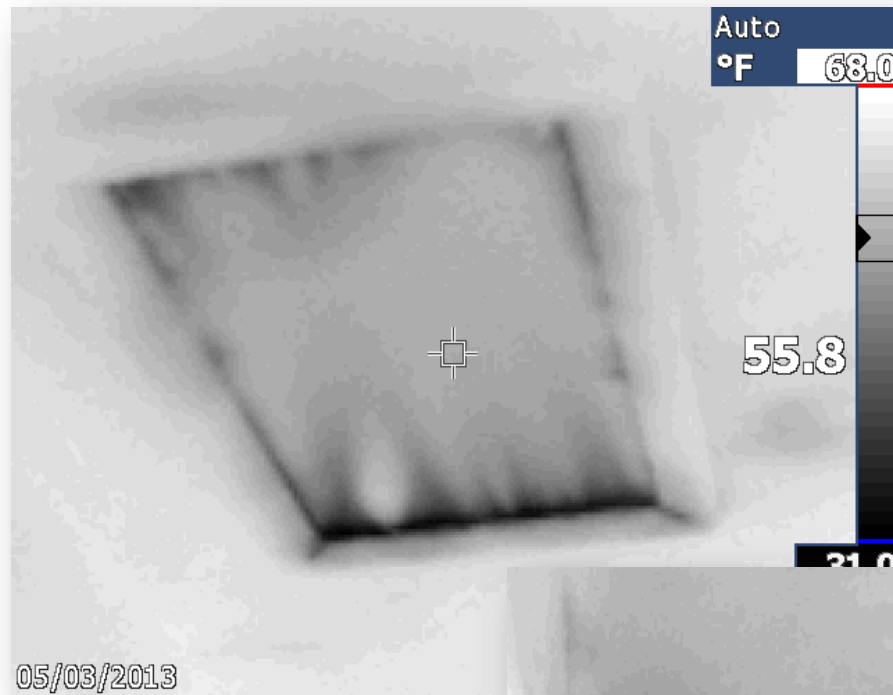
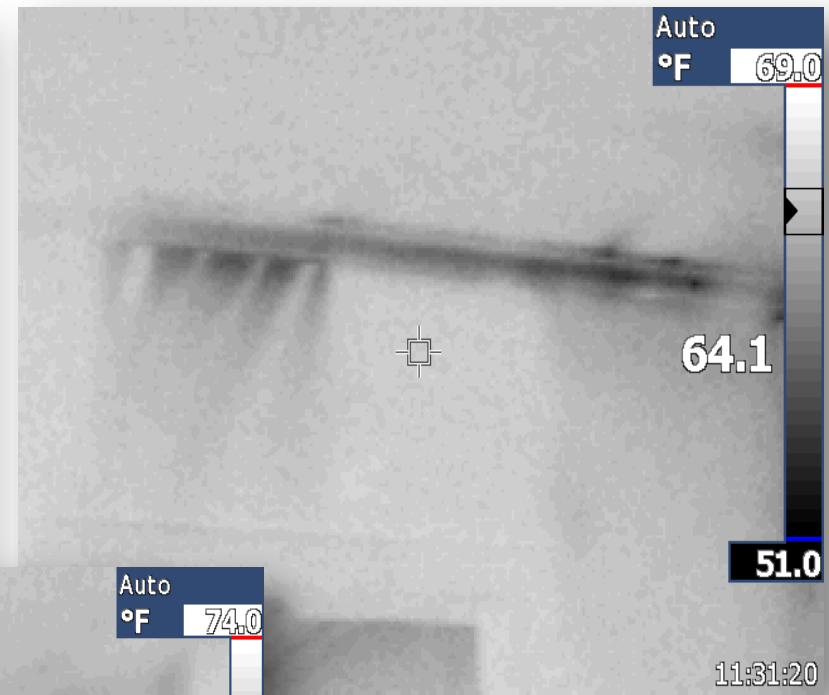
Attic top plate not sealed

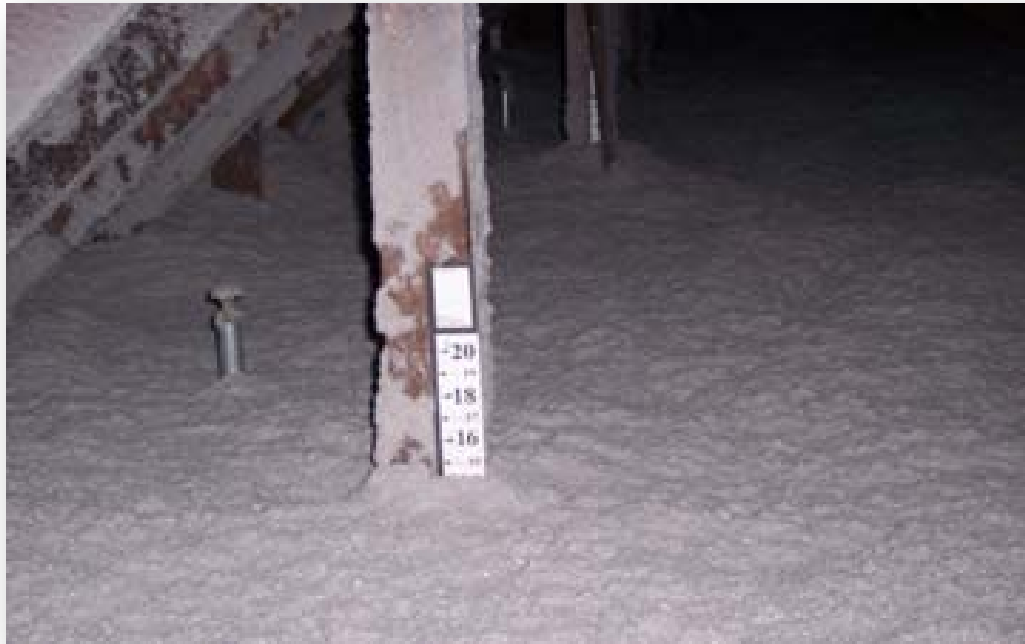
- Long lasting proof of R-50 insulation value
- Even coverage
- Proper material
- Air sealed
- Safety and access blocking

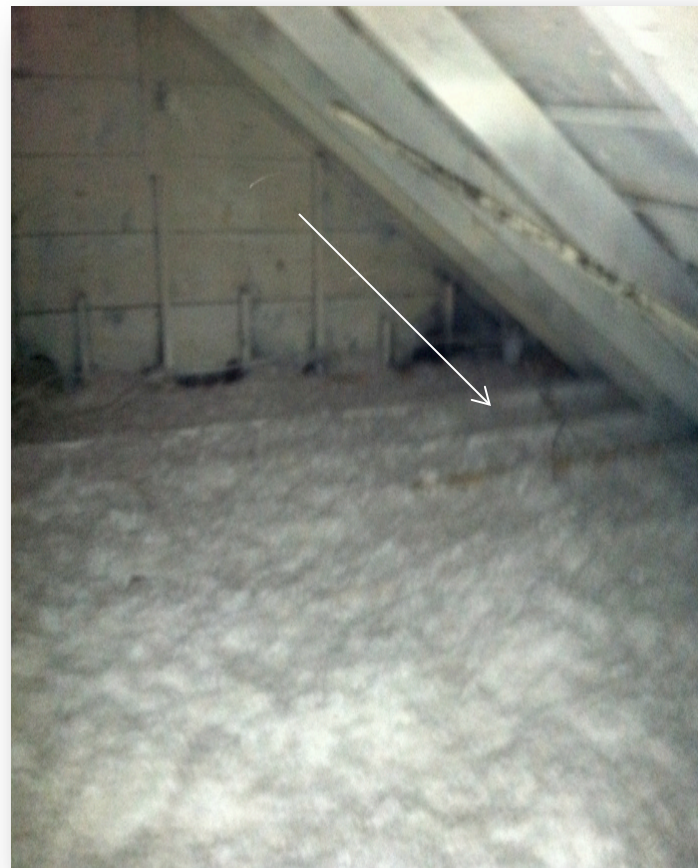
- Level insulation throughout the attic ensures a consistent R-value throughout the attic
- Post-insulation, the inspector may see wind washing from ventilation

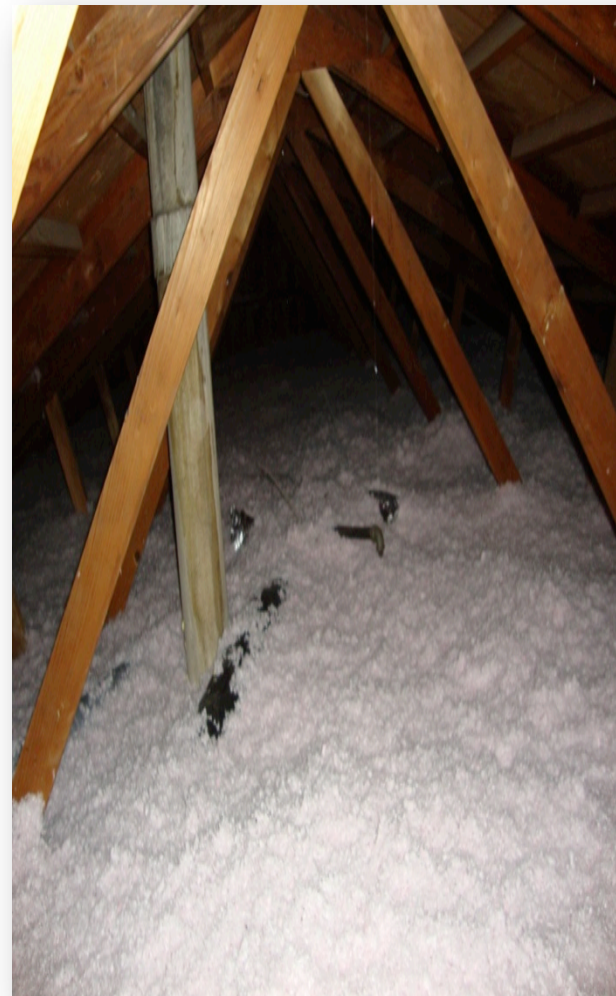
- Fiberglass in Attic?
  - Not ideal for attics
    - Attracts vermin
    - Not a recycled product
  - Best if used for weaker construction strength
    - Mobile home ceilings
    - Cathedral ceilings

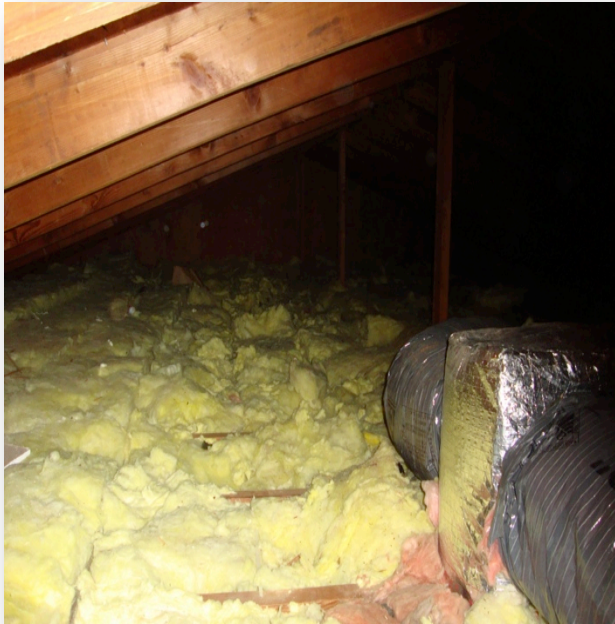
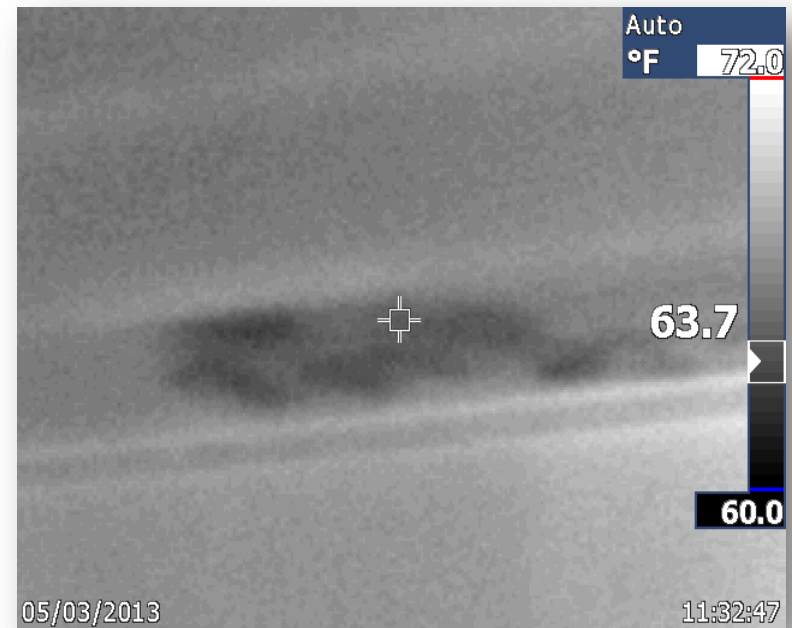
- Ceiling joists not covered
- Uneven insulation leaves gaps and causes thermal bridging

Infrared camera shows leakage at ceiling (with disturbed insulation from worker footprints) which was not adequately restored before finishing the job.

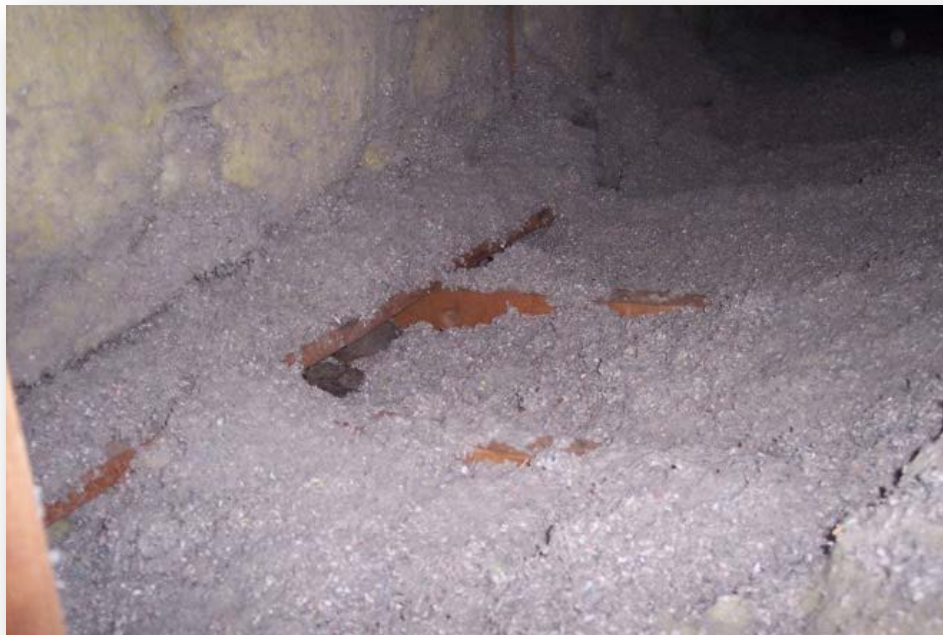
- Existing insulation in partial attic is left piled up
- Uneven insulation reduces effectiveness and allows for thermal bridging

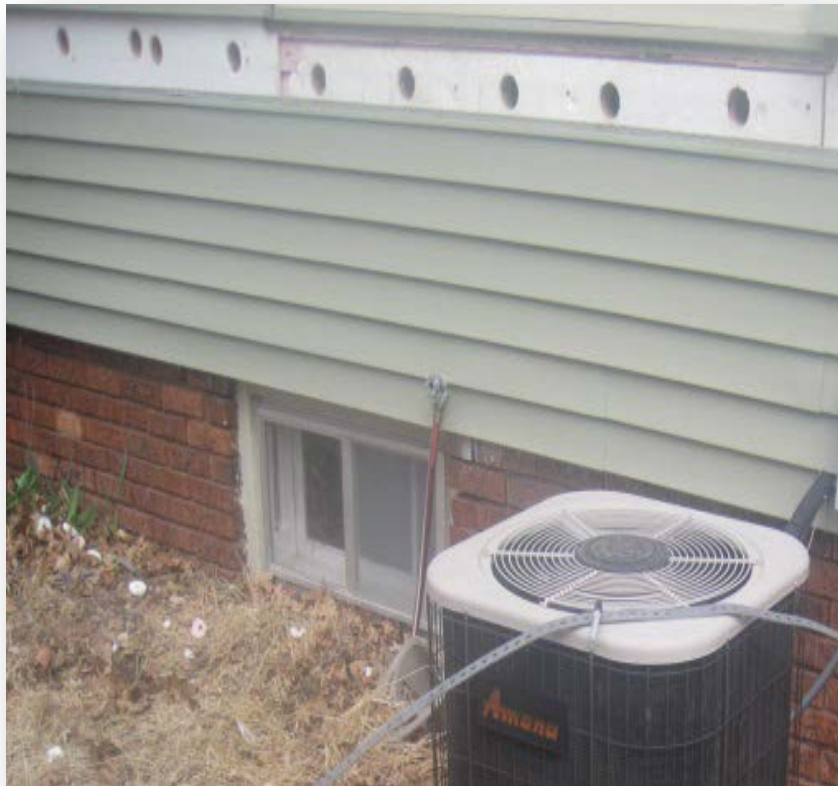
- Wall insulation should be pursued aggressively as it is usually the second or third most cost-effective upgrade
- Lead safe work practices are not a barrier

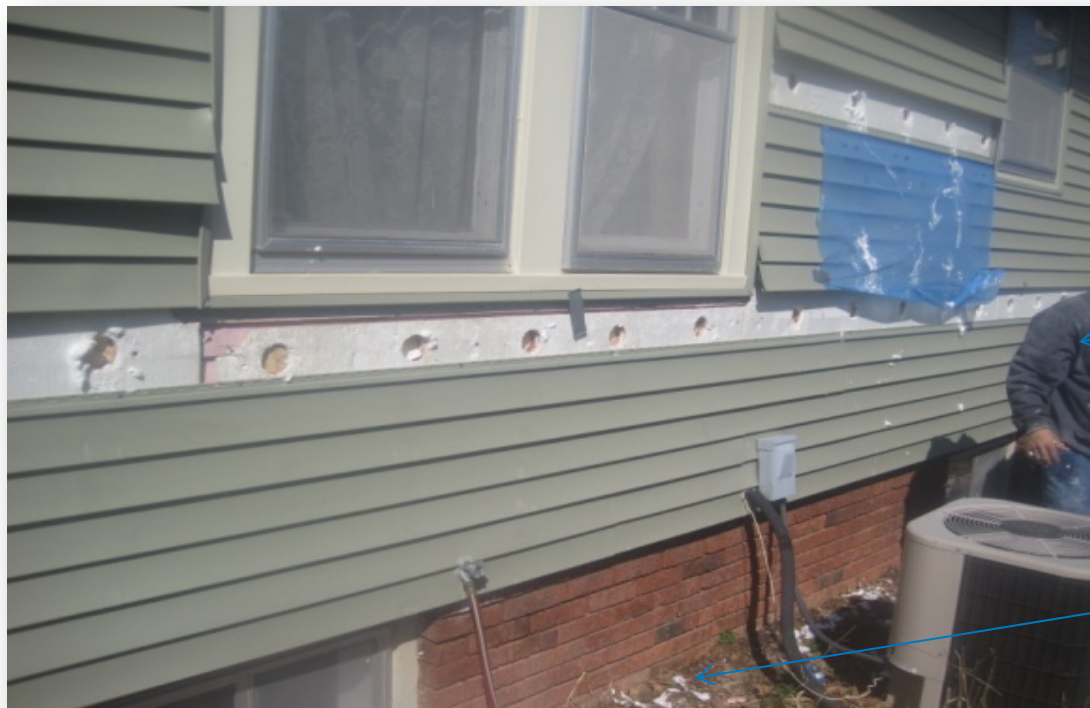
Worker has no protective equipment

Lead paint chips on ground

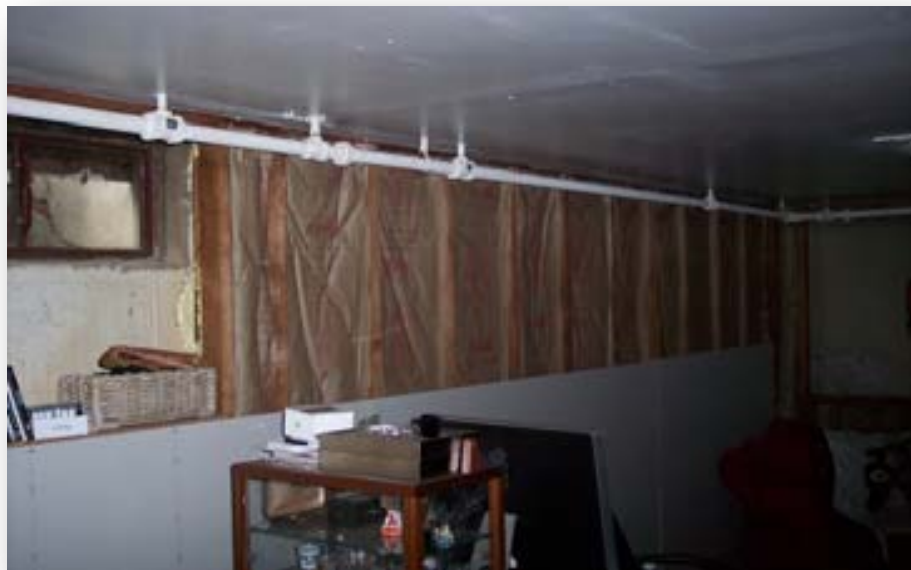
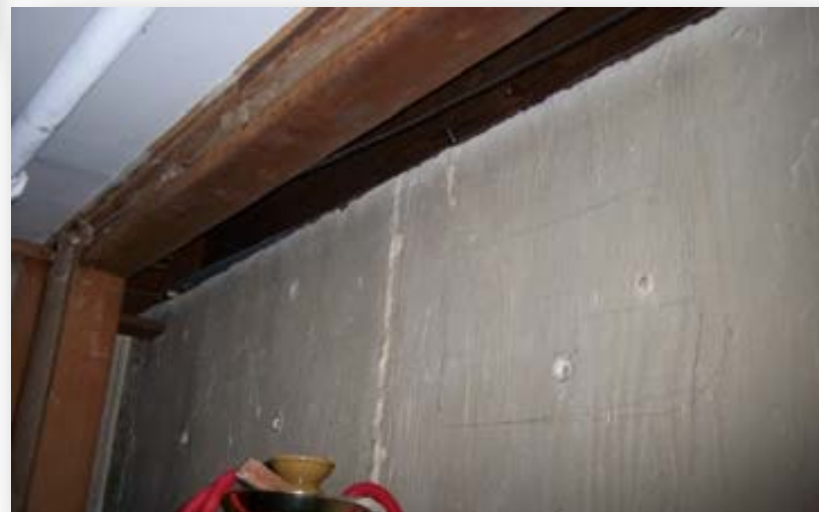
- Large gaps compromise effectiveness
- Potential moisture problems due to rim joist space not air sealed

- Did not insulate and seal rim joist spaces
- Did not apply insulation flush with surface

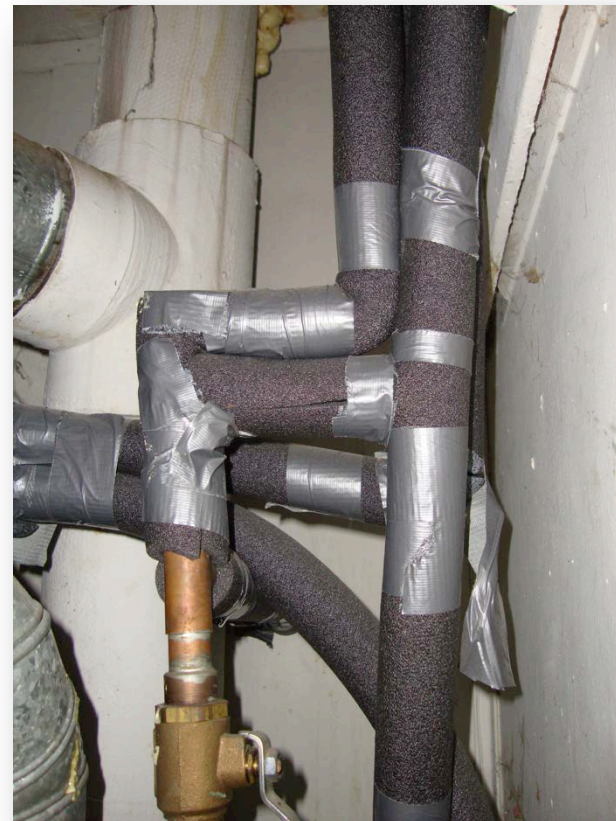
- Misuse of duct tape
  - Good insulation coverage but...
  - Foil backed ultra grip tape is recommended

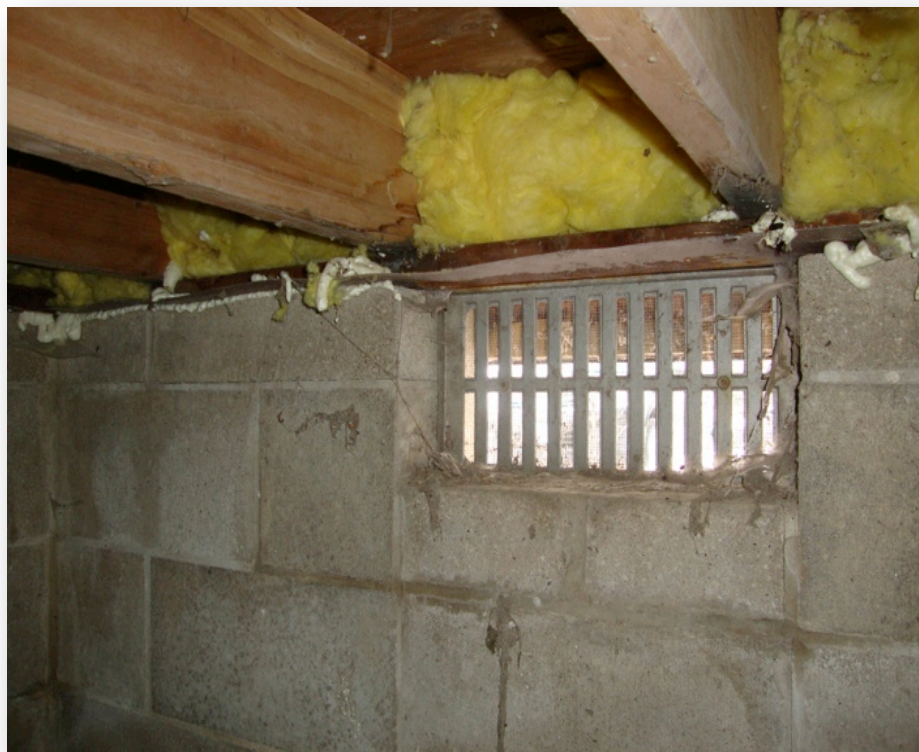
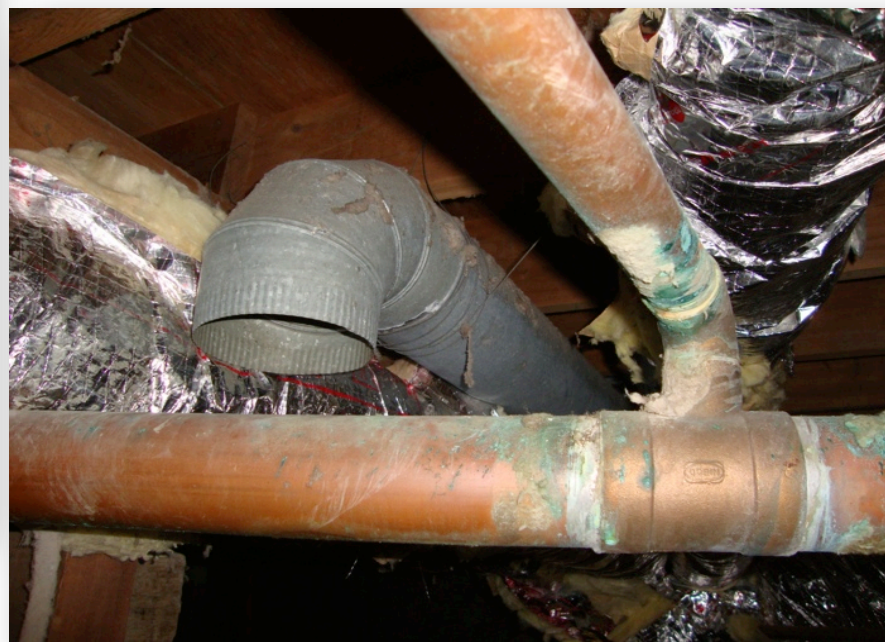
The crawlspace vents are wide open, AND the ducts are delivering heated air, making it a conditioned space.

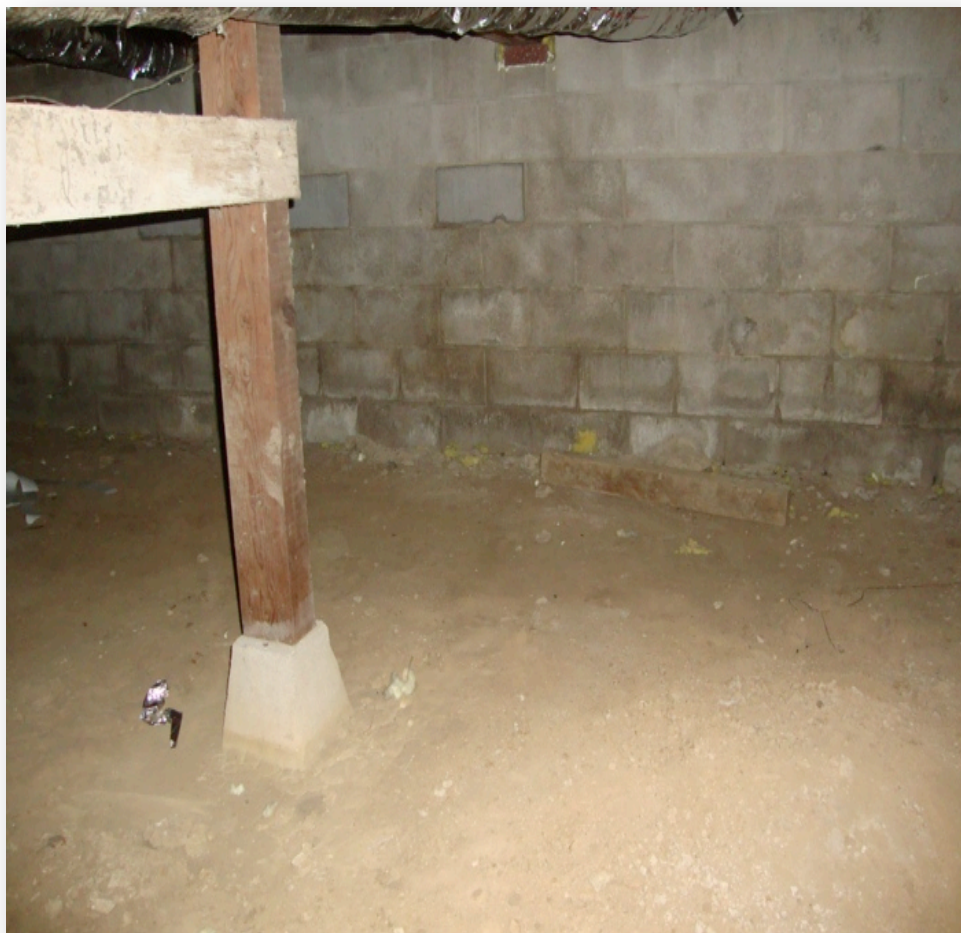
A six millimeter poly or plastic should be applied to the ground for multiple benefits

- Vapor barrier
- Radon barrier
- Storage space - A plus for the homeowner

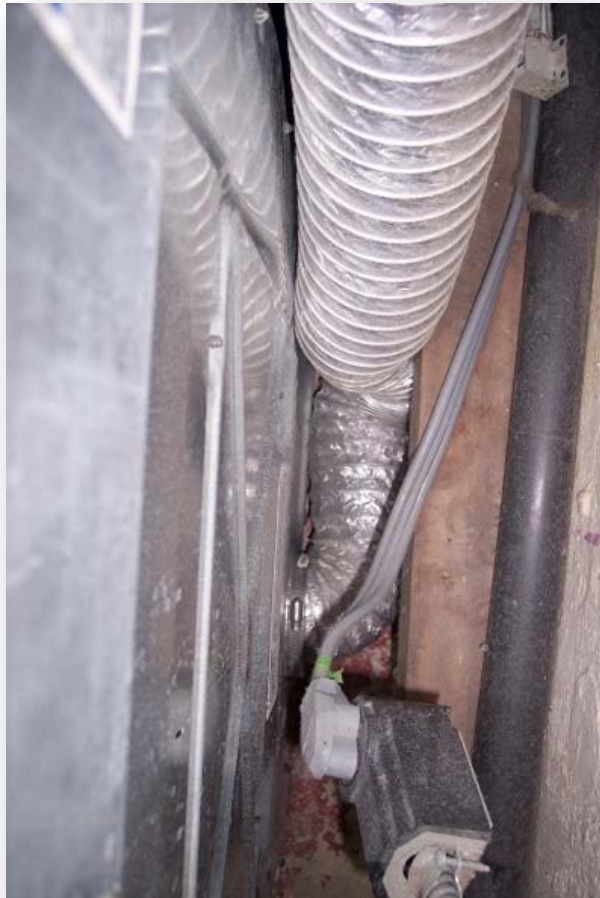
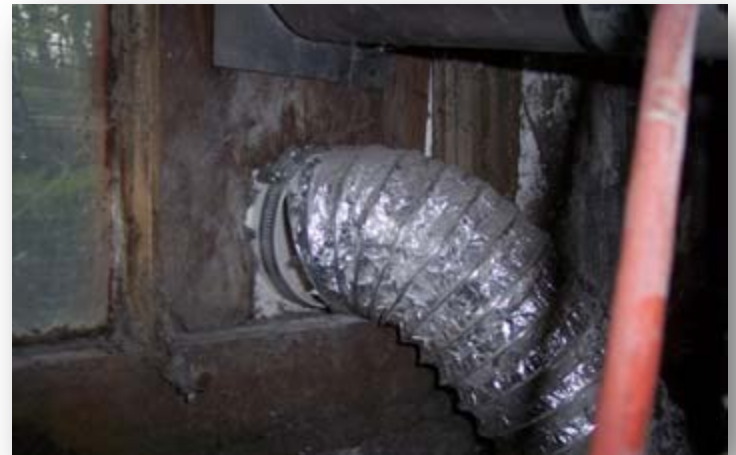
Kinked clothes dryer vent hose is a health and safety concern

Existing torn clothes dryer vent hose left unrepaired can create moisture problems

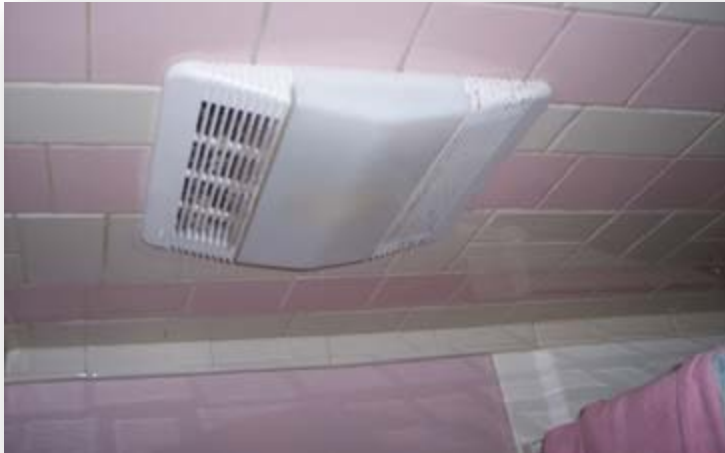
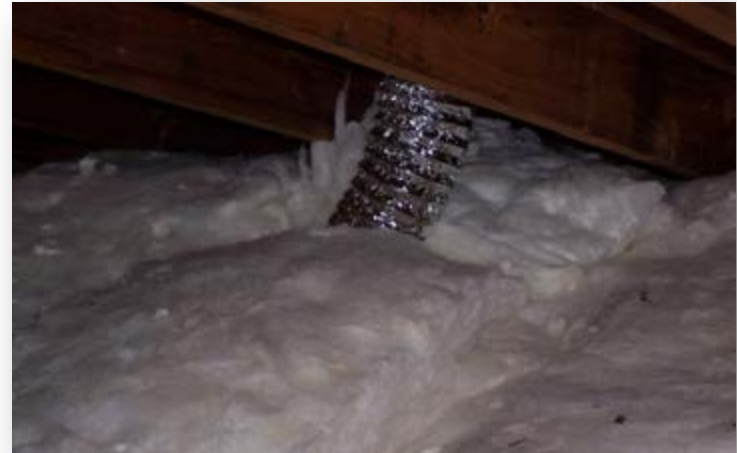
New bathroom vent fan  
properly installed and vented  
through the attic
