Advanced High-Strength Steel Stamping

ASP-050
Gene Hsiung
General Motors
May 18th, 2012

Project ID LM063

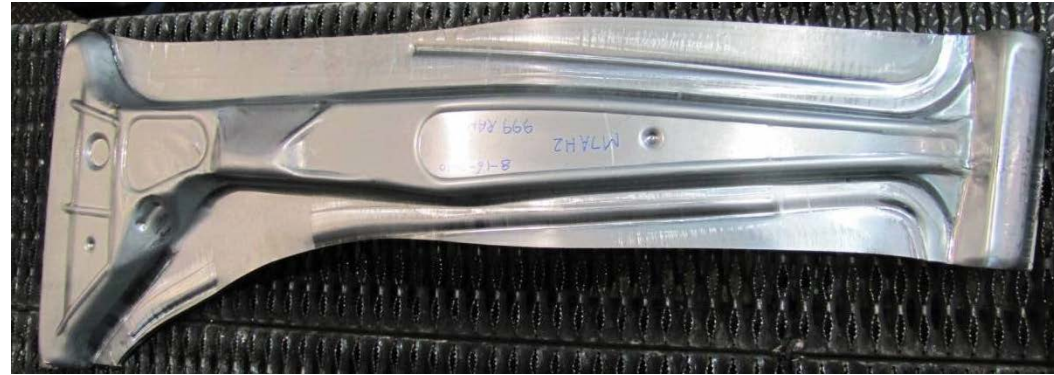
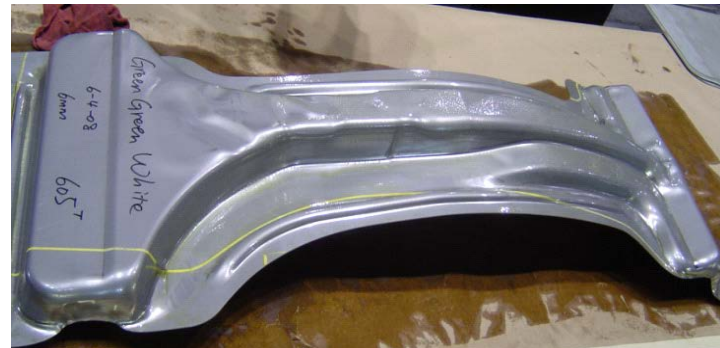
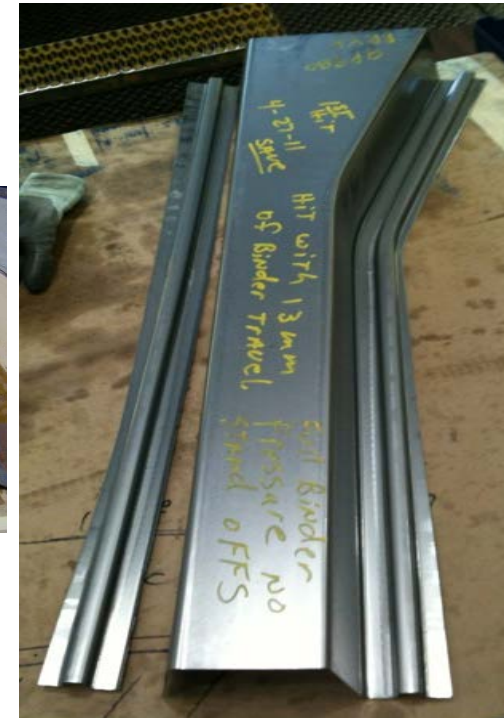
Four stamping trials were conducted using three draw dies:

- GM P-Pillar
- Chrysler B-Pillar
- Chrysler Straight Rail

- Evaluate formability
- Evaluate spring-back

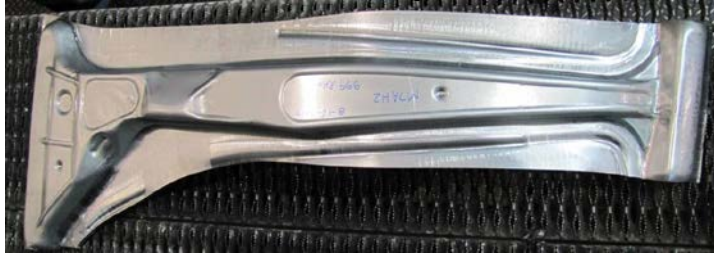
GM B-Pillar Tryout

- DP980 performance varies
- DP980 formability performance in general has been improved continuously
- DP980 with better formability performance has been developed
- Q&P980 performs well
- With proper design, complex parts can be made out of these DP980 Steels

Stamping Trial #1		
Material	Supplier	Comments
DP980T/550Y Bare	M - 1	Blanks were 18mm short on narrow end. Formed panel had splits in the bead on the wide end on long side. Necking in the datum boss
DP980T/600Y Bare	M - 2	Some parts were fracture free, some had necking in a bead and on the radius in the area of the roof rail.
MP980T/700Y Bare	M - 3	Part had no splits. Panel was not warm after forming. Galling is not evident.
DP980T/ 550Y GA	M - 5	Severe splits. Panel can not be scanned with these fractures.
DP980 / 700 GI	M - 4	Blank had splits in the bead along the long side of the panel. The datum embosses also had splits
DP980 / DUCRI 680Y	M - 6A	No Splits, No necking. Panels ran clean with little die wear.
DP980 / DUCRI 635Y	M - 6B	No Splits, No necking. Panels ran clean with little die wear.
DP980 / DARI 760Y	M - 6C	No Splits, No necking. Panels ran clean with little die wear.
DP980 /690Y GI	M - 7A	No Splits, No necking. Panels ran clean with little die wear.

DP980 / 670Y CR	M - 7B	No Splits, No necking. Panels ran clean with little die wear. NOTE: When circle grid panel was drawn, splits occurred.
Stamping Trial #2		
Material	Supplier	Comments
DP980T/550Y Bare	M1 TKS	Necking in the area of the datum boss. No splits Little galling took place
MP980T/700Y Bare	M2 USS	Necking in the area of the datum boss. No Splits. Galling took place. Die had to be polished after each hit.
QP980T/DUCRI 680Y	M3 QP	No necking or splitting. No splits. Little galling two place.

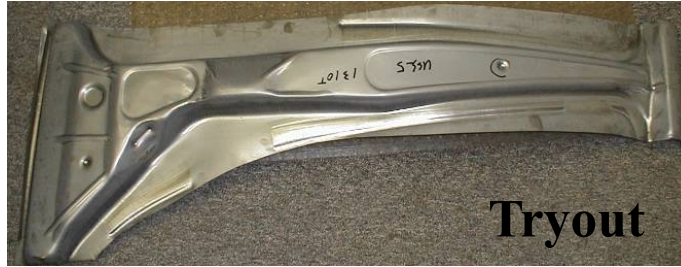
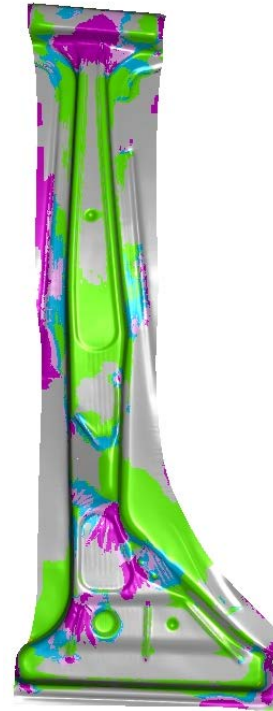
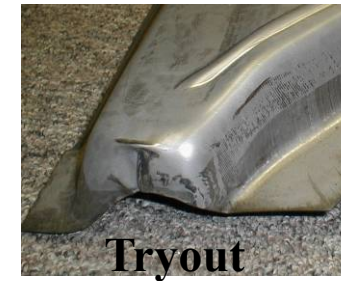
GM B-Pillar Simulation using USS
DP 980

- The formability simulation results correlates with tryout very well
- It's hard to hold the part shape, mainly due to twisting and side wall curl spring-back
- The newly developed material hardening model (Yoshida) is promising, but requires more material testing

CRACK
RISK OF CRACK
SAFE
WRINKLE TENDENCY
WRINKLE
SEVERE WRINKLE
INSUFFICIENT STRETCH

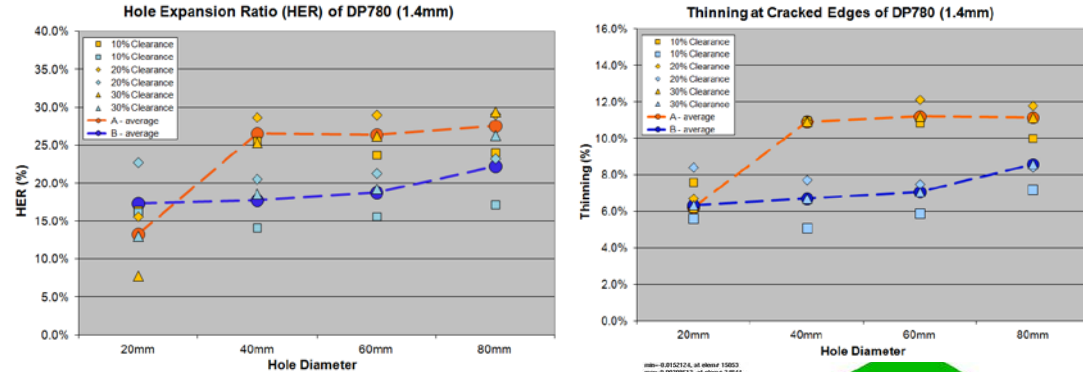
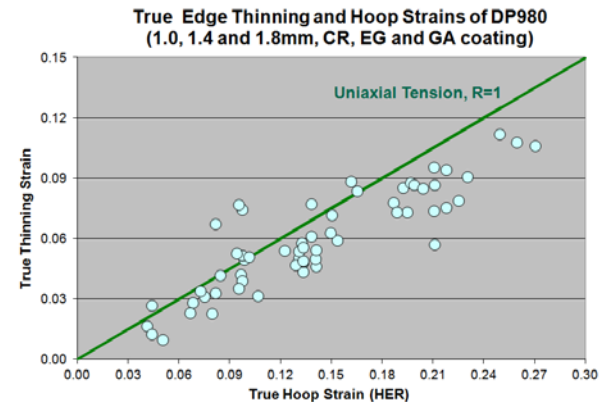
Laboratory Hole Expanding Test

- The hoop (HER) and thinning strains of DP780 and DP980 increase with the hole diameters
- The sheared edge conditions caused by the microstructures of DP780 and DP980 steel can reduce or diminish the increases in HER and edge thinning
- The increases in the edge hoop (HER) and thinning strains are due to the strain gradient determined by the sample geometry and tooling configurations

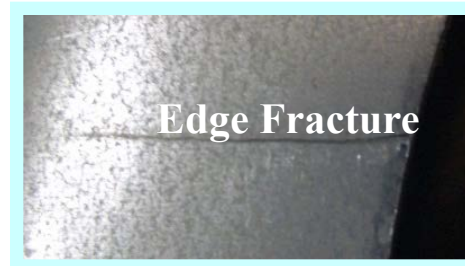
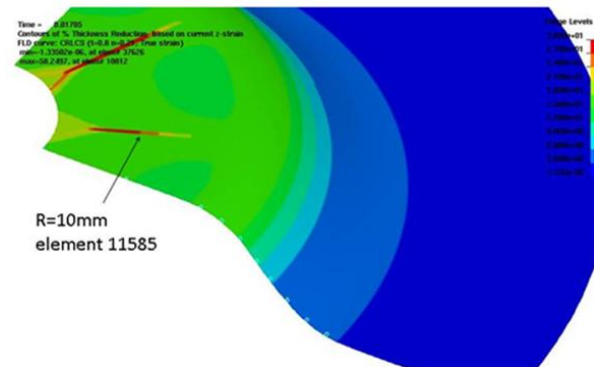
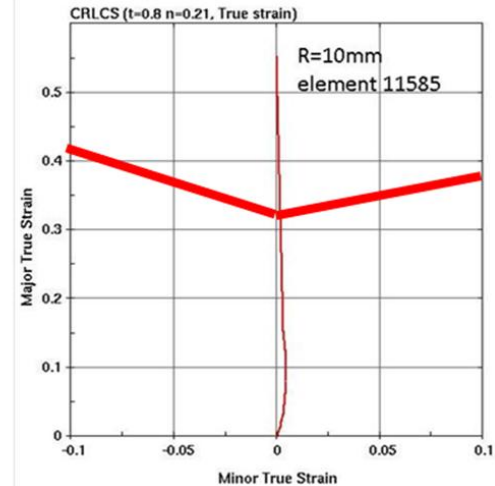
Two Failure Modes

- Edge Fracture: Larger hole samples do not have a sufficient area in biaxial tension to develop a necking type of failure before the edge fractures
- Necking/Split: Change of strain path leads to a failure by necking/split under plane strain condition

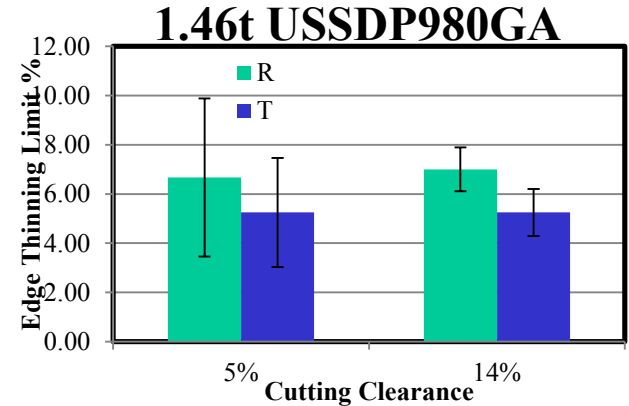
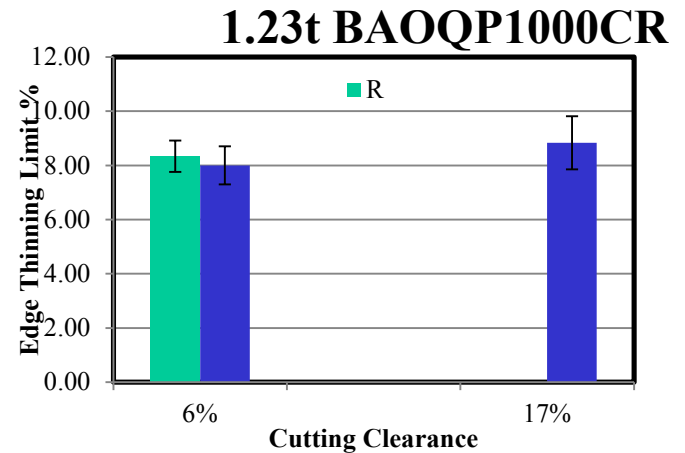
Large cutout stamping trial results

Key Learning: Improved edge stretch thinning limit was noticed on the three DP980 AHSS comparing with the limit found a few years ago

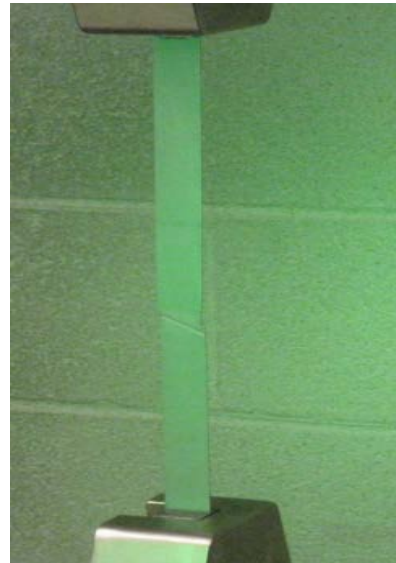
Pre-Form Effect

- The pre-form process does not affect the edge stretching ability of DP980, Q&P980 and DP780, but reduces the edge stretching ability of HSLA50 and 590R

Material / direction	Fracture Region (I/O perform) Larger Radius	Fracture Region (I/O perform) Medium Radius	Fracture Region (I/O perform) Smaller Radius
590 R (Rolling)	Inside	Inside	Inside
590 R (Transverse)	Outside	Inside	Inside
DP 780 (Rolling)	Outside	Outside	Inside
DP 780 (Transverse)	Outside	Outside	Outside
DP 980 (Rolling)	Outside	Outside	Outside
DP 980 (Transverse)	Outside	Outside	Outside
DP 980c (Transverse)	Outside	Inside	Inside
HSLA 50 (Rolling)	Inside	Inside	Inside
HSLA 50 (Transverse)	Outside	Outside	Outside
Q&P 980 (Rolling)	Outside	Outside	Outside
Q&P 9780 (Transverse)	Outside	Outside	Outside

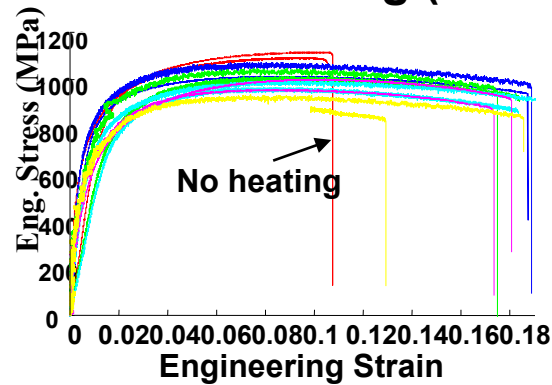
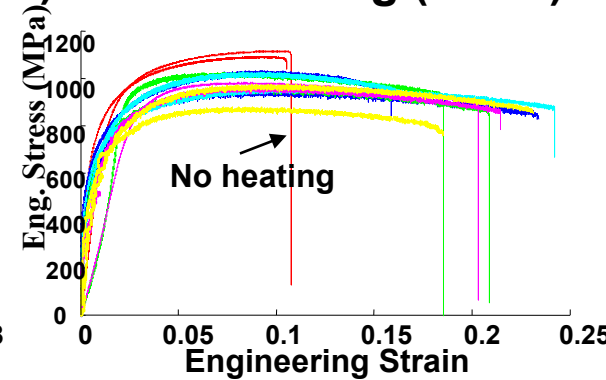
UTS vs. T_{max}

• Slow cooling (20°C/s)
• Fast cooling (2°C/s)

Elongation vs. T_{max}

- Induction local heating can be used to reduce the tensile strength and increase the elongation for the tested DP980 sheet steel.
- Critical parameters and their recommended ranges have been investigated. Lower T_{max} above austenite transformation temperature and Slow cooling rate (2°C) give better improvements
