# Effect of Jatropha based Biodiesel, on engine hardware reliability, emission and performance

General Motors

DEER Congress 2010

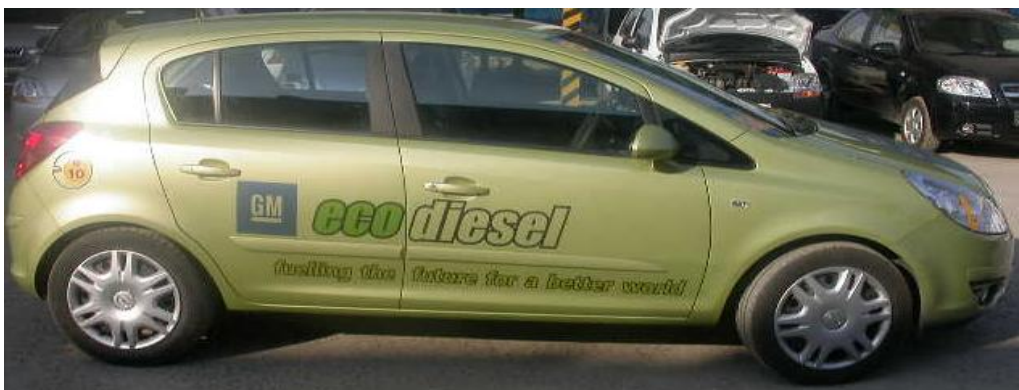
6 Opel Corsa equipped with GM 1,3L Euro4 diesel engine and Under Floor DPF

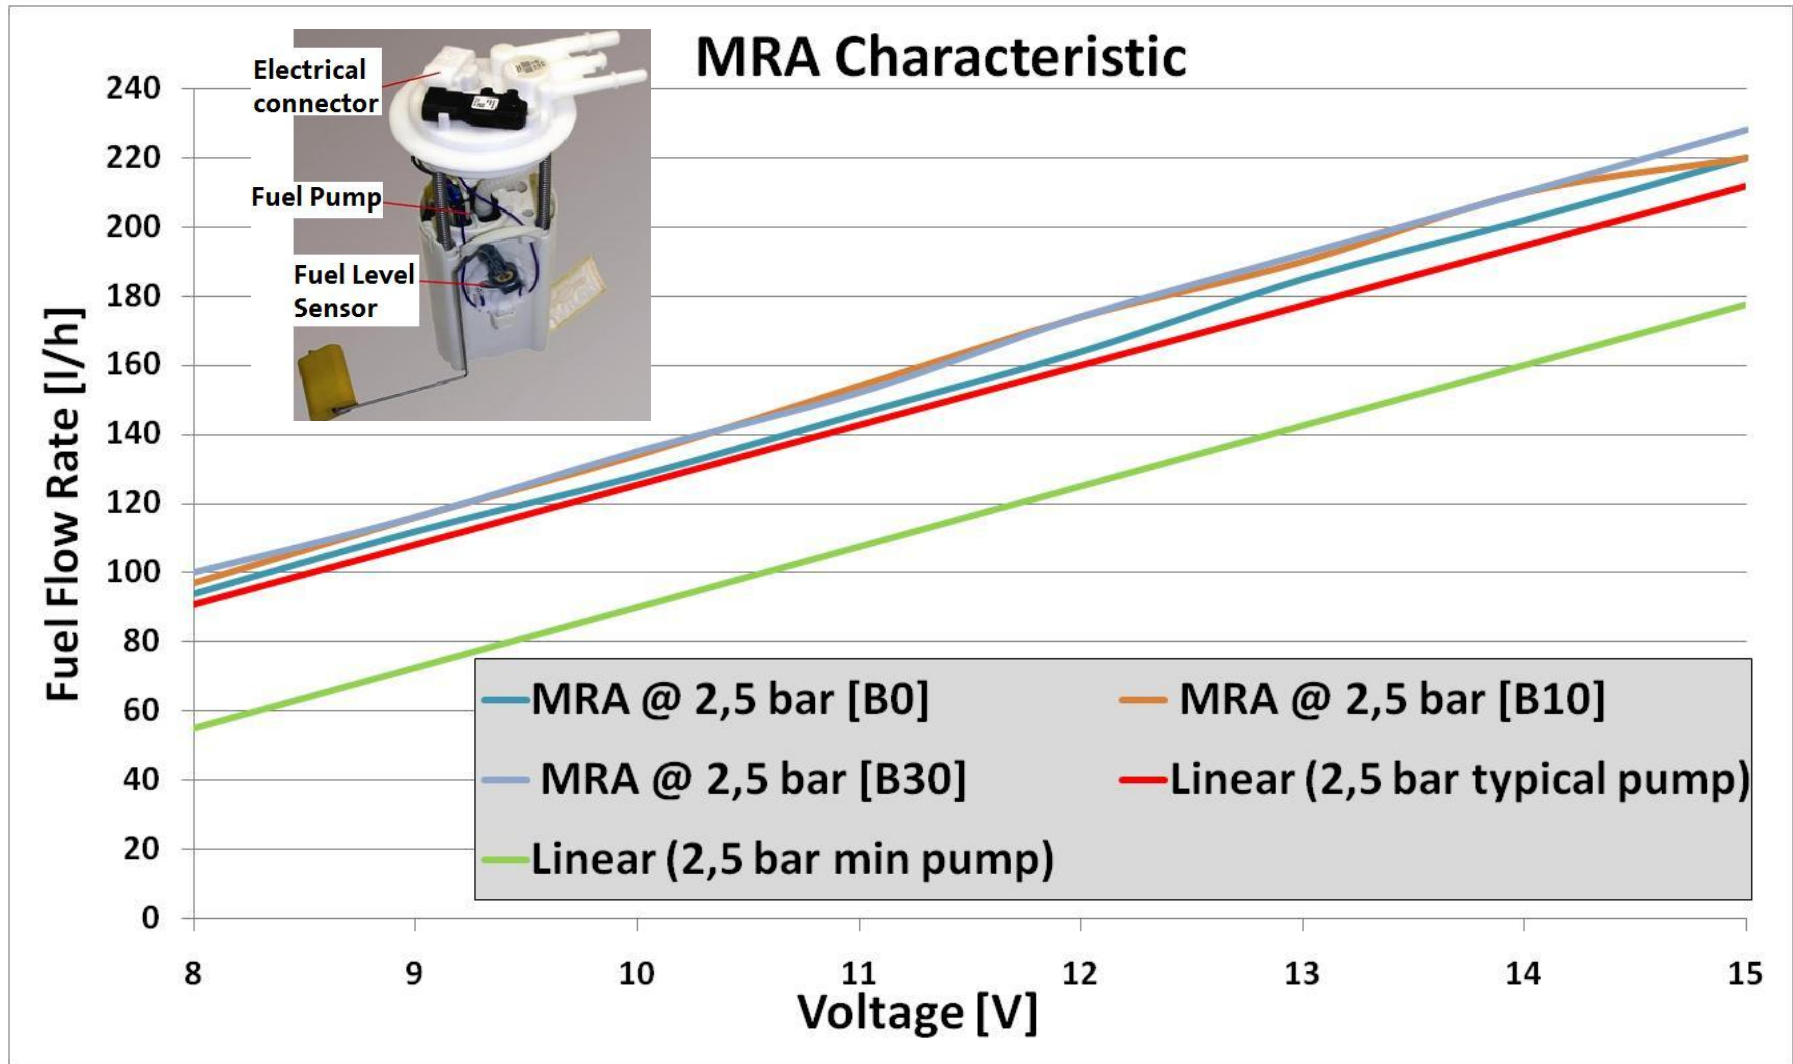
# Technical report on MRA (Module Reservoir Assembly)

There is no Performance degradation in B0/B10/B30 MRAs

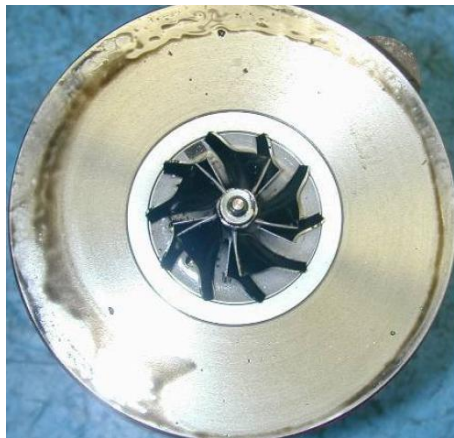
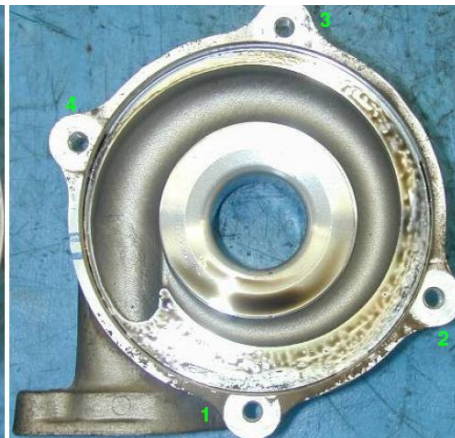
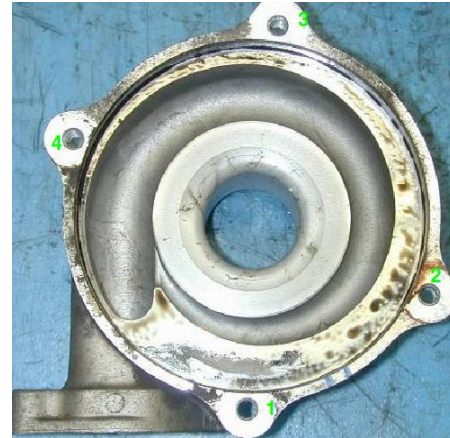
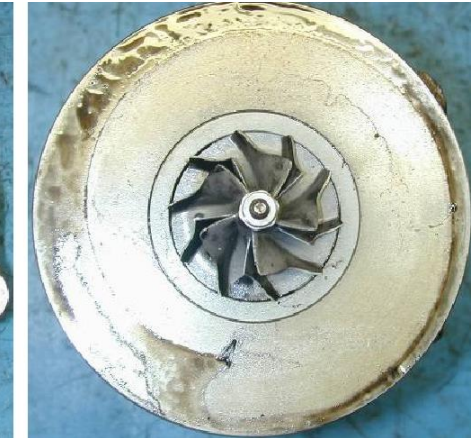
**B30**

B30 TC shows increased corrosion at the VGT mechanism.

Increased corrosion probably due to low oxidation stability of biodiesel that in turn leads to higher acidity and corrosion capability.

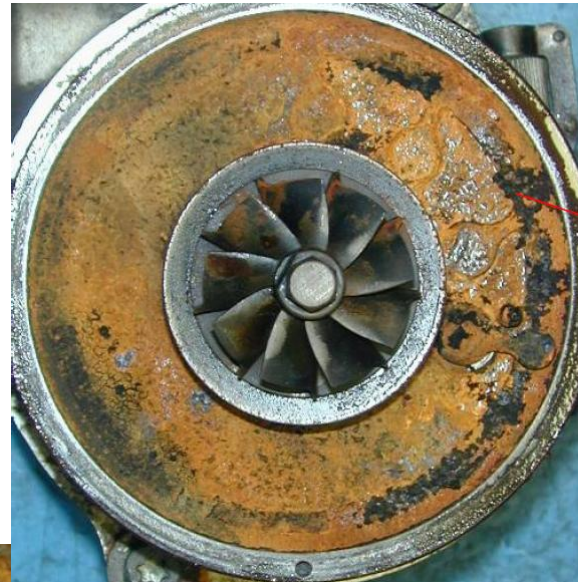
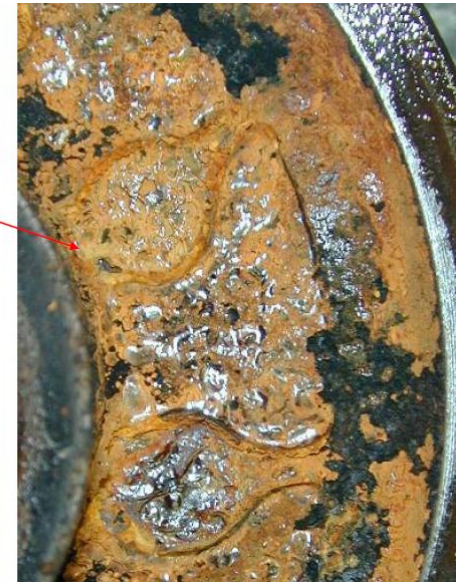
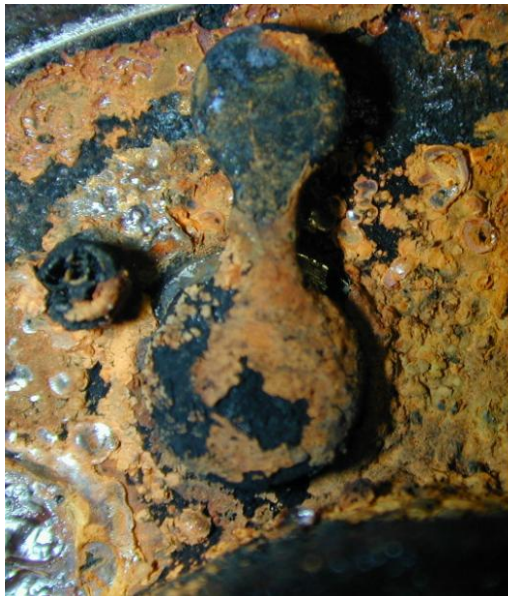
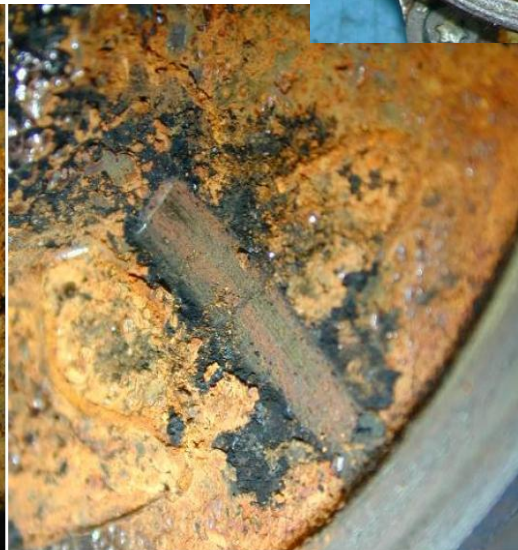
**B30**

It can be clearly seen the prints from vane lever on deposits

Deposit build up to 0.5mm.

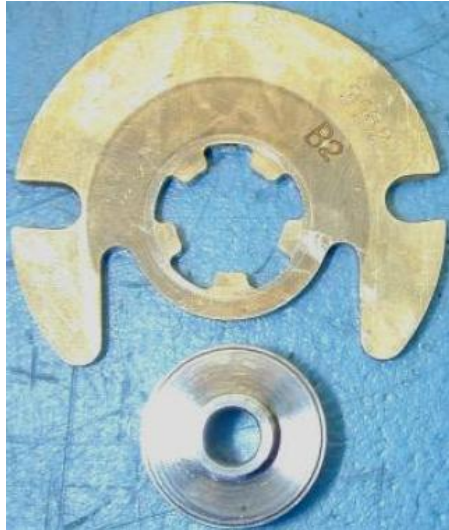
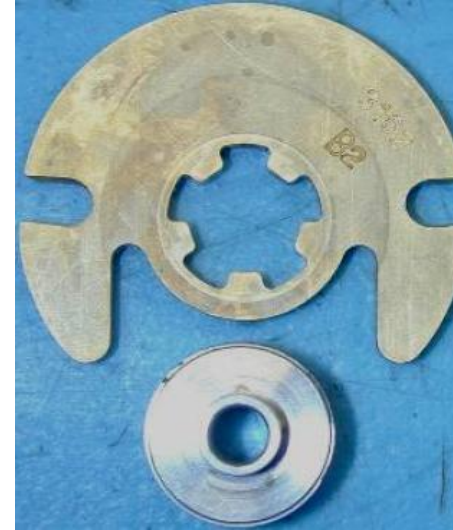
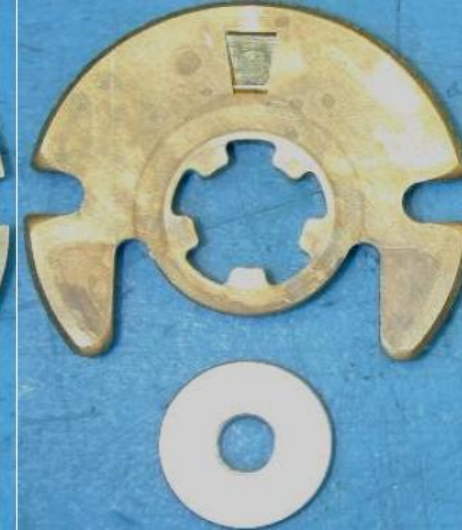
Slightly higher wear for B30 TC  
(2-3  $\mu\text{m}$  vs. 1-2  $\mu\text{m}$  for B0)

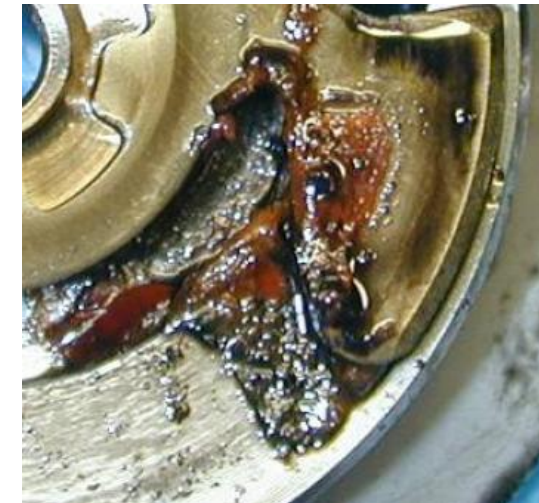
Untypical jelly build  
up on thrust bearing  
for B30 TC

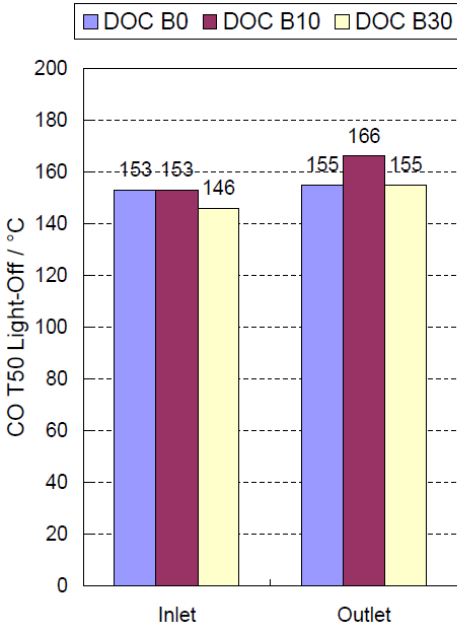
NO significant trend in DOC in Pt particles size and washcoat active surface area as well as HC and CO light off temperature increasing the level of blending

There seems to be no influence of the Biodiesel level on catalyst poisoning and Catalyst performance under the test conditions.
