4.1. ALARA Activities at the Savannah River Site

4.1.1. Process Water Deionizer Disposition

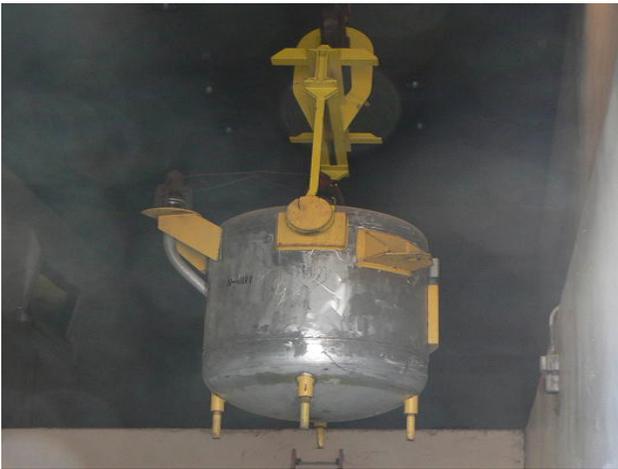
Exhibit 4-1:
Dose rate being taken with an RO-7 used as an extended tool to maximize distance from deionizer.

- ◆ Camera and RO-7 on extended cable sent over cells using the overhead crane to verify ID numbers and obtain dose rates (see *Exhibit 4-1*)
- ◆ Observed similar work being performed in R-area and P-area
- ◆ Lower dose deionizers dispositioned first
- ◆ Verified proper ventilation
- ◆ Preparation of work area
- ◆ Use of remote dose rate instruments and remote Kanne monitoring

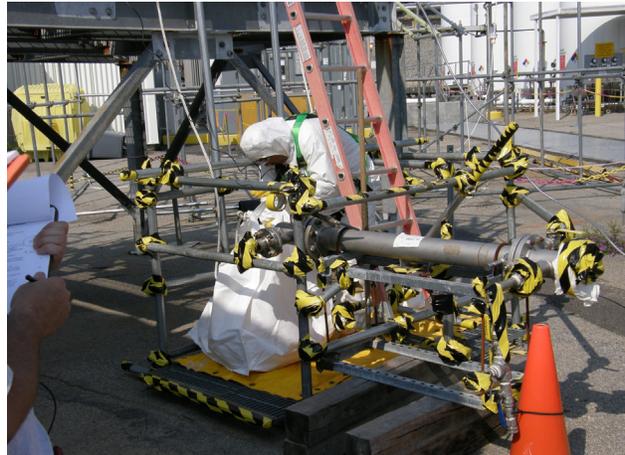
Exhibit 4-2:
Coalescer media replacement mock-up.

LWO successfully completed the first major production outage (3 months) and restarted ISDP processing in January 2009. Outage accomplishments include implementing a document safety analysis (DSA) change to open up process cleaning options at MCU. A remotable DSS coalescer prefilter was designed, constructed, mocked-up, and installed into the tight confines of the MCU process area (see *Exhibit 4-2*). A feed and bleed modification was completed at MCU to reduce required operator intervention. Demisters were designed and installed on the 96H process vessel vent (PVV) jumpers to reduce dose accumulation in the PVV duct system. The outage scope involved thousands of safe construction, maintenance, and facility man-hours

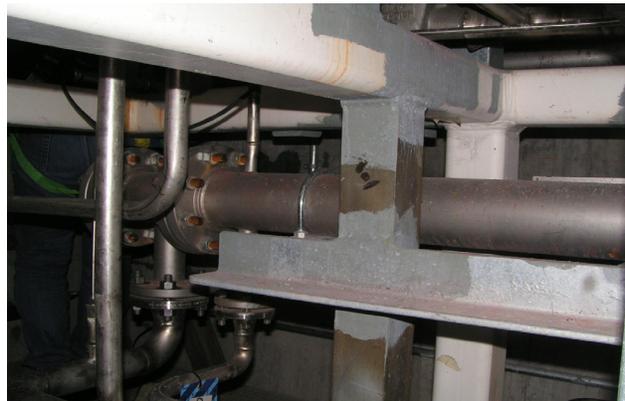
Exhibit 4-3:
Coalescer media housing in MCU process cell.

There was a potential for high radiation exposure from high dose rates in the process cells at MCU and in the strike tank process cells and PVV lines at 96H ARP. The risk associated with coordination of a sequence of work activities that involved various work groups, including maintenance and construction (e.g., the decontaminated salt solution hold tank (DSSHT) pump replacement by maintenance personnel was performed between prefilter installation steps by construction personnel due to the proximity of pumps to new filter location) (see *Exhibits 4-3 and 4-4* for examples of tight work spaces).

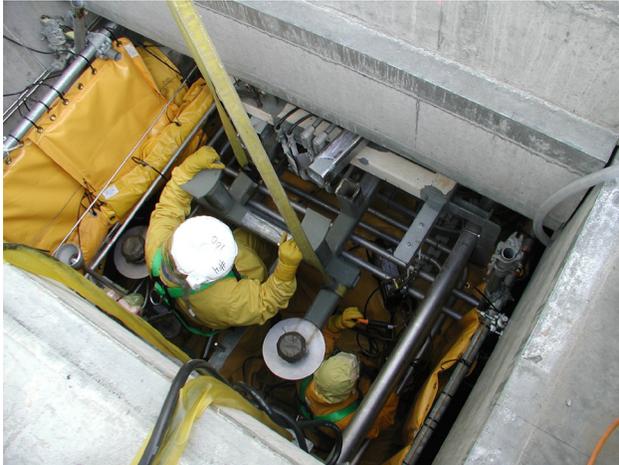
Exhibit 4-4:
MCU process cell entry for prefilter installation.

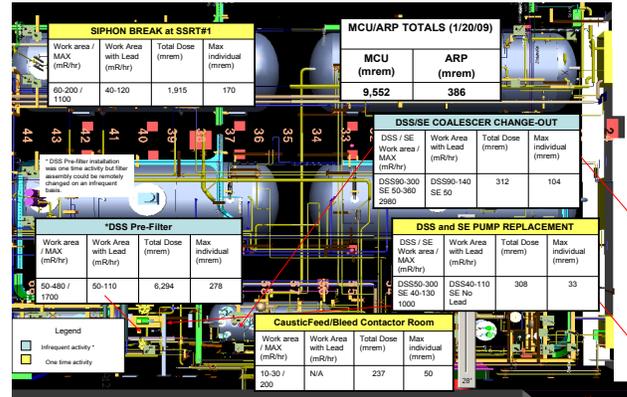
Exhibit 4-5:
MCU and ARP outage dose summary.

The maximum dose rate prior to de-inventory in the work area was 3 R/hr to 4 R/hr but was reduced to a maximum rate of 1.7 R/hr prior to shielding. After preparation activities were completed, work area dose rates ranged from 40 mrem/hr to 140 mrem/hr for most of the outage scope work. The total dose for the MCU and 96H ARP outage activities were 9552 mrem and 386 mrem, respectively (estimated to be >25 rem), with a maximum individual worker dose of 278 mrem for the DSS prefilter installation activities (see Exhibit 4-5 for dose summary data).

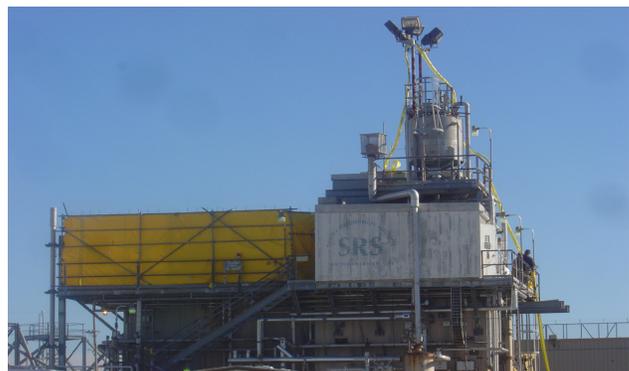
Exhibit 4-6:
Windbreak installed around the evaporator cell area.

- ◆ Elaborate de-inventory and flush plans/procedures
- ◆ Large quantities of creative “first of a kind” shielding designed/fabricated/installed along with work platforms
- ◆ Large containment areas (windbreaks) above process cells for various jobs within adjacent cell cover areas with HEPA ventilation as needed (see Exhibit 4-6)
- ◆ Teletrak dose tracking system for all major outage jobs involving the potential for significant dose

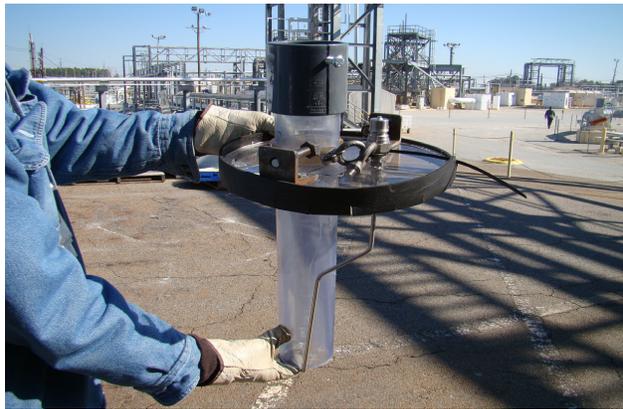
Exhibit 4-7:
Adapter/guide cover plate.

The adapter/guide cover plate included the following features (See *Exhibit 4-7*):

- ◆ Flush rig to flush the lancing hose during removal
- ◆ Guide tube to align the lancing hose with the catheter port
- ◆ Seal and secure to the cell cover port opening
- ◆ Used as a sleever device (deploy sleeve, as the hose was being removed)

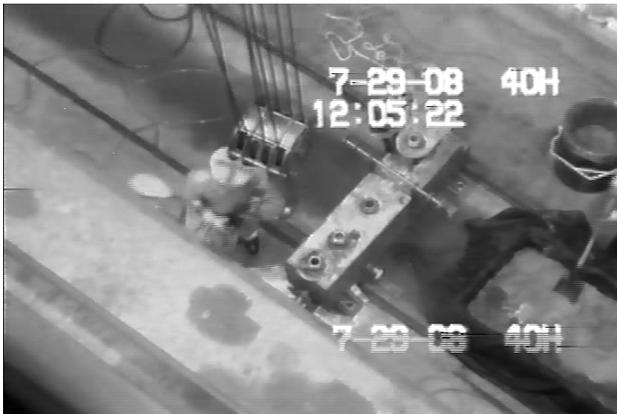
Exhibit 4-8:
Decanter

The 16.1-1S decanter is used in the RERUN process of H-Canyon to separate organic and aqueous solutions prior to being processed through evaporators. On January 20, 2008, it was noted that all solution going through the decanter was being pushed out the organic side of the decanter, indicating pluggage in the underflow weir.

Engineering and Operations jointly devised a plan to obtain video footage of the inside of the decanter. The video footage confirmed their assumptions that the decanter, after 50 years of service, had become plugged with sand from sump material being transferred through the decanter.

The attempts to pump the sand out of the decanter were unsuccessful, and a plan was developed to remove the decanter remotely, using the New Hot Crane, to the H-Canyon Railroad Tunnel where internal flushes would be made using manual tools. This challenging job had never been performed and there were many unknown variables. (See *Exhibit 4-8*).

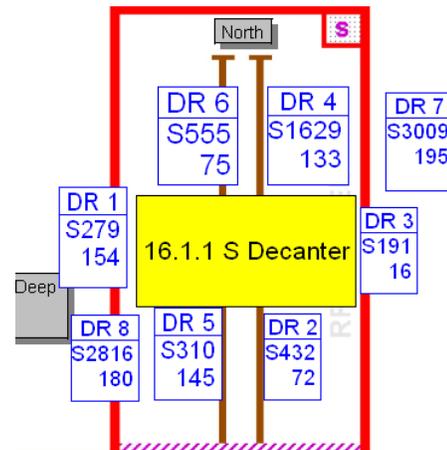
Exhibit 4-9:
Combination of doses at 5cm and 30cm distances from the decanter.

The initial radiological surveys of the work were completed using the Teletrack instrumentation. The readings in *Exhibit 4-9* represent a combination of doses at 5 cm and 30 cm distances from the decanter.

- At 5 cm: 8544 mrem/hr skin (decanter nozzles)
450 mrem/hr whole body (decanter nozzles)
- At 30 cm: 3009 mrem/hr skin (decanter nozzles)
195 mrem/hr whole body (decanter nozzles)

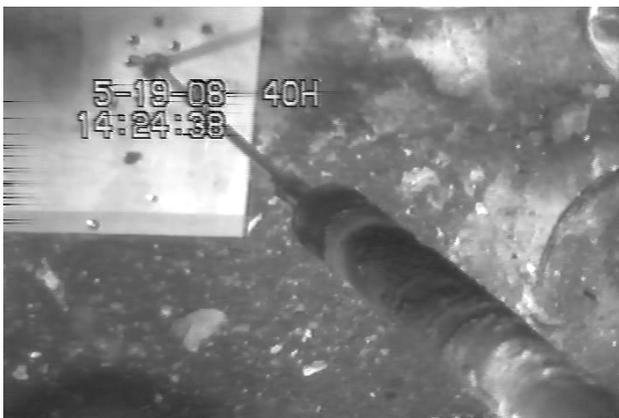
Exhibit 4-10:
Fabricated Jumper Tool

The liquid level jumper houses the components in support of level indication by using the differential pressure of two dip tubes within vessels or sumps in the canyon. The facility has two options if the jumper fails: repair or replacement. The replacement cost is ~\$30K, but the repairs can present bigger challenges. H-Canyon Operations and Engineering assessed the fault to be caused by a clogged jumper. In a joint effort between H-Canyon Operations and F-Area Fabrication Shop, an inexpensive tool was fabricated to dislodge the material from the jumper (see *Exhibit 4-10*).

- ◆ By handling the highly contaminated jumper in the hot canyon.
- ◆ By fabricating a steel rod on a base sheet

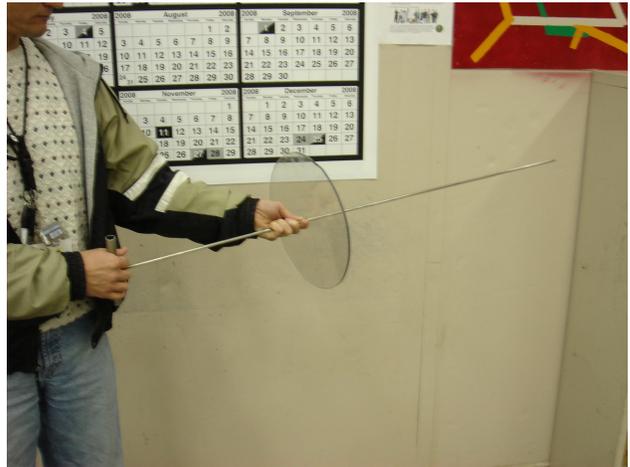
Exhibit 4-11:
Extended rod with betashield.

Once the pump was separated from the J-Tube, it was determined that there was blockage in the J-Tube. Additional decontamination efforts were unsuccessful. A plan was developed to rod out the J-Tube using extended rods, pipe snake, beta radiation shields (see *exhibit 4-11*), and catch containments; however, this first attempt did not remove all of the material. A second plan was developed to include use of a pressure washer (see *exhibit 4-12*) with a directed spray nozzle. A mock-up using the pressure washer was performed in the maintenance shop using a clean J-tube and a sludge simulate.

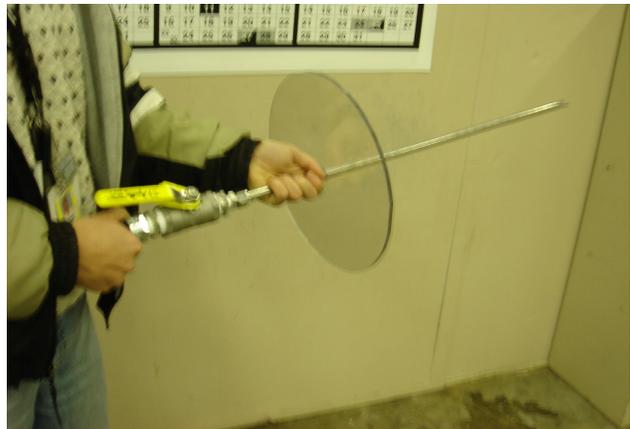
Exhibit 4-12:
Pressure washer wand.

The pressure washer was successful in removing the material in a quick and efficient manner. All material from the blockage was gathered in the containments and drained to the cell sump to be flushed into the canyon waste stream.

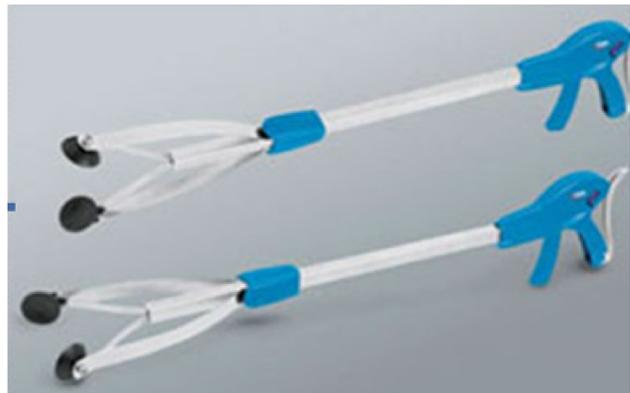
Exhibit 4-13:
Reach-It Tool.

- ◆ Use of rubber mats and lexan to shield the beta radiation and reduce the extremity dose
- ◆ Use of the Teletrak Teledosimetry System along with Electronic Personnel Dosimeters (EPDs) and timekeeper to provide real time monitoring of personnel dose
- ◆ Workers were restricted from cell work until dosimetry results were received.
- ◆ Maintenance mechanics were rotated to spread the collective dose
- ◆ Reach-it tool was used for handling ceramic reducer (see *Exhibit 4-13*).

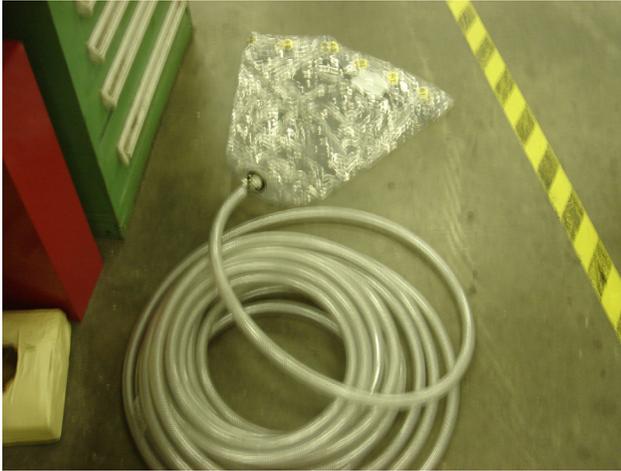
Exhibit 4-14:
Catch containment.

- ◆ Cell ventilation in operation
- ◆ Use of catch containments to prevent spread of contamination (see *Exhibit 4-14*).
- ◆ CDMC floor was prepared with plastic
- ◆ Plastic suits were worn to protect the workers from contaminated liquid

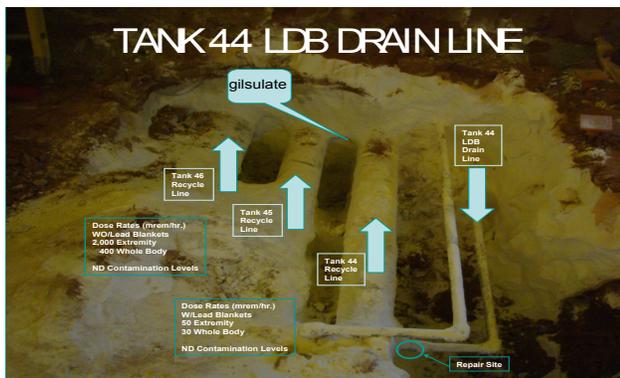
Exhibit 4-15:
Tank 44 Drain Line.

F Tank Farm waste storage facility includes tanks with underground transfer lines with Leak Collection Boxes (LDBs) installed to detect any leaks during a waste transfer. During testing of an LDB line, the test indicated a leak within a section of a drain line (see *Exhibit 4-15*). A work package was developed to excavate an area to uncover the underground transfer lines and LDB. During the planning, high dose rate estimates were calculated. To reduce the dose, during the removal of the gilsulate, a mechanical device referred to as a Vaxcavator, was procured. The excavation area had a containment hut installed with portable HEPA units, including an air conditioner unit, due to the high temperatures.

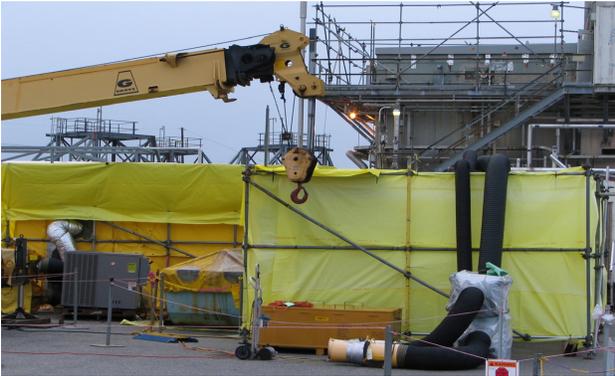
Exhibit 4-16:
Hut Surrounding Excavation.

- ◆ Hut installed around the excavation (see *Exhibit 4-16*)
- ◆ Hut included portable HEPA ventilation
- ◆ An air conditioner unit was installed due to high temperatures
- ◆ Vaxcavator used to remove gilsulate
- ◆ Lead blankets installed during the soil removal
- ◆ Teletrax system

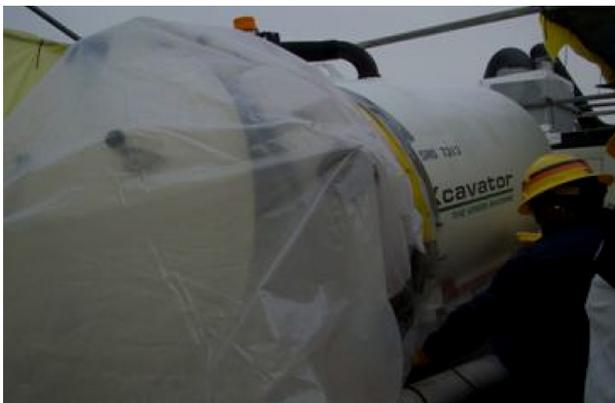
Exhibit 4-17:
HEPA Filter Attached to Vaxcavator

- ◆ Mockups were performed to develop a method of sleeving out the spent gilsulate for Industrial Hygiene controls
- ◆ A HEPA filter was installed on the exhaust system - attached to the Vaxcavator (see *Exhibit 4-17*)
- ◆ Gilsulate was removed through a 6" PVC pipe (prevented the suction duct from collapsing during the operation of Vaxcavator)
- ◆ The 6" pipe also allowed a method to perform a radiation absorbed dose (RAD) profile to identify the depth of the transfer line

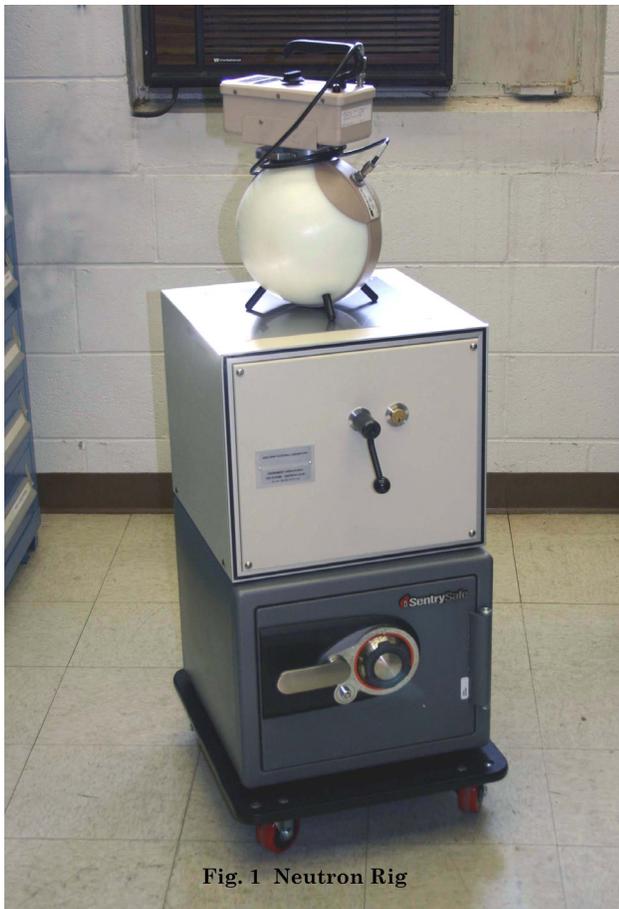
Fig. 1 Neutron Rig

**Exhibit 4-18:
Neutron Rig**

An instrument operational test fixture for neutron detectors has been designed and fabricated at Argonne National Laboratory for performing preoperational tests on portable neutron survey instruments (see *Exhibit 4-18*). This test fixture was developed after success with a test fixture for gamma-ray detectors.

The test fixture makes it possible to check the performance of the neutron detector (Rem Ball) in a reproducible manner. There is a dimple in the top plate of the test fixture that indicates where to place the Rem Ball. The Rem Ball dose rate with the source exposed is 27 mrem per hour. With the source in the

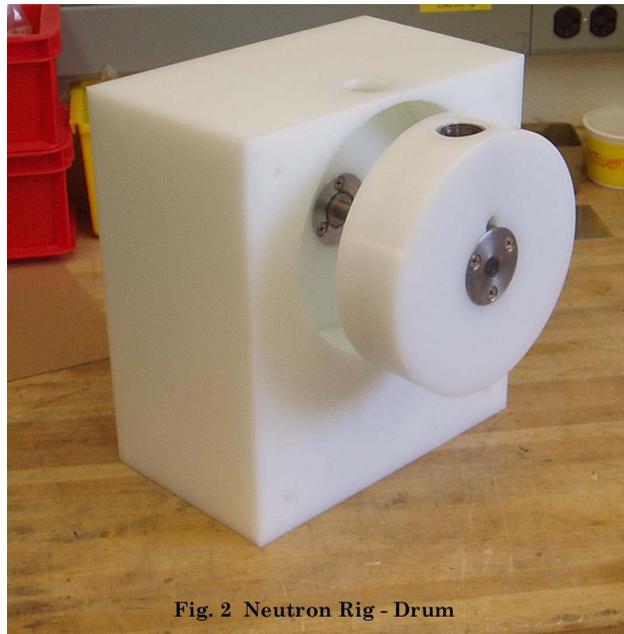
Fig. 2 Neutron Rig - Drum

**Exhibit 4-19:
Neutron Rig - Drum**

The neutron test fixture consists of a 12-inch cube of high-density polyethylene with 7.5% lithium/polyethylene as shielding material. Inside the cube is a 6.75-inch diameter drum containing a 200 mCi $^{241}\text{AmBe}$ neutron source. The drum is rotated to move the source from the "stored" position, centered in the cube, to the "exposed" position, with the source directly under the top of the cabinet, for testing the survey instruments (see *Exhibit 4-19*). The position of the source is controlled by an operating handle projecting through a metal cabinet that totally encloses the neutron test fixture. An indexing mechanism ensures correct source position and a keyed lock secures the source in the "stored" position and prevents operation by unauthorized persons (see *Exhibit 4-20*, cabinet cover removed).
