Long-term Testing of LED Luminaires

I35W Bridge
Minneapolis, MN

GATEWAY
Demonstrations

October 2014

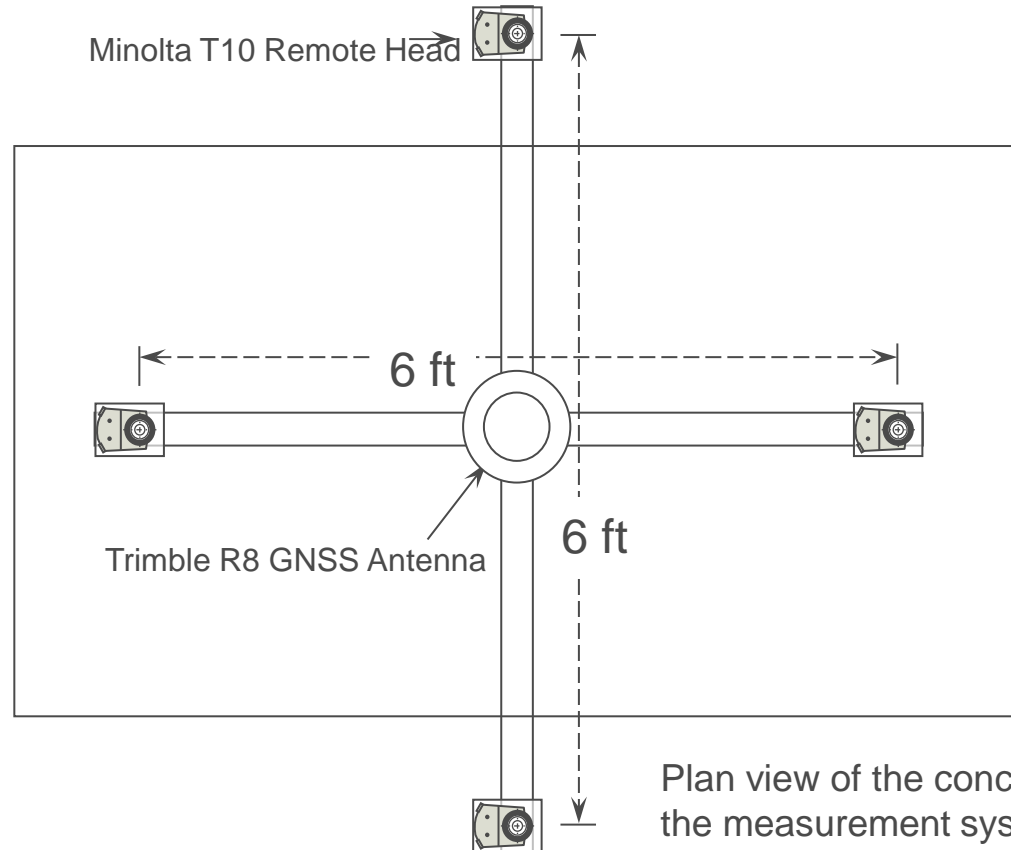
Project incorporated a 3-year monitoring effort using a vehicle-mounted system developed by VTTI

Plan view of the concept for mounting the measurement system over the cargo area of a pickup truck.

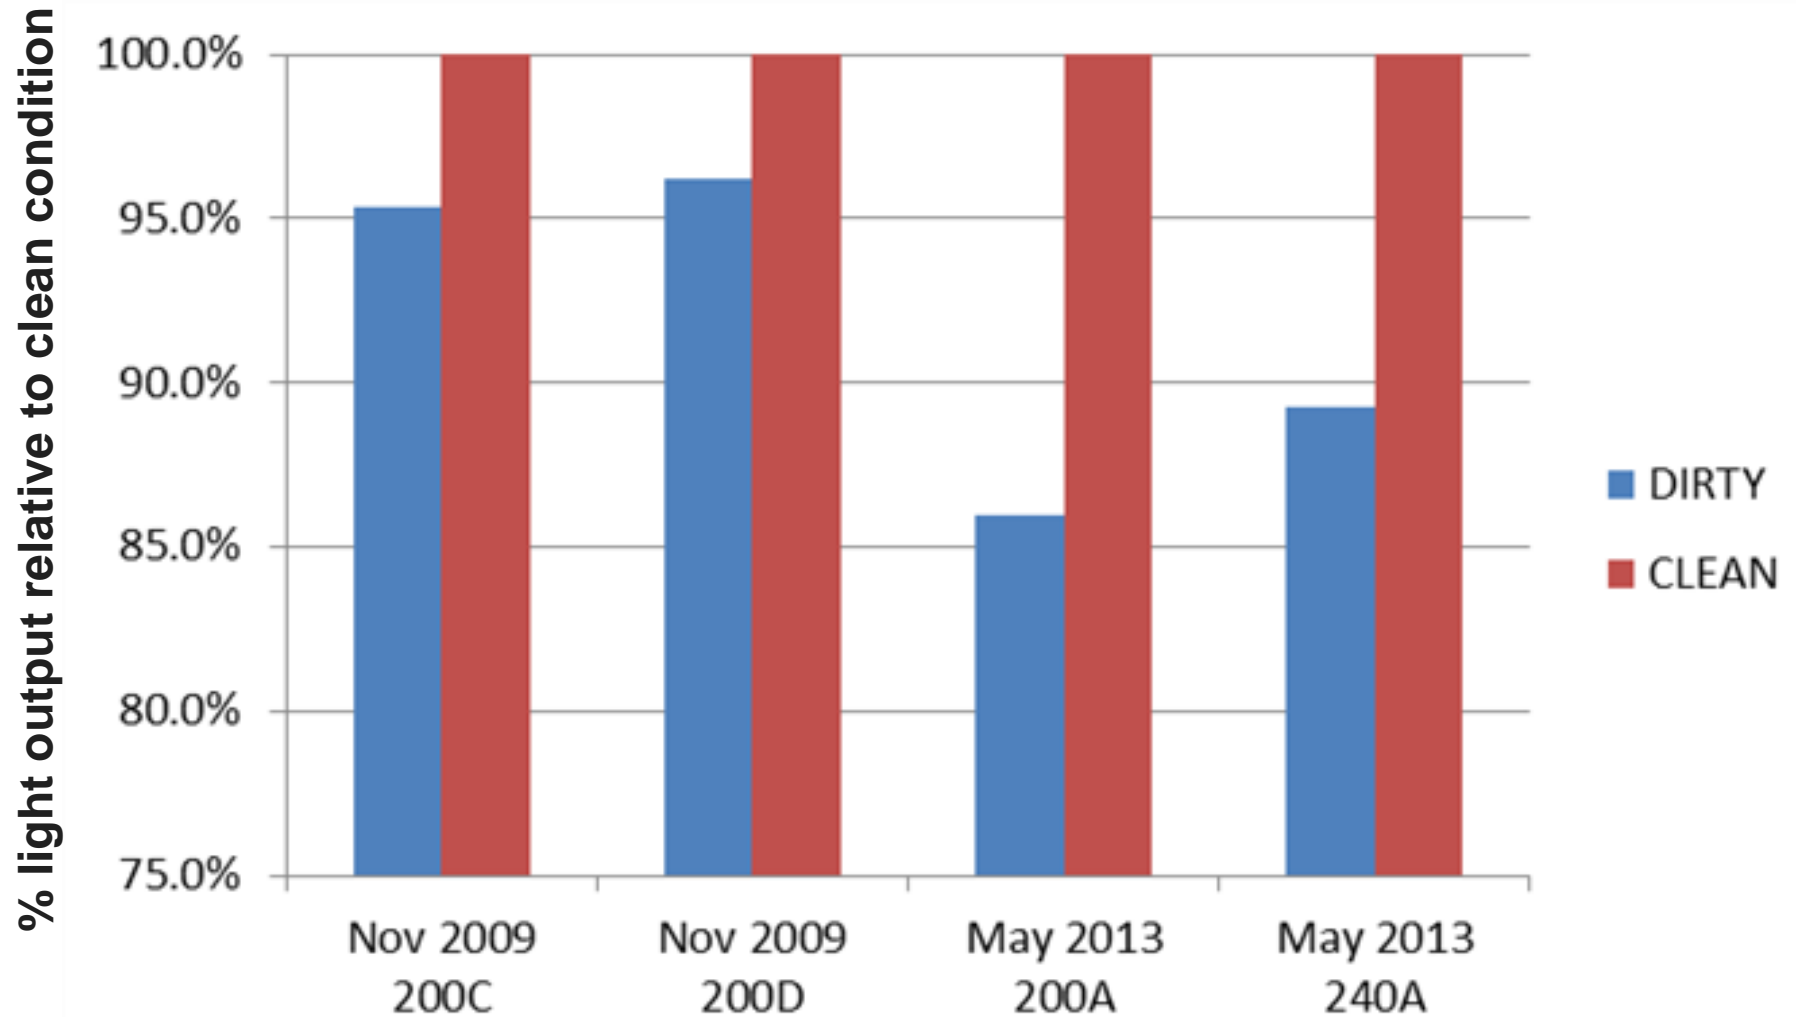
Luminaire dirt depreciation

- Average loss of 4-5% at 5000h
- Average loss of 12-13% at 20,300h
- Loss greater at higher angles
- Intensity increased at low angles
- Minimal effect on color properties

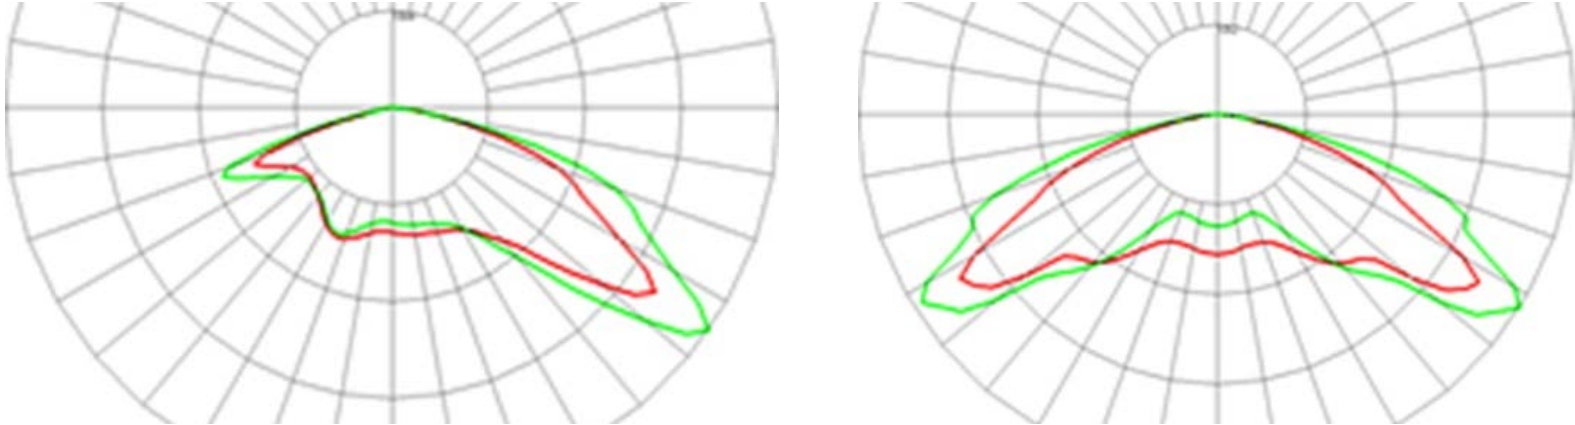
Effect on Distribution

- Greater loss at higher angles
- Intensity *increased* at low angles

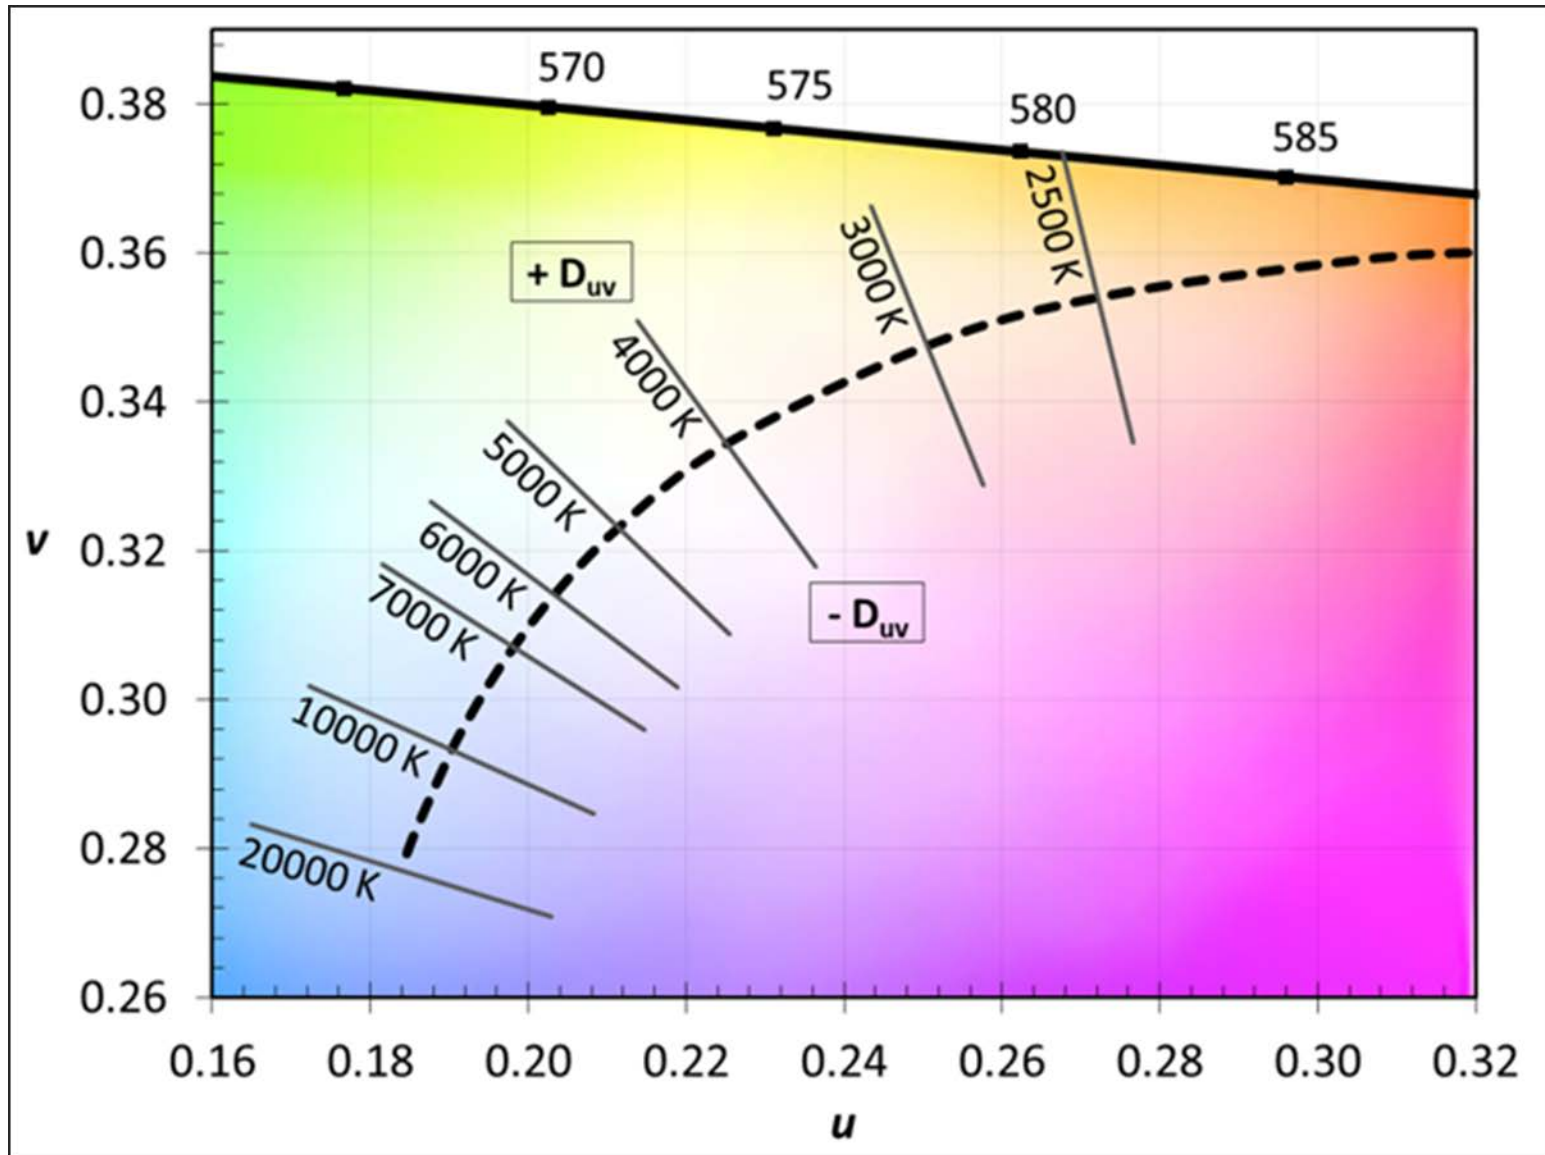
Long-term color data

- Initial ratings: 6000K, 75 CRI
- CCT: shifting lower (warmer)
- Duv: Shifting further above blackbody (greenish)
- Luminaire 200-B had $\Delta u'v' = 0.0117$ at 6000 hours
ENERGY STAR[®] max at 6000 hours = 0.007

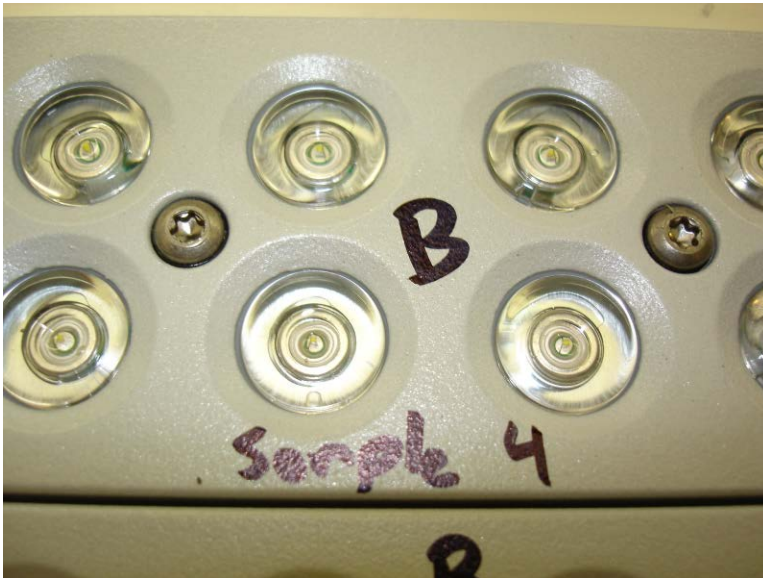
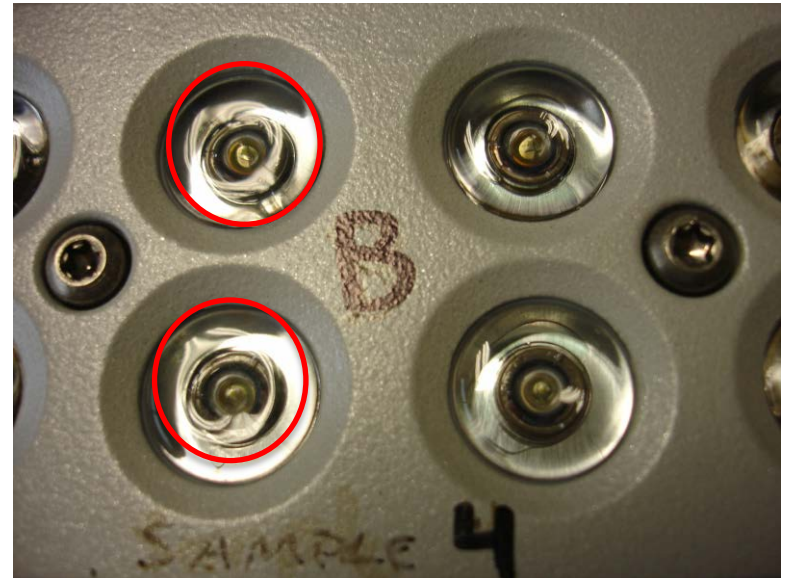
Test Sample* Showing Formation

Photo on left is initial condition. Right photo shows sample after 54 weeks of thermal cycling.

*BetaLED laboratory sample; not I-35W bridge luminaire.

*Optical gel was replaced by manufacturer to measure impact of bubble
