**TRANSMITTAL OF THE SUMMARY REPORT OF HISTORIC-ERA
ARCHAEOLOGICAL RESOURCES WITHIN THE PORTSMOUTH GASEOUS
DIFFUSION PLANT, PIKE COUNTY, OHIO (RSI/PORTS-228)**

Enclosed for your information is the report "*Summary Report of Historic-Era Archaeological Resources within the Portsmouth Gaseous Diffusion Plant, Pike County, Ohio*" (RSI/PORTS-228).

Summary Report of Historic-Era Archaeological Resources within the Portsmouth Gaseous Diffusion Plant, Pike County, Ohio (RSI/PORTS-228)

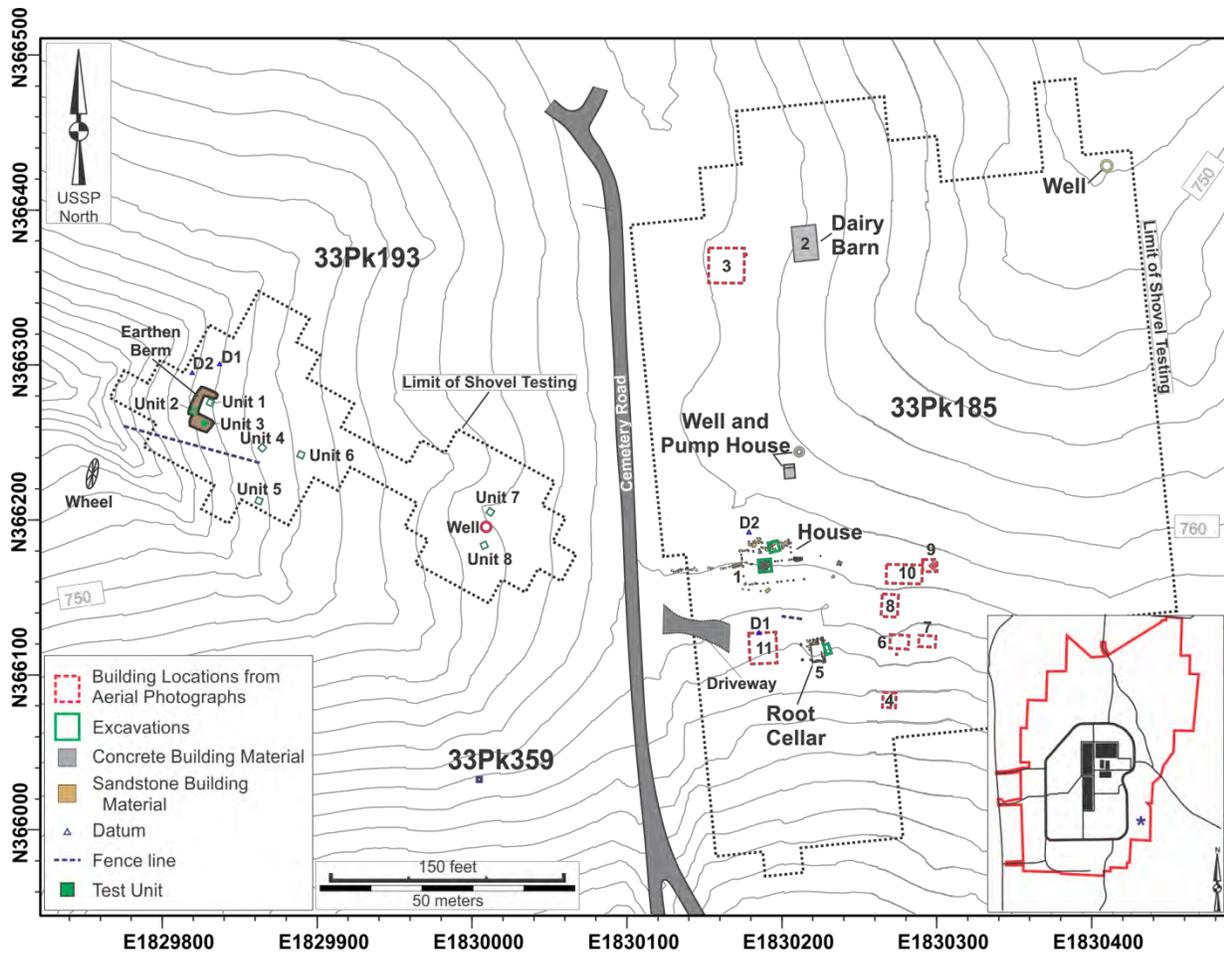
Figure 7. Illustration of the South Shyville Farmstead (33Pk185) (adapted from Pecora and Burks 2012a).

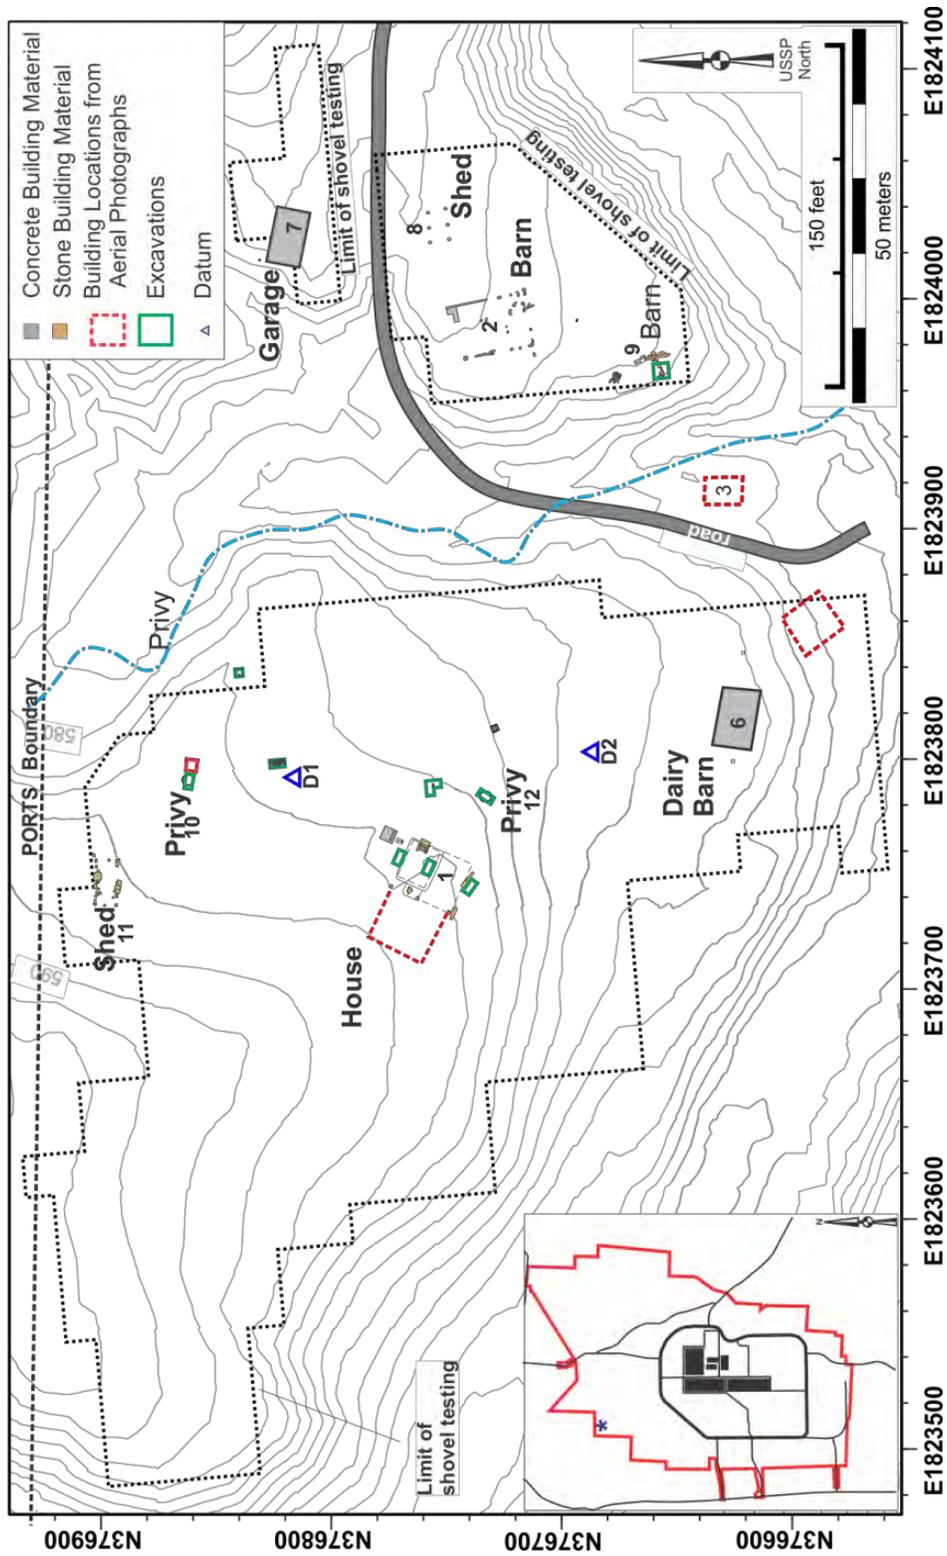
Figure 10. Illustration of the Ruby Hollow Farmstead (33Pk203) (adapted from Pecora and Burks 2012a).

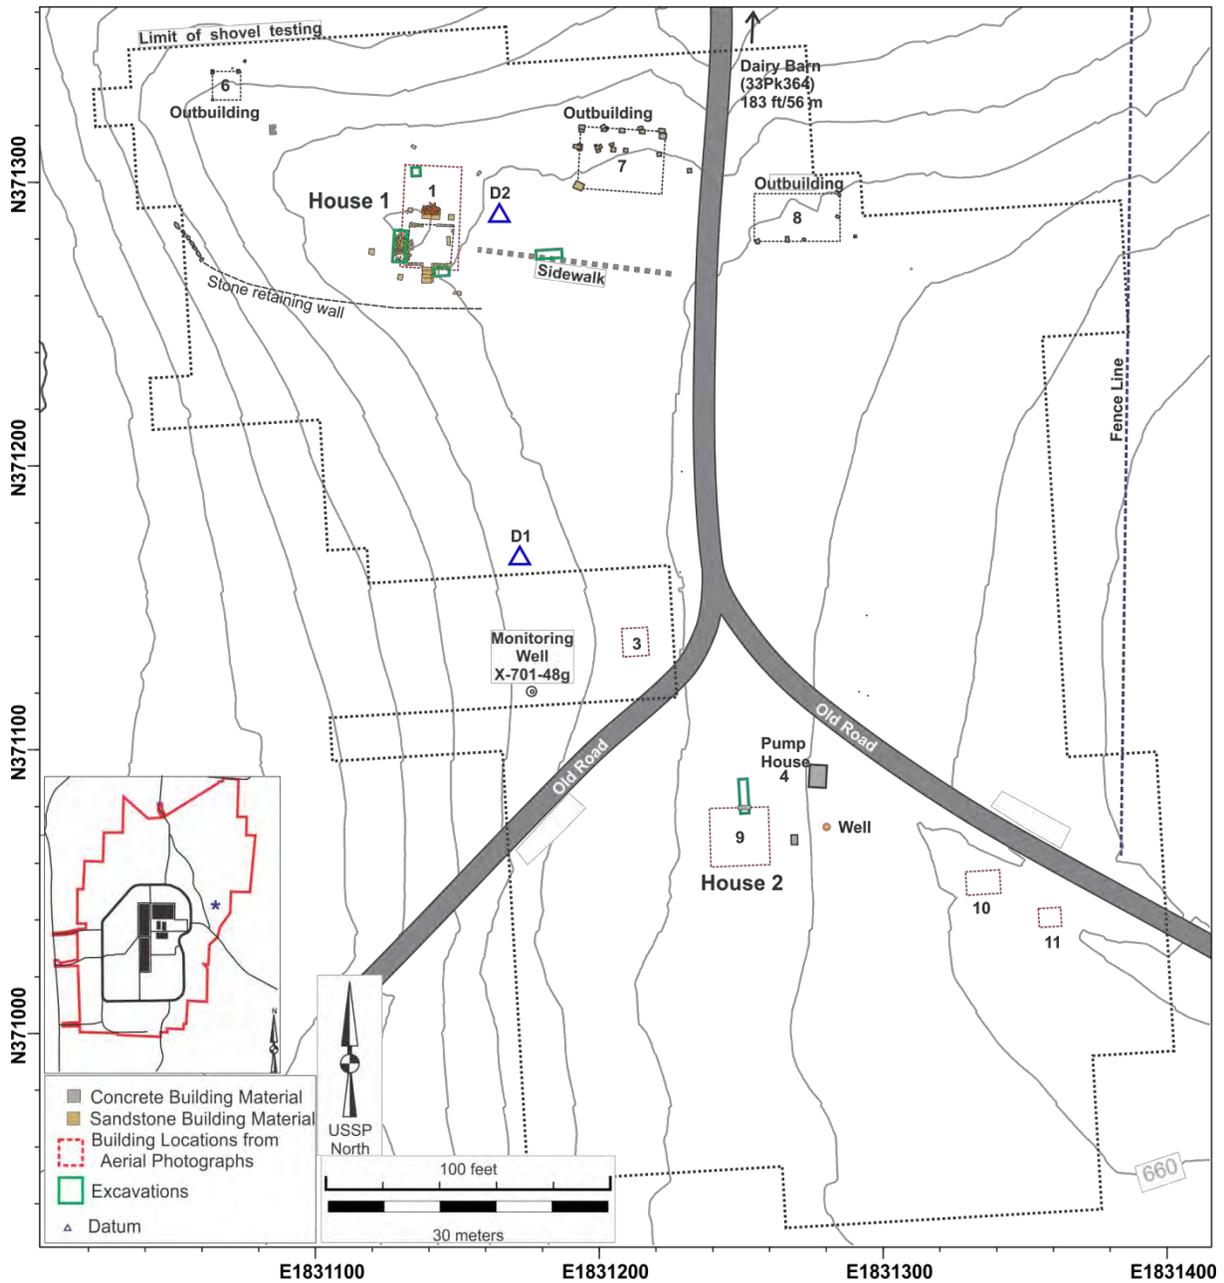
Figure 11. Illustration of the Terrace Farmstead (33Pk206) (adapted from Pecora and Burks 2012a).

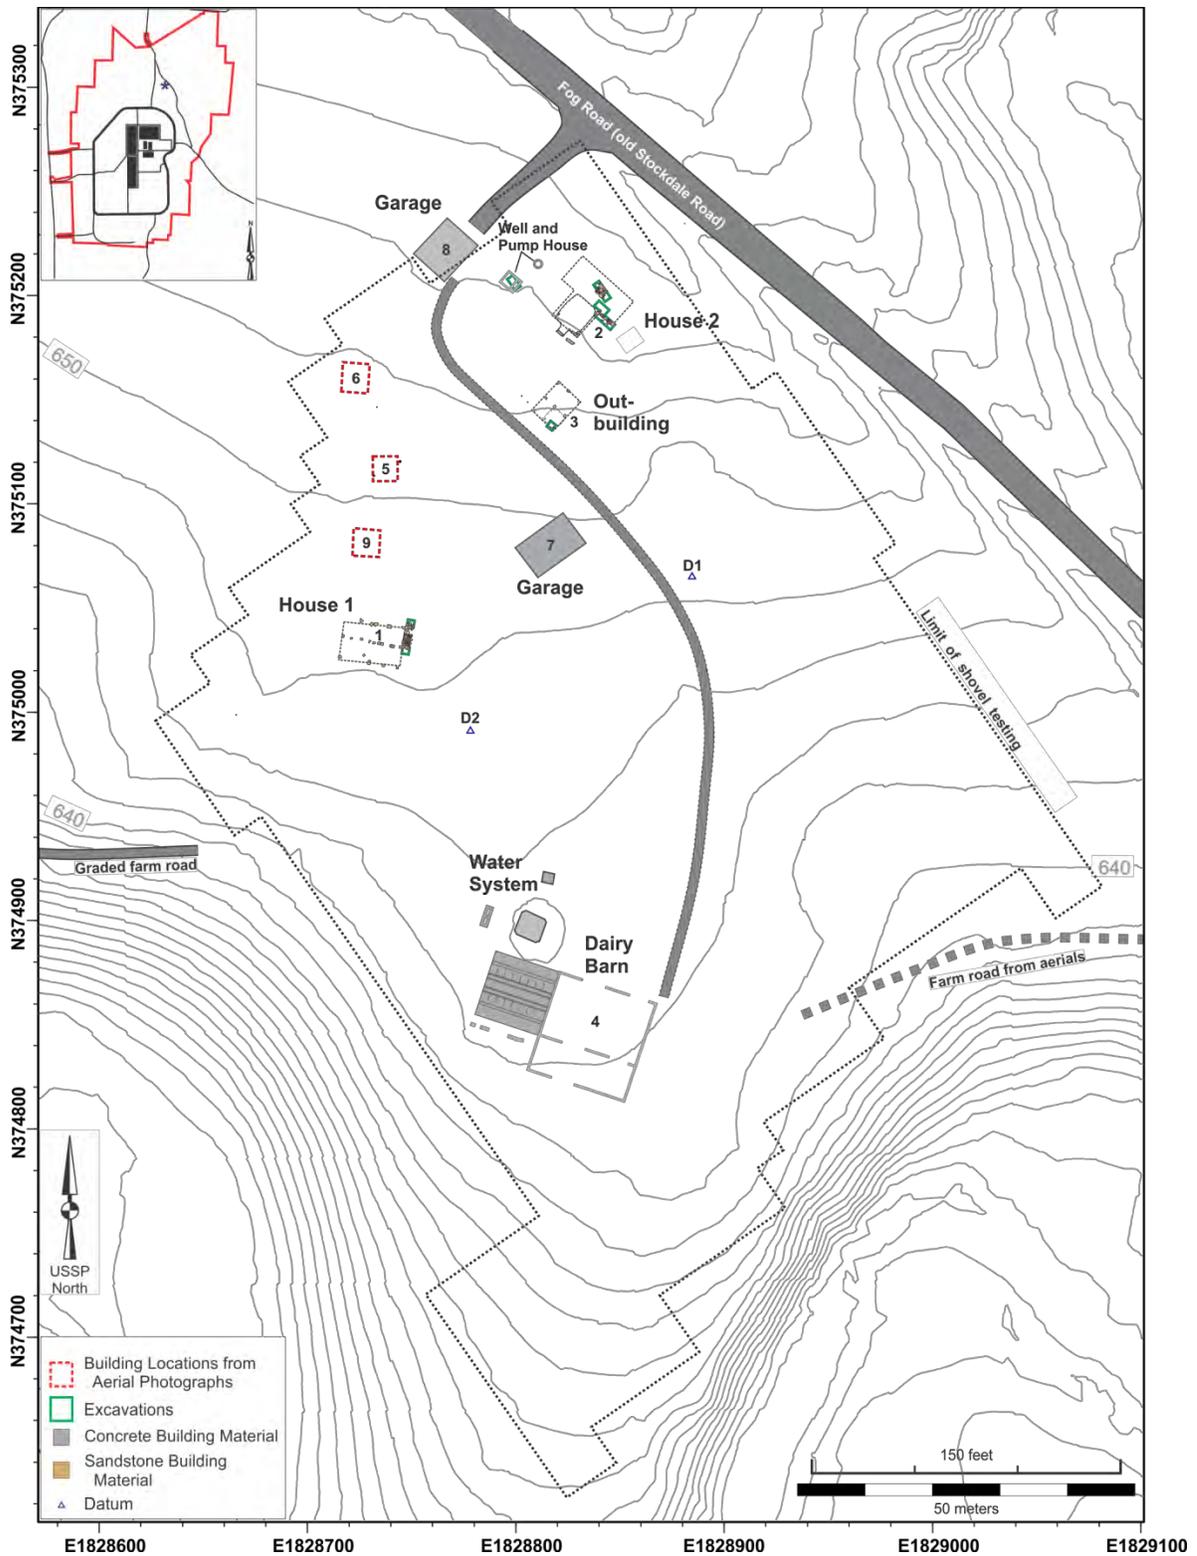
Figure 15. Illustration of the Stockdale Road Dairy (33Pk217) (adapted from Pecora and Burks 2012a).

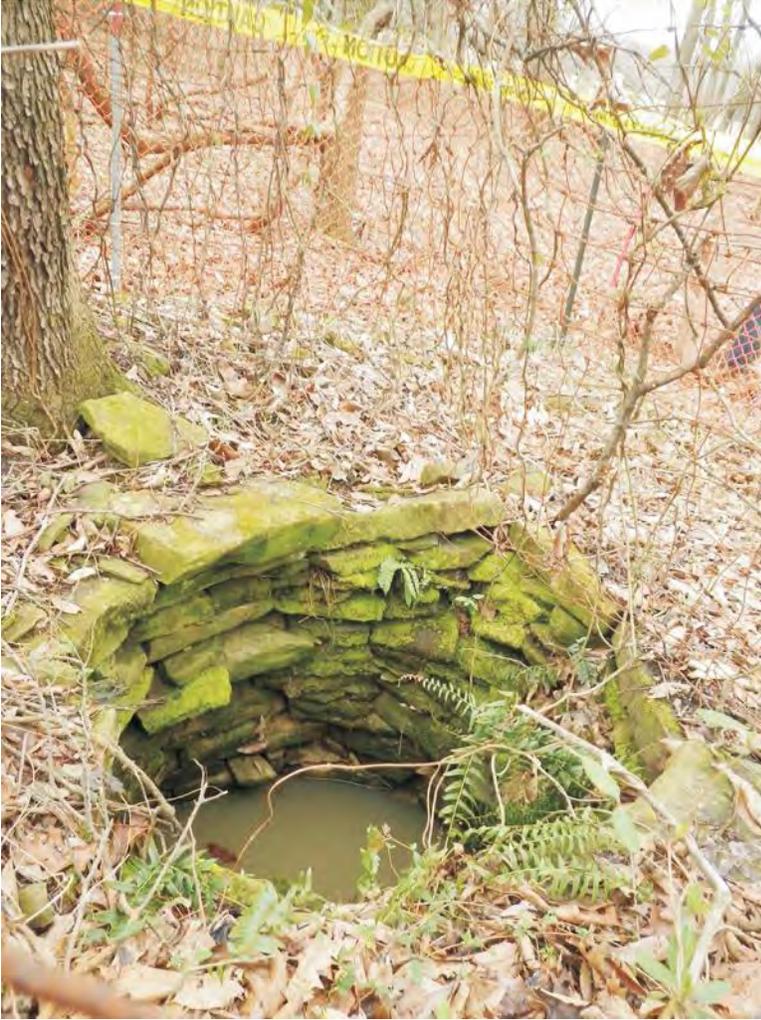
Figure 36. Photograph of the isolated stone-lined well at site 33Pk359.

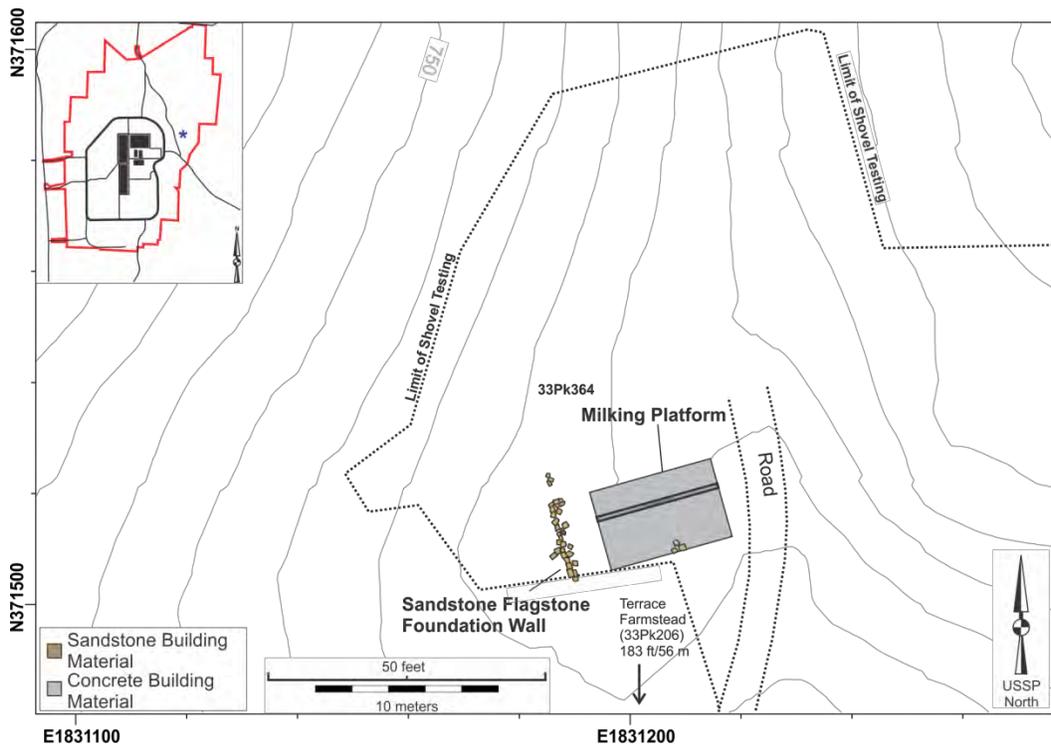
Figure 37. Illustration of site 33Pk364 (33Pk206 barn foundation) (adapted from Pecora and Burks 2012a).

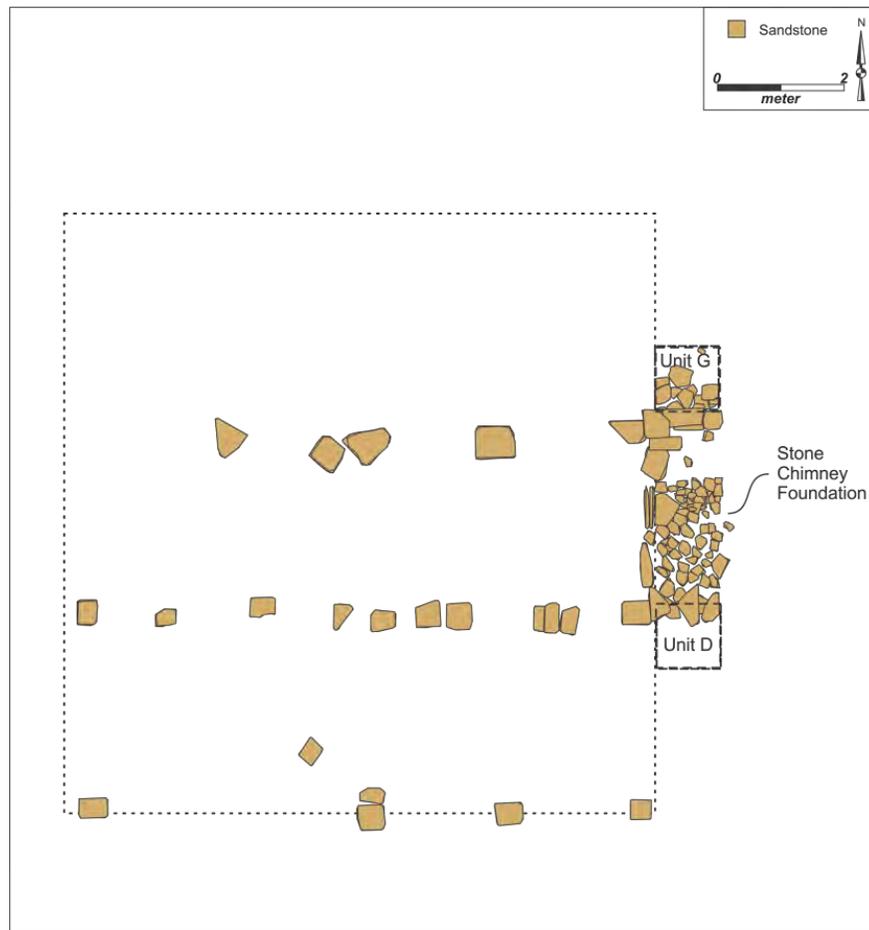
Figure 62. Example of a rough stacked stone support pier house foundation at Stockdale Road Dairy (33Pk217).

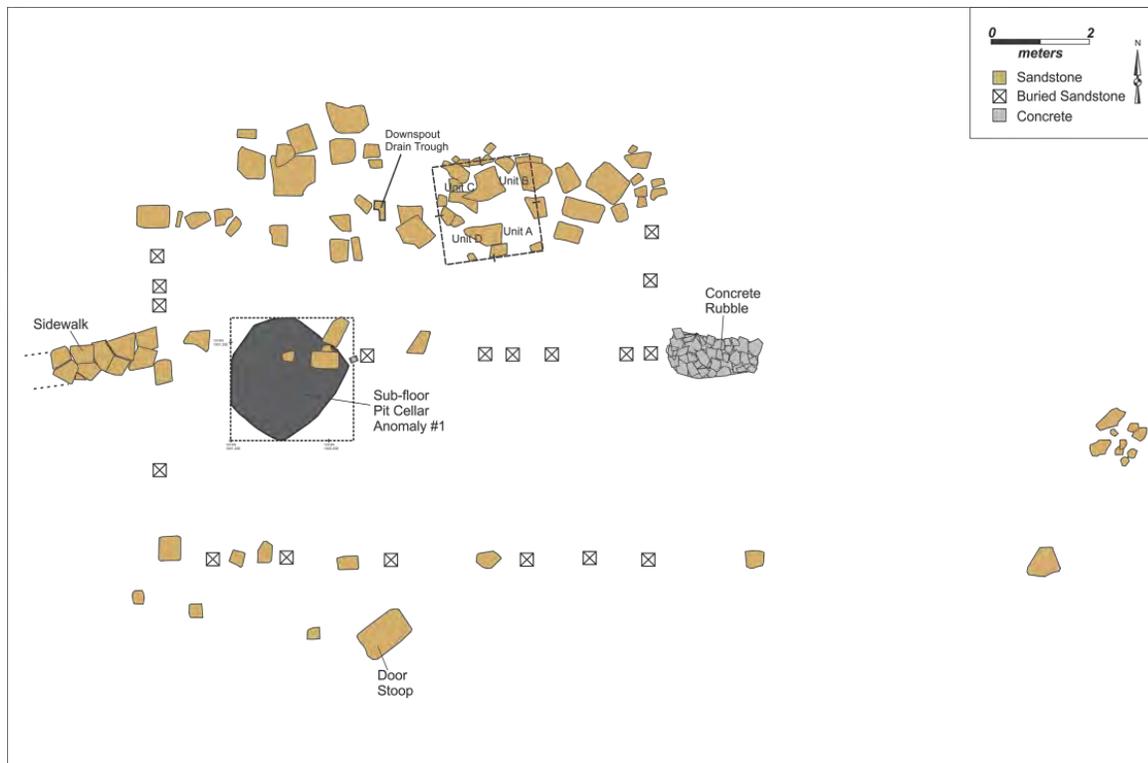
Figure 63. Example of a rough stacked stone support pier house foundation at South Shyville Farmstead (33Pk185).

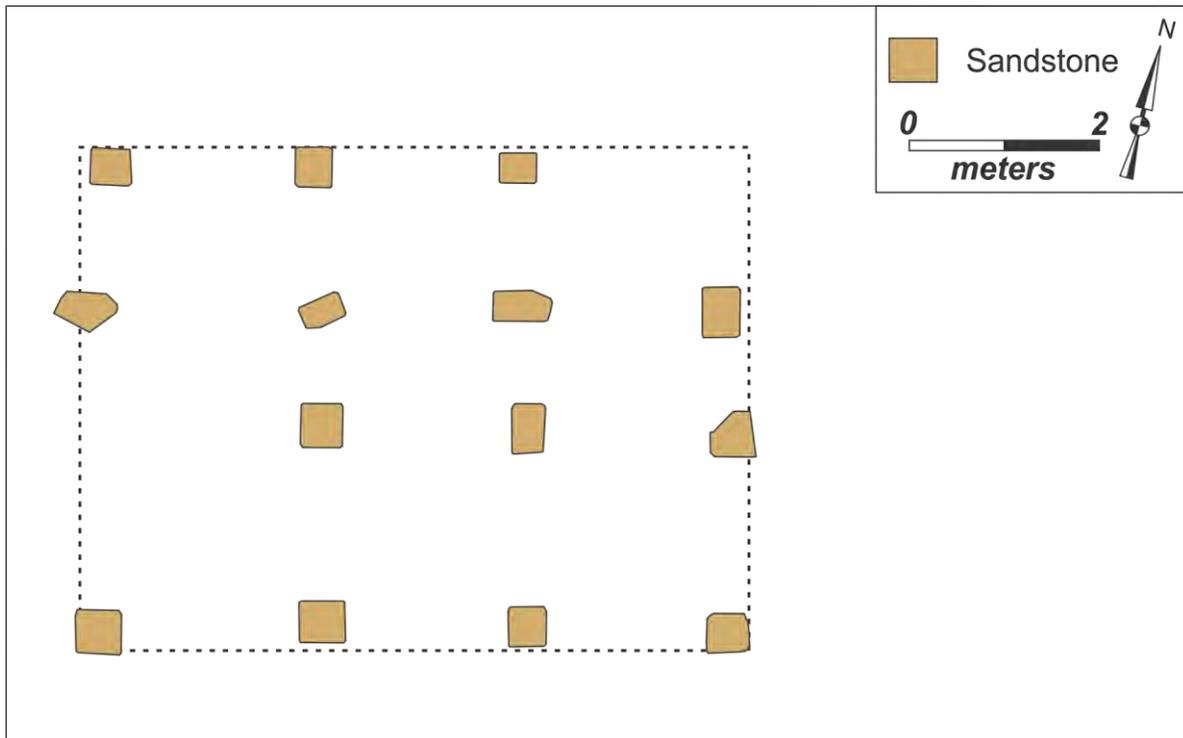
Figure 64. Example of a cut sandstone block support pier outbuilding foundation from Bamboo Farmstead (33Pk211).

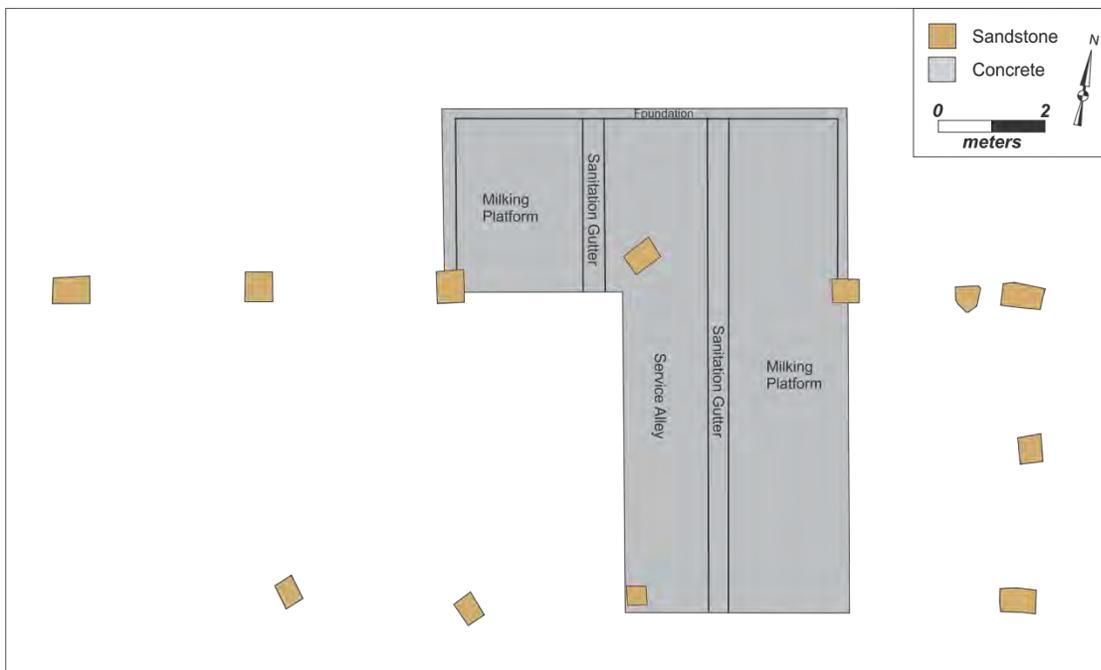
Figure 65. Example of a cut sandstone block support pier barn foundation with poured concrete milking parlor improvement from Bamboo Farmstead (33Pk211).

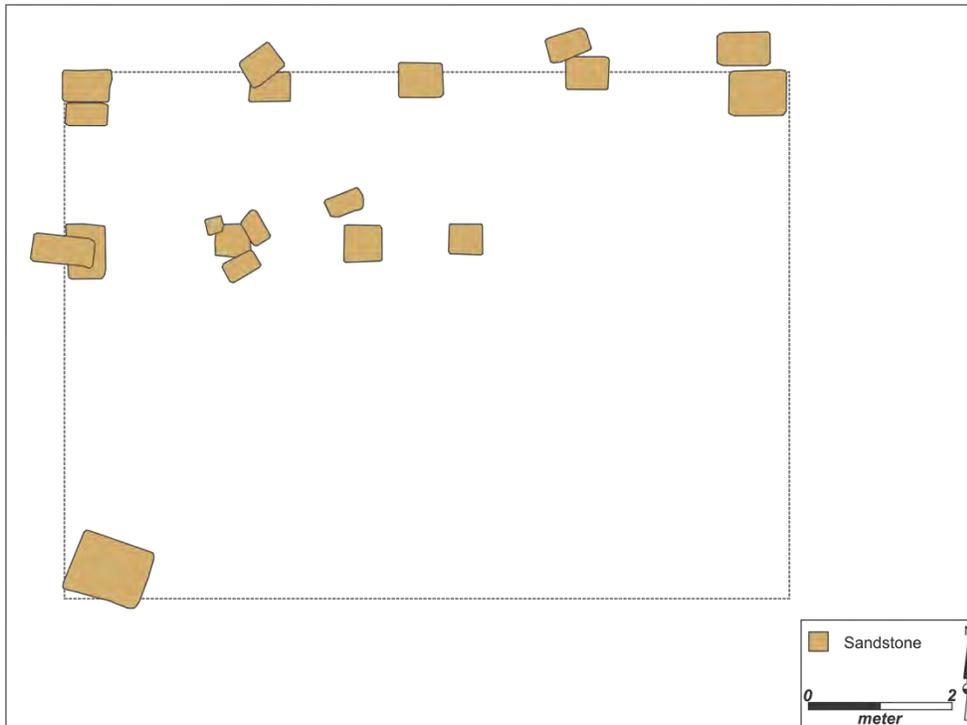
Figure 66. Example of a cut sandstone block support pier outbuilding foundation from Terrace Farmstead (33Pk206).

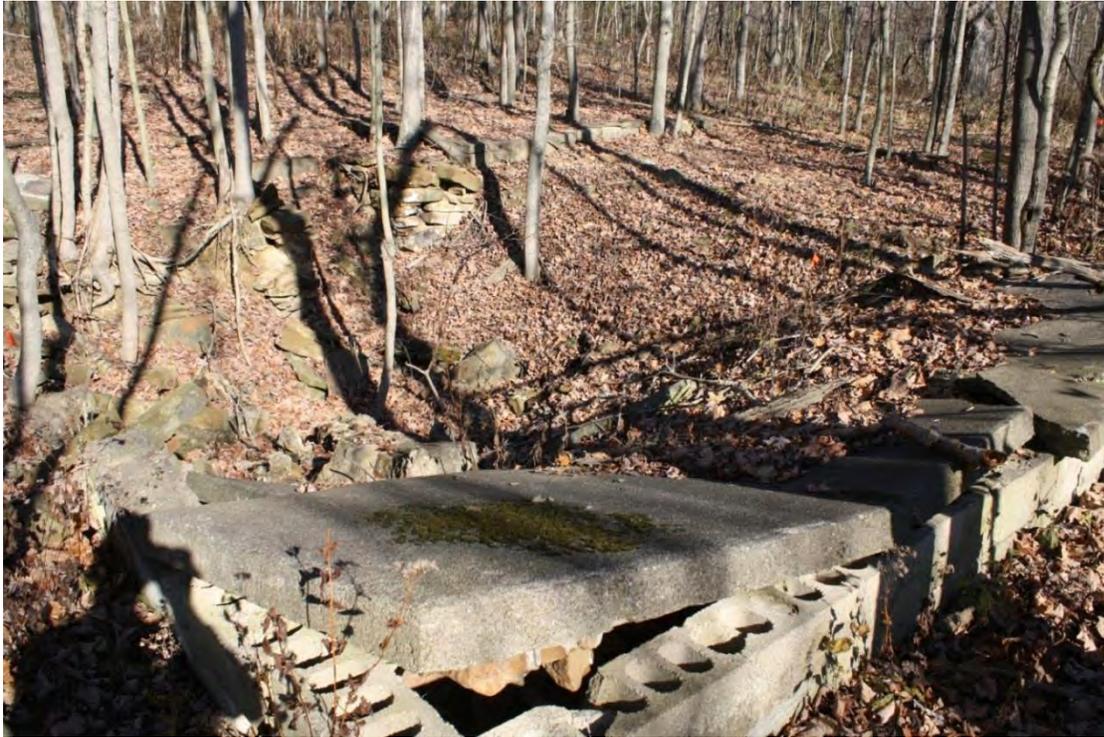
Figure 67. Photograph of a rough fieldstone masonry cellar foundation (background) with cinder block and poured concrete (foreground) at Brodess Farmstead (33Pk311).

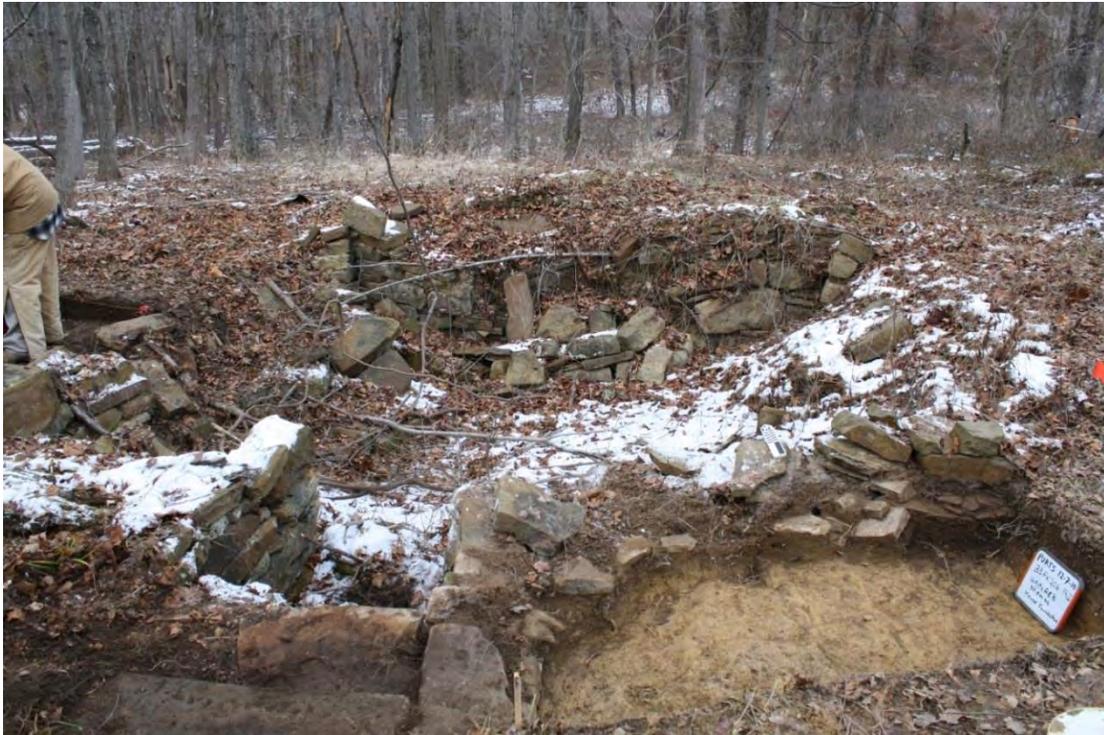
Figure 68. Photograph of a rough fieldstone masonry cellar foundation (partially collapsed) at Terrace Farmstead (33Pk206).

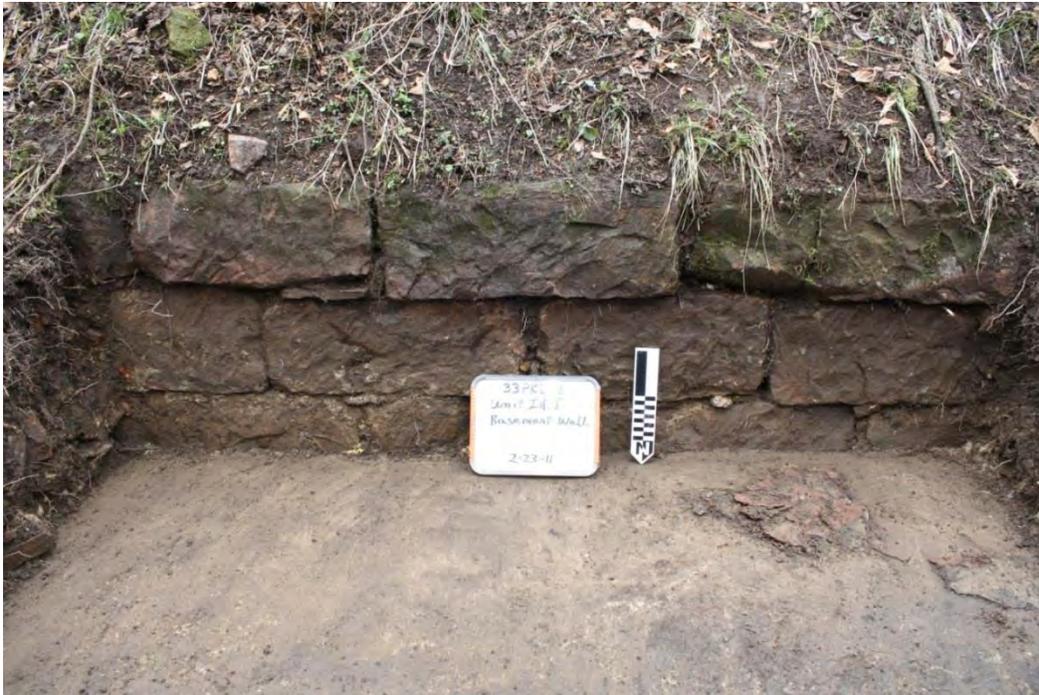
Figure 69. Photograph of a cut stone masonry cellar foundation wall (with a poured concrete floor) at Ruby Hollow Farmstead (33Pk203).

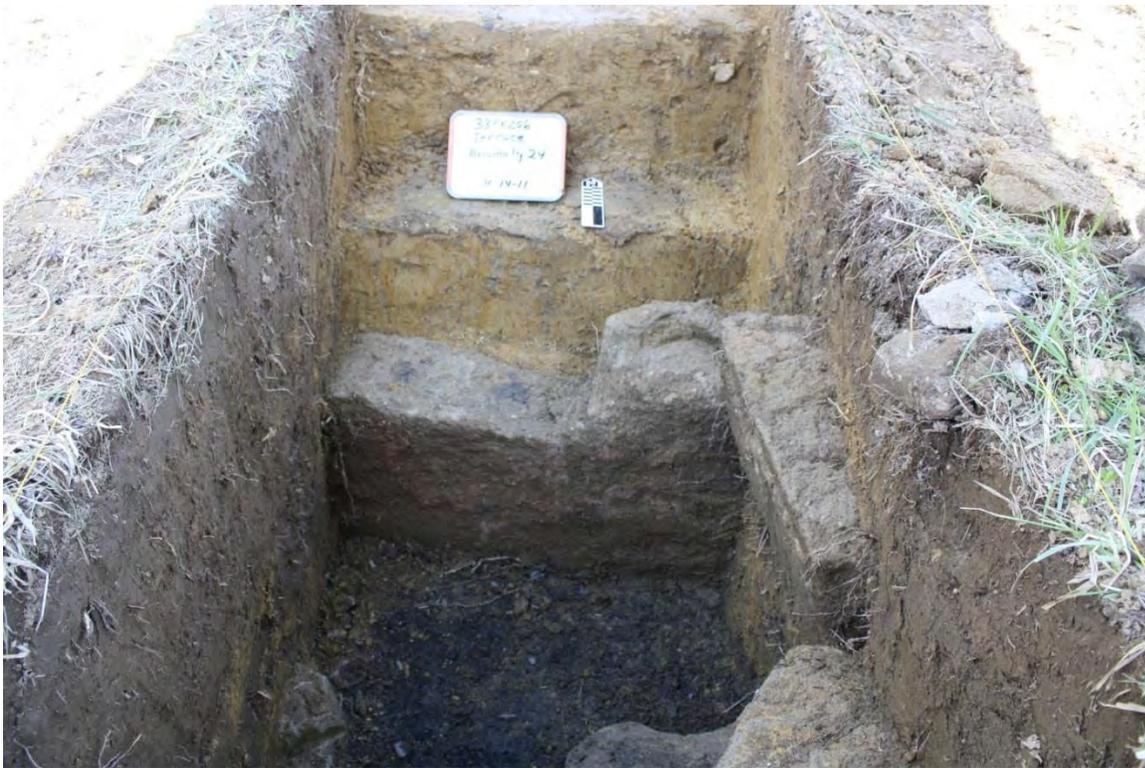
Figure 71. Photograph of a poured concrete cellar foundation at Terrace Farmstead (33Pk206).

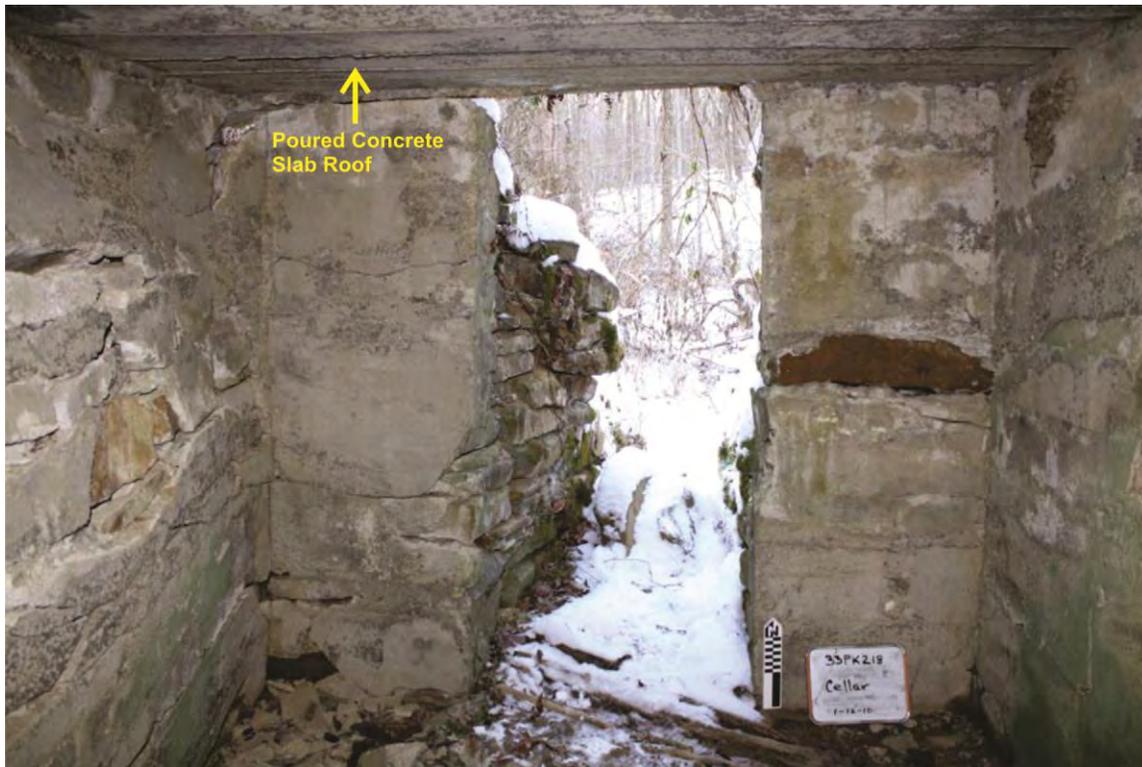
Figure 72. Photograph of a poured concrete slab roof (stone masonry walls have mortar skin coat) on external root cellar at Cornett Farmstead (33Pk218).

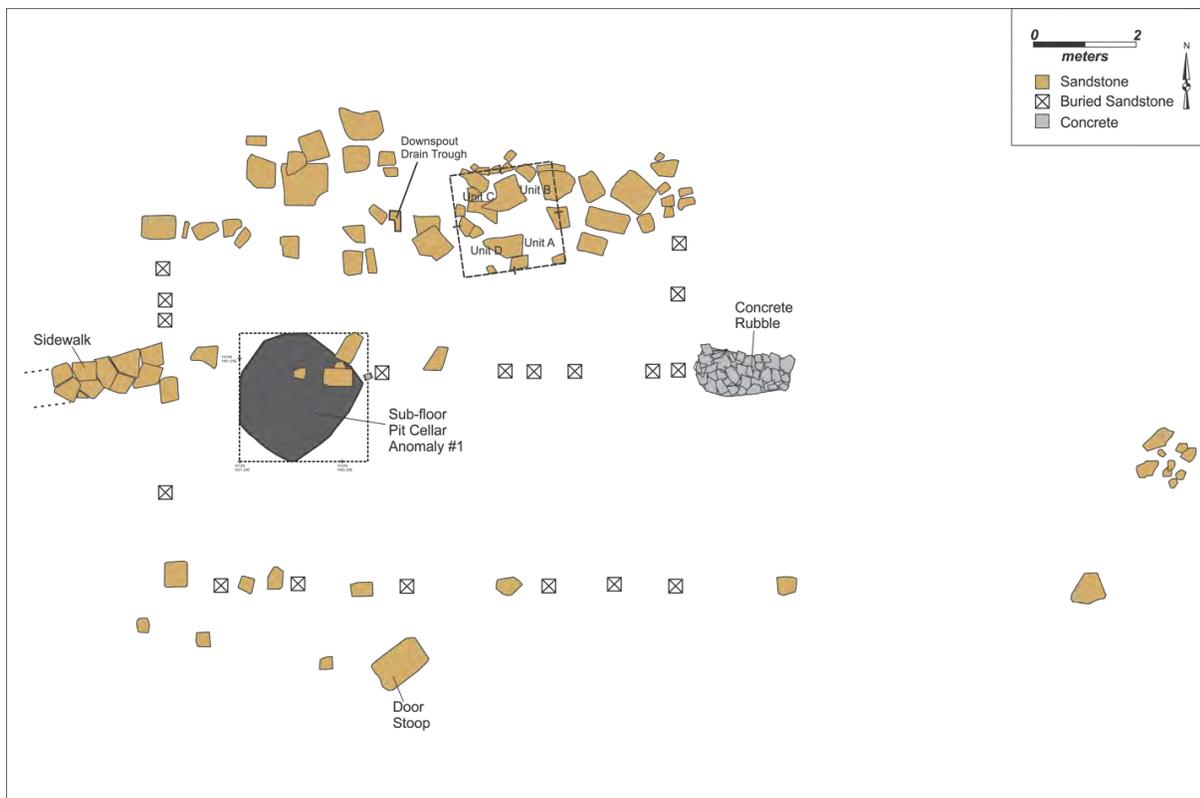
Figure 73. Illustration of the house foundation at South Shyville Farmstead (33k185).

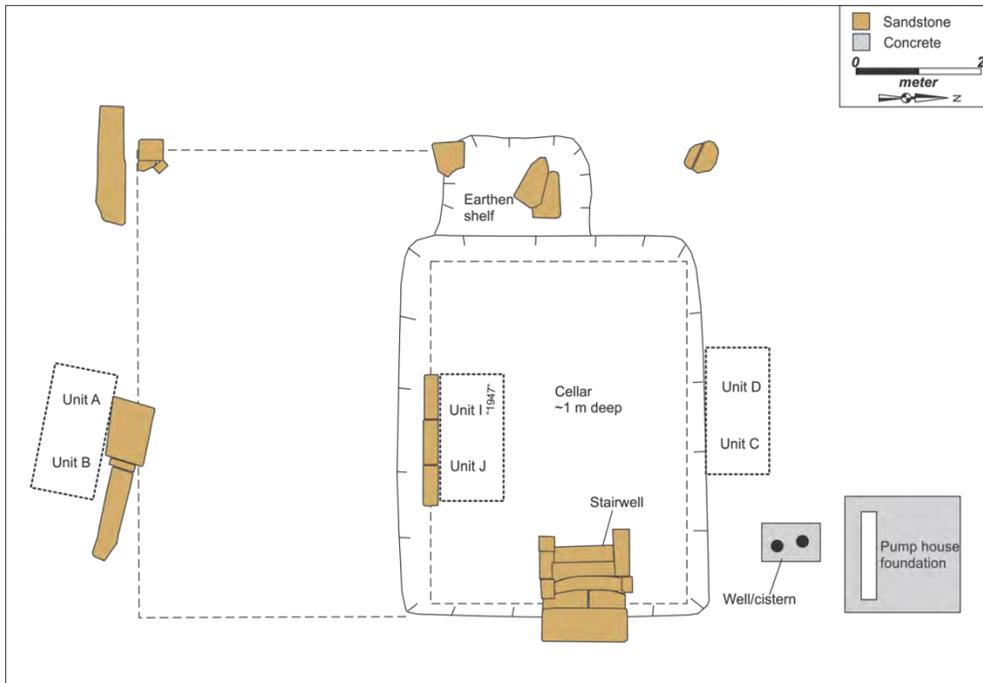
Figure 74. Illustration of the house foundation at Ruby Hollow Farmstead (33Pk203).

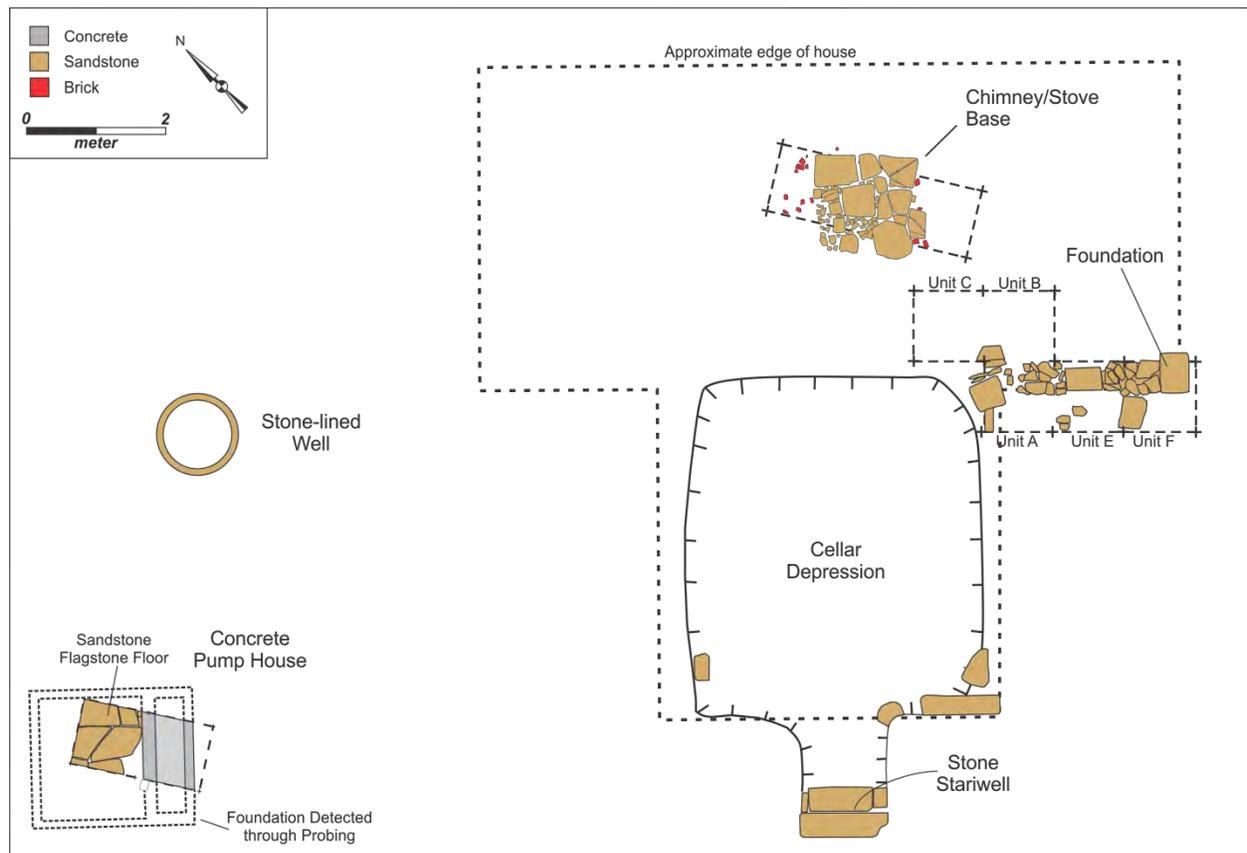
Figure 75. Illustration of a house foundation at Stockdale Road Dairy (33Pk217).

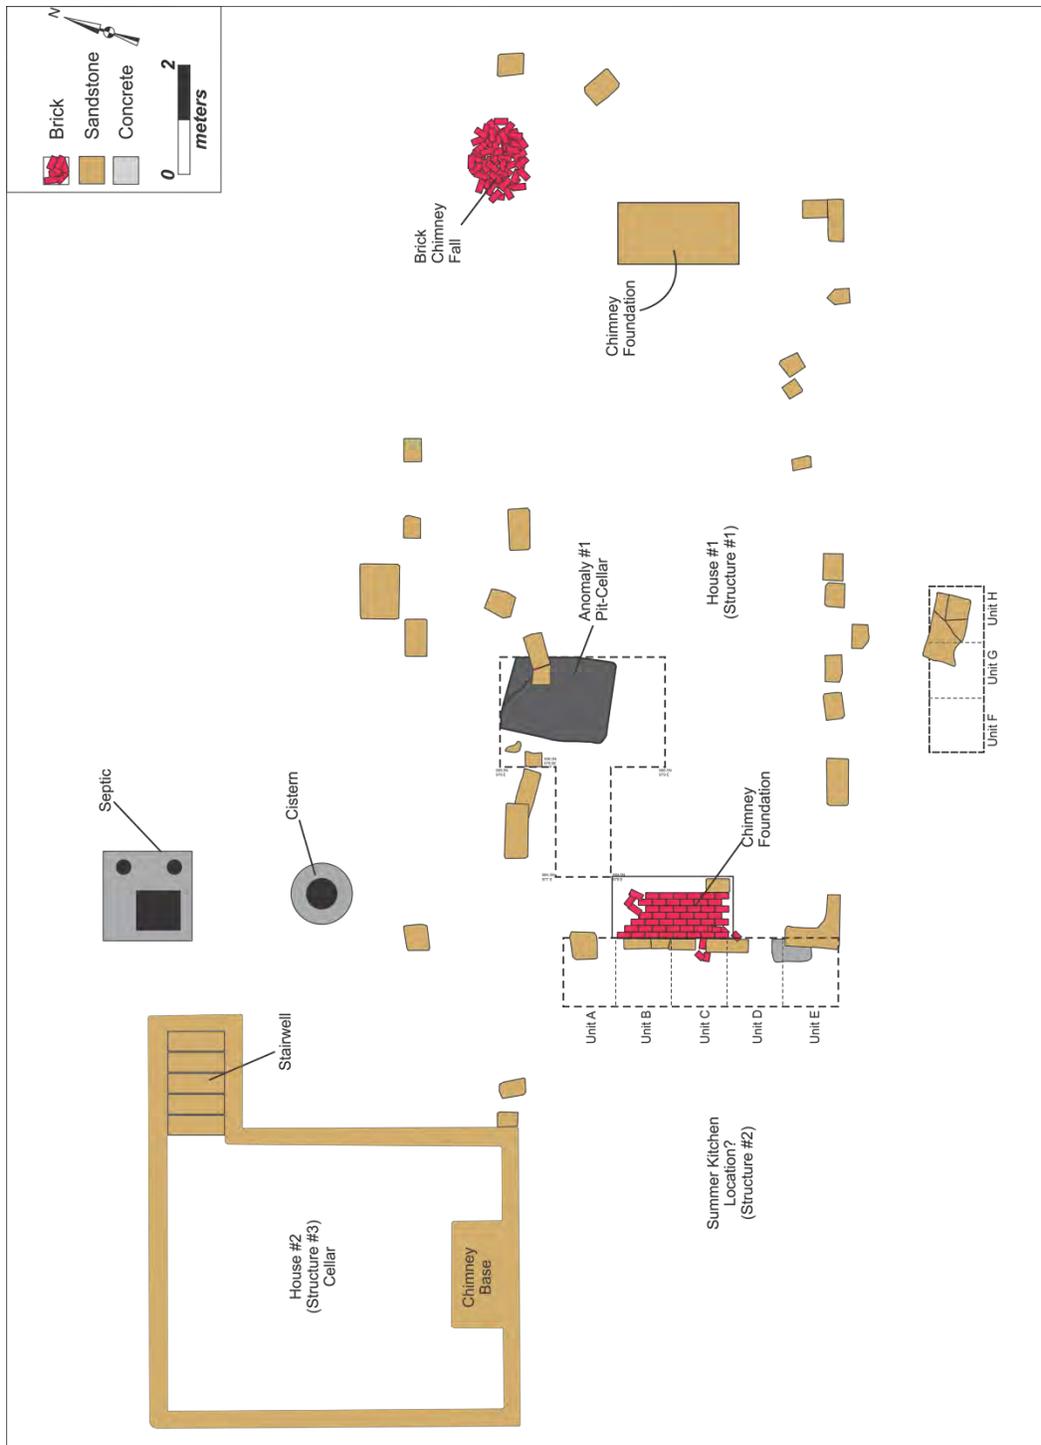
Figure 76. Illustration of house arrangement at Bamboo Farmstead (33Pk211).

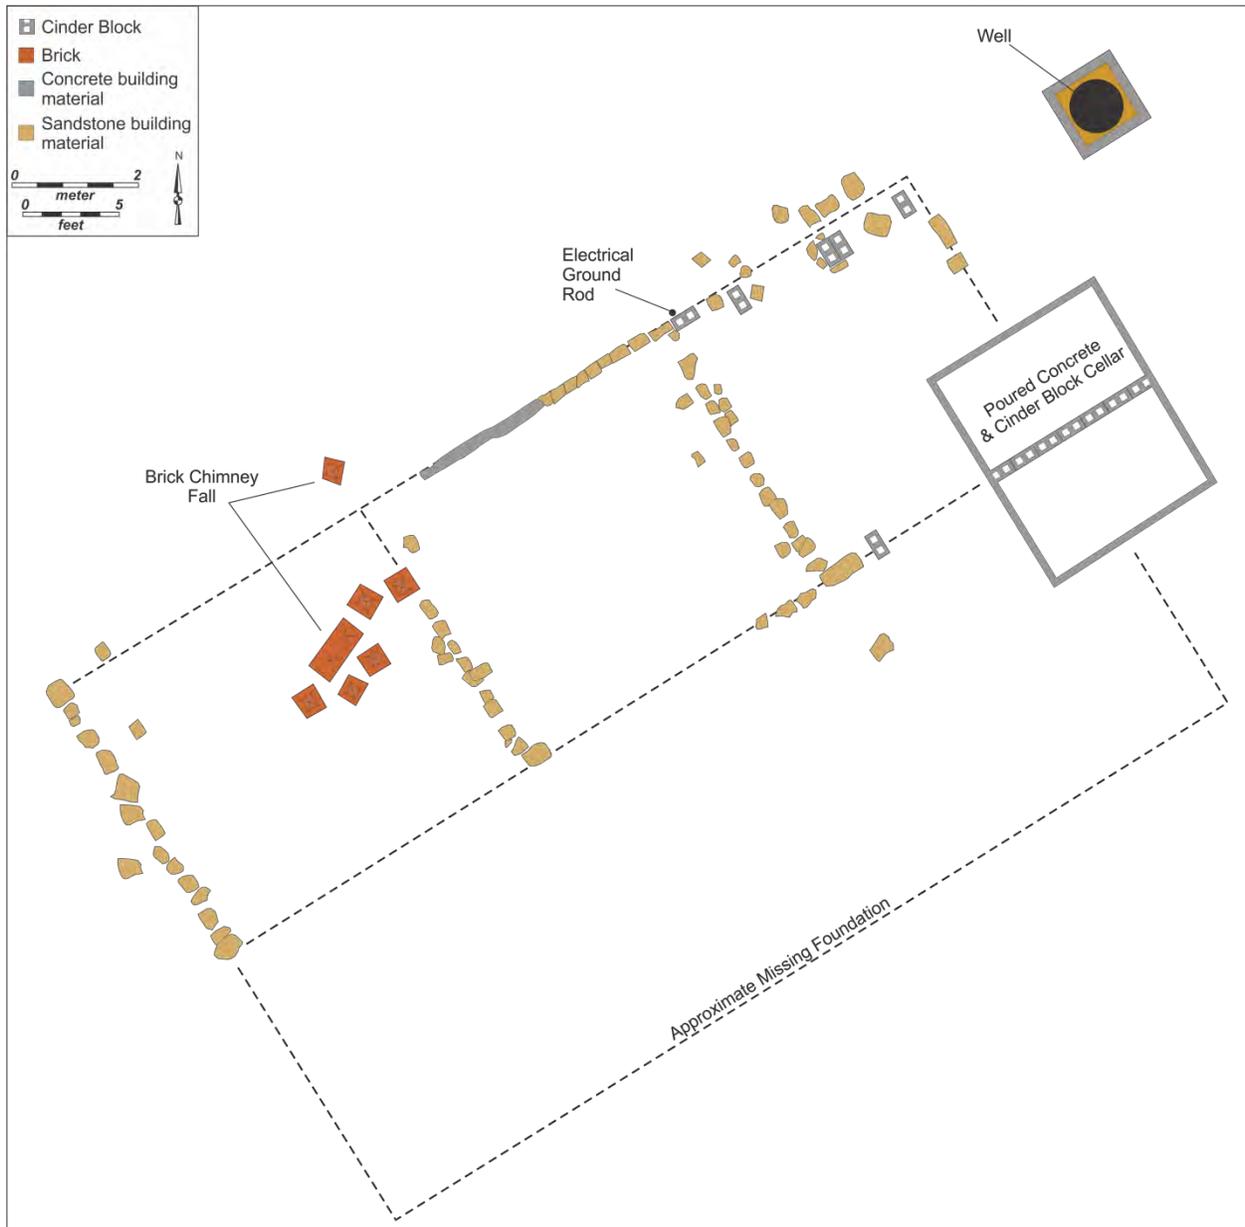
Figure 77. Illustration of the house foundation at Mechling Farmstead (33Pk318).
