**TRANSMITTAL OF THE SUMMARY REPORT OF HISTORIC-ERA
ARCHAEOLOGICAL RESOURCES WITHIN THE PORTSMOUTH GASEOUS
DIFFUSION PLANT, PIKE COUNTY, OHIO (RSI/PORTS-228)**

Enclosed for your information is the report "*Summary Report of Historic-Era Archaeological Resources within the Portsmouth Gaseous Diffusion Plant, Pike County, Ohio*" (RSI/PORTS-228).

Summary Report of Historic-Era Archaeological Resources within the Portsmouth Gaseous Diffusion Plant, Pike County, Ohio (RSI/PORTS-228)

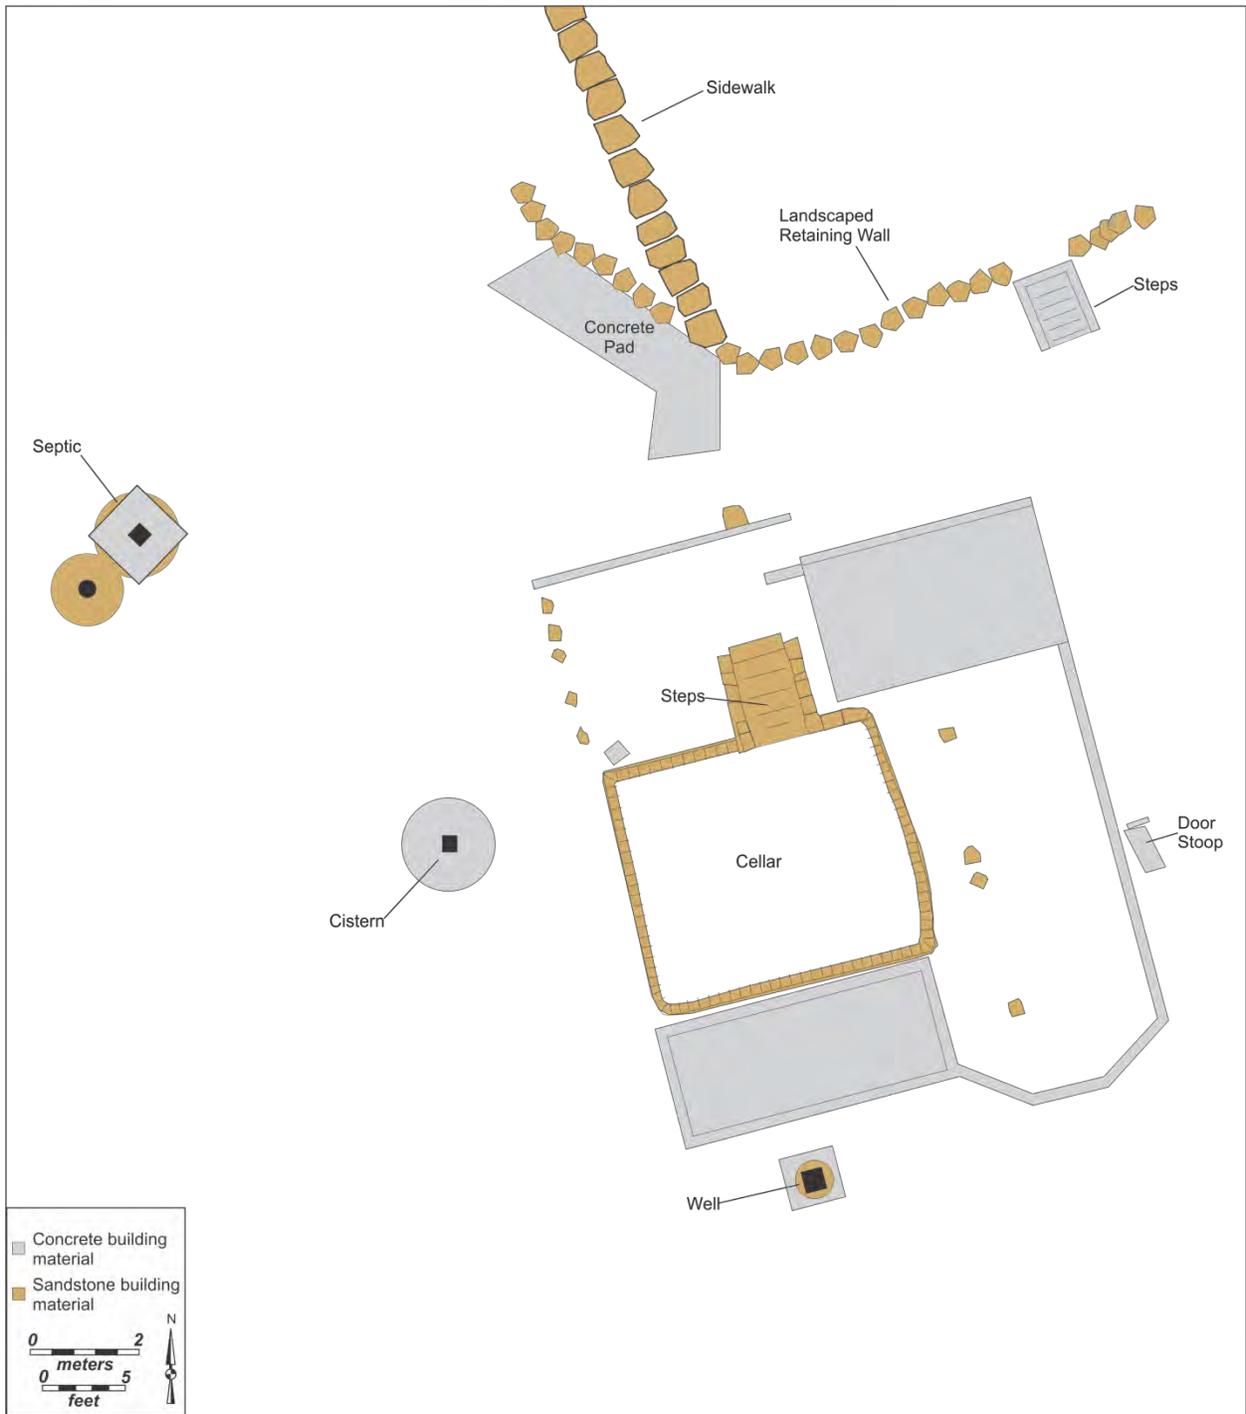
Figure 78. Illustration of the house foundation at Brodess Farmstead (33Pk311).

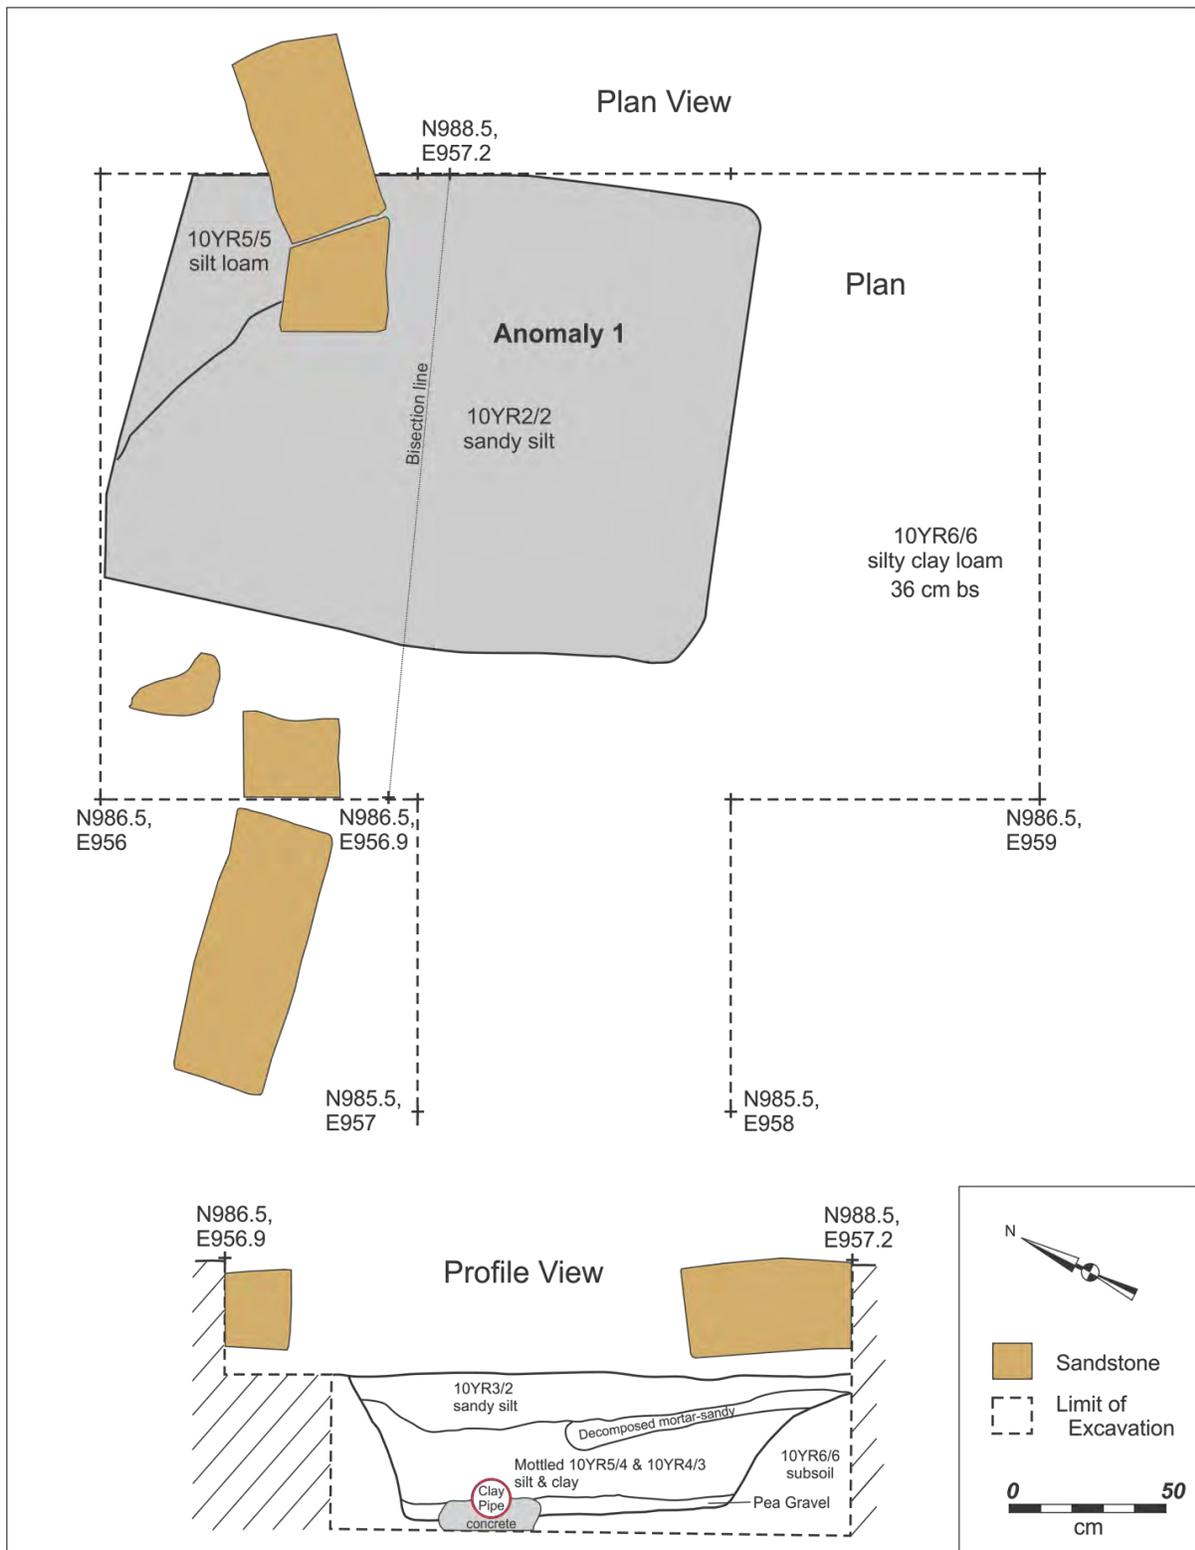
Figure 83. Plan view and profile illustration of an internal pit/trap cellar at Bamboo Farmstead (33Pk211).

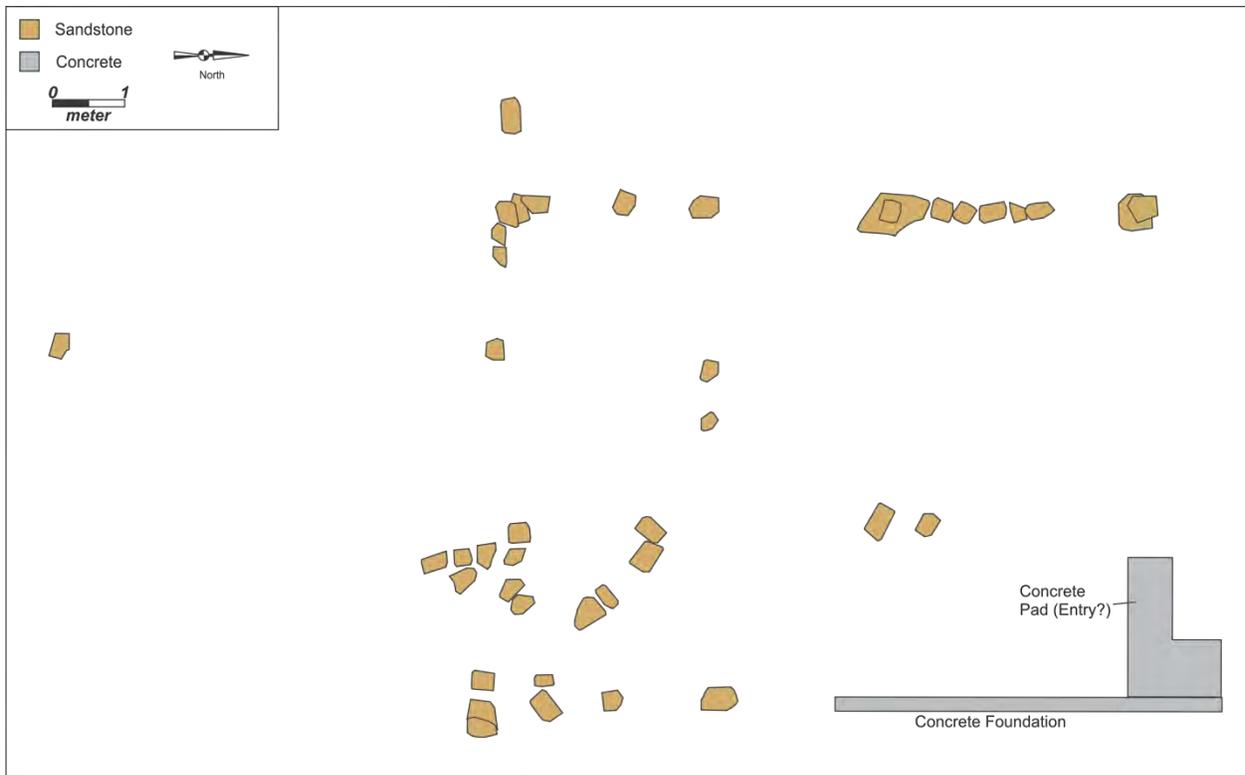
Figure 84. Illustration of a barn foundation at Ruby Hollow Farmstead (33Pk203).

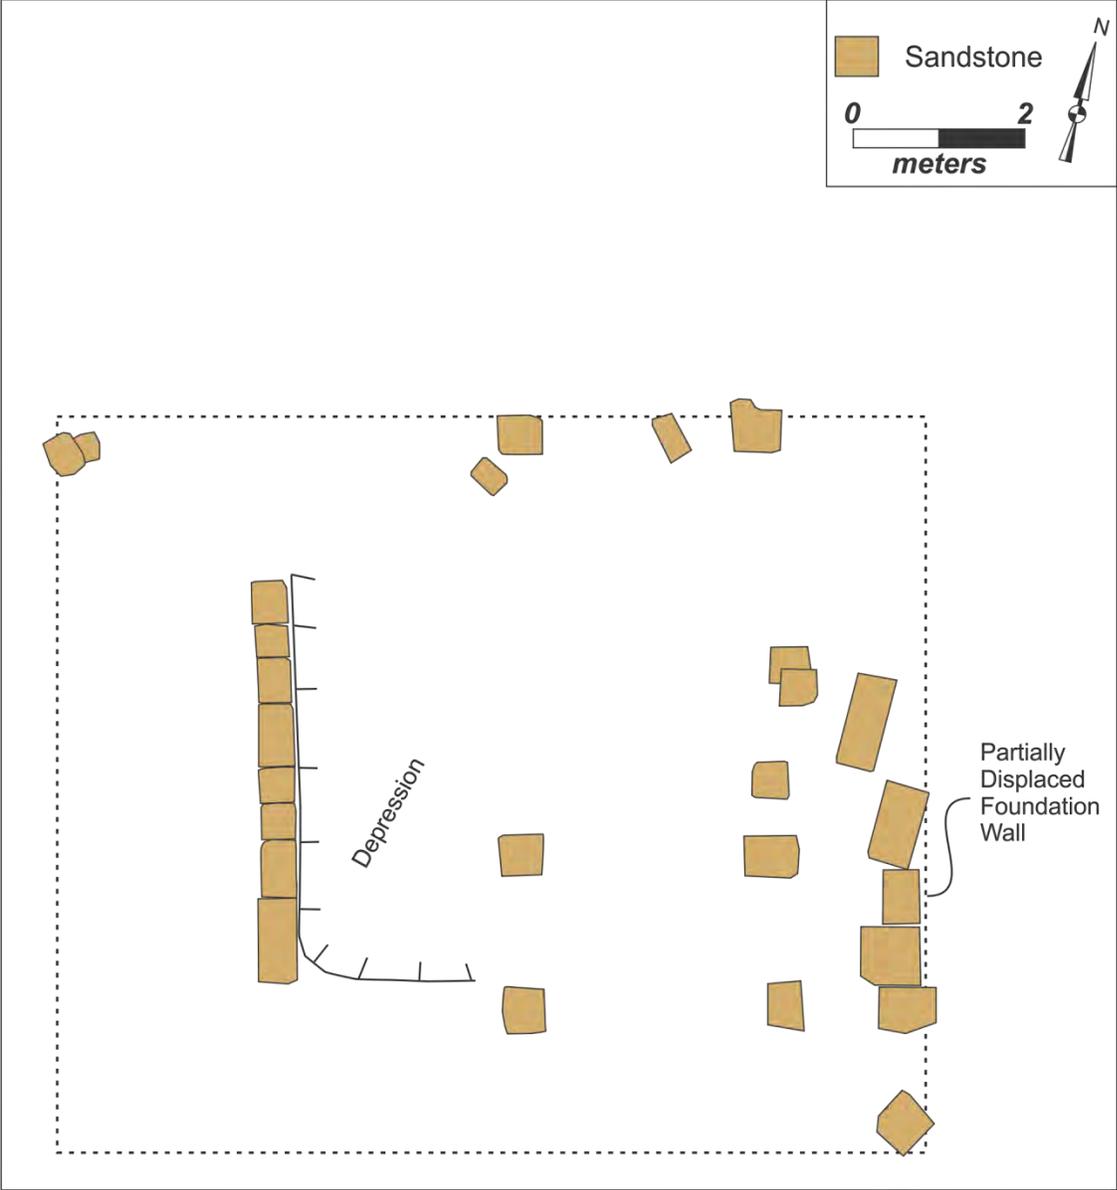
Figure 85. Illustration of a barn foundation at Bamboo Farmstead (33Pk211).

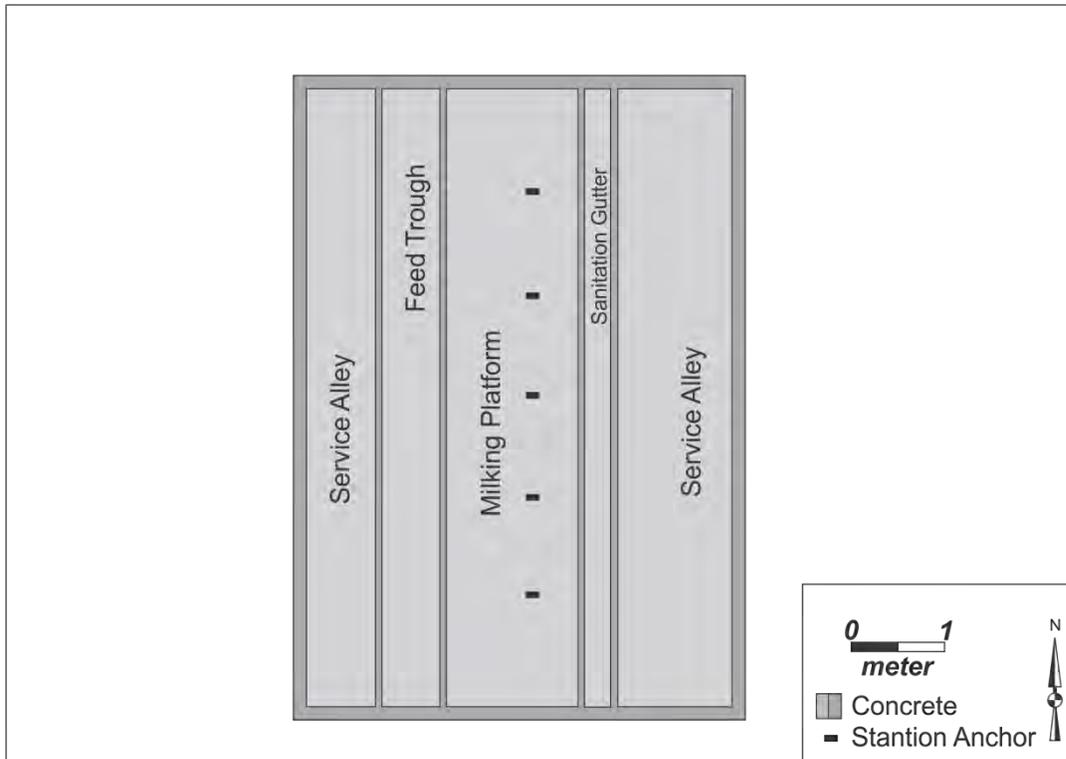
Figure 86. Illustration of a milking platform at South Shyville Farmstead (33Pk185).

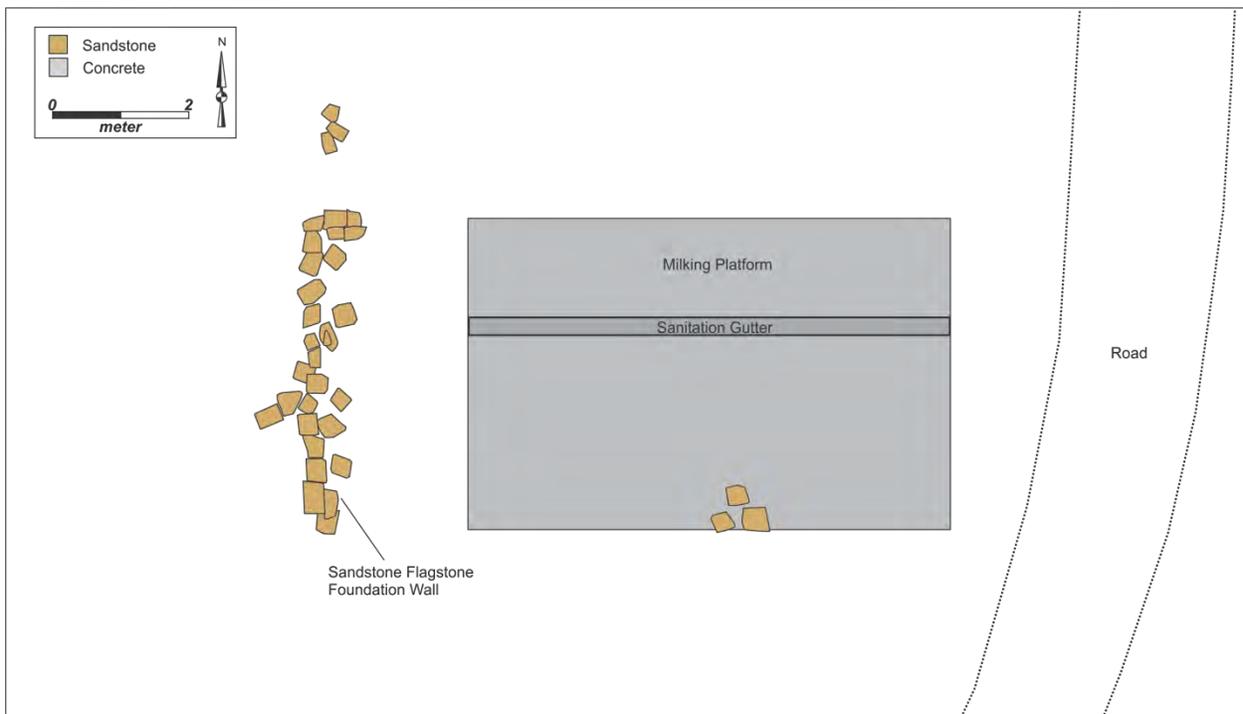
Figure 87. Illustration of a barn foundation with internal milking platform at Terrace Farmstead (33Pk216).

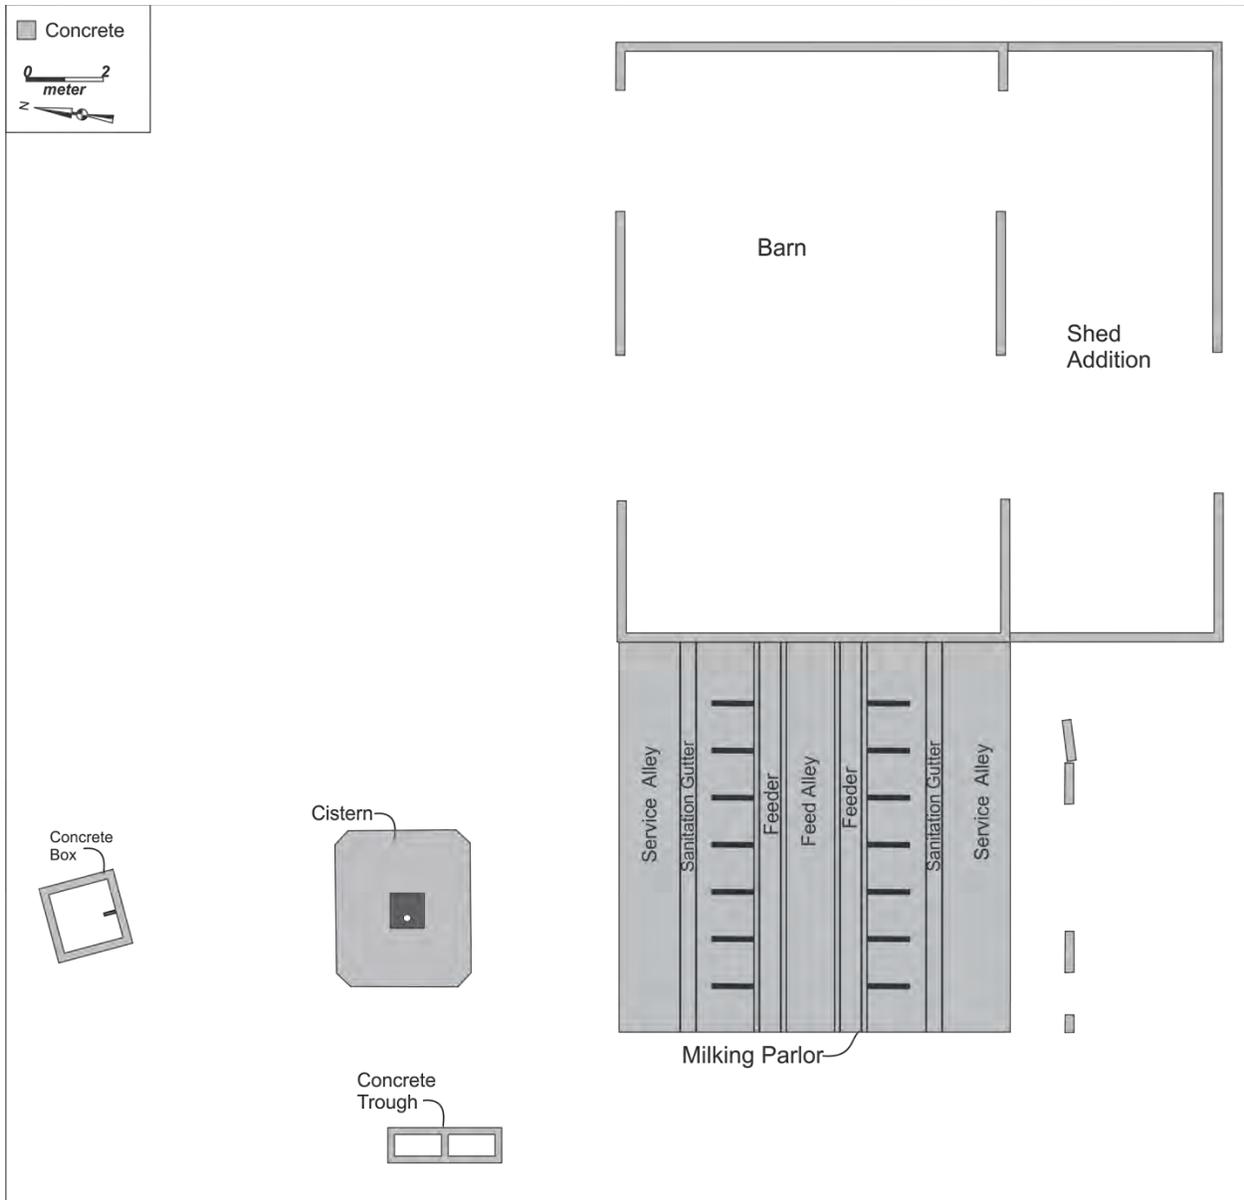
Figure 88. Illustration of a barn and attached milking parlor at Stockdale Road Dairy (33Pk217).

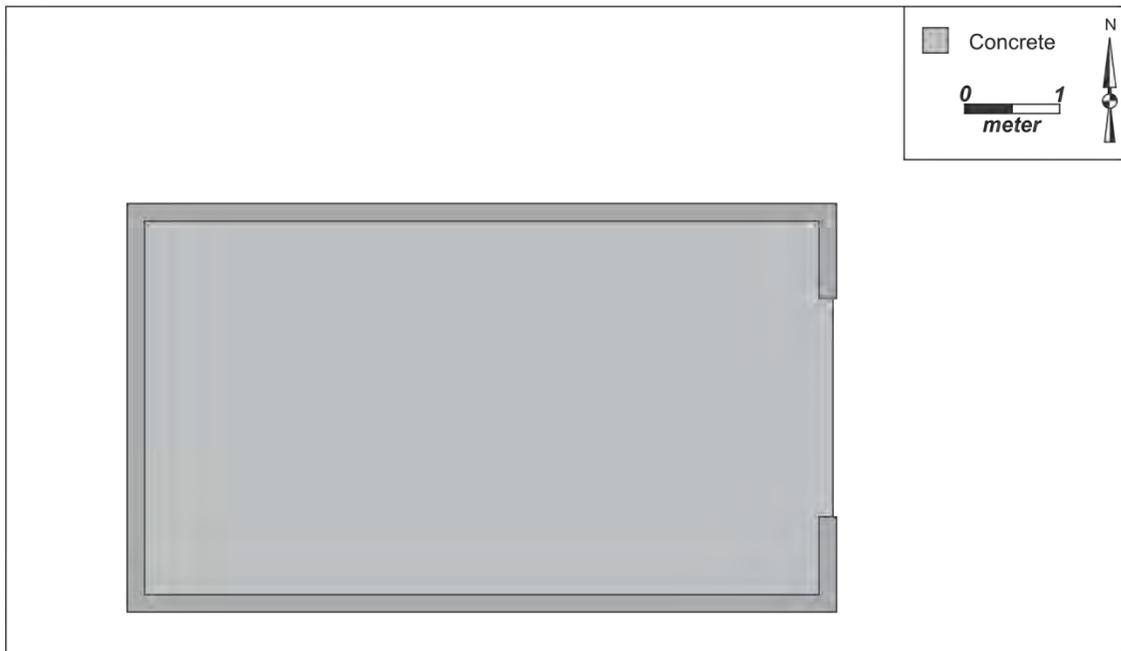
Figure 89. Illustration of a poured concrete garage at Ruby Hollow Farmstead (33Pk203).

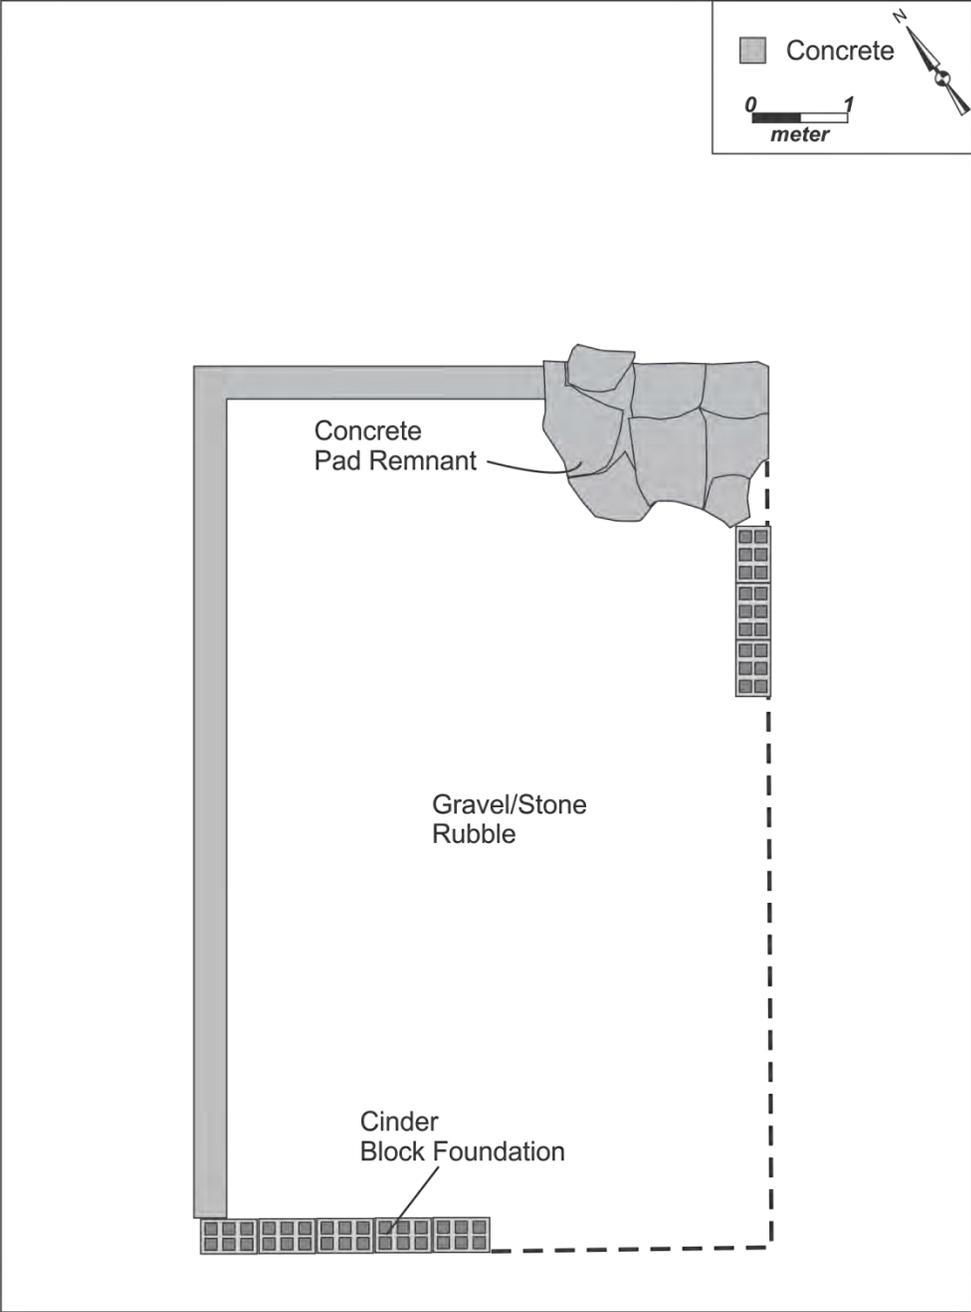
Figure 90. Illustration of a cinder block and poured concrete garage foundation at Stockdale Road Dairy (33Pk217).

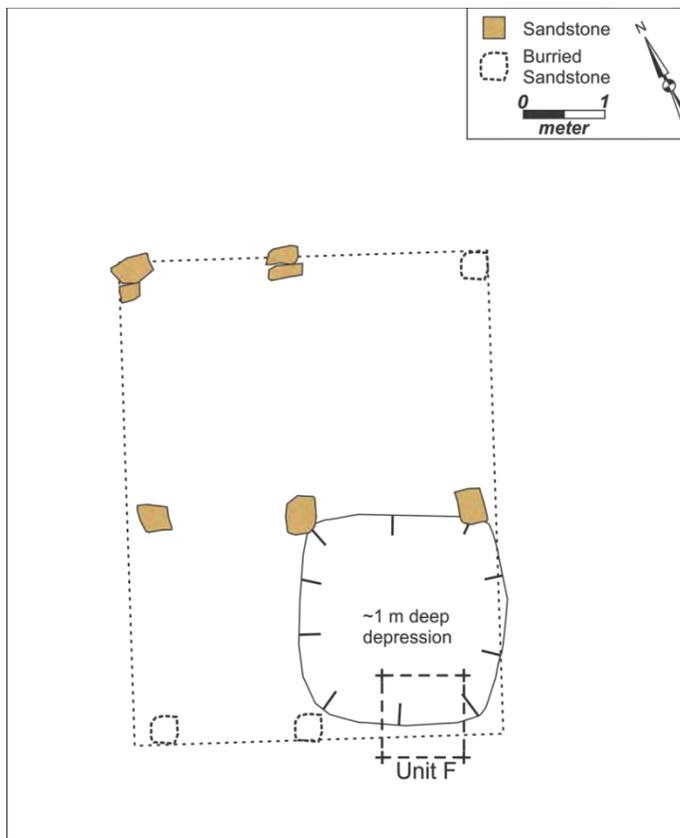
Figure 91. Illustration of a small outbuilding foundation with possible privy vault in southwest corner at Stockdale Road Dairy (33Pk217).

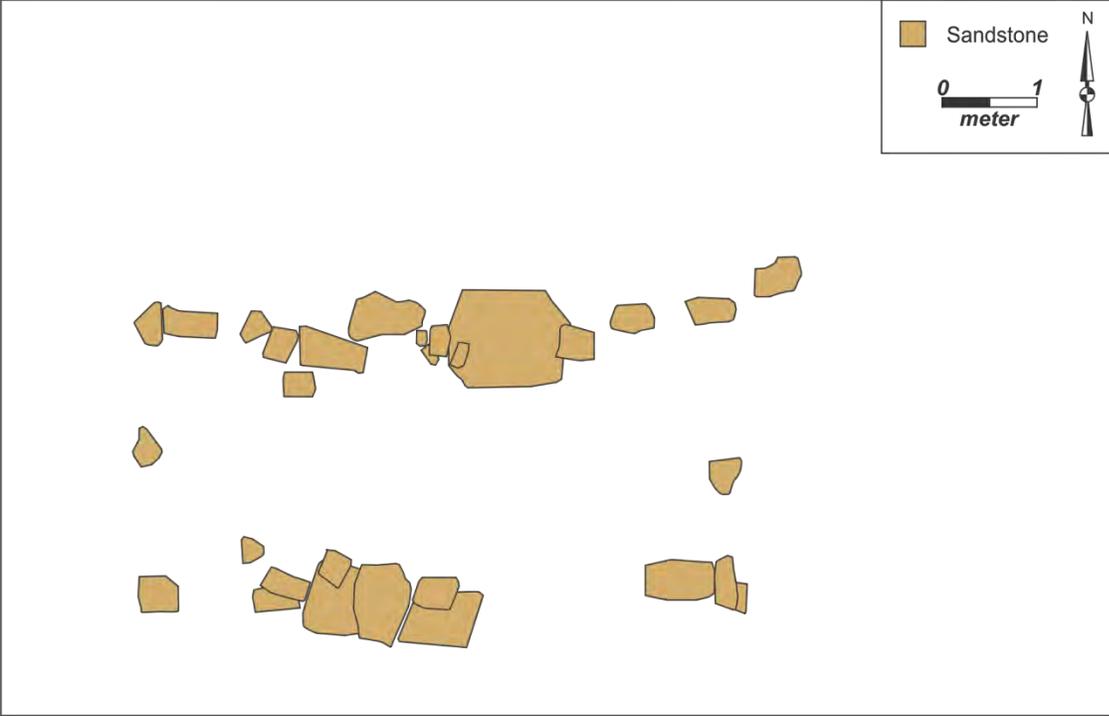
Figure 92. Illustration of a small outbuilding foundation at Ruby Hollow Farmstead (33Pk203).

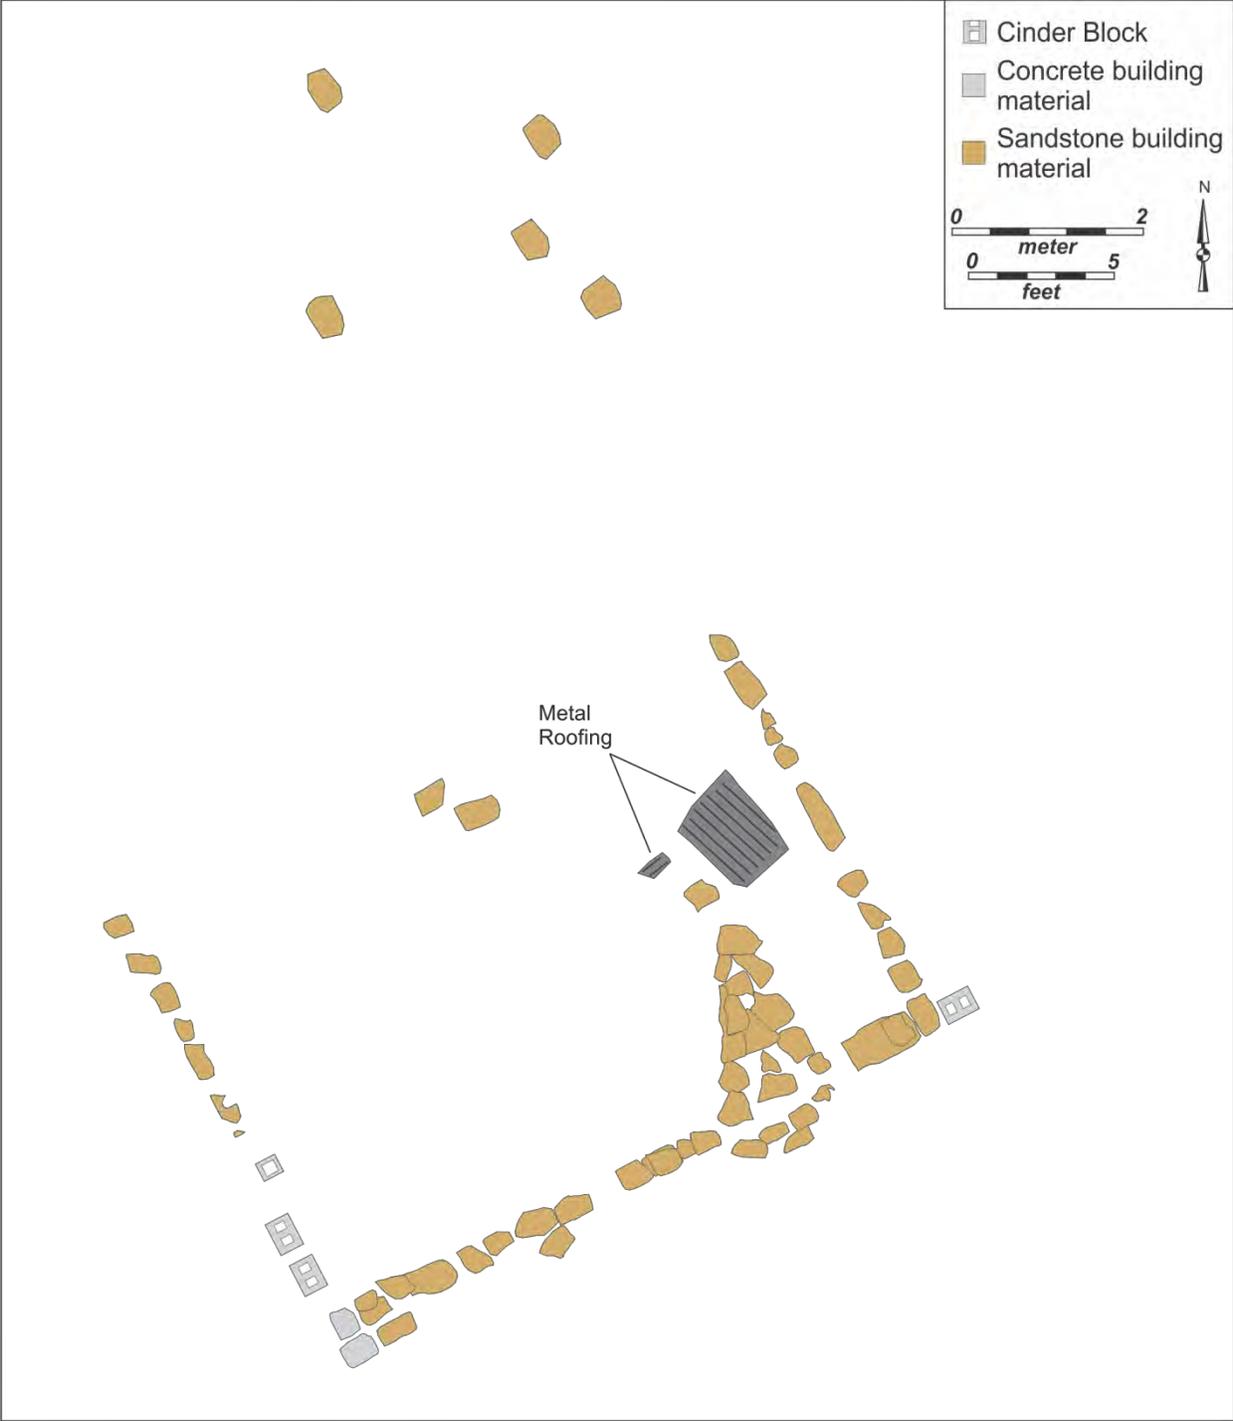
Figure 93. Illustration of a small outbuilding foundation at the Mechling Farmstead (33Pk318).

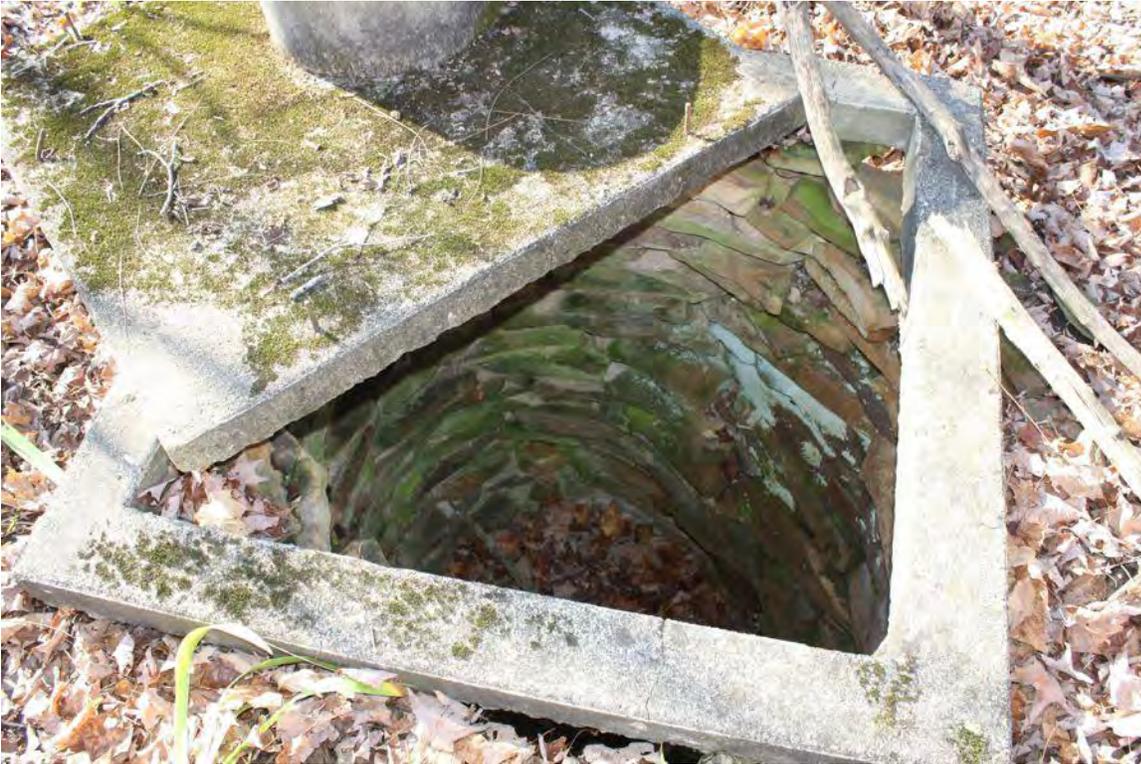
Figure 97. Photograph of the septic system at Brodess Farmstead (33Pk311).
