Continued investigation into the behavior of breached TPBARs during reactor operation

ANDREW CASELLA, ROBERT MONTGOMERY, LARRY BAGAASEN, INGRID BURGESSON, MONTE ELMORE, BRAD JOHNSON

38th Tritium Focus Group Meeting

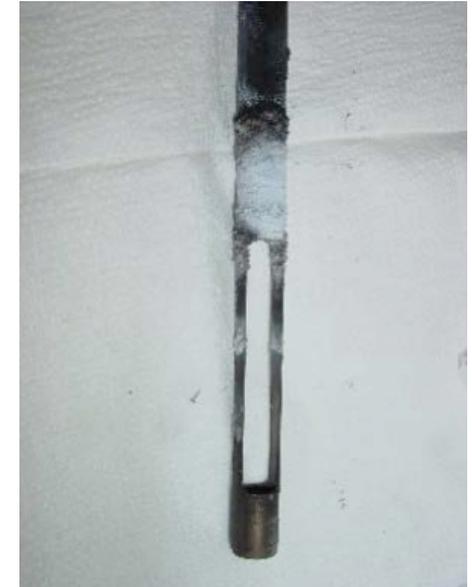
Baldwin

Time, days	Apparent Li Leaching, %	Apparent Al Leaching, %	pH Values
0	0	0	6.18
0.17	113	51	7.18
0.33	216	89	7.14
1	346	136	7.49
2	389	153	7.96
5	111	38	6.29
8	14	6	5.88
14	2	1	5.36

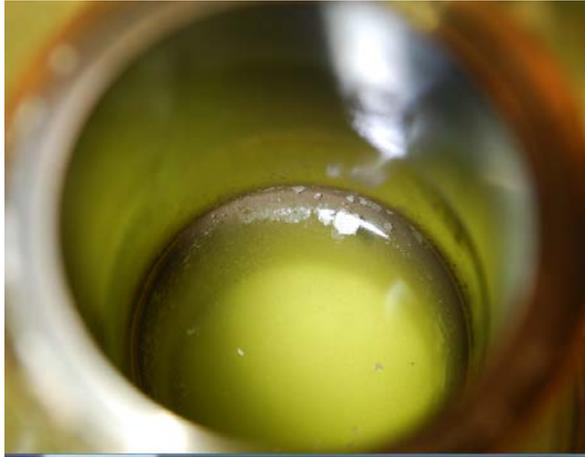
Caustic attack leads to leaching of chrome from stainless steel

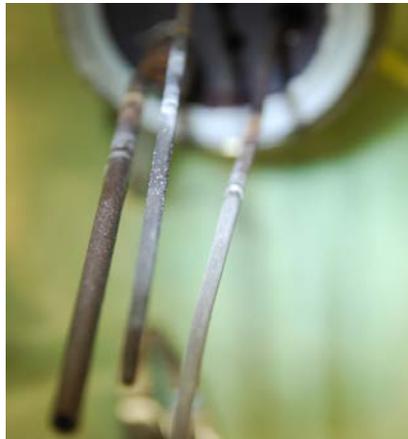
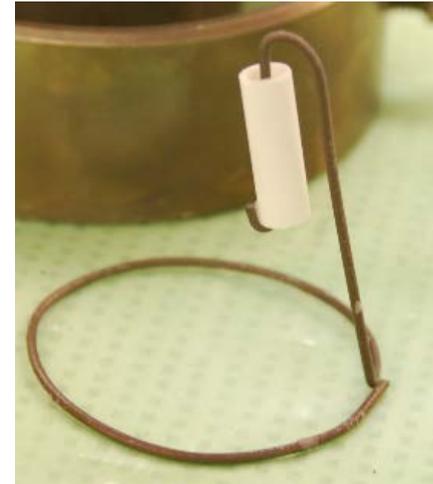
Particulate deposition visible on vessel dip tubes
