Environmental Sciences Laboratory

Assessment of Potential Gold King Mine Release Impacts to Durango, Colorado and Shiprock, New Mexico LM UMTRCA Sites

April 2017

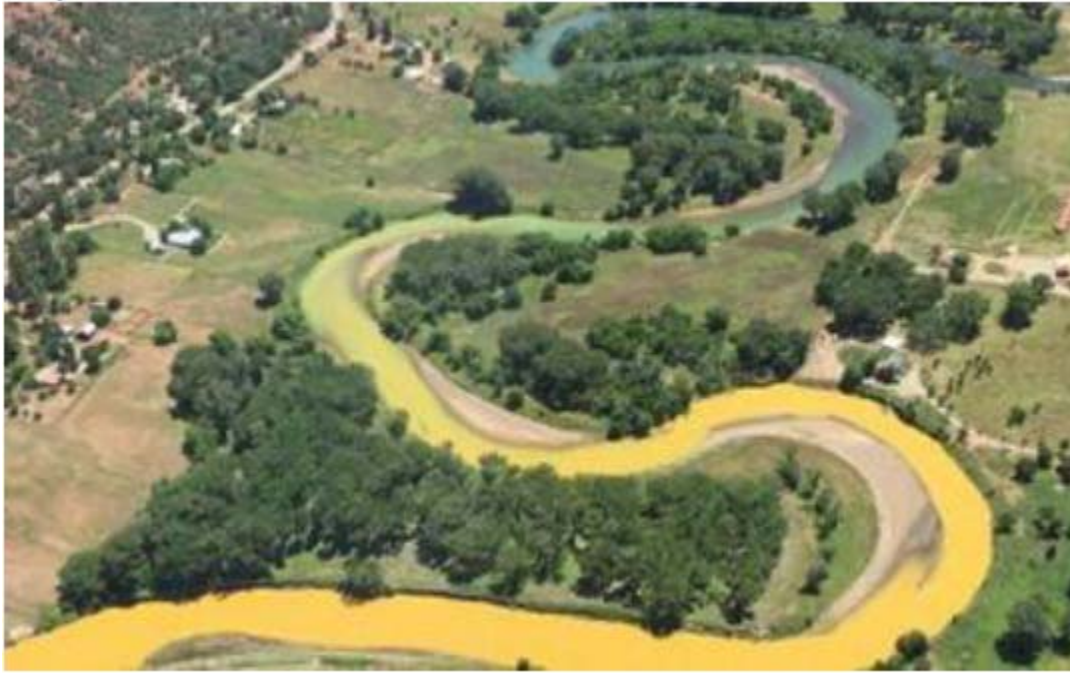
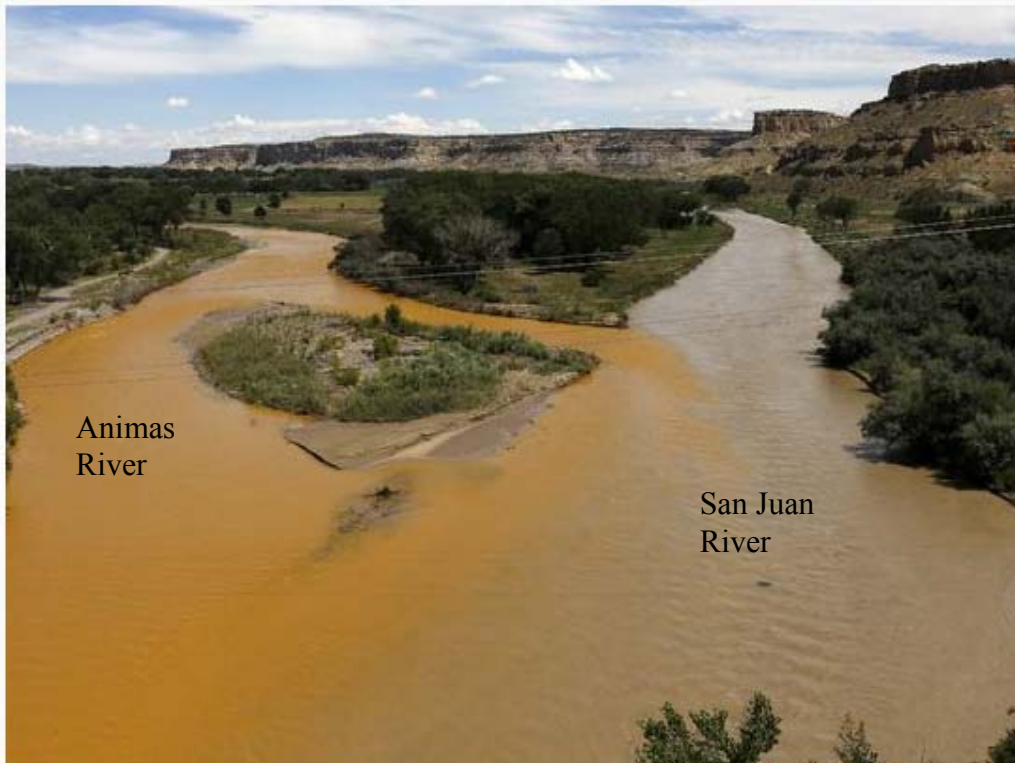
*Figure 2. Photographs of Gold King Mine Plume in Animas River
(a) North of Durango and (b) at Animas River–San Juan River Confluence*

(a) Flyover view of Animas River segment approximately 10 miles north of Durango processing site, August 6, 2015 (view to south). *Source:* EPA 2017, Figure 4-13B (Bruce Gordon EcoFlight).

(b) Animas River and San Juan River confluence at Farmington, NM, August 8, 2015 (view to east). *Photo courtesy of The (Farmington, N.M.) Daily Times.*

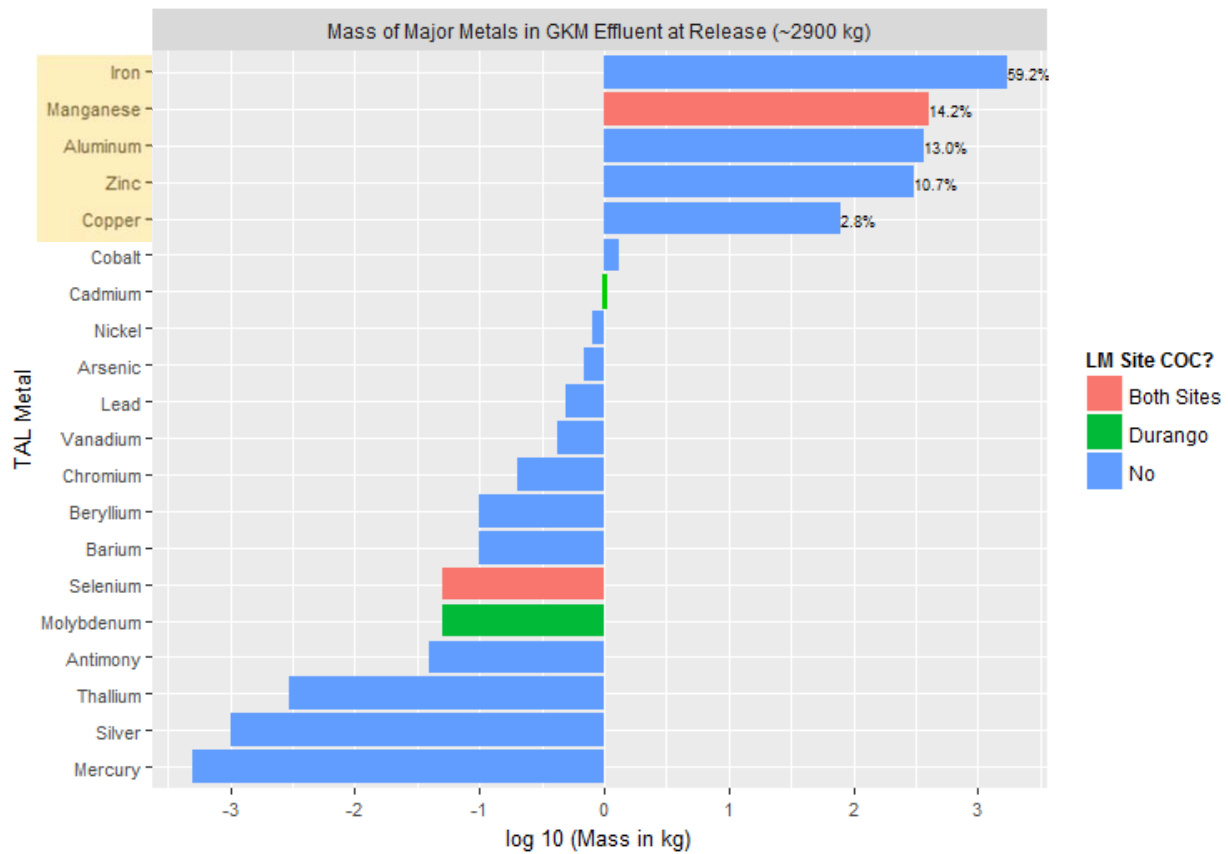
Figure 4. Masses of Major and Trace Metals in GKM Effluent Release

In this figure, metals are listed in order of descending contribution to the total mass load based on the chemical makeup measured at the mine. A log scale is used to better show relative contributions of trace metals.

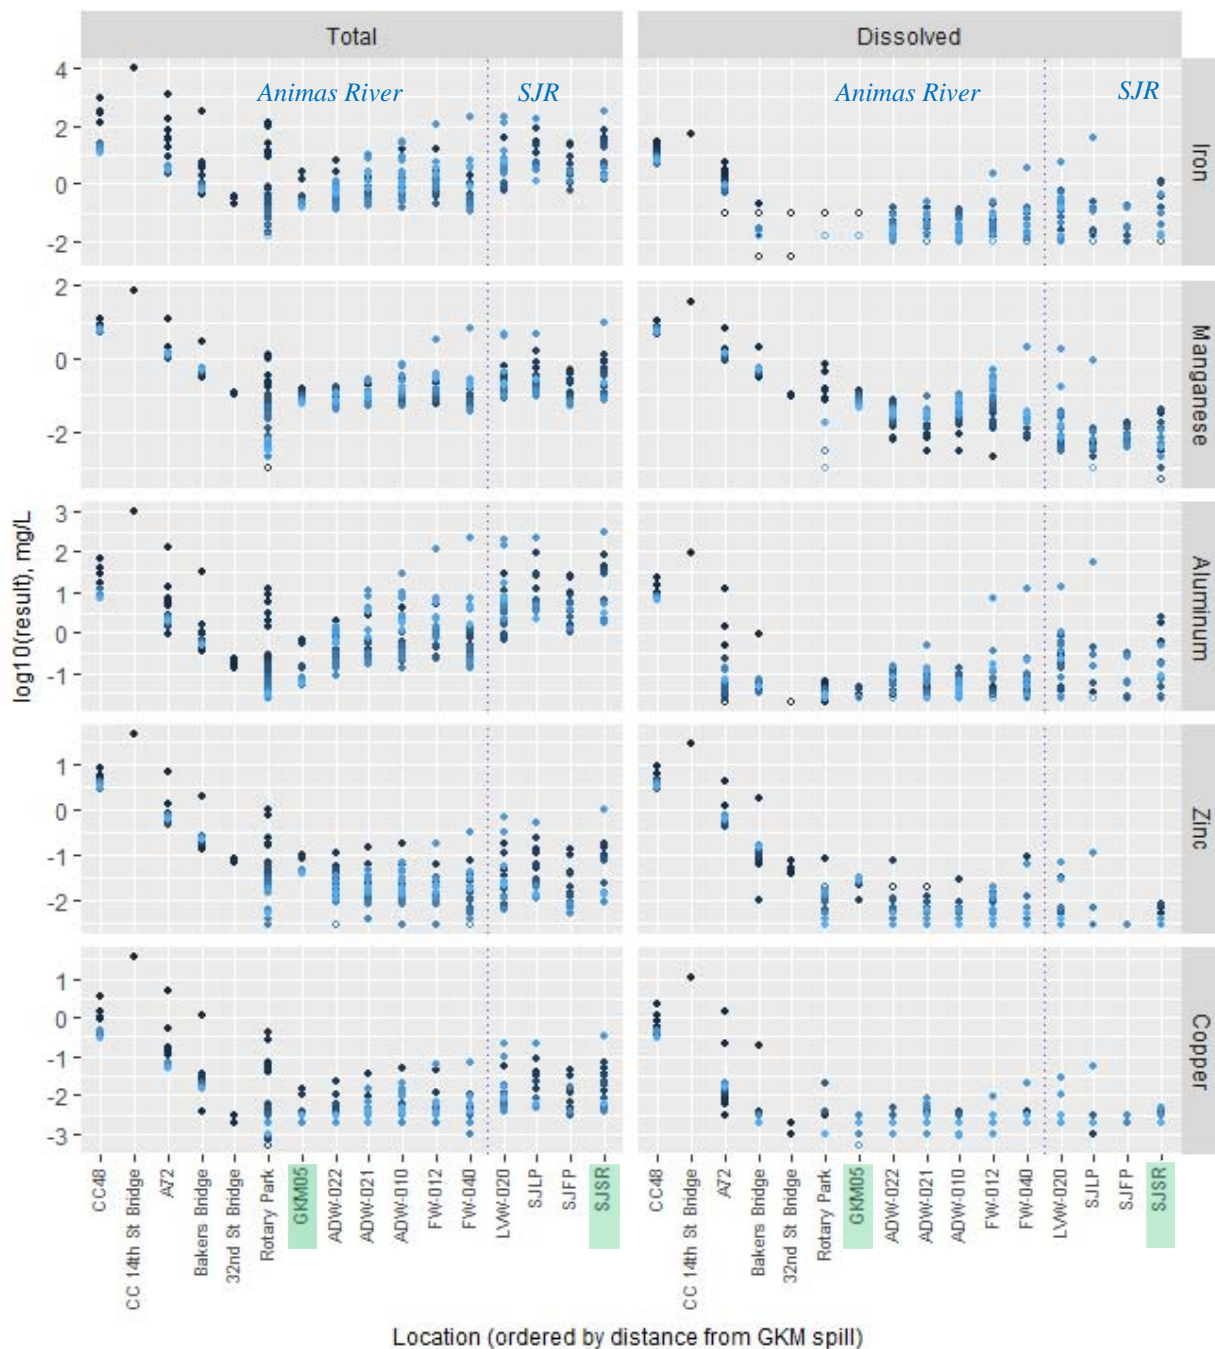
Figure 6. Major GKM Metals in Animas and San Juan River Surface Water Samples, August 2015

: Vertical dotted line denotes change in drainage, from the Animas to the San Juan River (SJR).

As noted for Figure 6, in some cases results overlap, masking the number of data points collected. For example, except for locations closest to the GKM site, most results for mercury were reported as below the detection limit.

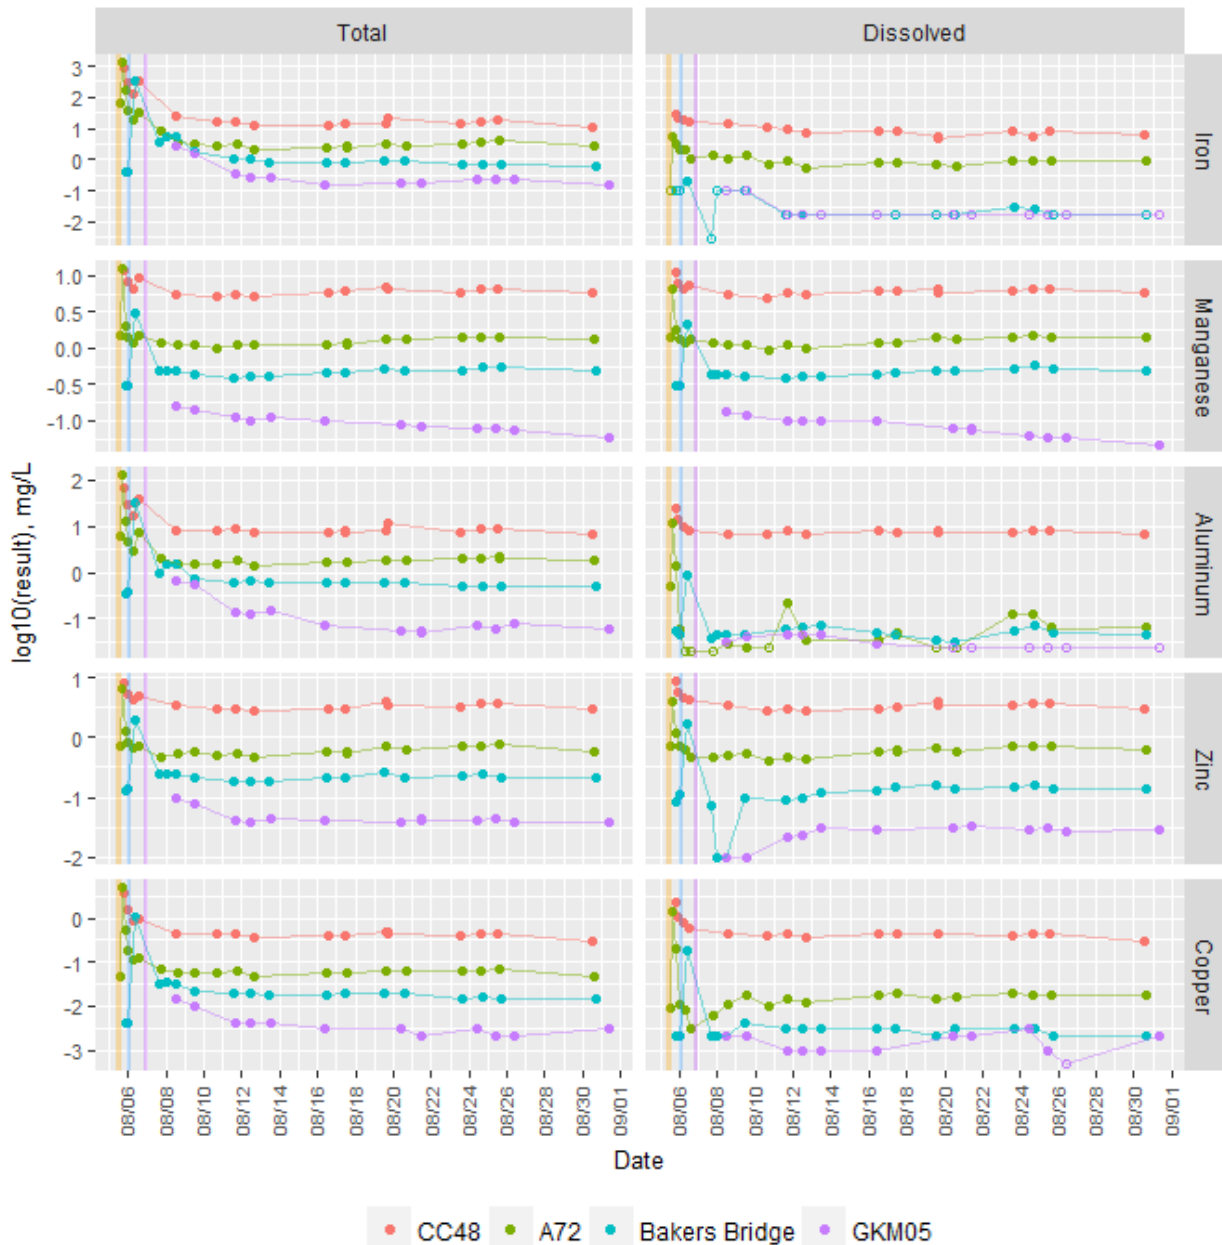
Figure 7. Concentrations of Primary GKM Metals in Surface Water at Select Animas River Locations, August 2015

In the legend, locations are listed in order of distance, or river miles (mi), downstream of GKM (Figure 3): CC48, Cement Creek (8 mi); A72 below Silverton (10 mi); Bakers Bridge (40 mi); and GKM05 in Durango (~60 mi).
 | First vertical line denotes August 5, 2015, ~11:00 a.m. GKM release; plume arrived at A72 by ~1:00 p.m.
 | Second vertical line denotes estimated plume arrival time at Bakers Bridge, ~2 a.m. on August 6, 2015 (EPA 2017).
 | Third vertical line denotes plume arrival time at Rotary Park in Durango, ~10 p.m. on August 6, 2015, as observed by MSI (MSI 2016a, 2016b).

In contrast to the marked differences in GKM metal magnitude shown in Figure 7 for locations in or north of Durango, temporal patterns and concentration magnitudes are very similar for the subset of samples shown in Figure 26. The most notable trend apparent in this figure is the concomitant spike in total and dissolved concentrations on August 27, coinciding with a rain event (Figure 25). This was also noted by BOR in its assessment of San Juan River quality before, during, and after the GKM release (BOR 2016).

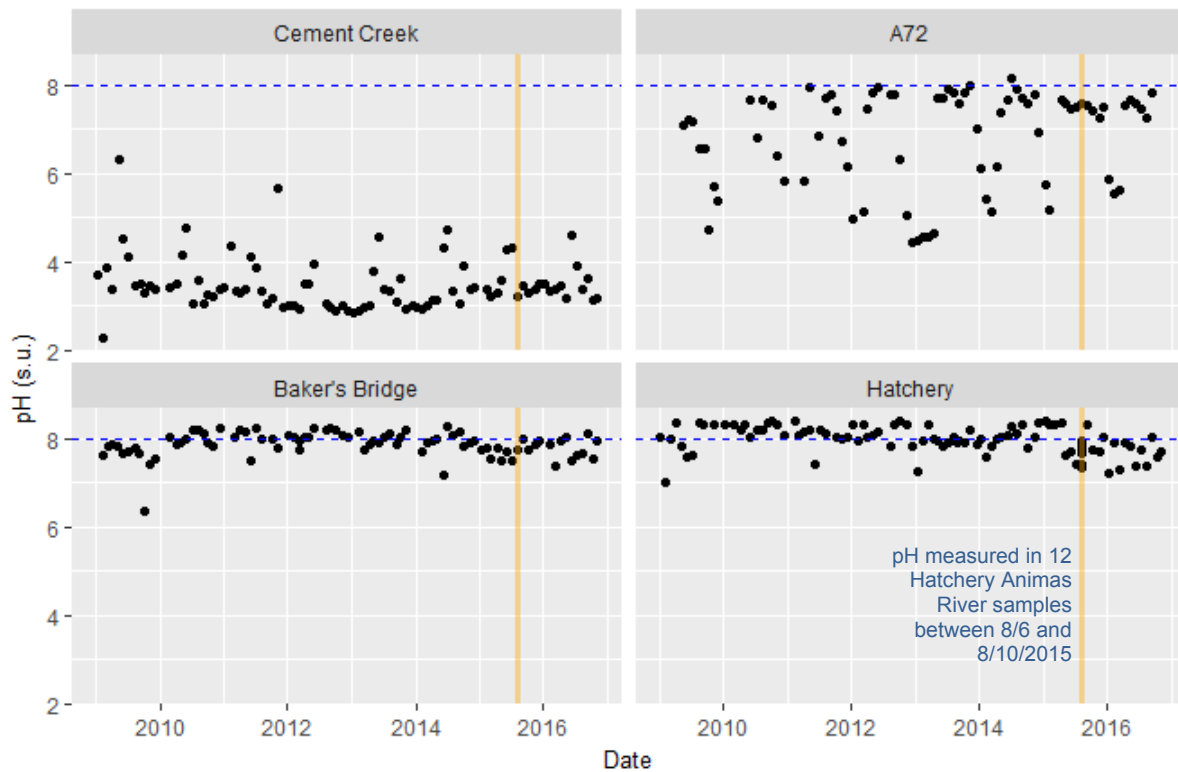
Figure 9. pH in Cement Creek and Animas River at Select Locations, 2009–2016

Source: River Watch (2016).

As discussed in Section 2.2.1, pH—a historical indicator of AMD—was not measured in samples collected during EPA’s emergency response monitoring. To evaluate the differences in water quality found in the region, we relied on data from MSI and River Watch (details provided in Table 3). Figure 9 plots pH for the period 2009–2016 for four locations that have been regularly monitored by these organizations: Cement Creek, A72 below Silverton, Bakers Bridge (about 40 miles south of GKM), and the Hatchery, just north of Rotary Park in Durango (Figure 3). Although this plot is not useful for identifying changes in pH during the release (River Watch collects samples monthly), it does illustrate the degraded water quality, with pH averaging about 3.5–4, that characterizes the Cement Creek drainage, reflecting natural acid rock drainage that has been exacerbated by mining. The variable pH found at location A72 is influenced by changes in flows (e.g., spring runoff) and mixing from Cement Creek, the upper Animas River, and Mineral Creek (with Cement Creek being the most acidic). Closer to Durango, at Bakers Bridge and the Hatchery, the pH is about 8.0, typical of non-AMD impacted stream conditions.

The primary conclusion to be drawn based on the data shown in Figure 9 and Figure 10 is that although short-term GKM plume impacts in the watershed are apparent (as evidenced by spikes coinciding with the release), water quality is degraded in the headwaters in this region, likely the combined effect of historical mining and naturally occurring mineralization.

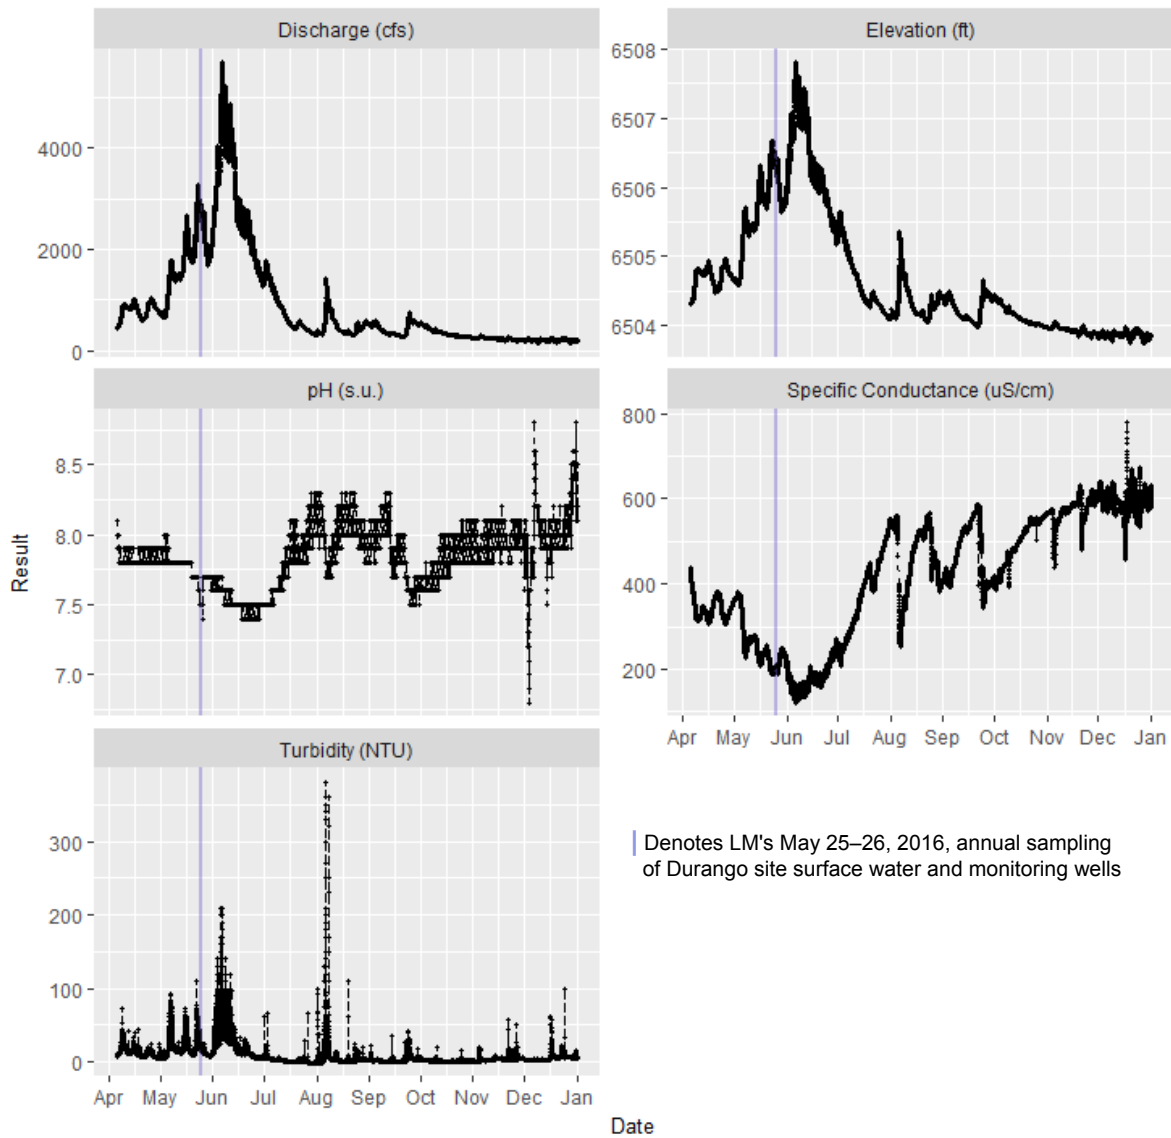
Figure 16. 15-Minute Measurements of River Flows, Elevation, and Field Parameters at Durango USGS Gage 09361500: April 5, 2016, through December 31, 2016

This figure plots all data for the Durango USGS gage since instantaneous measurements of pH, specific conductance (SC), and turbidity began on April 5, 2016. Corresponding data for discharge and elevation are also shown (these parameters have been measured since 2007).

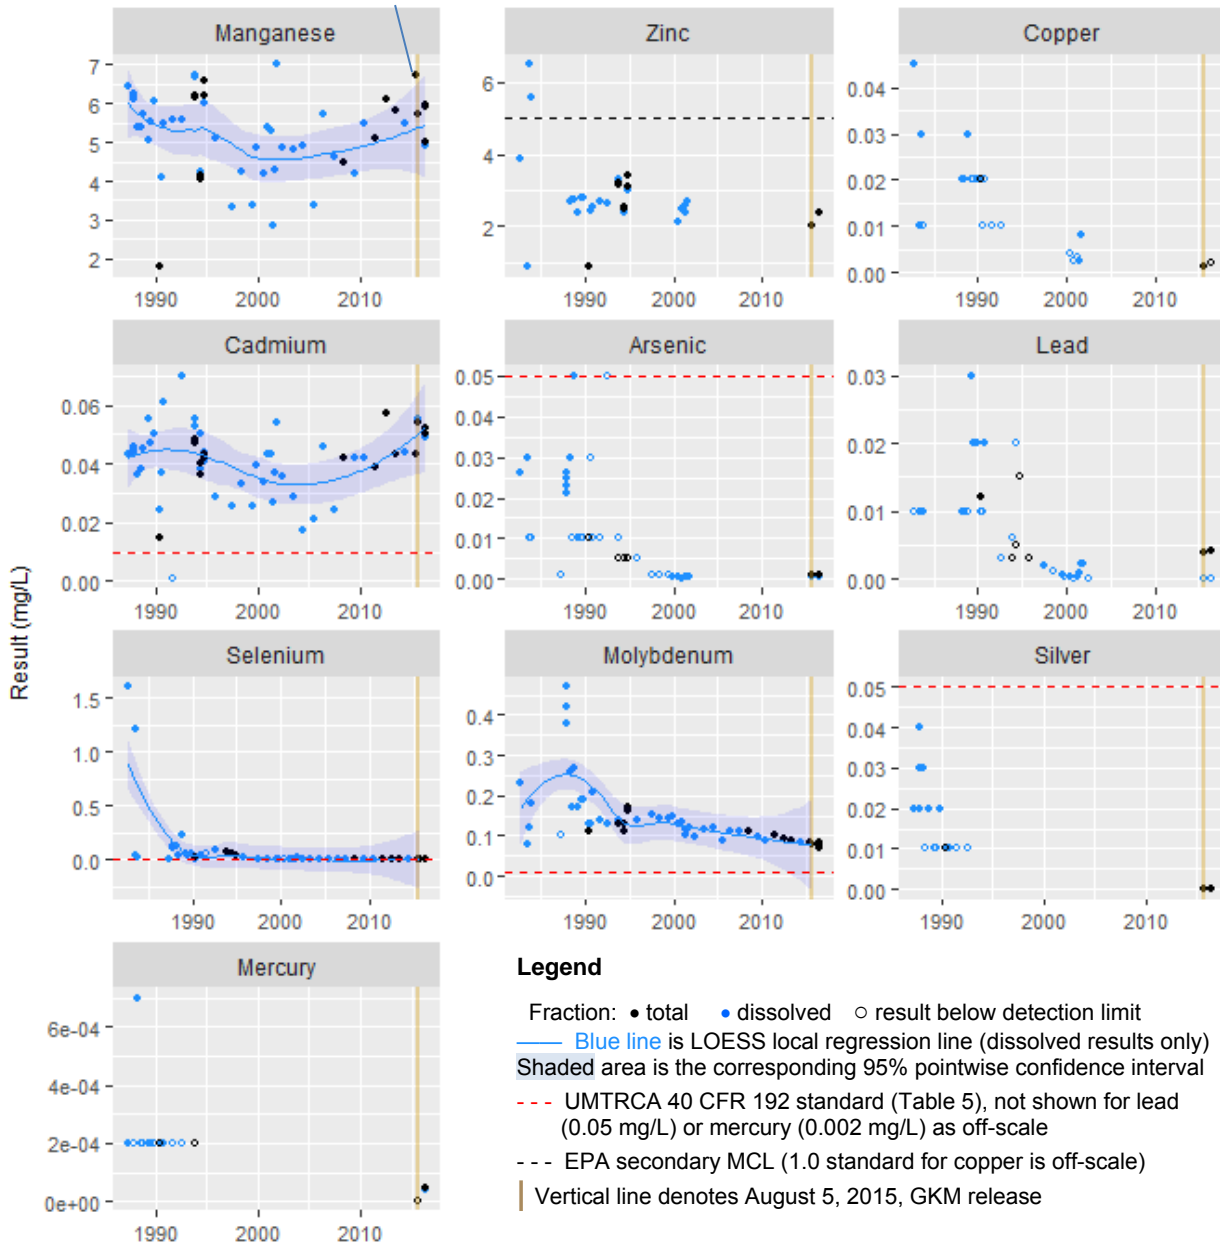
Figure 20. Historical Metals Concentrations in Durango Mill Tailings Site Well 0612

Note:
Smoothing (regression) line only applied to those well-parameter combinations where there are sufficient data for trending.

Figure 20 plots historical results for the suite of metals analyzed for the August 2015 nonroutine sampling event in well 0612. Corresponding UMTRCA groundwater standards are also shown or noted for comparison. No deviation in concentration trends is apparent for the post-GKM (August 2015) and subsequent (June 2016) annual sampling event. For manganese, the constituent most likely to be indicative of GKM plume impacts, the only recent apparent deviation corresponded to the June 2015 sampling event, a high runoff period that preceded the release.

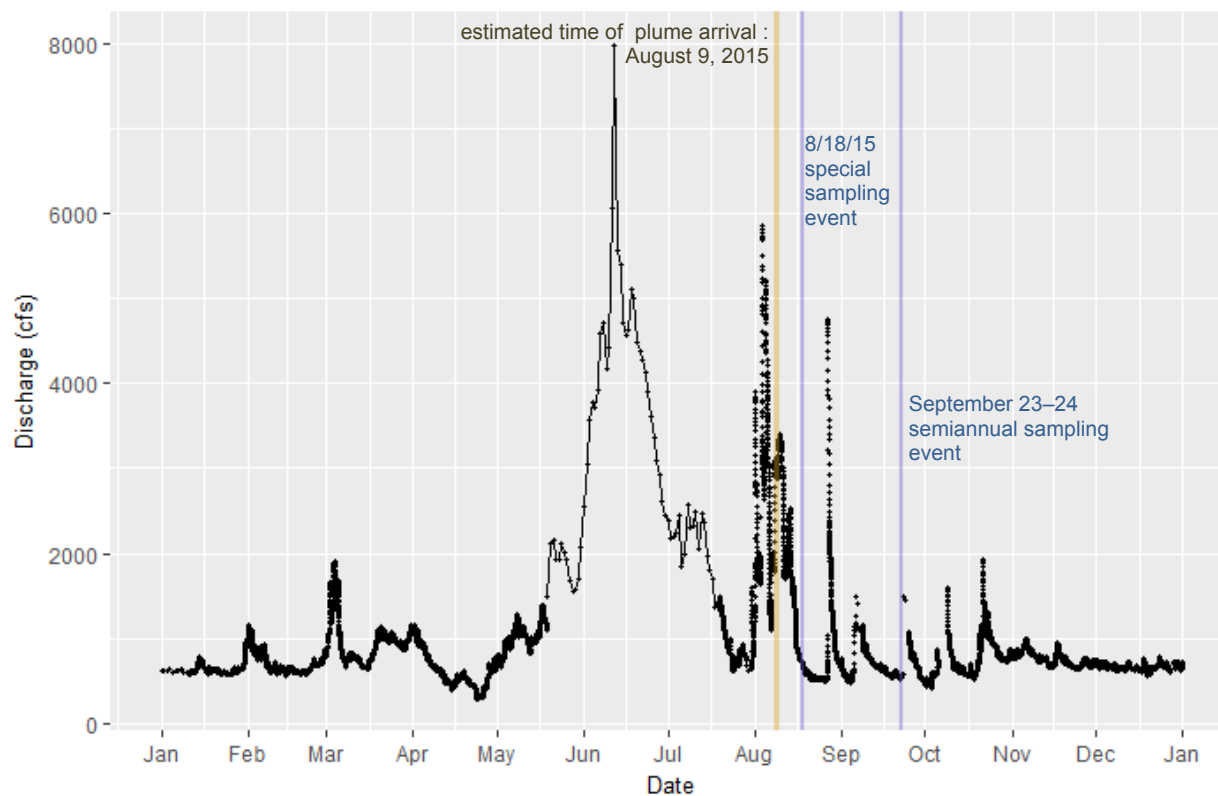
Figure 24. Streamflows in San Juan River at Shiprock USGS Gage 09368000, Year 2015

Vertical line denotes estimated time of GKM plume arrival at Shiprock (early a.m., August 9, 2015)
Denotes LM sampling events: the August 18, 2015, post-GKM nonroutine sampling, and September 2015 semiannual routine monitoring

Figure 24 shows the discharge measured at the Shiprock (09368000) river gage in 2015. Similar to what was shown for Animas River flows at Durango (Figure 12), this figure illustrates the wide range in flows that occur in a given year. During the high-flow period associated with snowmelt runoff in June–July, San Juan River discharge approached 8000 cfs. Subsequent peaks likely reflect monsoonal storms characteristic of this region, which typically occur in the late summer or fall.

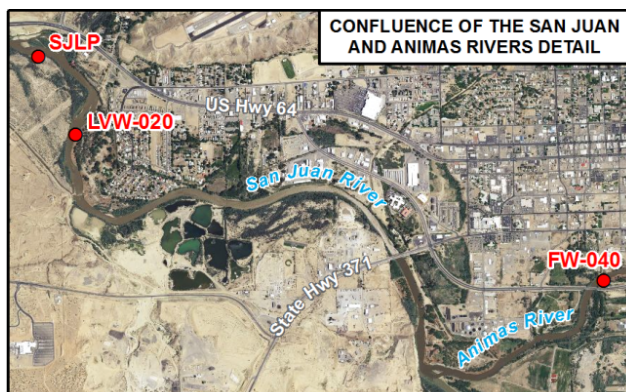
As a first step in framing the analysis of potential GKM impacts at the Shiprock site, LM first reviewed EPA's emergency sampling data for the five locations listed below. Because relative locations of the first three stations near the Animas–San Juan rivers confluence are not readily apparent in Figure 3, the associated graphic (inset below) provides greater detail.

- FW-040, Animas River north of the San Juan River confluence (see inset)
- LVW-020, San Juan River downstream of confluence¹⁰
- SJLP, about 30 miles upriver from Shiprock
- SJFP, San Juan River near Kirtland (Figure 3)¹⁰
- SJSR, San Juan River near Shiprock (Figure 23)

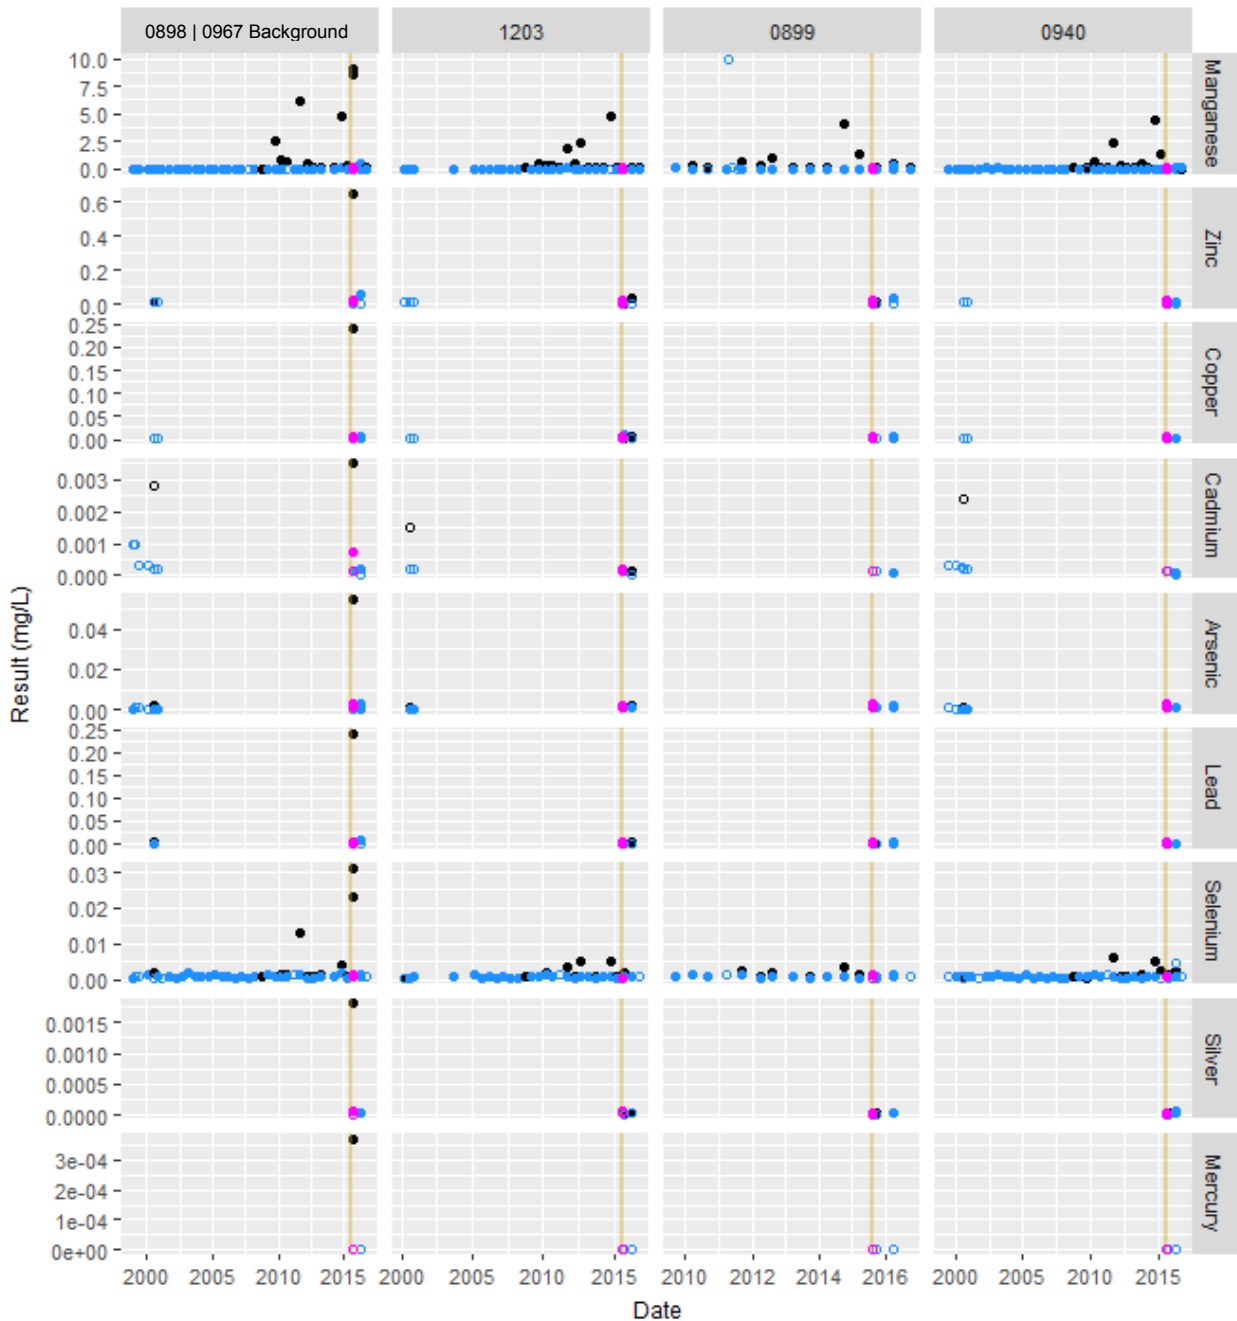
Figure 28. Historical Metals Concentrations in Shiprock Site Surface Water Samples

| Vertical line denotes August 5, 2015, GKM release

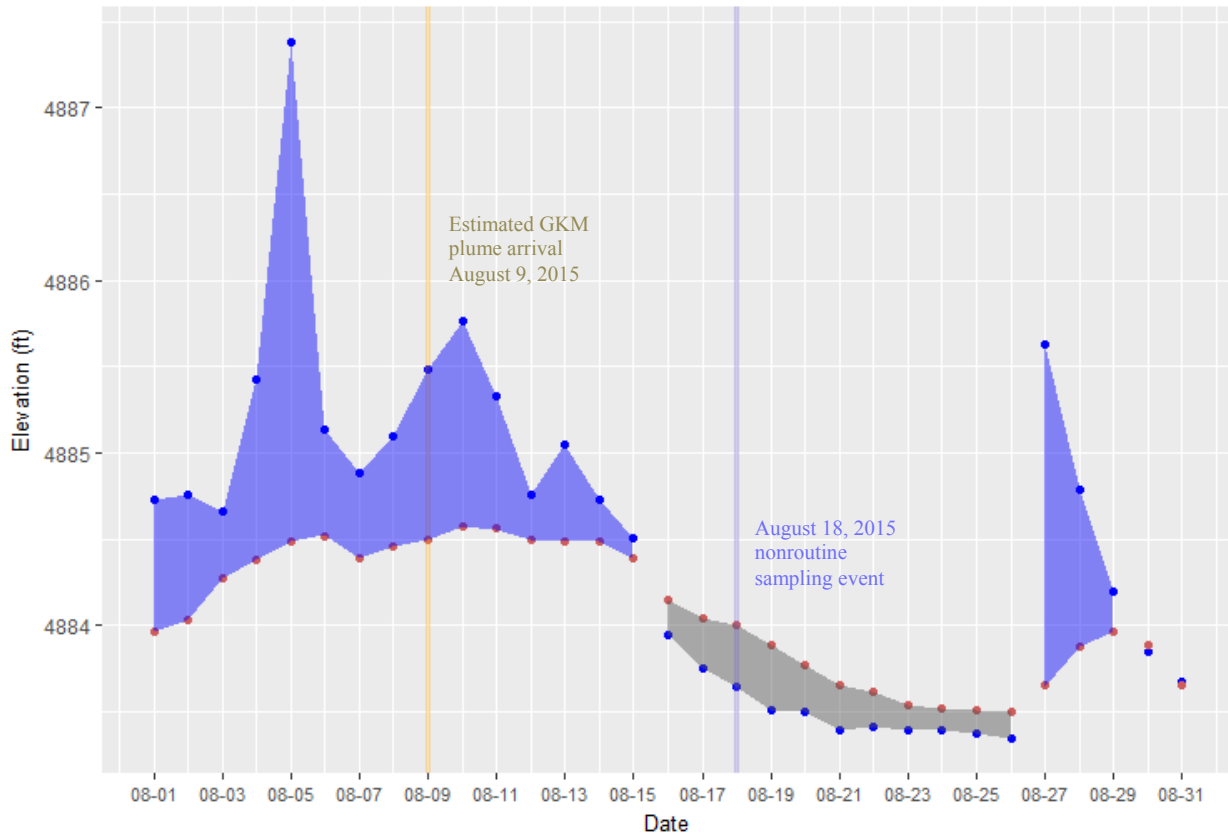
Figure 34. Zoom View of San Juan River vs. Well 0857 Groundwater Elevations, August 2015

- San Juan River elevation at USGS gage 09368000 • Groundwater elevation in near-river well 0857
- Period when groundwater is gaining from San Juan River
- Period when groundwater is losing to the San Juan River
- | Denotes estimated time of GKM plume arrival, August 9, 2015, 0:00
- | Denotes LM's August 18, 2015, nonroutine sampling event

At the time of estimated plume arrival at Shiprock, there was an approximate 1 ft gradient from the river to the floodplain in the region of well 0857 (August 2015 zoom view provided in Figure 34). So, there was the potential for the alluvial aquifer to draw river water, possibly including dissolved metals, during the time the GKM release plume passed. These (aquifer) gaining conditions were sustained for about a week, followed by an approximate 10-day period when the aquifer was losing to the river near the gaging station. LM’s nonroutine sampling took place at that time (i.e., under losing conditions). These conditions probably apply to all near-river wells evaluated in this subset except well 0612 (see Section 5.3.3).

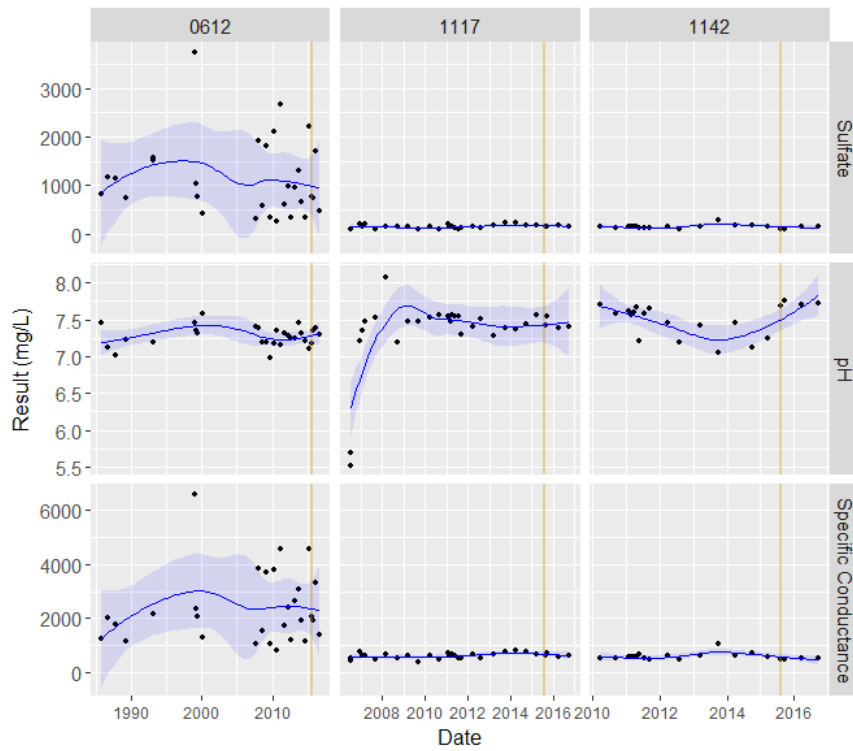
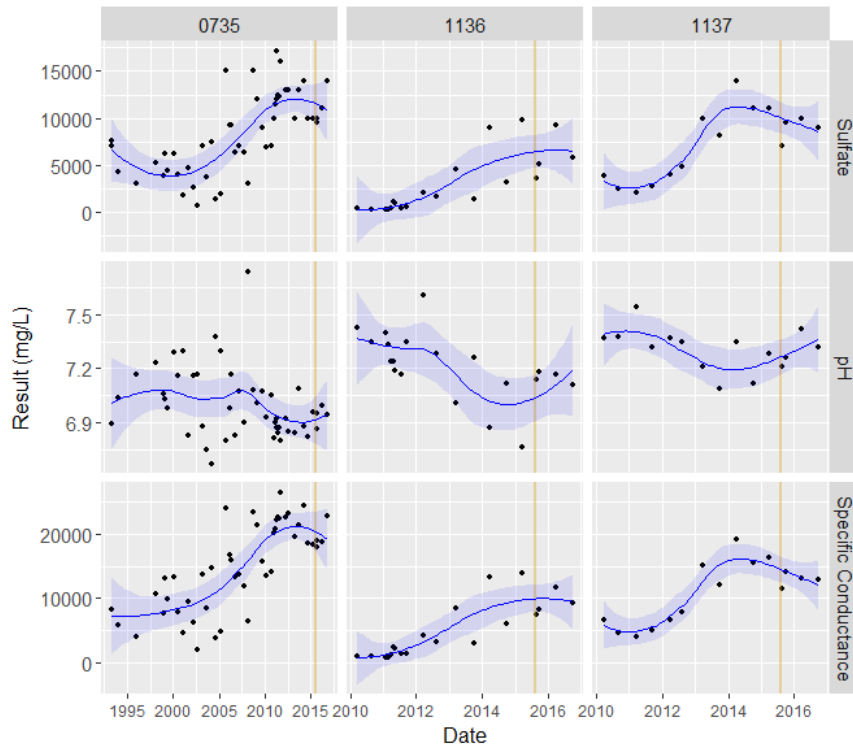
Figure 37. Historical Sulfate Concentrations and Field Measurements in Shiprock Site Wells

(a) Wells with Lower Magnitude Sulfate and SC: 0612, 1117, and 1142

(b) Wells with Higher Magnitude Sulfate and SC: 0735, 1136, and 1137
