Frozen Soil Barrier at Oak Ridge National Laboratory

Elizabeth Phillips, US Department of Energy,
Oak Ridge Office of Environmental Management
Tritium Focus Group Meeting, May 2018

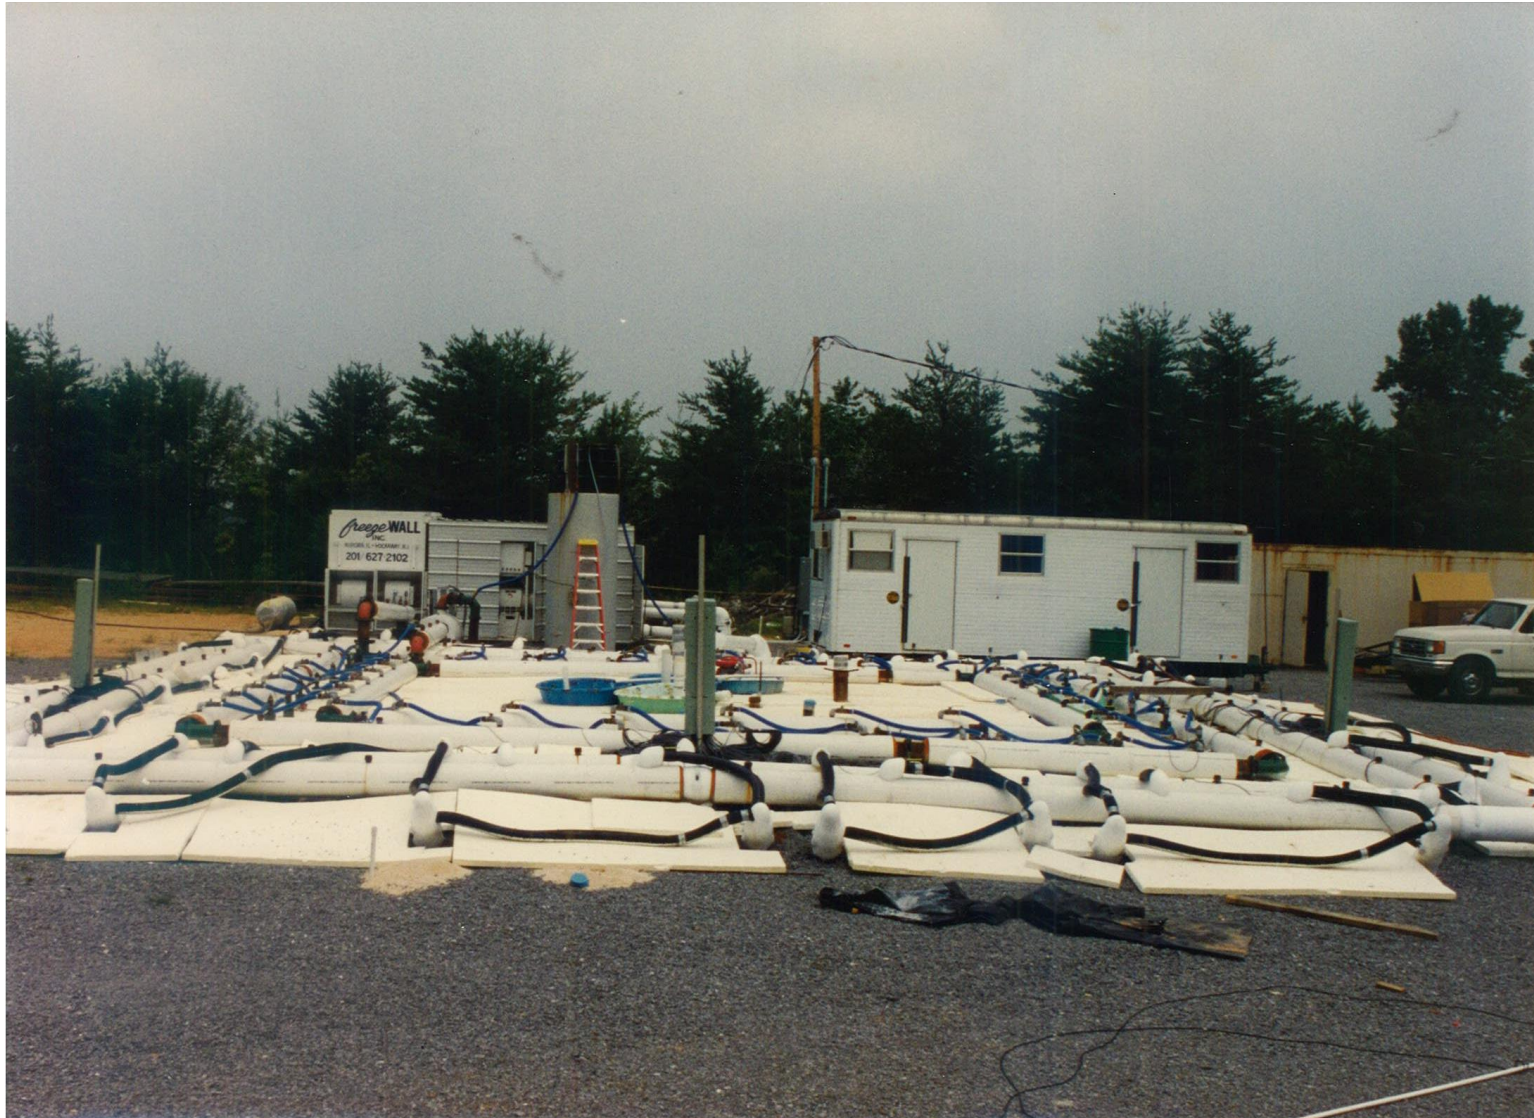
This image depicts a typical brine system surface configuration

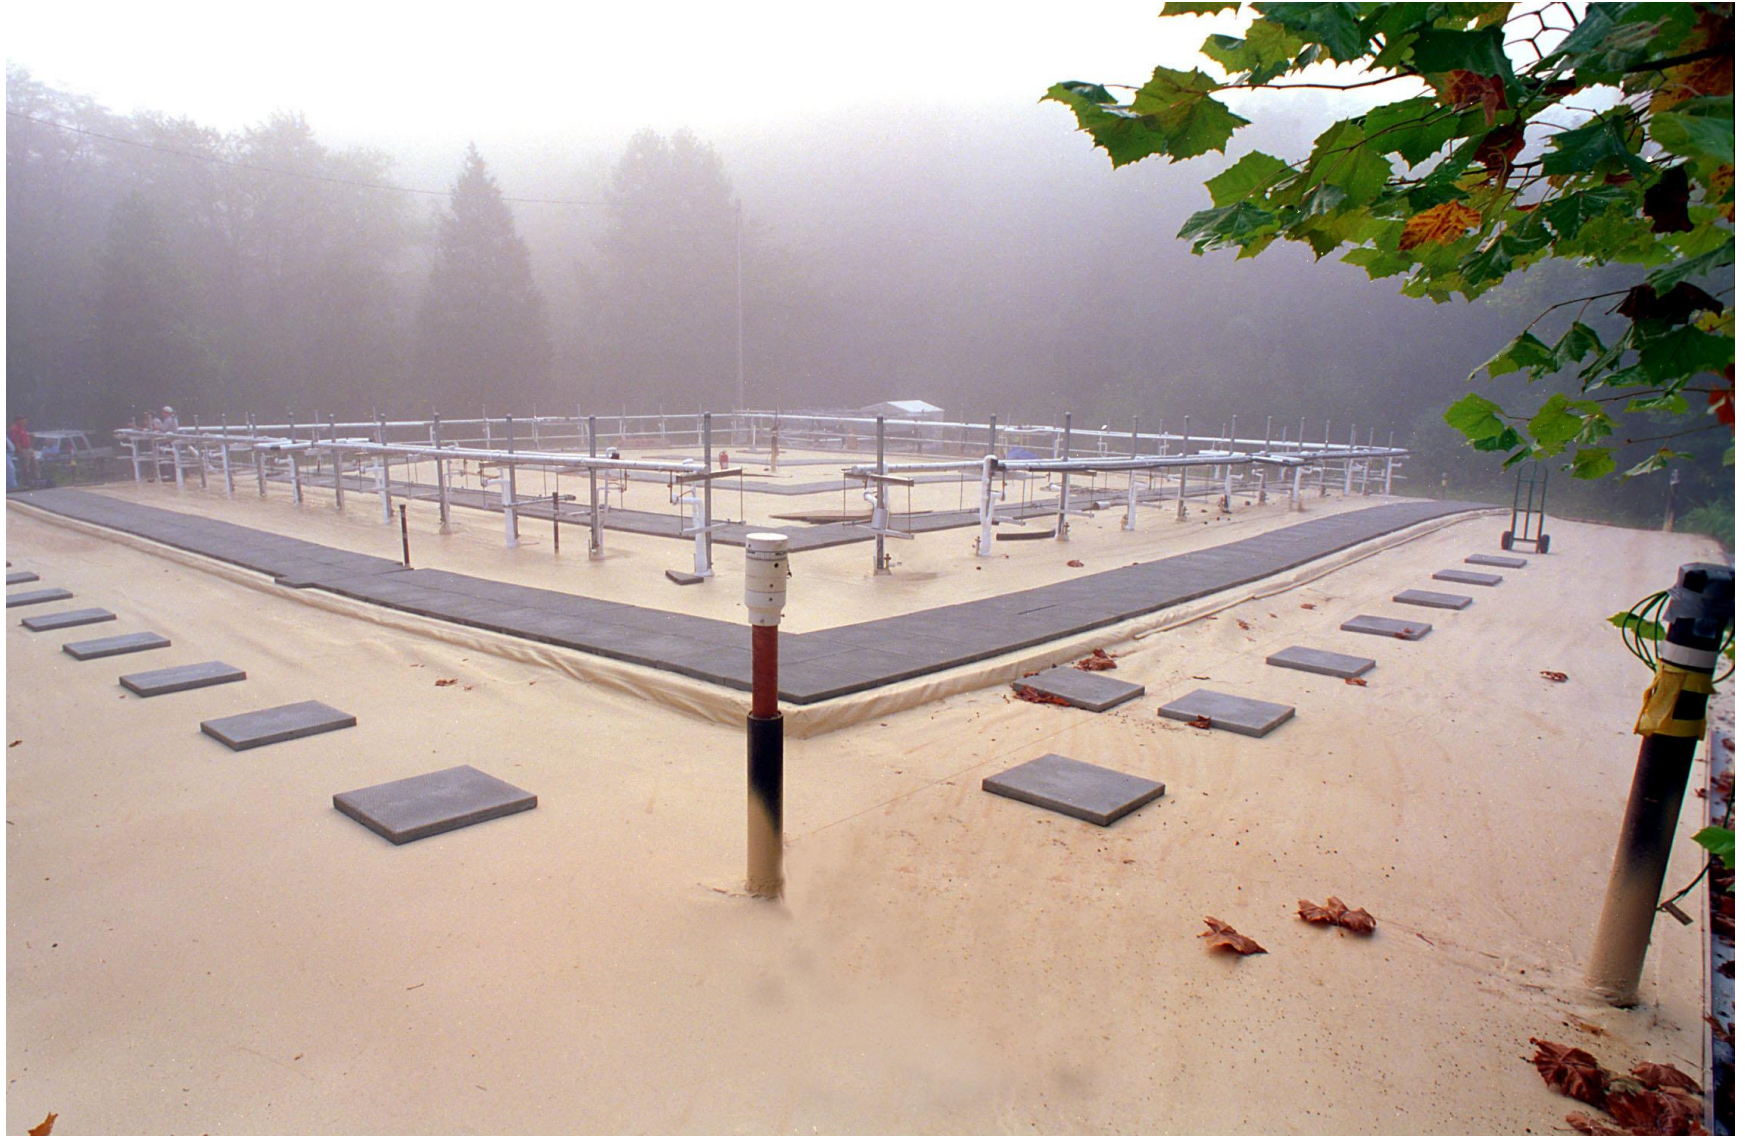
The ORNL completed barrier - facing south

The barrier was formed to the planned design

- A 25 x 27 meter box was formed around the pond.
- An insulated cover and sprayed on poly-urea membrane covered the box.
- When the soil reached 0 degrees C, frozen pore water creates the barrier and for this design it was to be a 4 meter thick barrier.

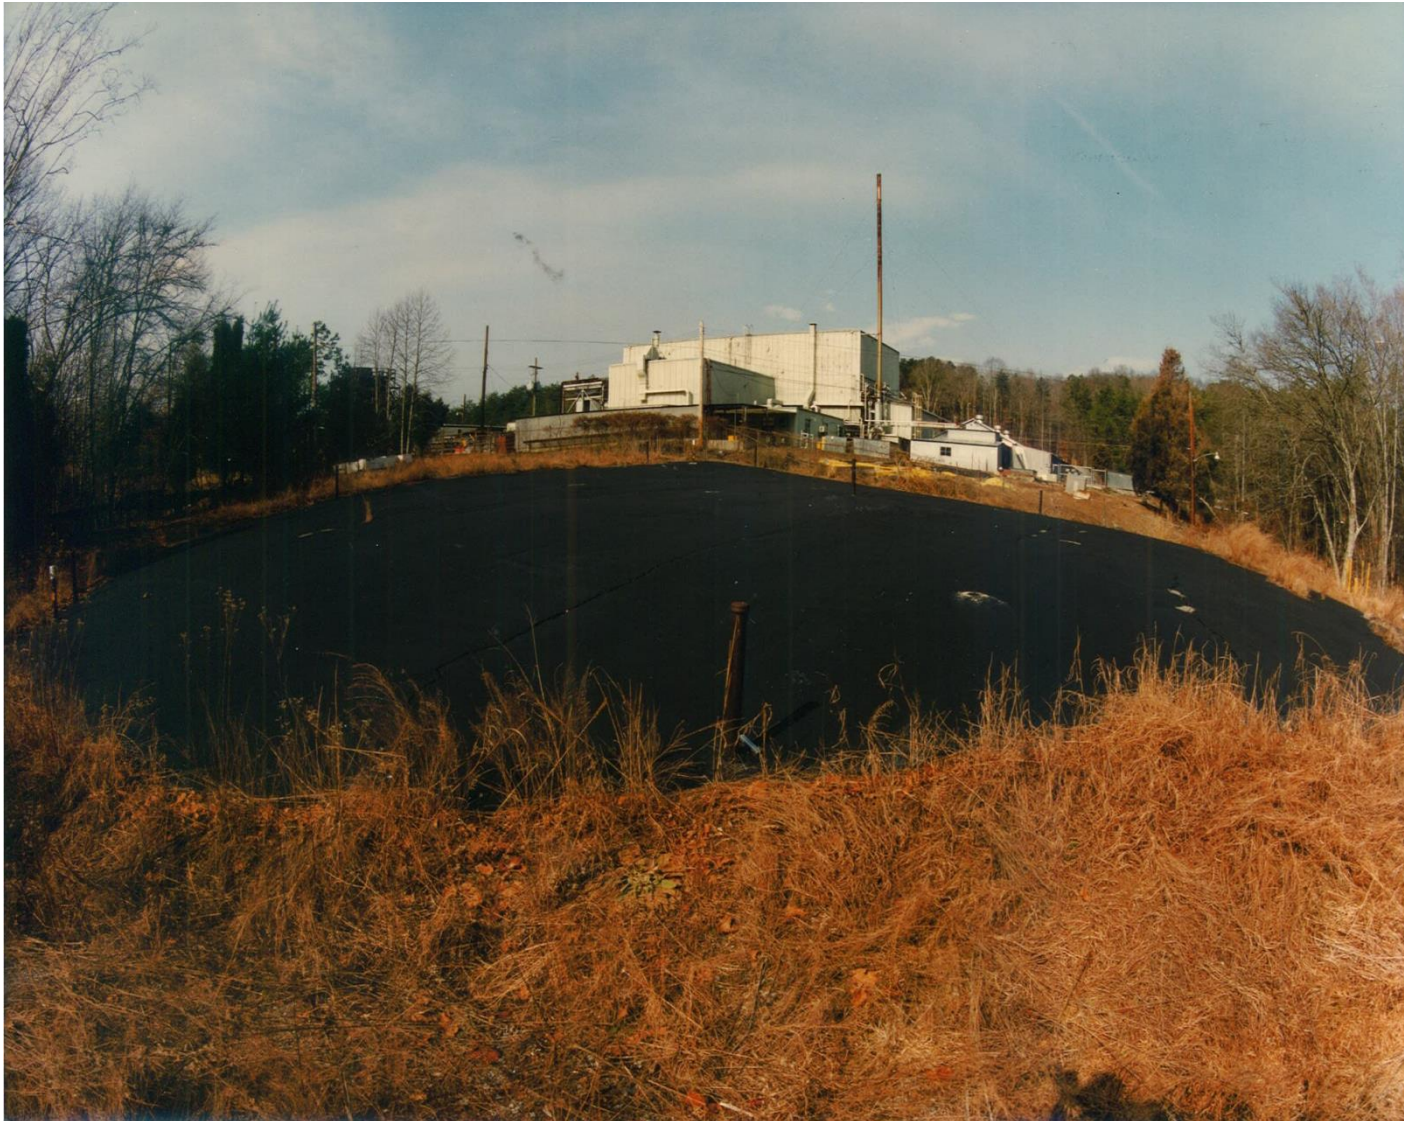
The HRE Pond was chosen as the location for the barrier

- The HRE Pond was located in Melton Valley, south of the main ORNL complex.
- A tributary stream was receiving radioactive groundwater from the site and flowed into White Oak Lake via White Oak Creek.
- The soil is about 10 meters deep and the top of bedrock contains a permeable, weathered layer that creates a preferential flow path for groundwater.
- Water level data collected at the site from standpipes, piezometers, and wells indicated that groundwater at the site exhibits significant responsiveness to rainfall and storm events.

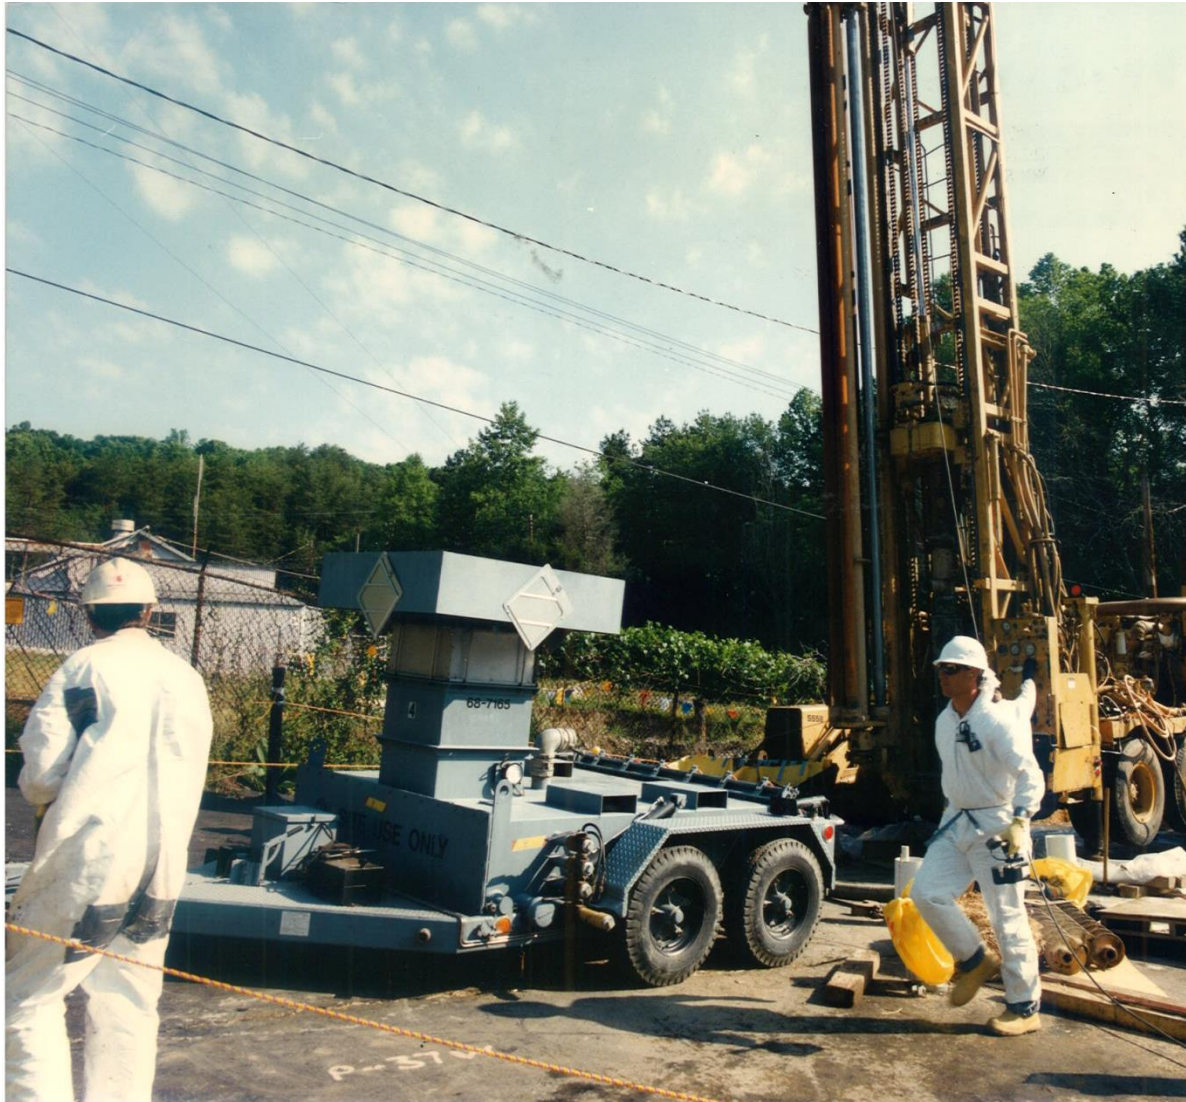
The barrier used a radioactive cuttings containment system with HEPA filter invented at ORNL

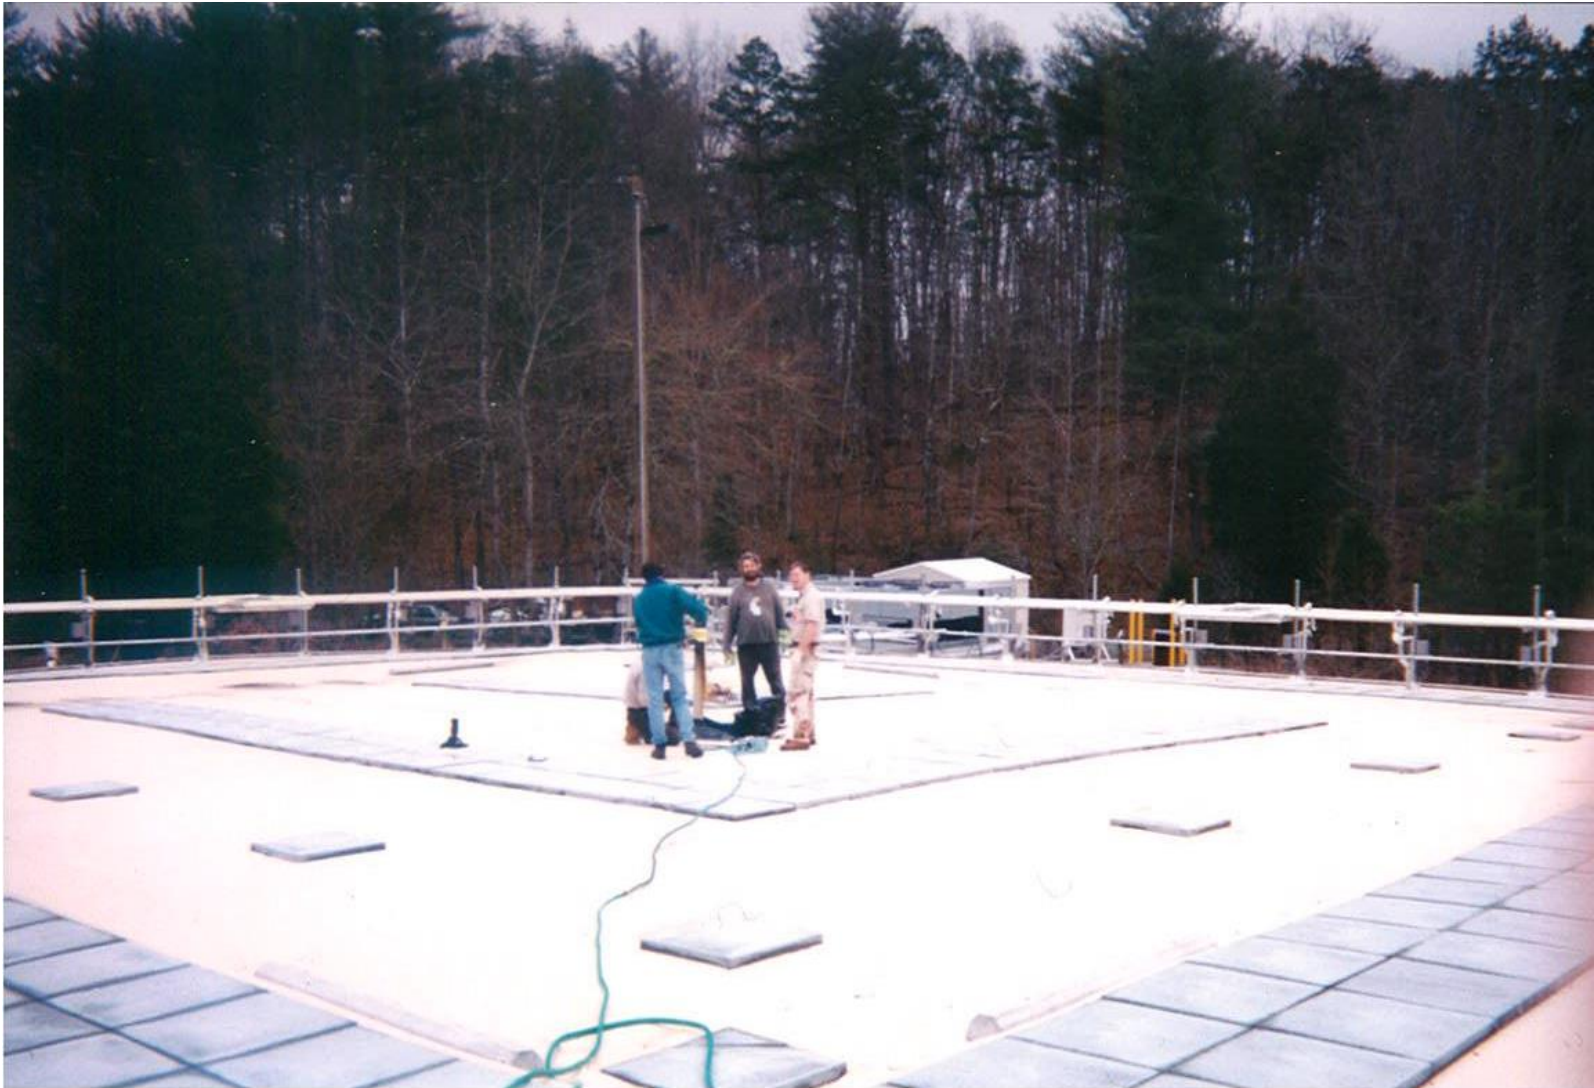
Dye was injected into the post-construction site to determine the barrier's integrity

- An 8-day simulated power outage showed no shrinkage of the barrier.
- A dye tracer test conducted outside the barrier after it was complete showed that dye was not detected inside the frozen pond area, and the zone within the frozen barrier behaved as if it were hydraulically isolated from the surrounding area.
- The barrier operated from September 1997 to 2004 and, when excavated months later, the soil was still frozen and the thermoprobes were in pristine condition.

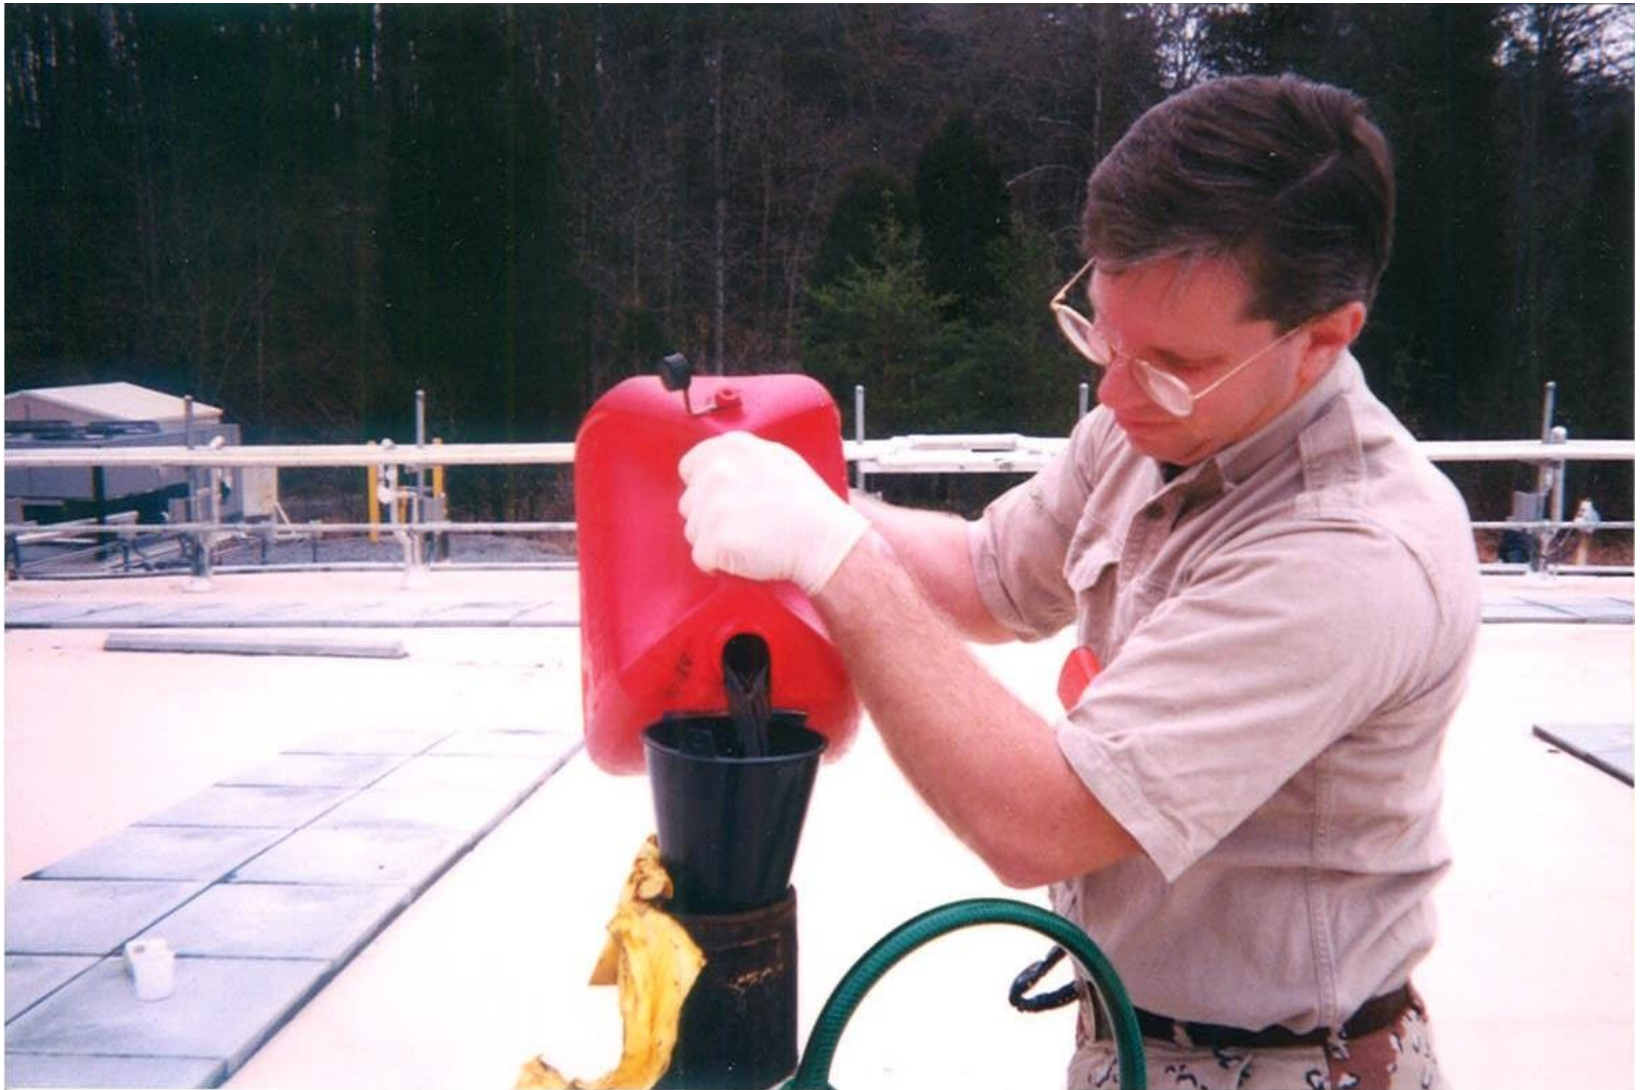
Dye was injected into the center stand pipe

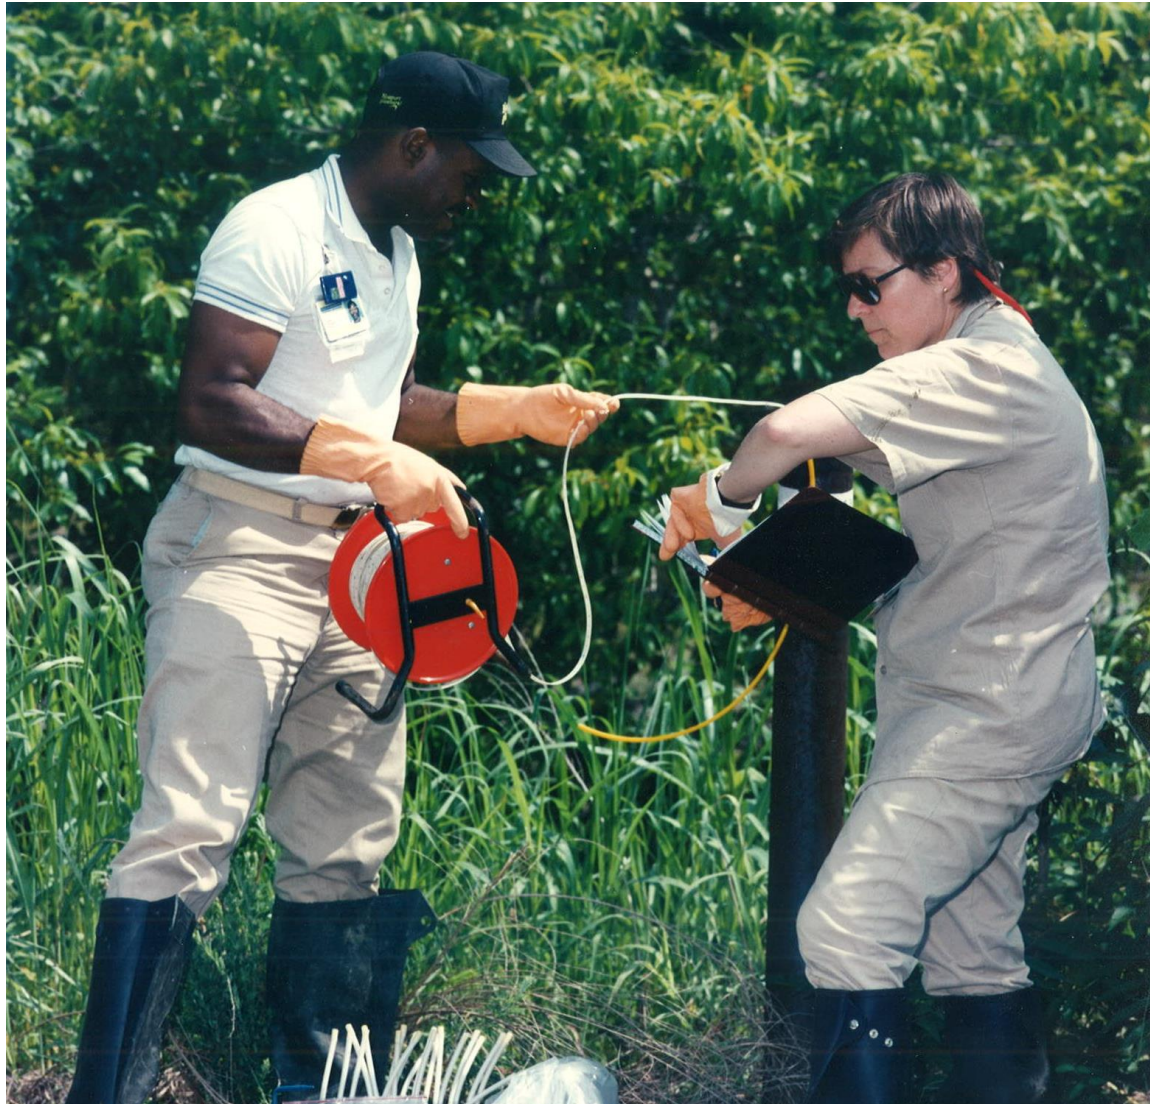
ORNL scientists measured groundwater levels

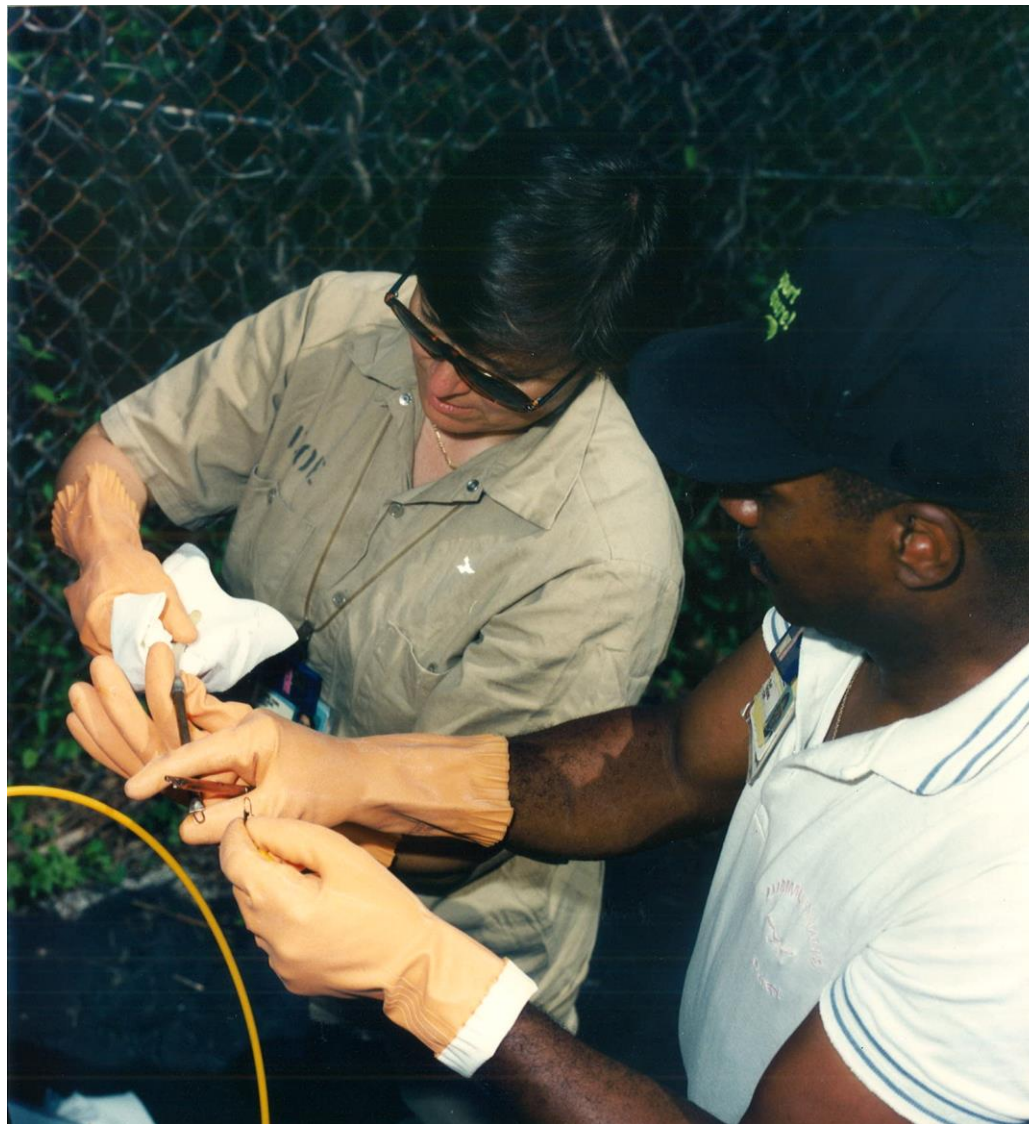
Helium sampling devices were deployed at the site

- Prior to the barrier installation groundwater flow and dye tracer studies were performed by ORNL scientists and EPA SITE scientists.
- Three types of fluorescent dye and helium gas tracers were used to verify connectivity of the pond to the wells, surface water, and springs.
- An electromagnetic geophysical survey was also conducted and detected 3 subsurface anomalies, one of which impacted the project results.
- Groundwater monitoring revealed extreme groundwater level response to storm events inside and outside the impoundment.
- Once the barrier reached its designed thickness, post barrier monitoring was initiated.

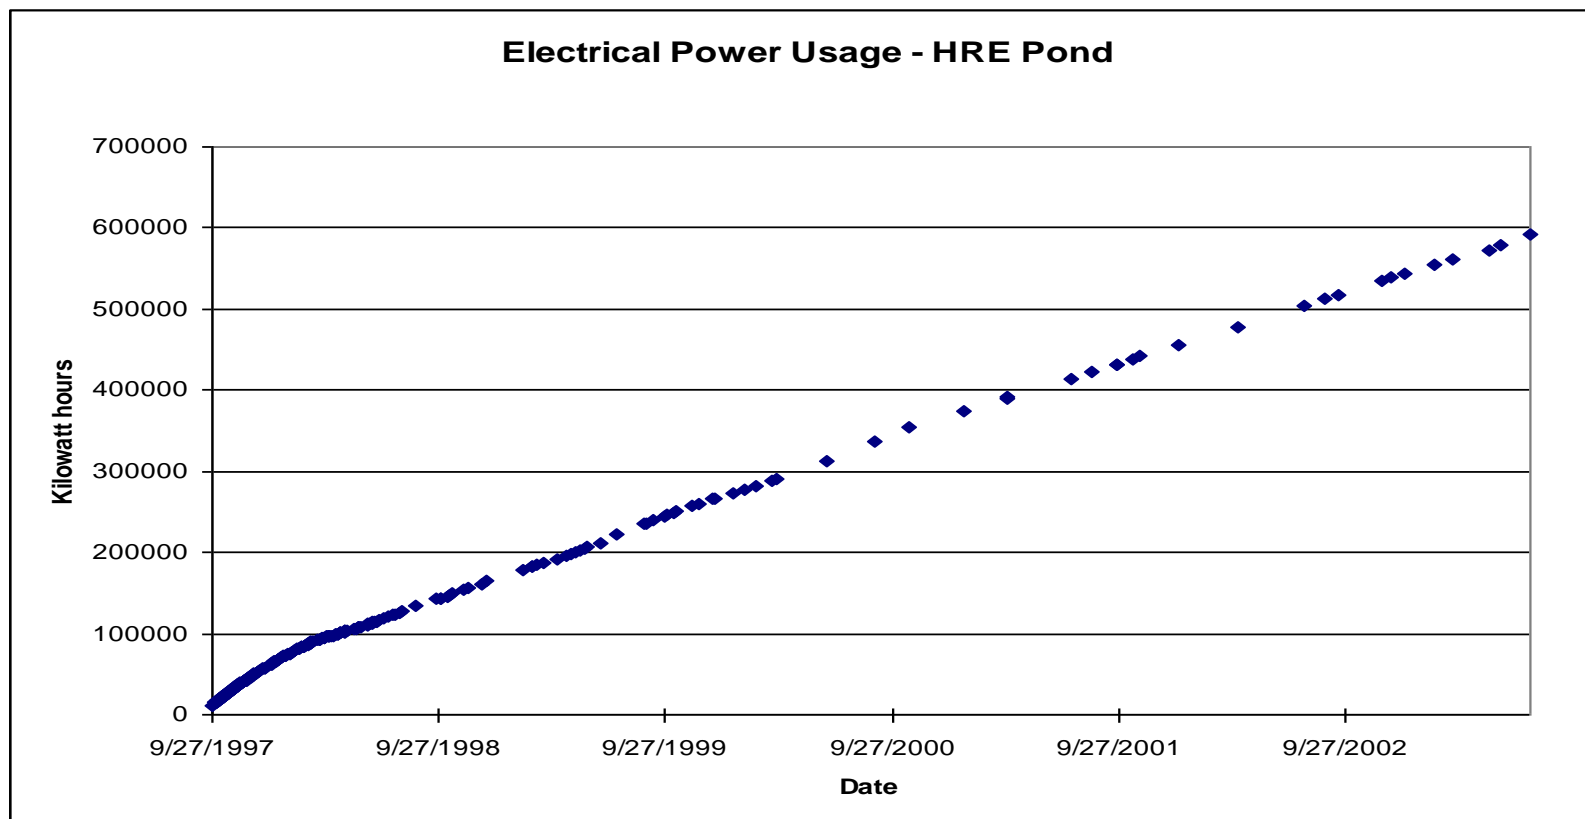
- The barrier was formed within 7 weeks and electrical usage to form the barrier was 33,000 kW hours.
- The barrier walls reached 4 meter thickness within 18 weeks and took 72,000 kW hours.
- The total volume of frozen soil was 36,000 cubic meters and the total amount of material contained inside the barrier was 56,250 cubic meters.

The Frozen Soil Barrier

Total Power Usage
