Appendix H  
Substation Geotechnical and  
Subsurface Exploration Report

# **GEOTECHNICAL AND SUBSURFACE EXPLORATION REPORT**

**FOR THE:  
PROPOSED ELECTRICAL SUBSTATION FOR THE ICEBREAKER  
OFFSHORE WIND DEMONSTRATION**

**LOCATED AT:  
CLEVELAND PUBLIC POWER SITE  
NORTH MARGINAL ROAD  
CLEVELAND, CUYAHOGA COUNTY, OHIO**

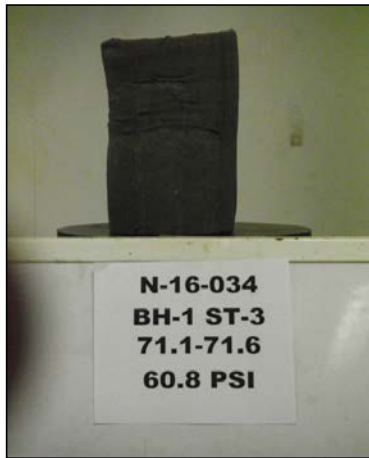
Effective Confining Stress,  $\sigma_3$ : 60.8 psi      Deviator Stress @ Failure,  $\Delta\sigma$ : 2,603 psf  
 Strain Rate: 1.00 %/min      Axial Strain @ Failure: 9.07 %  
 Major Principal Stress @ Failure,  $\sigma_1$ : 11,359 psf

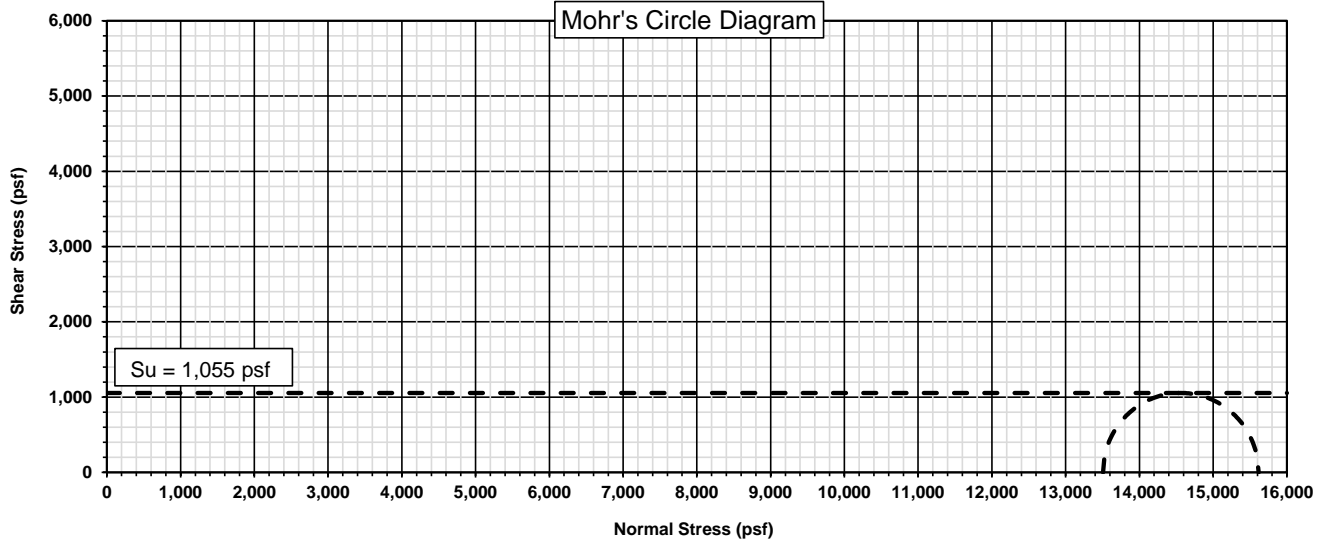
Effective Confining Stress,  $\sigma_3$ : 93.8 psi      Deviator Stress @ Failure,  $\Delta\sigma$ : 2,109 psf  
 Strain Rate: 1.00 %/min      Axial Strain @ Failure: 9.89 %  
 Major Principal Stress @ Failure,  $\sigma_1$ : 15,617 psf

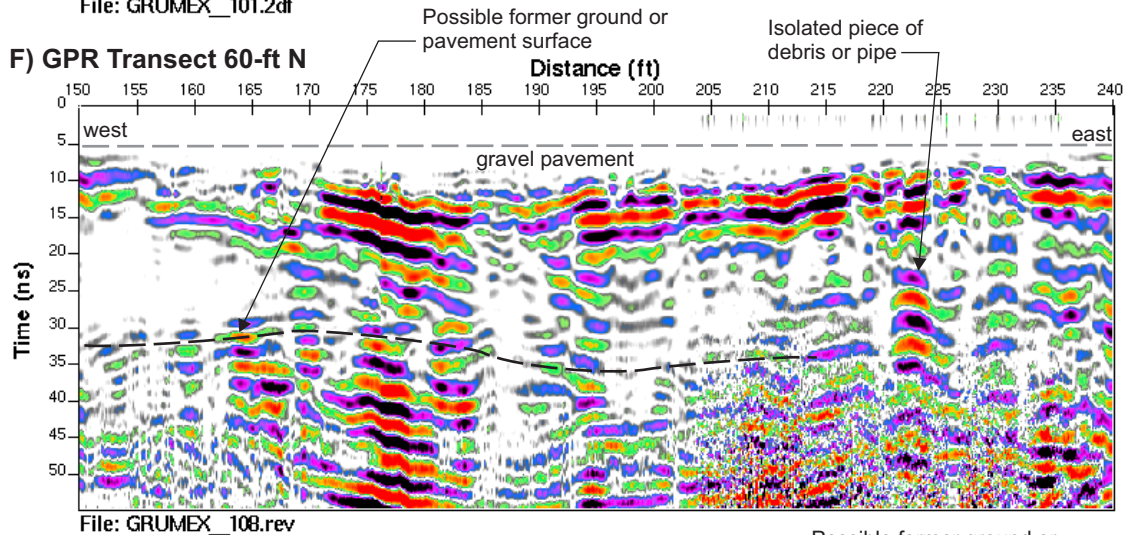
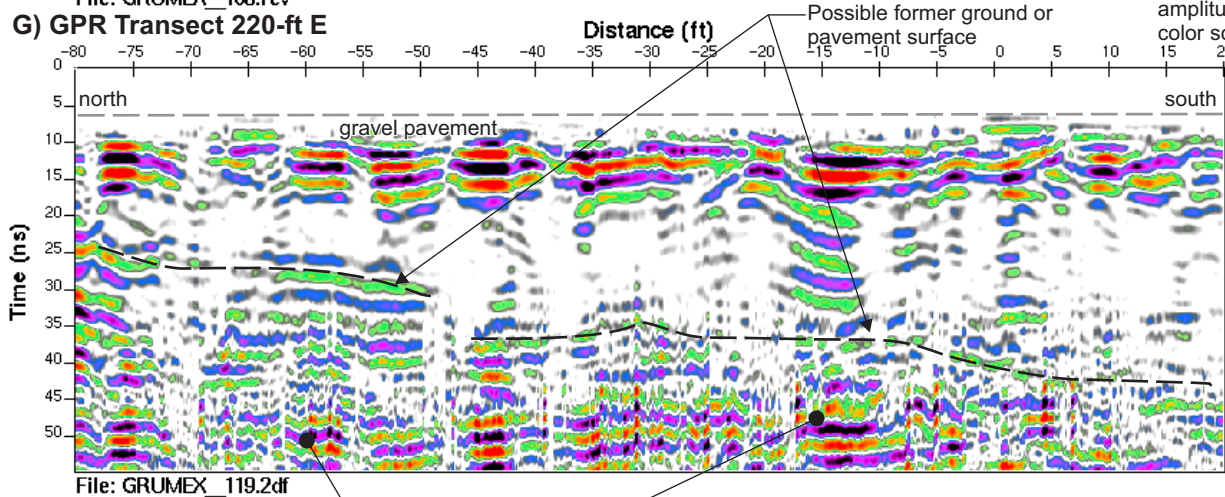
**Selected GPR Records - Northeast: HDD & Interconnect Areas**

Notes:  
 GSSI SIR-3000 w/ 270 MHZ antenna GPR system  
 512 samples/trace; ~10 traces/ft;  
 5-ft transect interval, N-S & E-W  
 Survey date: October 7, 2016  
 Refer to Figure 1 or 2 for GPR transect locations

Relatively few anomalous EM or GPR responses were observed within the HDD & Interconnect areas, although large portions of this area were obstructed and could not be scanned. The significant observations from this area include:
