2018 Long-Term Stewardship Conference

Erosion Control at the L-Bar, New Mexico, Disposal Site

William J. Frazier

Track 1.5 – LTS Practices & Challenges at DOE Legacy
Sites, Part 2

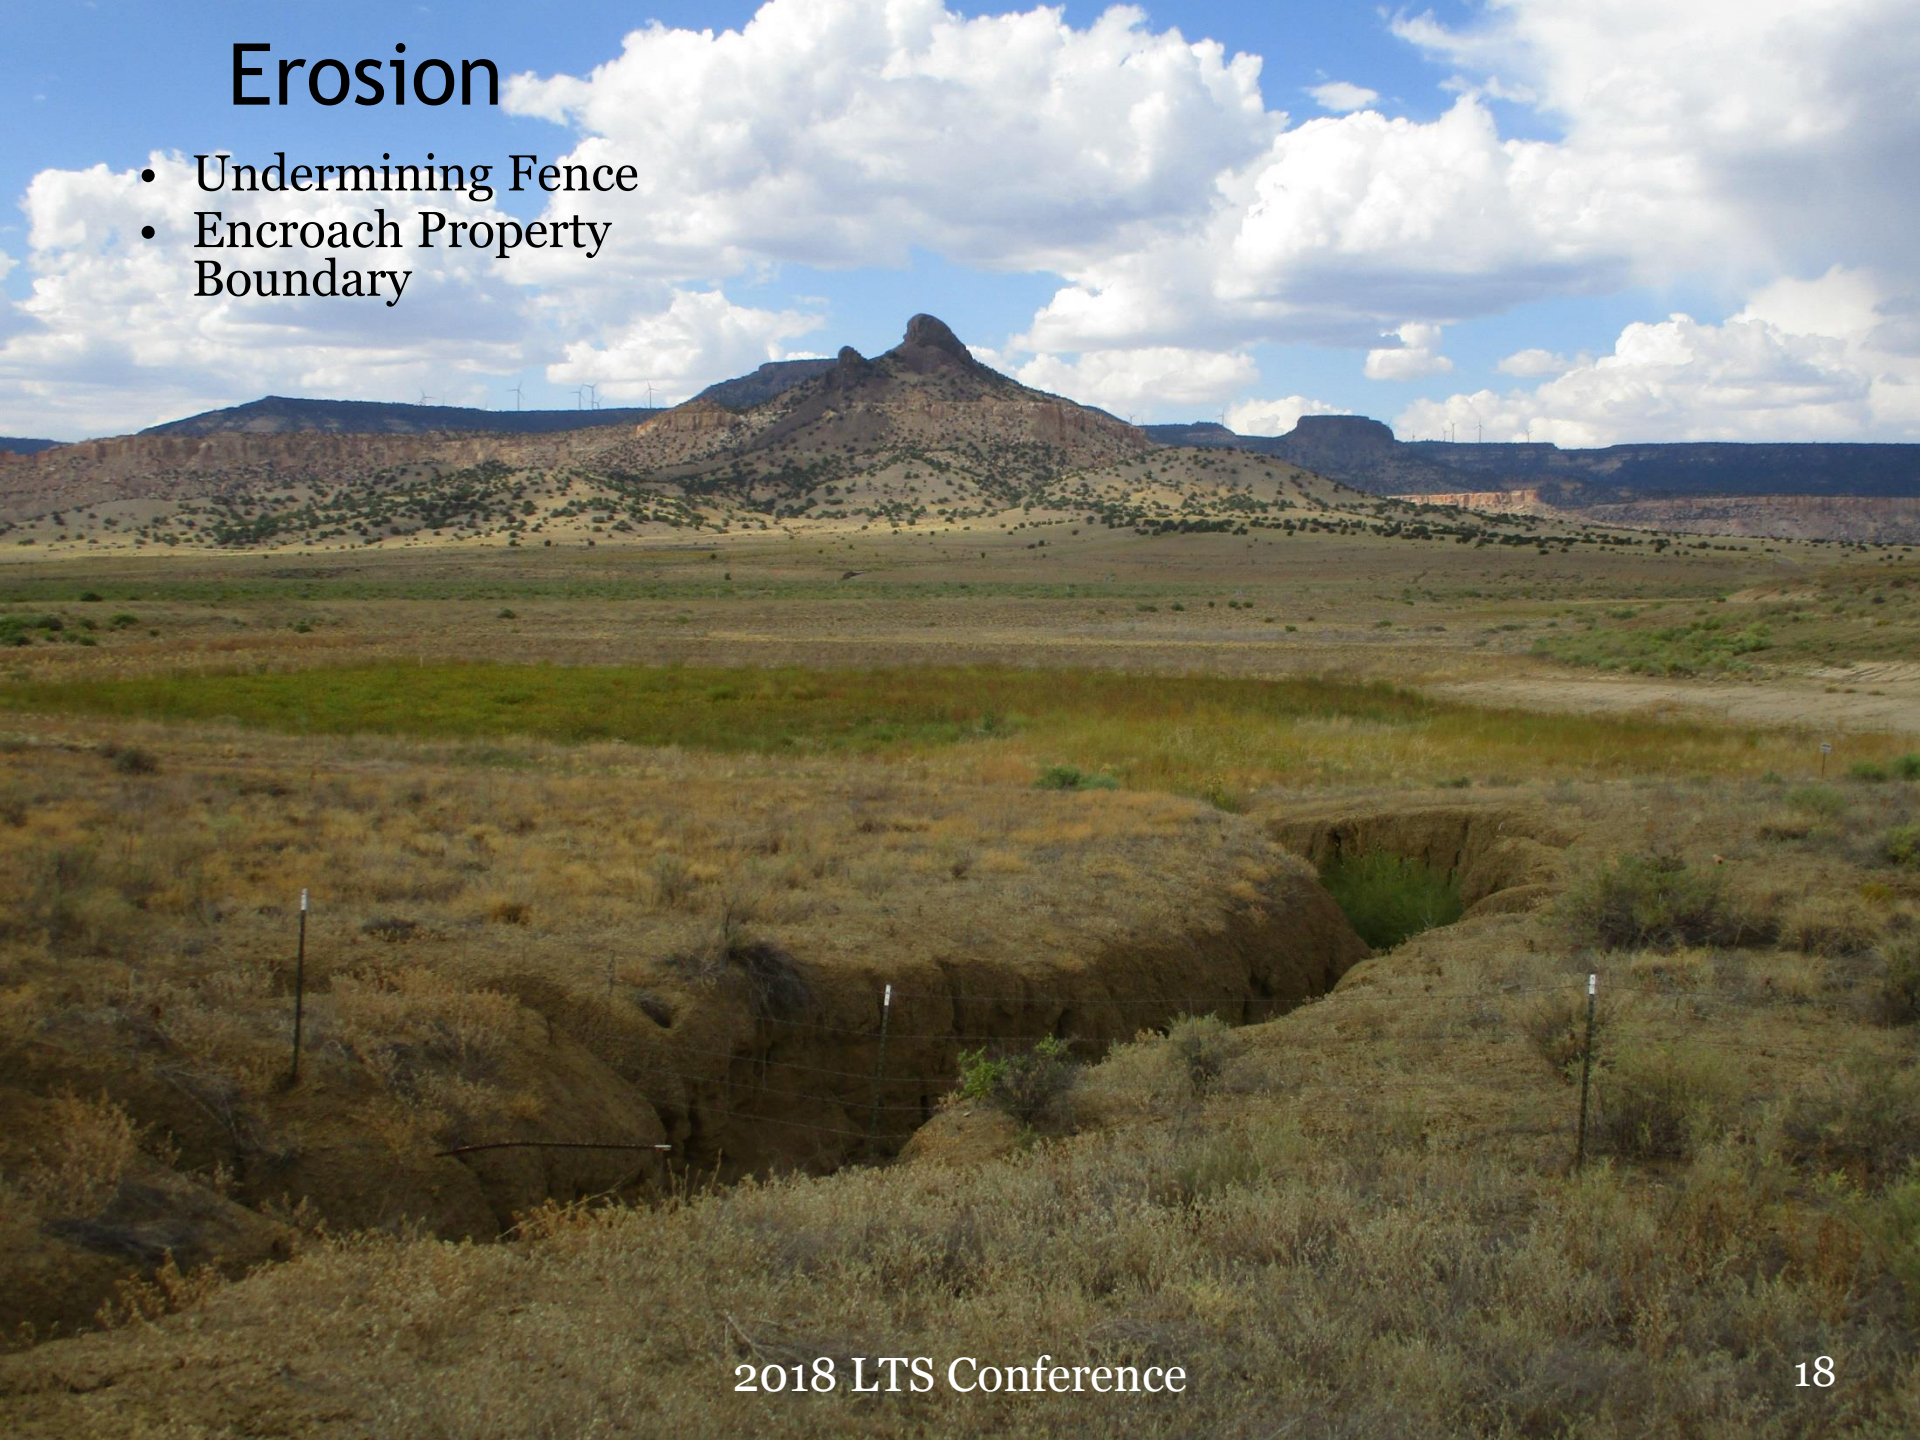
Erosion

- Undermining Fence
- Encroach Property Boundary

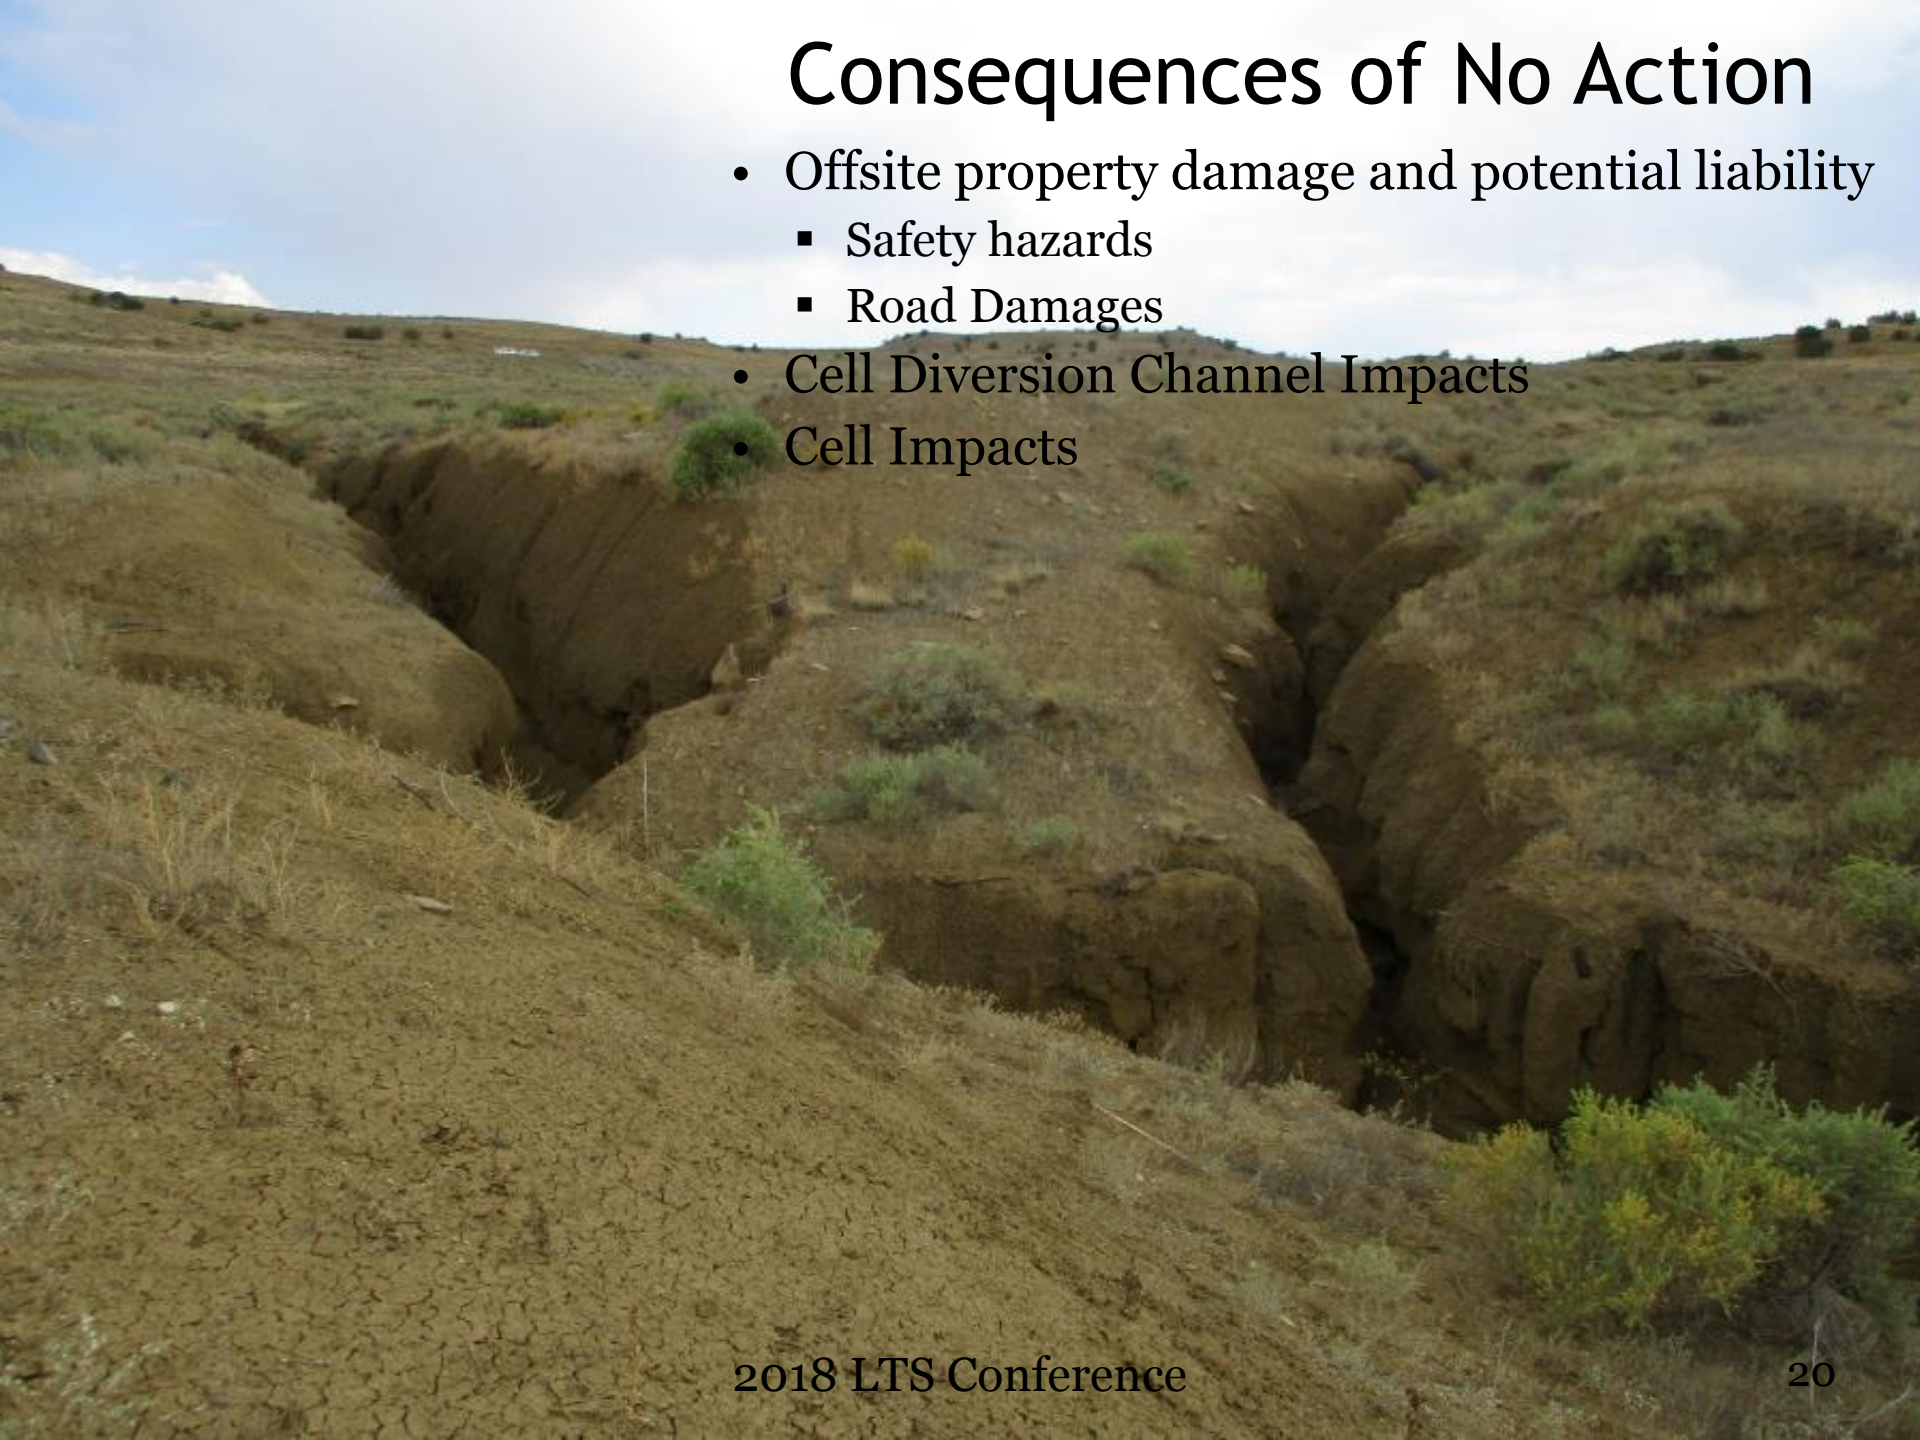
- System has not reached equilibrium
- Estimated headward erosion up to 63 feet per year

- Offsite property damage and potential liability
 - Safety hazards
 - Road Damages
- Cell Diversion Channel Impacts
- Cell Impacts

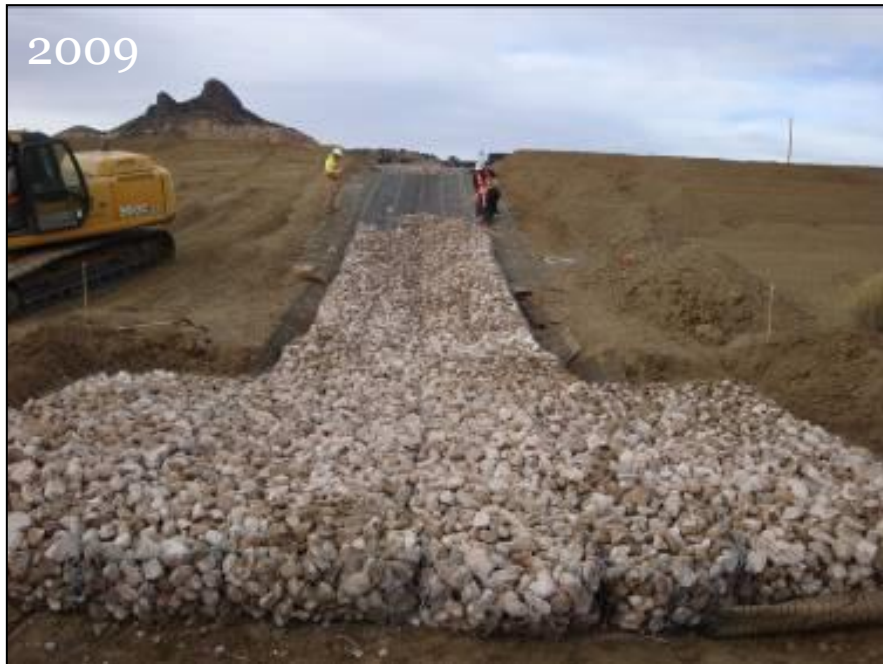
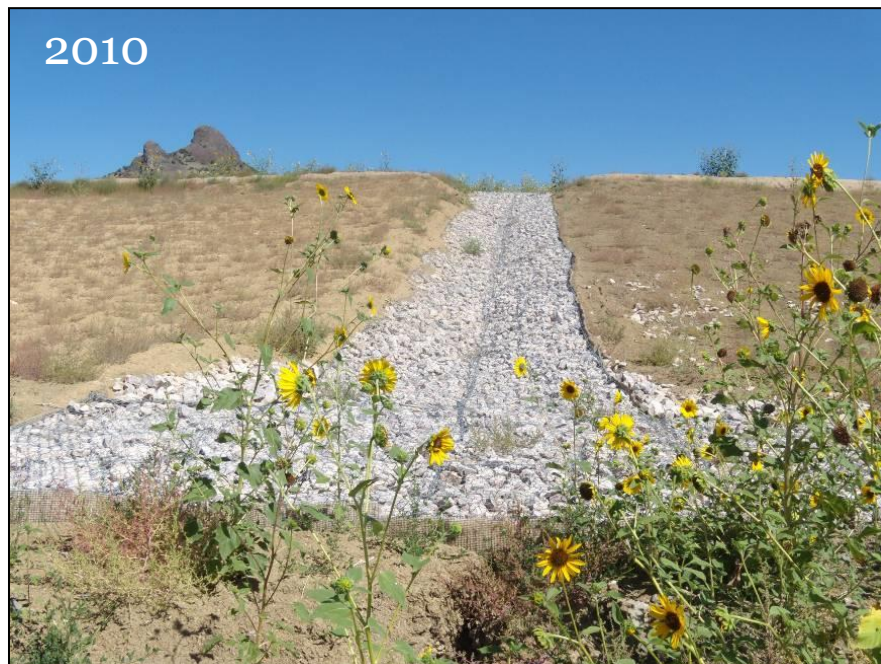
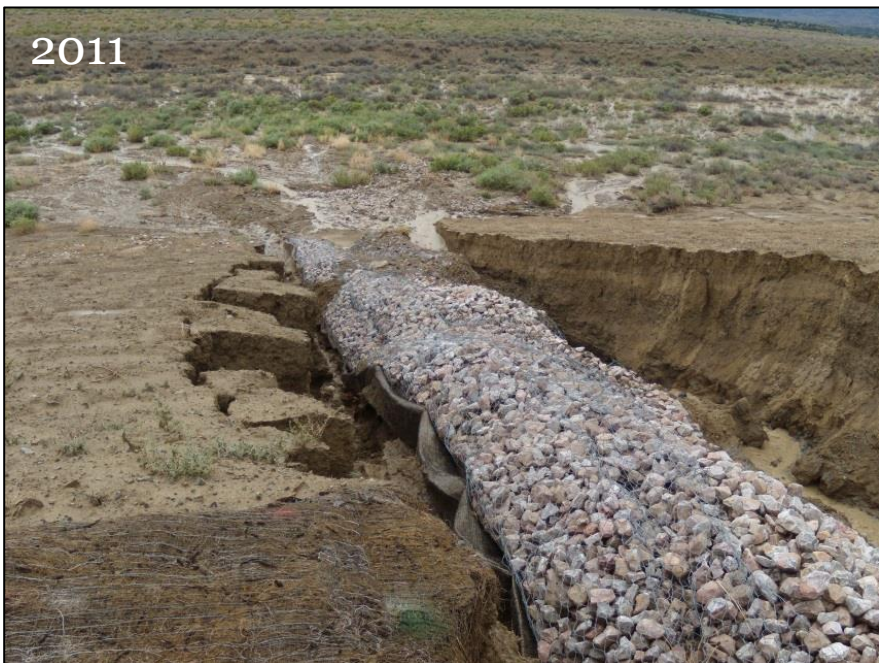
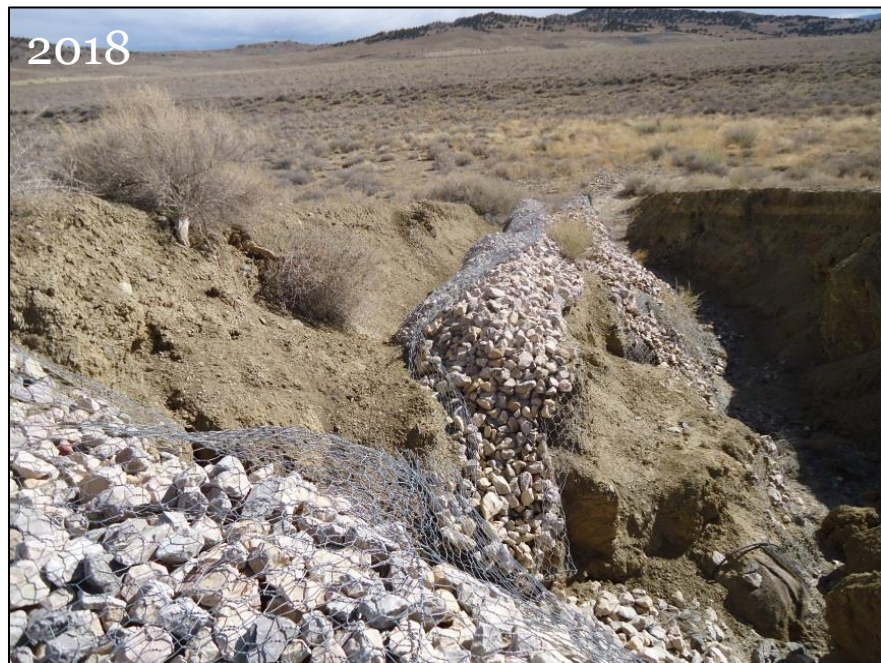
2009

2010

2011

2018

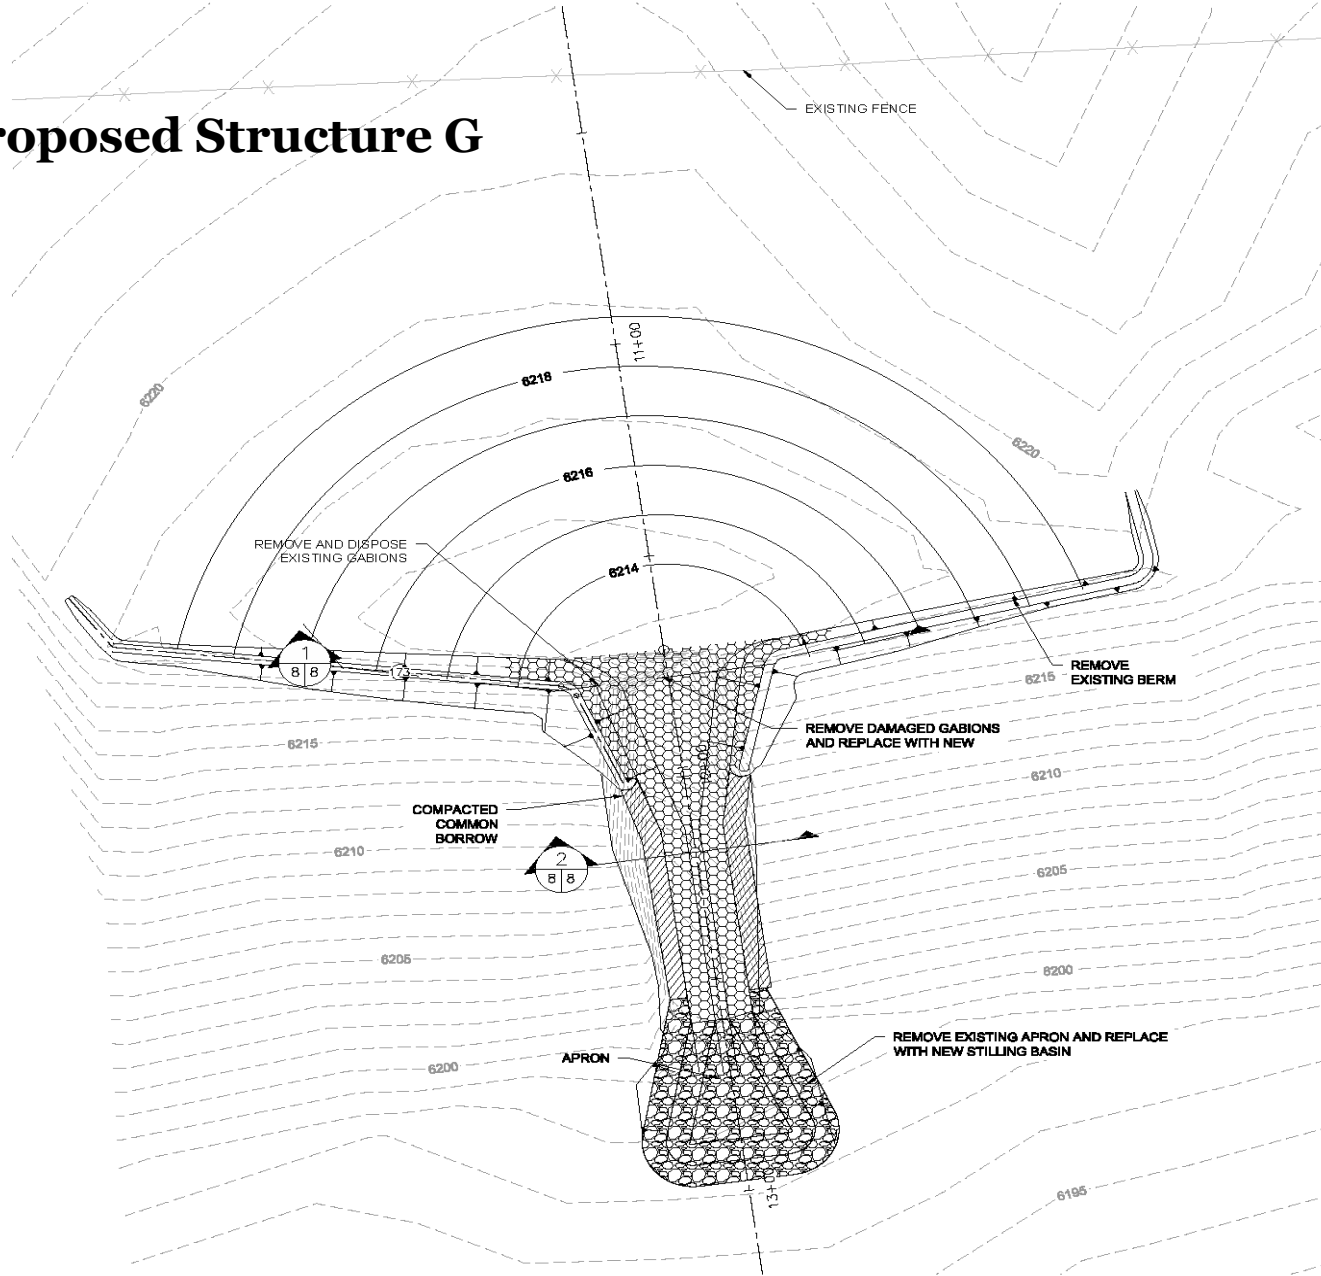
STRUCTURE G PLAN

Proposed Structure G

SCALE: 1"=20'
CONTOUR INTERVAL: 1 FOOT

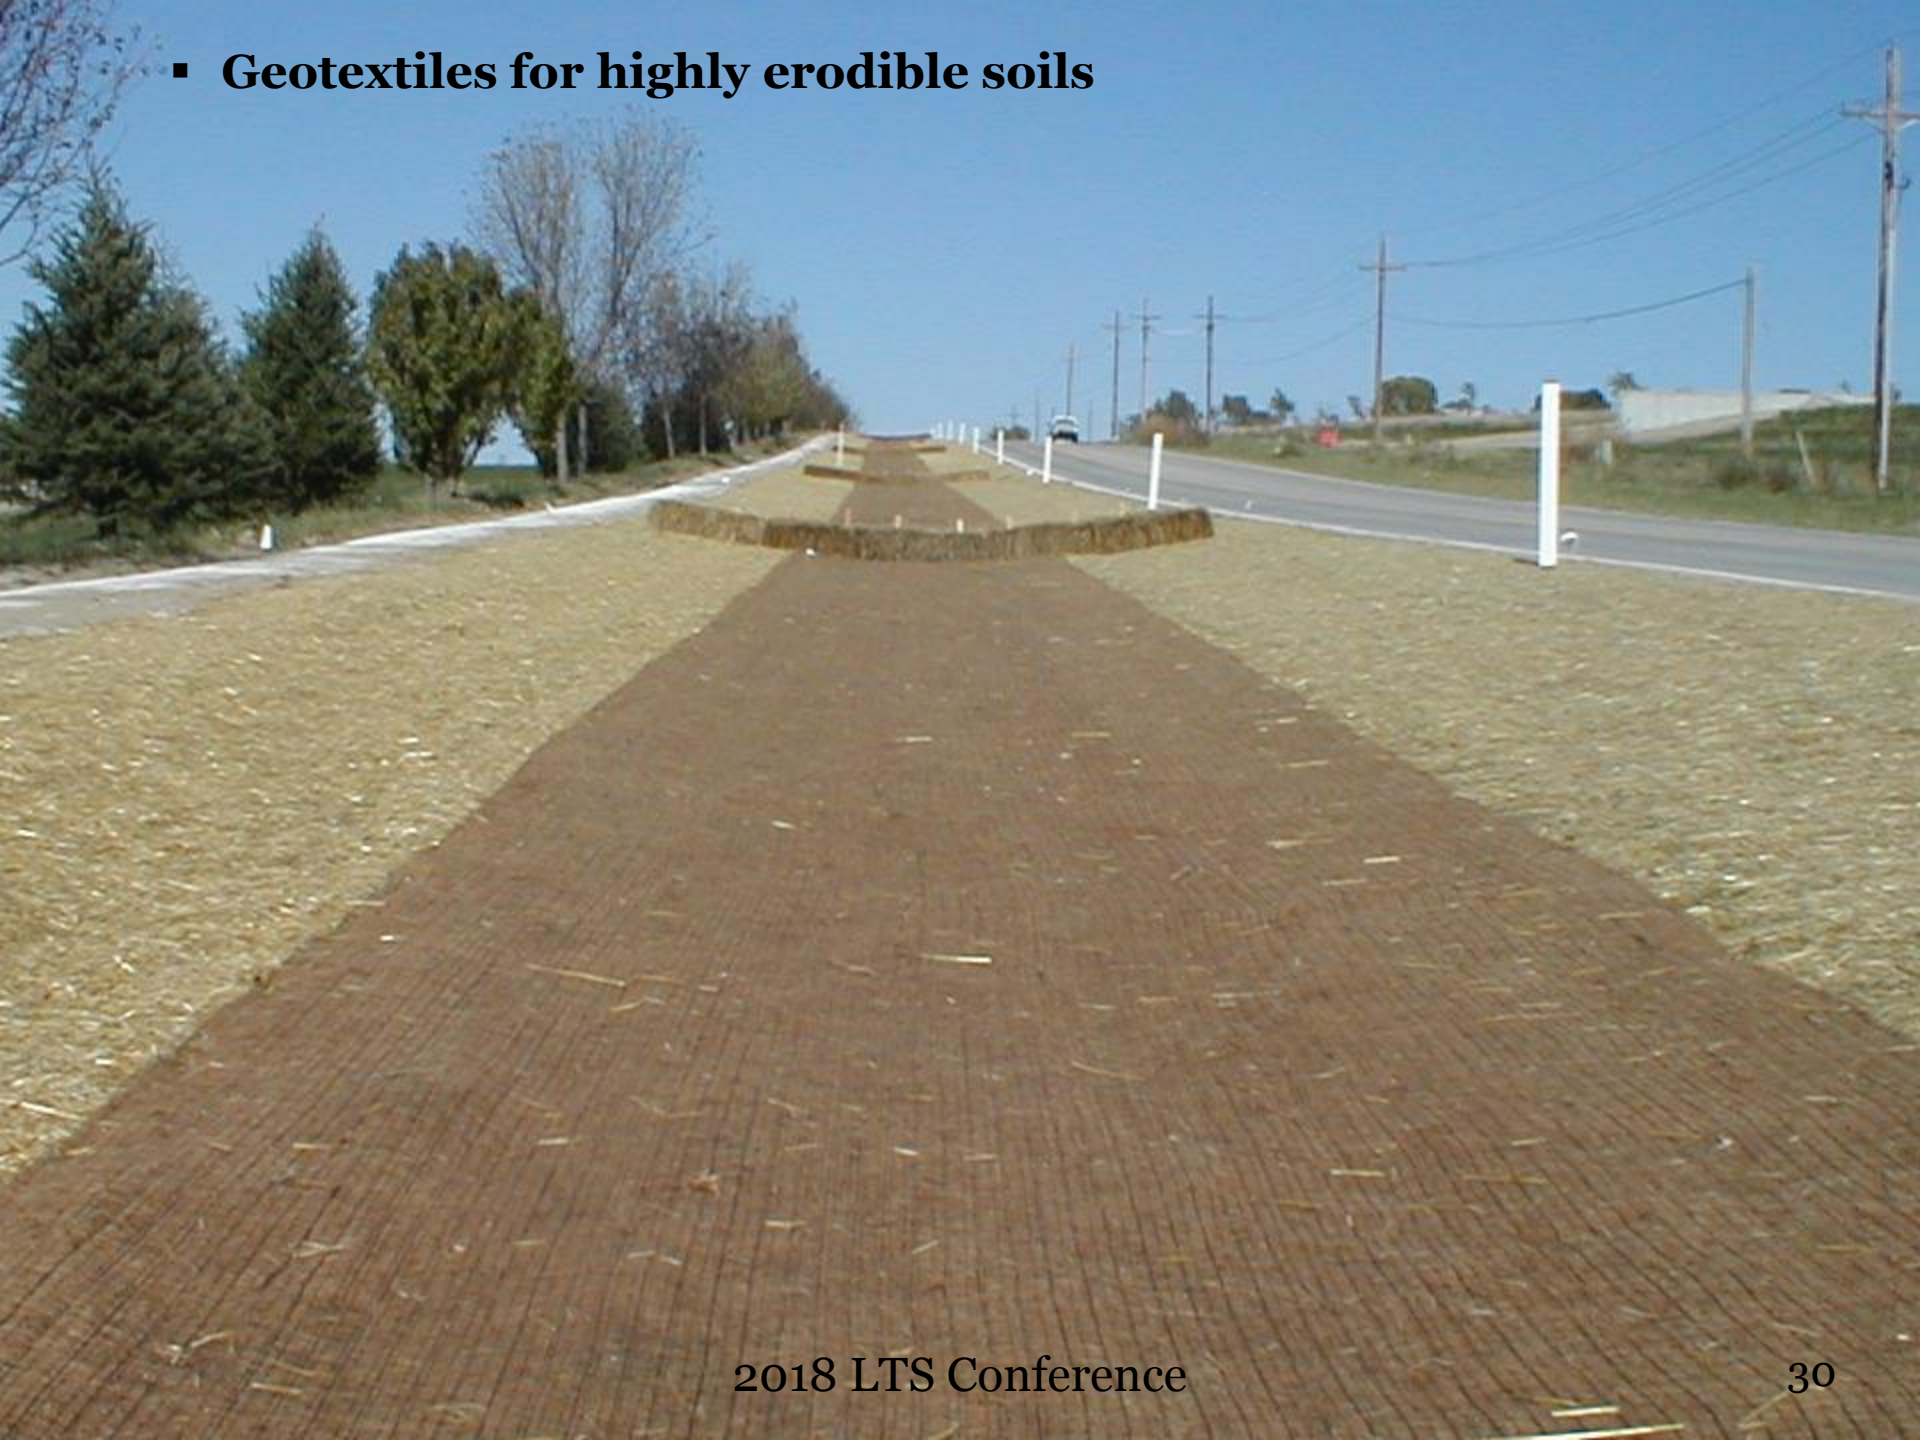
- **Geotextiles for highly erodible soils**

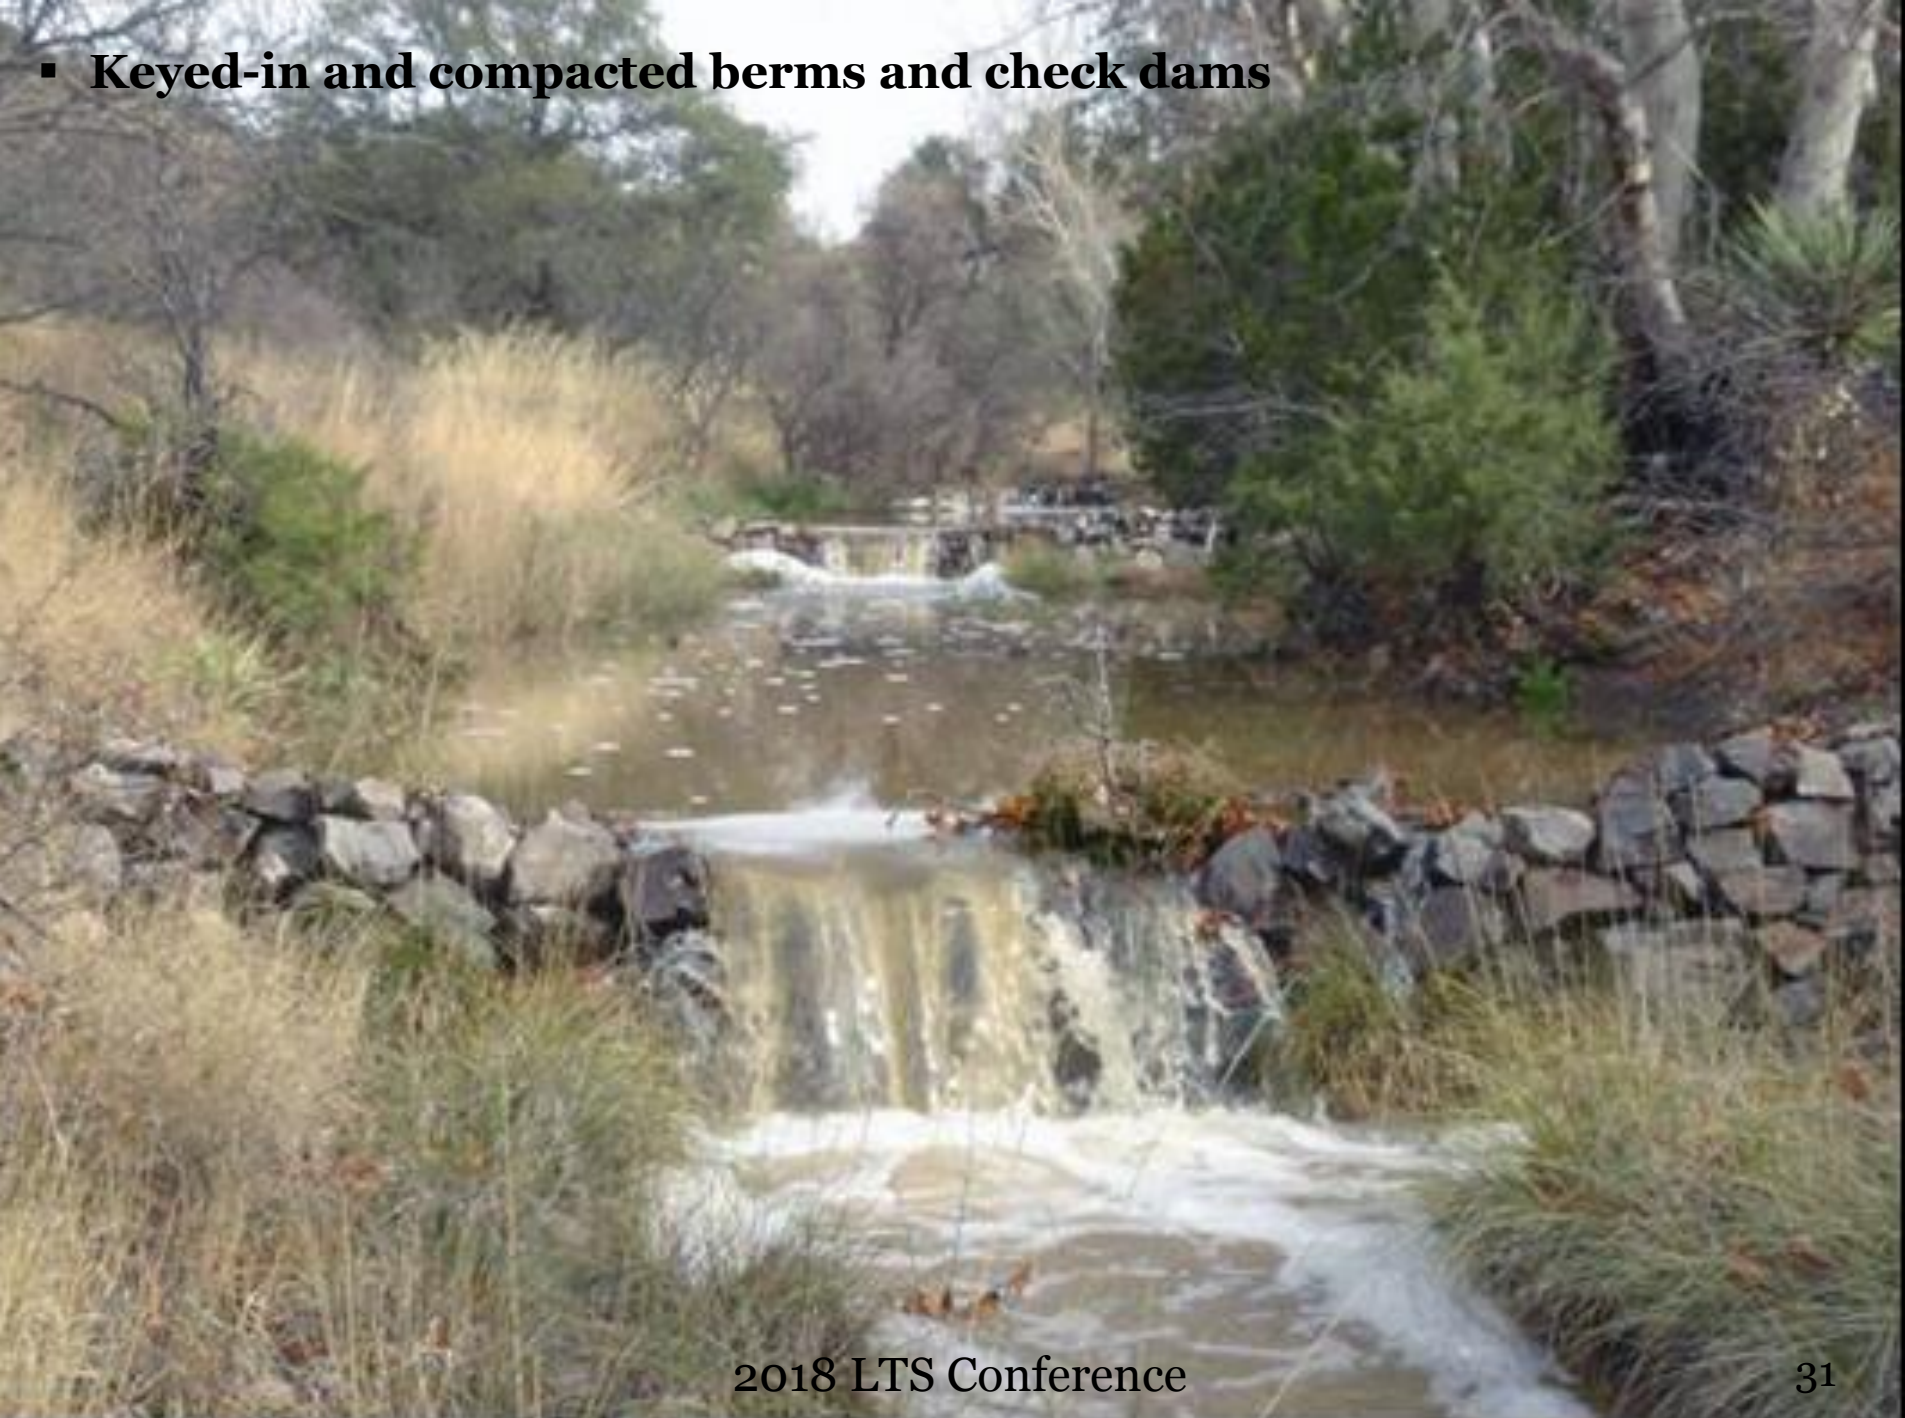
- **Keyed-in and compacted berms and check dams**
