# Long-Term Remediation of the Moab UMTRA Project

**Russell McCallister**

*Federal Cleanup Director*  
Moab UMTRA Project

**August 23, 2018**

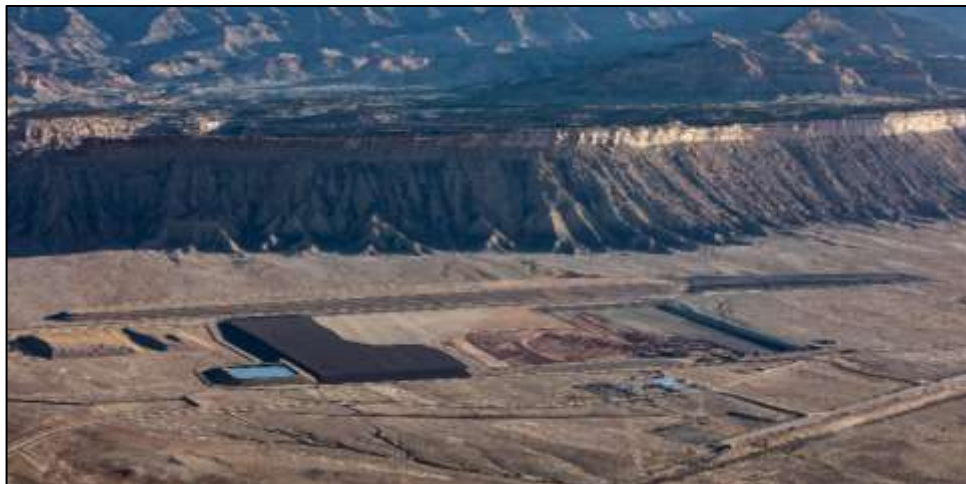
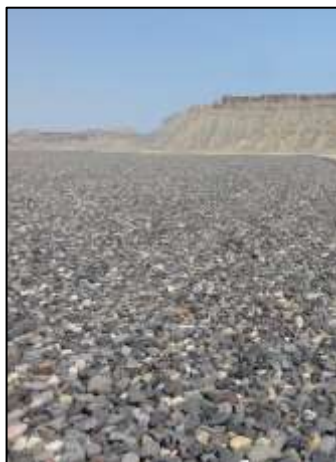
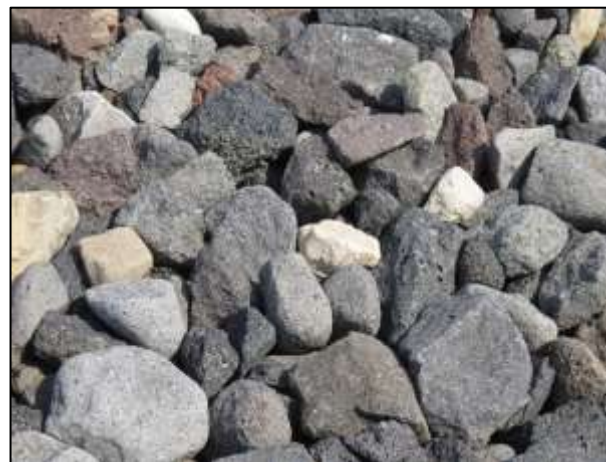
# Crescent Junction Disposal Site

- Cell is about 5,200 feet long by 2,400 feet wide
- Cell excavated in phases
- Tailings depth is 50 feet total, 25 feet below grade, 25 feet above
- 9-foot-thick, multi-layer cover

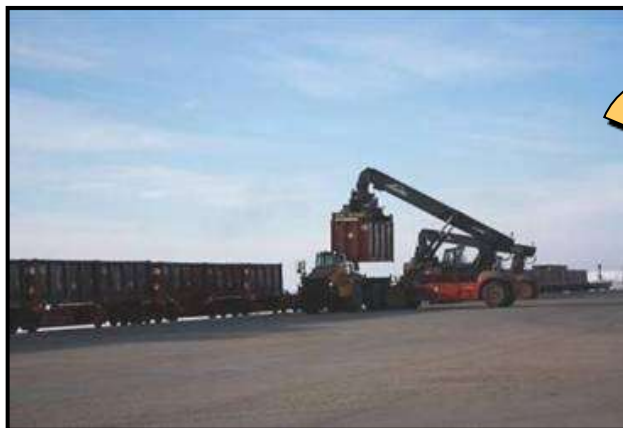
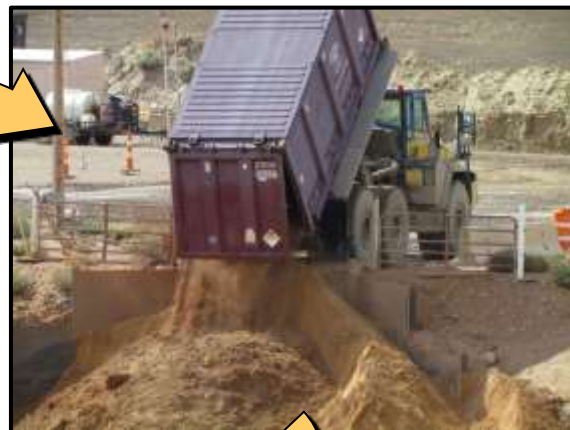
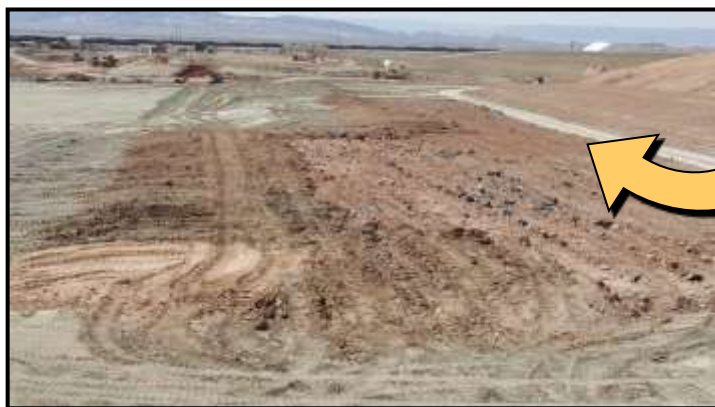
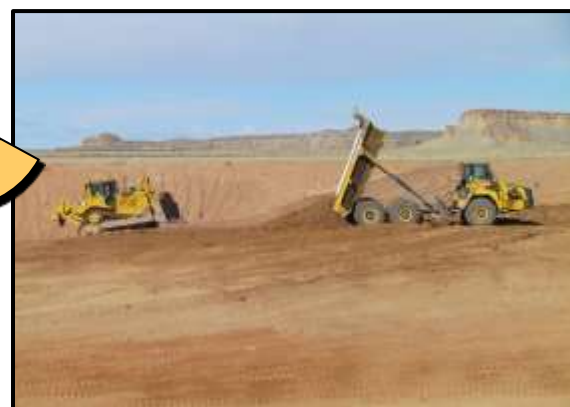
# Process Cycle in Crescent Junction

①

②

④

③

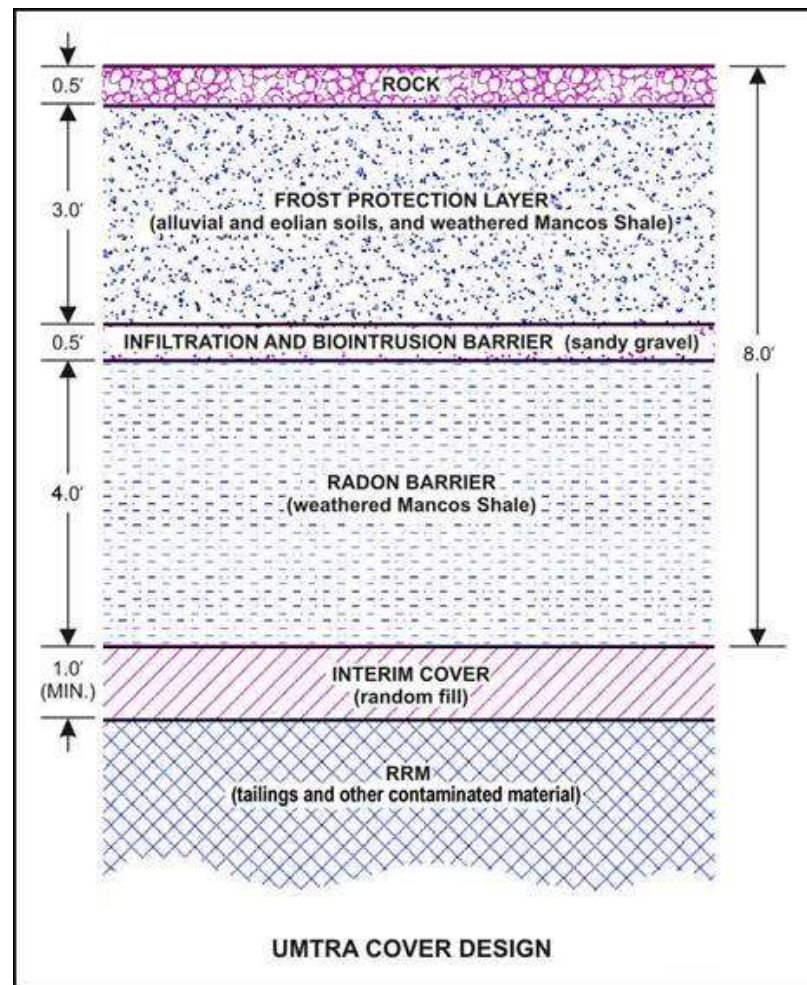
# Disposal Cell Composition

- Once the final grade for tailings material is met, interim cover is placed on portions of the cell
- The cell's cover consists of multiple layers of soil and rock
- The rock for the biointrusion layer and the uppermost layer is being quarried to meet NRC specifications for durability, and is being hauled from Fremont Junction, Utah.
