2018 Long-Term Stewardship Conference

Vapor Intrusion Mitigation
for Building 100 at the
Young - Rainey Science, Technology, and Research Center
Largo, Florida - 119

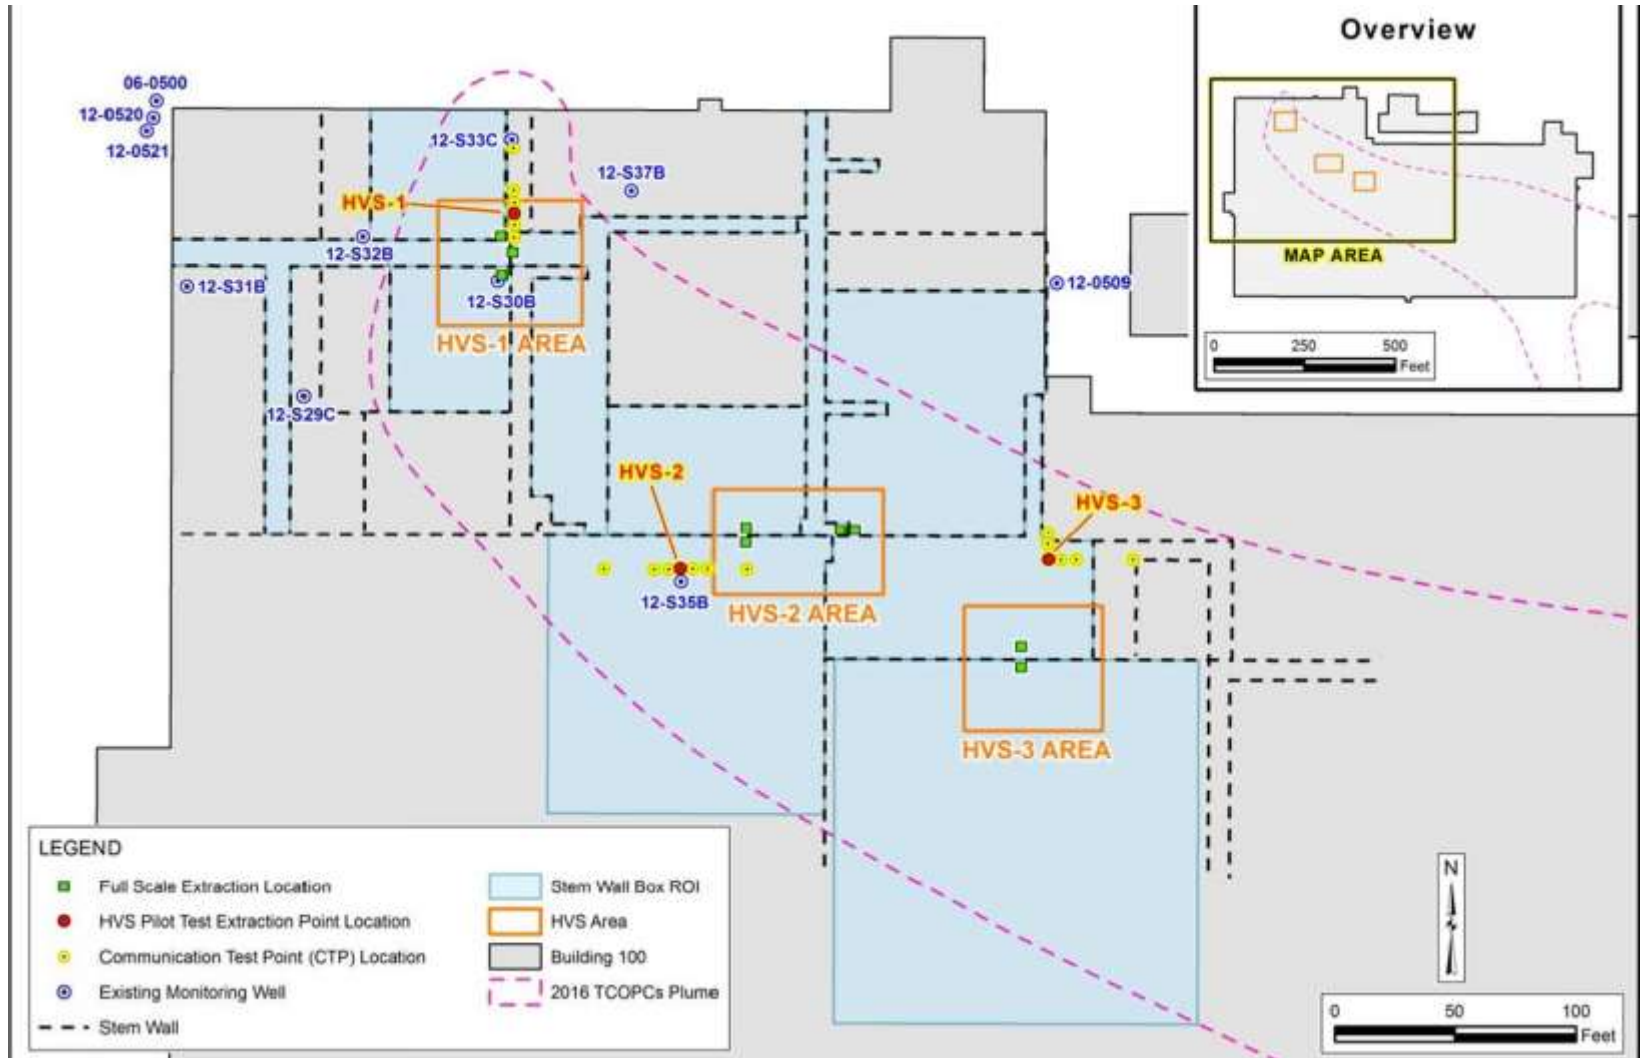
Sub-Slab Vapor Extraction Locations

- Consisted of six sub-slab high-volume vapor sampling locations along the axis of the groundwater plume
- Test results indicate a potential for vapor intrusion in the northwest portion of the building
- DOE elected to proactively address this potential risk by designing and installing a vapor intrusion mitigation system

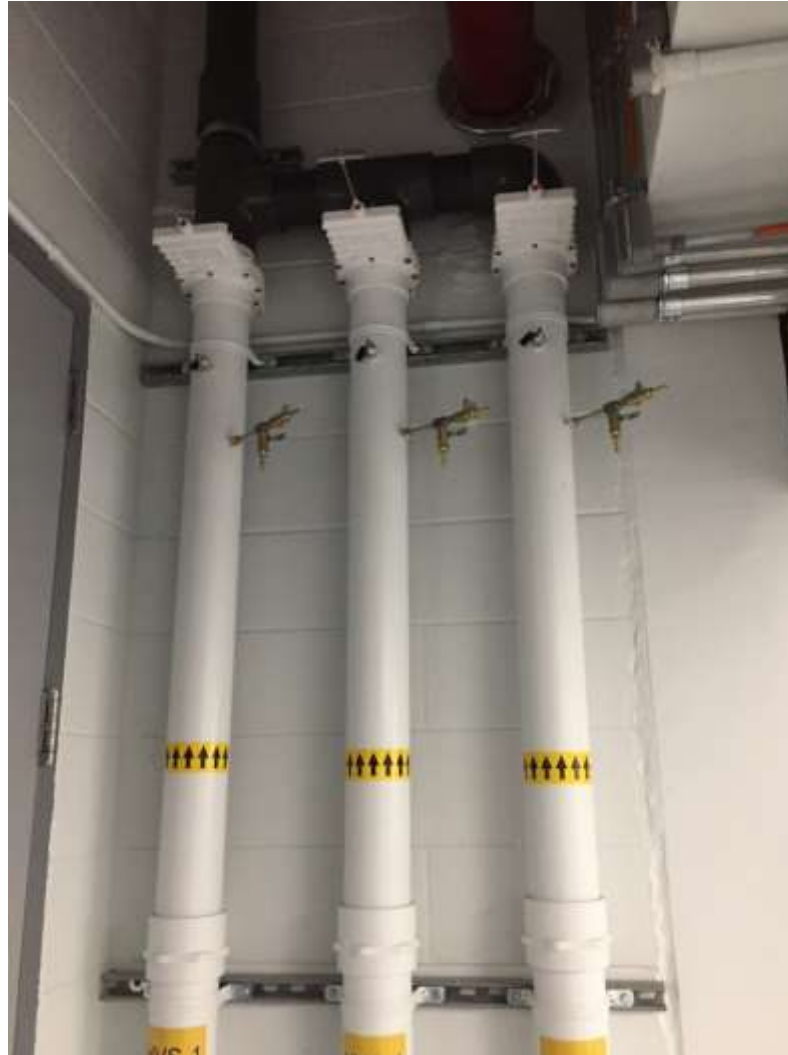
HVS-1 Area Risers

- Install vacuum points at selected locations to capture sub-slab vapor in the plume vicinity
- Install piping to convey the sub-slab vapor through the building to the roof for discharge
- Provide power with emergency backup for uninterrupted operation
- Include instrumentation for interface with the building monitoring system for automated system monitoring
