Small Business Vouchers – Sentient Project ID #T20

T20: Small Business Vouchers – Sentient

Project Summary

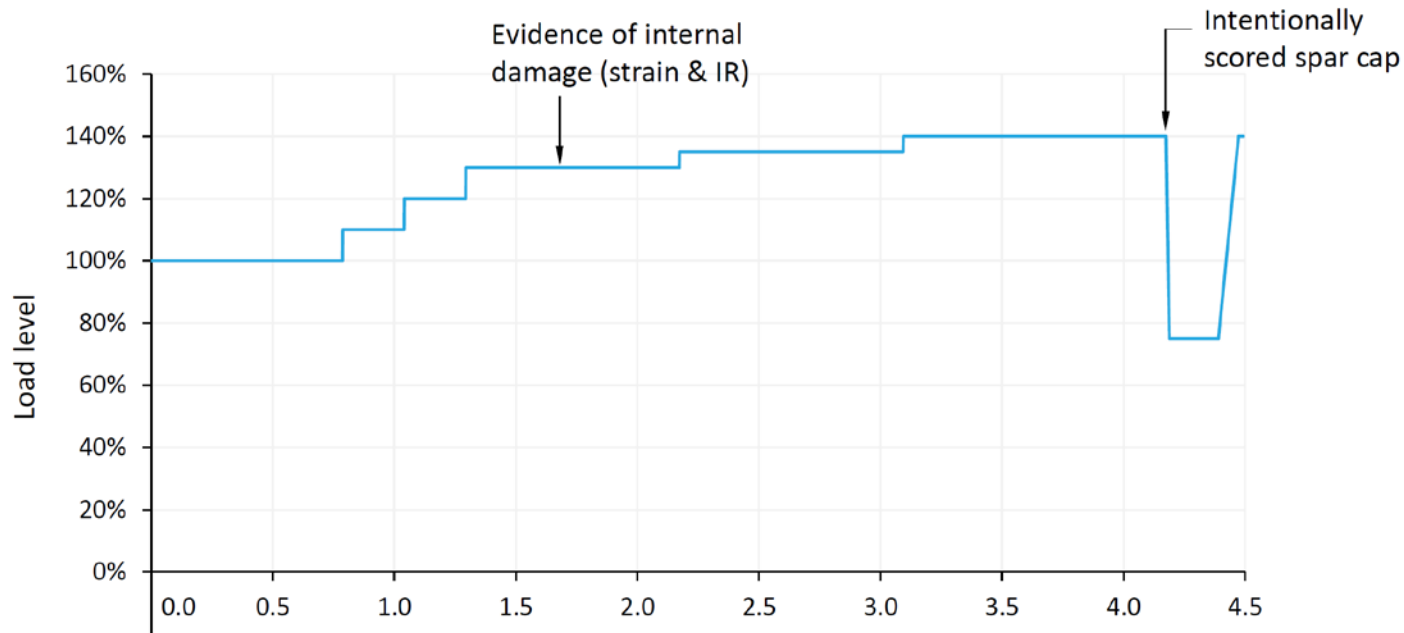
Test Loading Sequence

- Blade fatigue test required over 4 million cycles at up to **140%** one-million cycle fatigue equivalent load

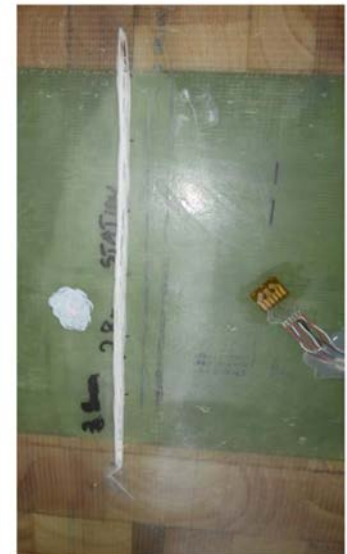
Figure 10.3. Damage introduced to the 2.8 m LP spar cap

- Strain levels were observed to naturally progress and reveal damage, but this did not result in blade failure
- The blade spar cap was cut partially through the depth to lead to failure
- Data acquisition was successful to track changes in blade state throughout the entire experimental campaign

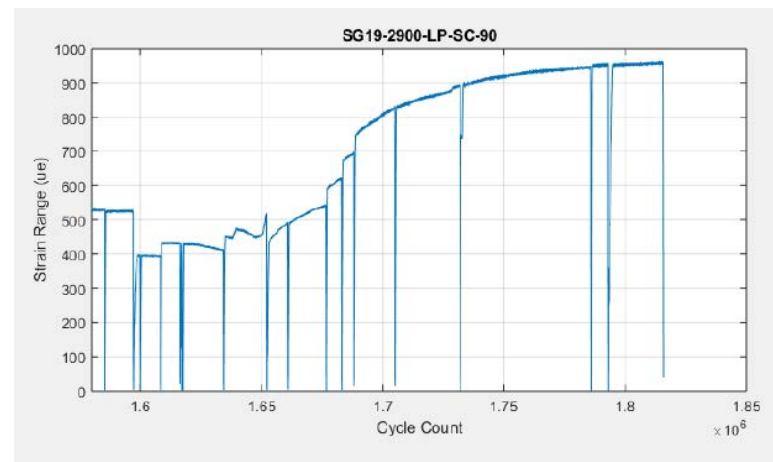
- Due to the NRT not being a fatigue-driven design, the blade required damage to be introduced for reaching blade failure
- Prior to introducing damage, stress concentrations were noticed in the blade where strain levels increased and thermal images revealed localized stress increases

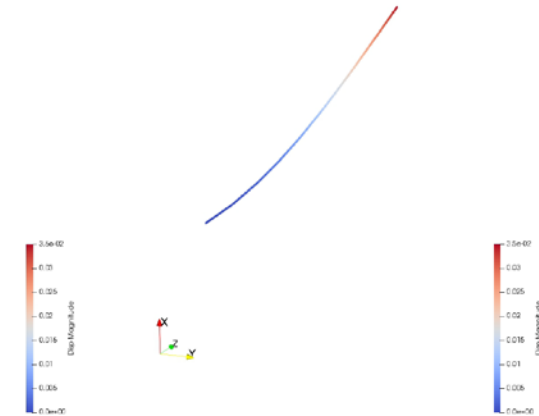
Mode 1 Frequency = 1.28 Hz

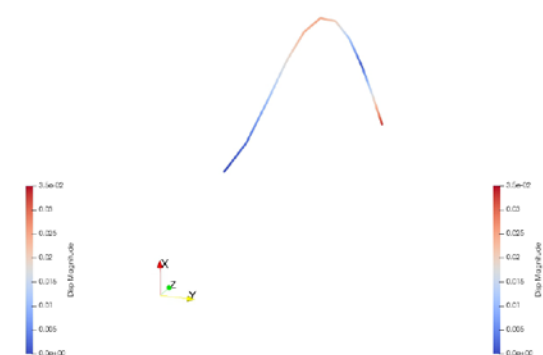
Mode 3 Frequency = 7.92 Hz
