# Integrated silicon/chalcogenide glass hybrid plasmonic sensor for monitoring of temperature in nuclear facilities

**Advanced Sensors and Instrumentation  
Annual Webinar**

**October 30, 2019**

Maria Mitkova  
**Boise State University**

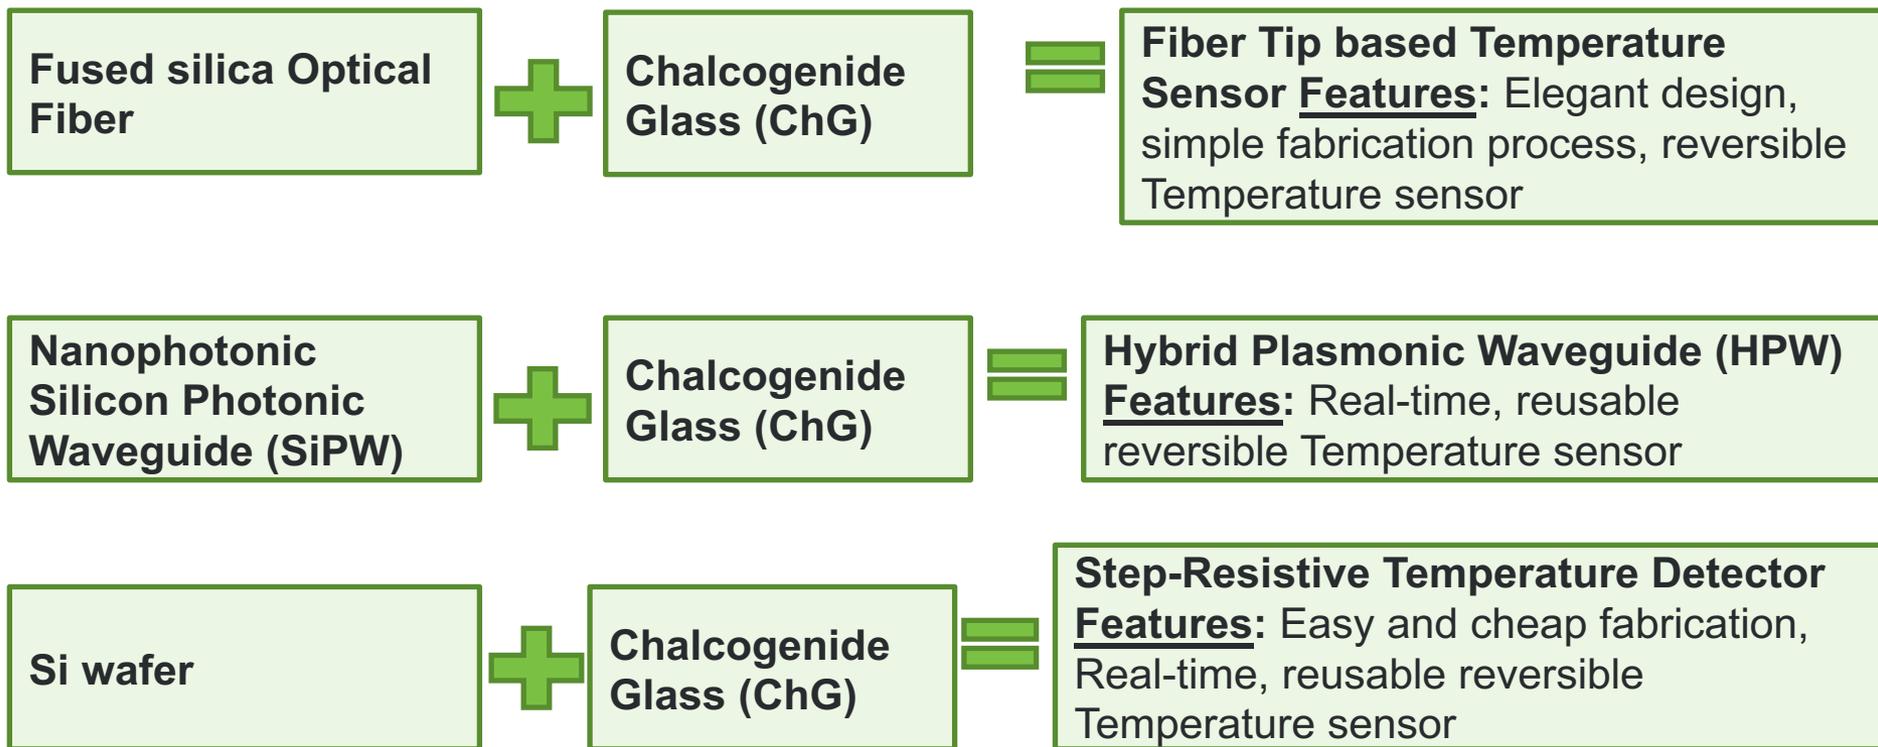
Three different device architectures.

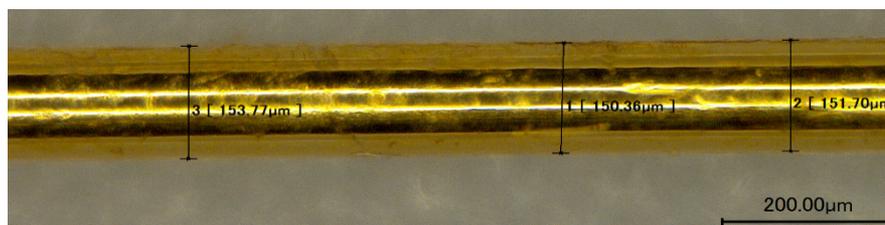
The outer diameter of the fiber is around **150 $\mu\text{m}$**  ( $153.3 \pm 2\mu\text{m}$ ). Gold top layer **12.5 $\mu\text{m}$** , Cladding **10 $\mu\text{m}$** , Core **105 $\mu\text{m}$** .

Figure. Schematic of the gold coated fiber and actual fiber and geometry.

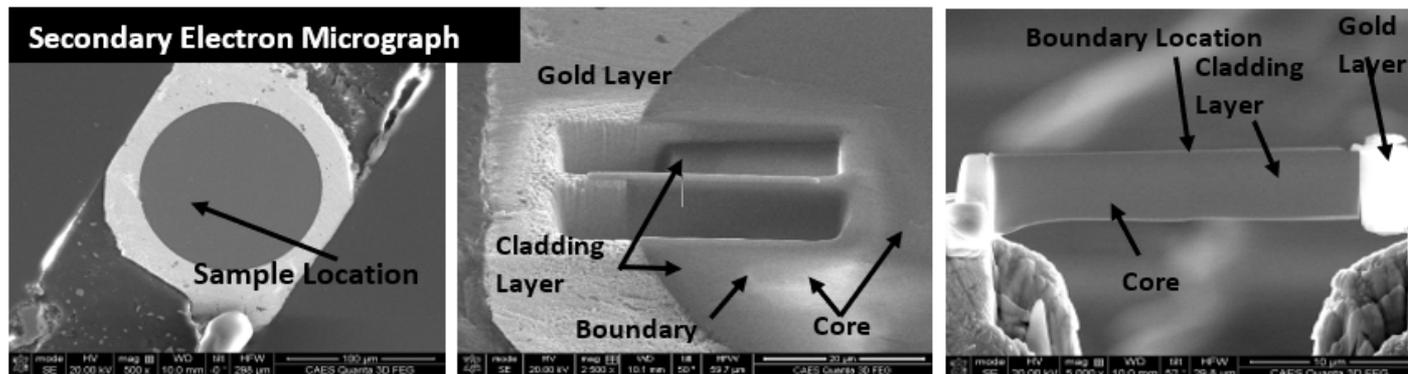
Figure. Cross section of the fiber and FIB lamella.

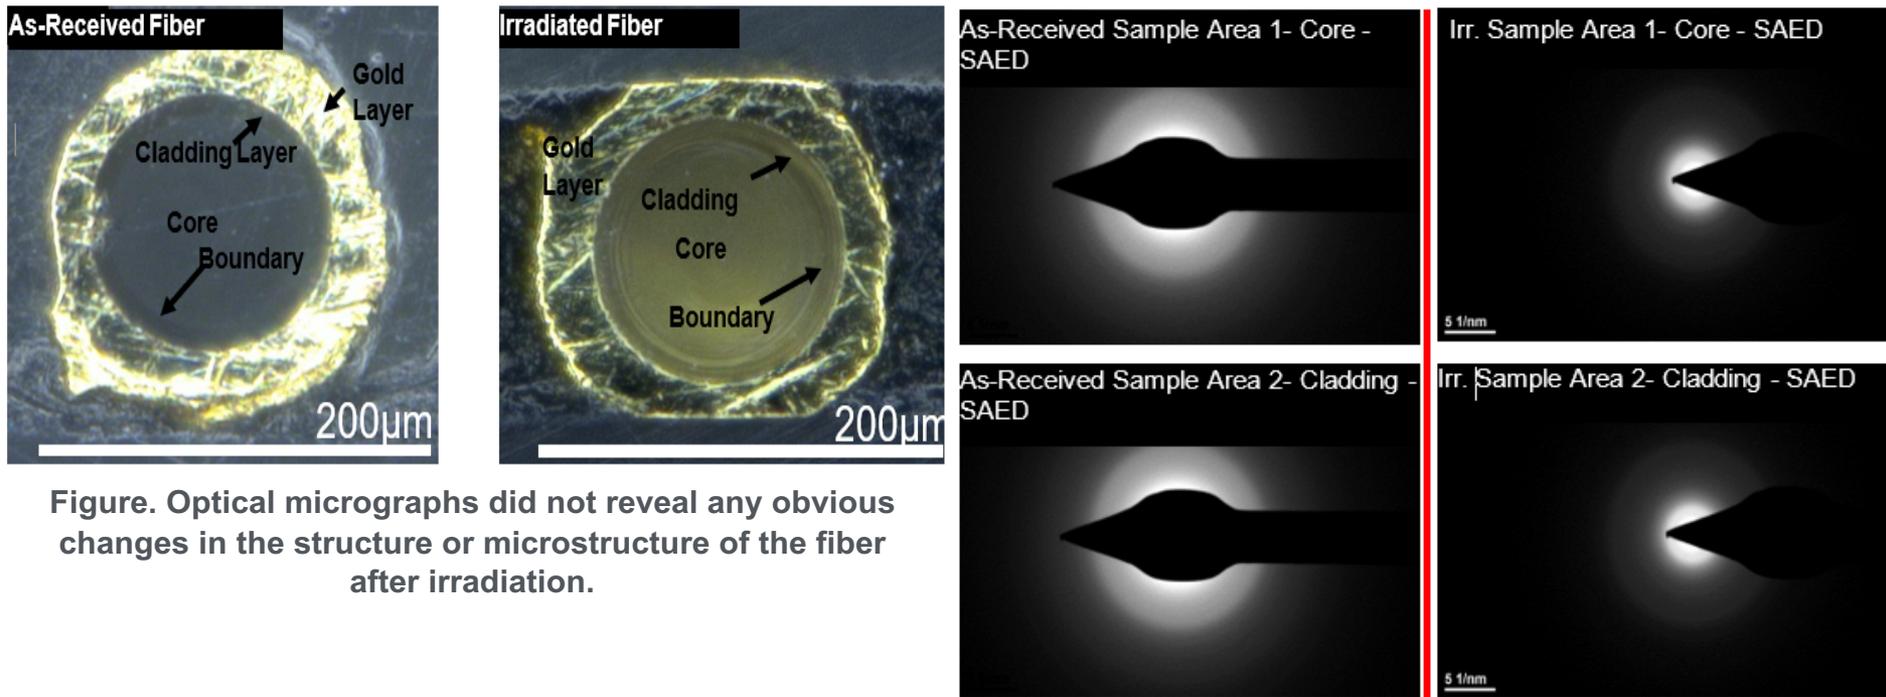
Figure. Optical micrographs did not reveal any obvious changes in the structure or microstructure of the fiber after irradiation.

Figure. Sample-Irradiated Characterization by SAED

- Irradiation of a fiber was carried out in the Aerojet-General Nucleosis, AGN-201, nuclear reactor at Idaho State University (ISU).
- The reactor is critical at 3.2 Watts, has a maximum operating power of 5 Watts thermal, and an average and peak thermal fluxes of  $1.5 \times 10^8$  and  $2.5 \times 10^8$  n/(cm<sup>2</sup>-s) at 5W.
- Only two of the isotopes produced, gold and silicon, are detectable with a High-Purity Germanium (HPGe) detector used for characterization at ISU.
- The low dose was not expected to produce any significant material damage in displacements per atom (dpa). The calculated dose for the fiber was  $1.9353216 \times 10^{-9}$  dpa.

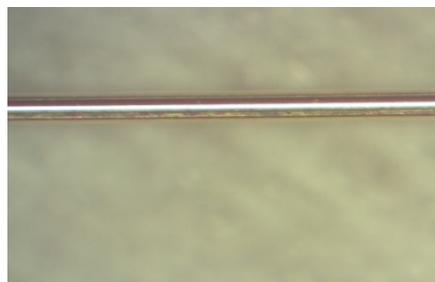
Gold coated fiber under microscope

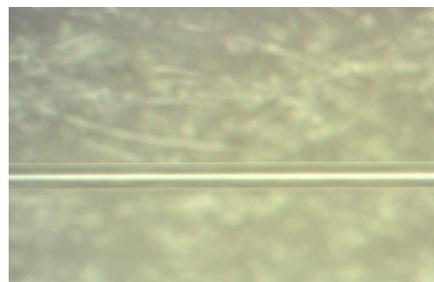
Gold etched fiber

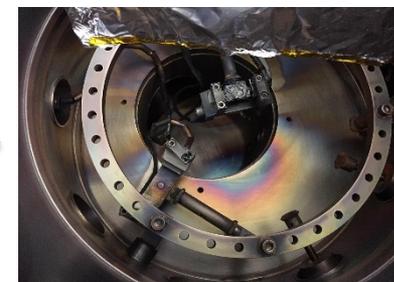
ChG deposition on fiber tip

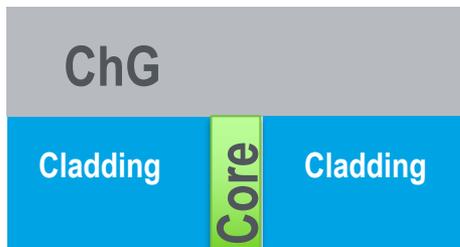
Schematic

Fiber with deposited chalcogenide glass on its tip

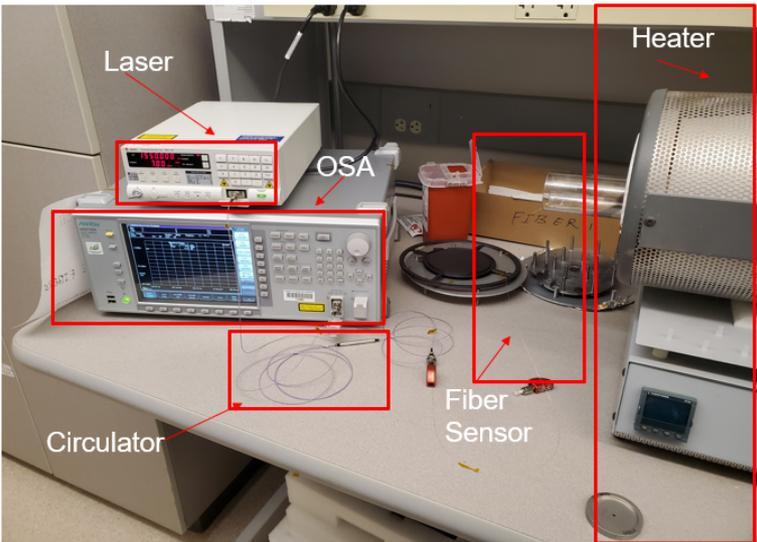
Figure. Fiber Sensor Testing Setup

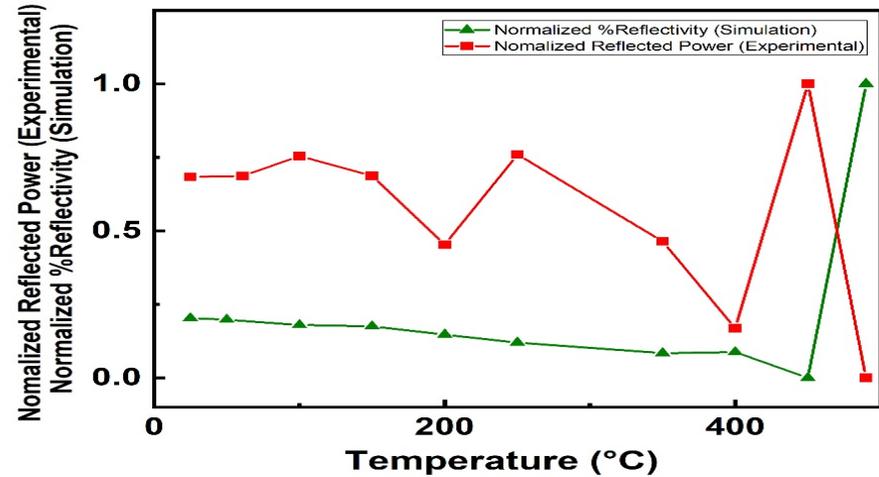
Figure. Normalized reflected optical power (from experiment) and % reflectivity (from simulation) as a function of temperature data. This is from a temperature sensor built on the tip of a radiation hard gold coated fiber ( $\text{Ge}_{30}\text{Se}_{70}$ ).

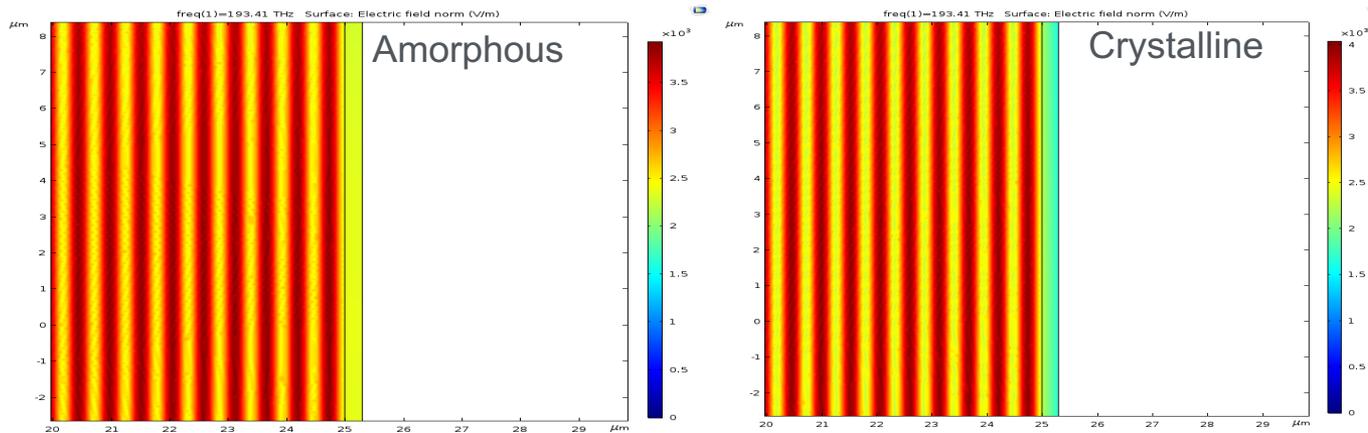
Figure. COMSOL Multiphysics simulation of Fiber Based Device ( $\text{Ge}_{30}\text{Se}_{70}$ ).

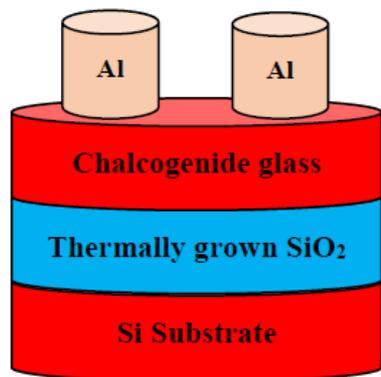
Amorphous to crystalline phase transition decreases materials resistivity.

Figure. Schematic of Device Structure

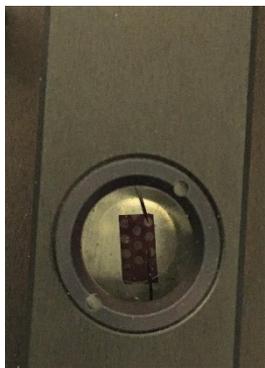
Figure. Device Under Testing

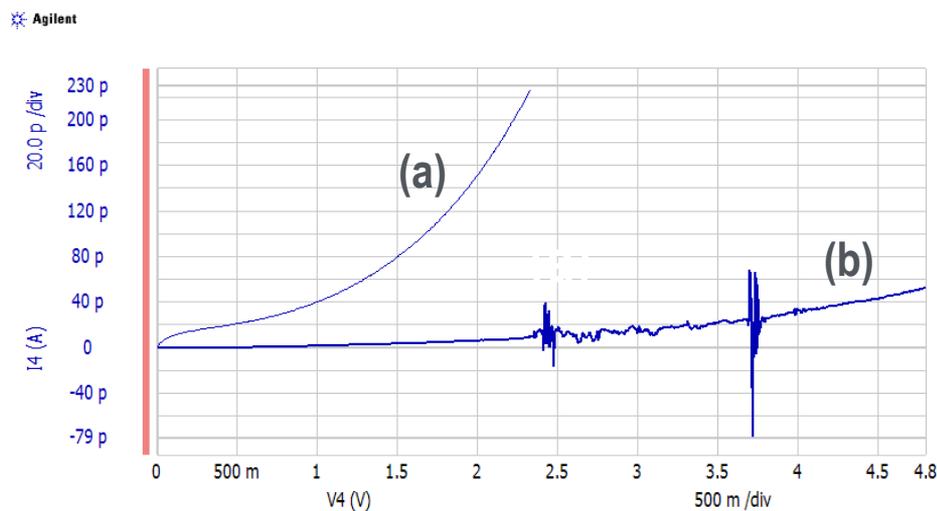
Figure. I-V characteristics in crystalline and amorphous (bold) phase.

- Initially high resistive material has become conductive due to its crystallization by increasing the device temperature to  $T_{\text{cryst}}$ . (a)
- The high resistive state was regained by using electrical pulse at room temperature, causing materials' amorphization (b) .

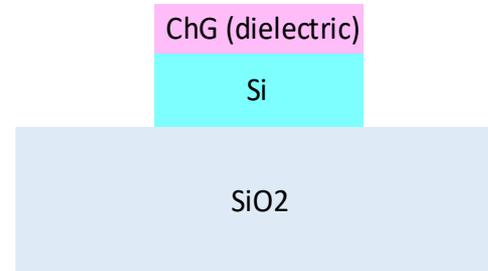
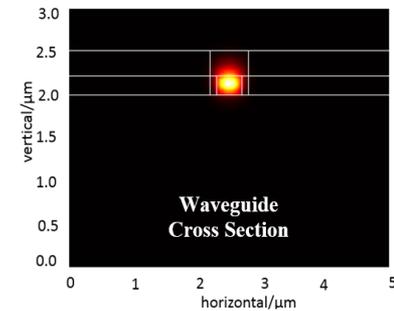
- Material acts like a dielectric.
- Very low absorption loss in near infrared.
- Fundamental mode is confined in the silicon waveguide.
- Mode propagates along the waveguide with nominal loss of  $\sim 2.5\text{-}3.0$  dB/cm.

Intensity profile of TM mode

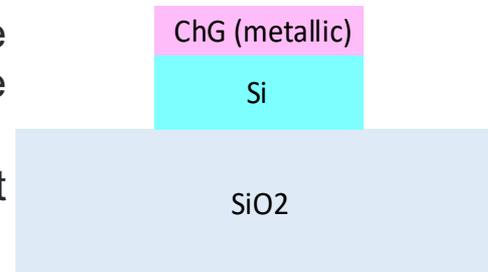
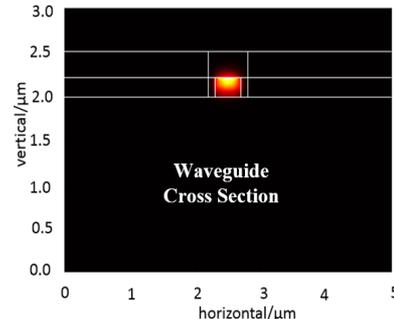
- Material crystallizes and exhibits conductive characteristics.
- Fundamental mode disappears.
- Tightly confined plasmon modes appear at the interface between silicon and the conductive material.
- The plasmonic modes provide confinement beyond the diffraction limit.
- Characterized by a very large propagation loss ( $\sim 1\text{-}10$  dB/ $\mu\text{m}$ ).

Intensity profile of TM mode

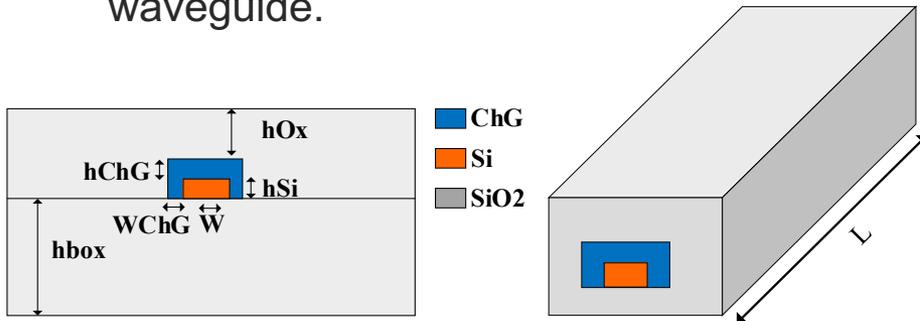
Complex Refractive index

Refractive index	Refractive index (n)	Extinction coefficient (k)
SiO <sub>2</sub>	1.45	-
Si	3.47	-
ChG (amorphous)	2.45	0.10
ChG (crystalline)	3.39	0.17

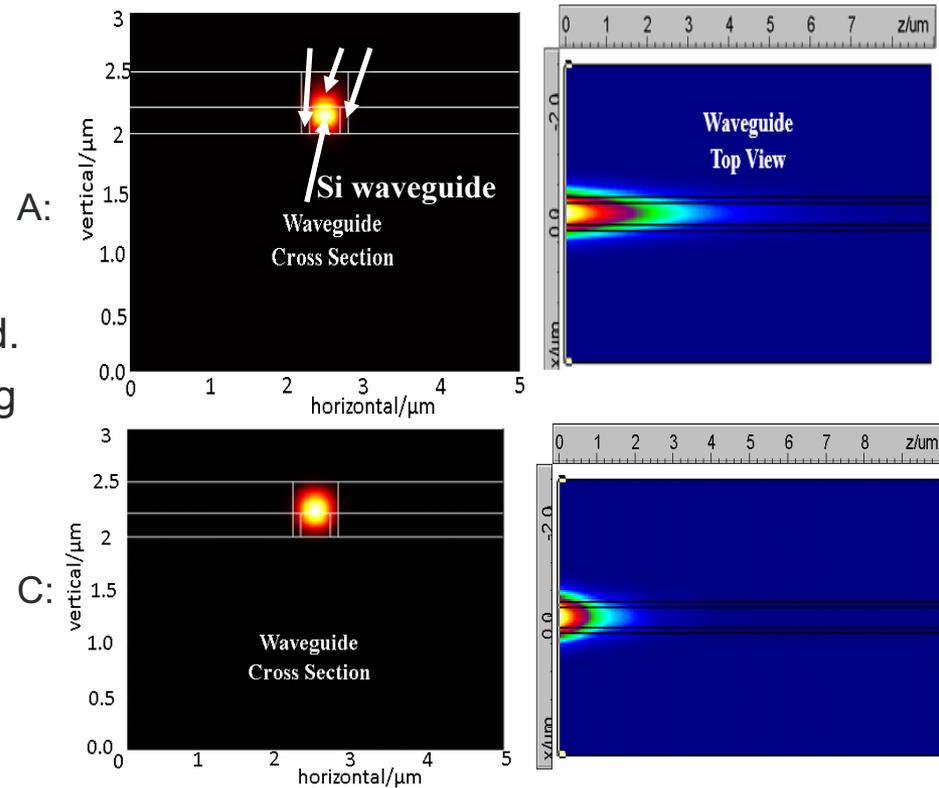
- The team used well-characterized complex refractive indices of  $\text{Ge}_{40}\text{S}_{60}$  chalcogenide glass.
- The complex refractive index is measured using ellipsometry.
- Simulations performed using FIMMWAVE Software, which uses Finite Element Method.
- High extinction ratio of 70 dB in a 22  $\mu\text{m}$  long waveguide.

Optimum design parameters

Parameters	Value ( $\mu\text{m}$ )
W	0.4
WChG	0.1
hChG	0.3
hSi	0.22
hOx	0.5
hbox	2
L	5

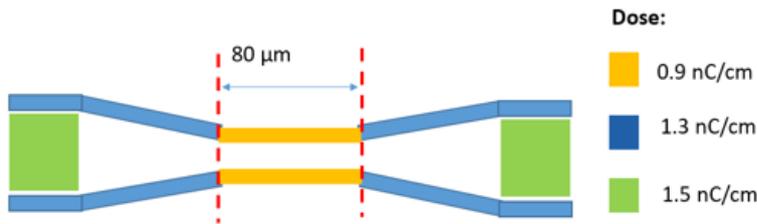
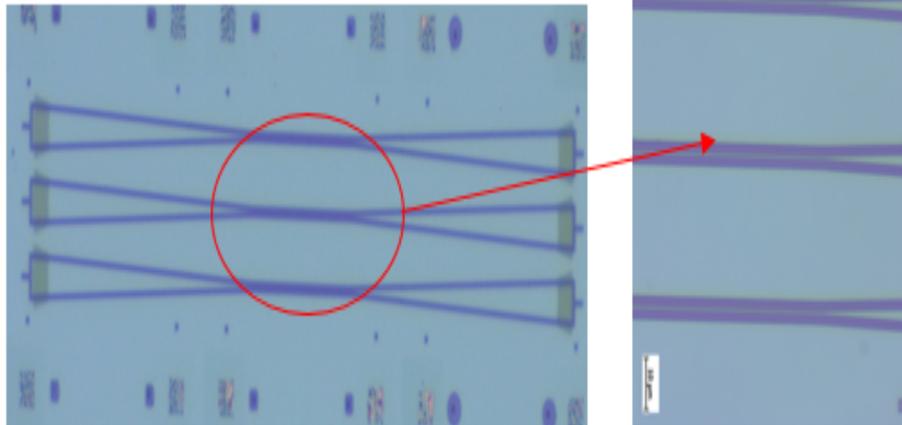
- For the fabrication of silicon waveguides terminated with grating couplers, we used Electron-Beam Lithography (EBL).

Fabricated device

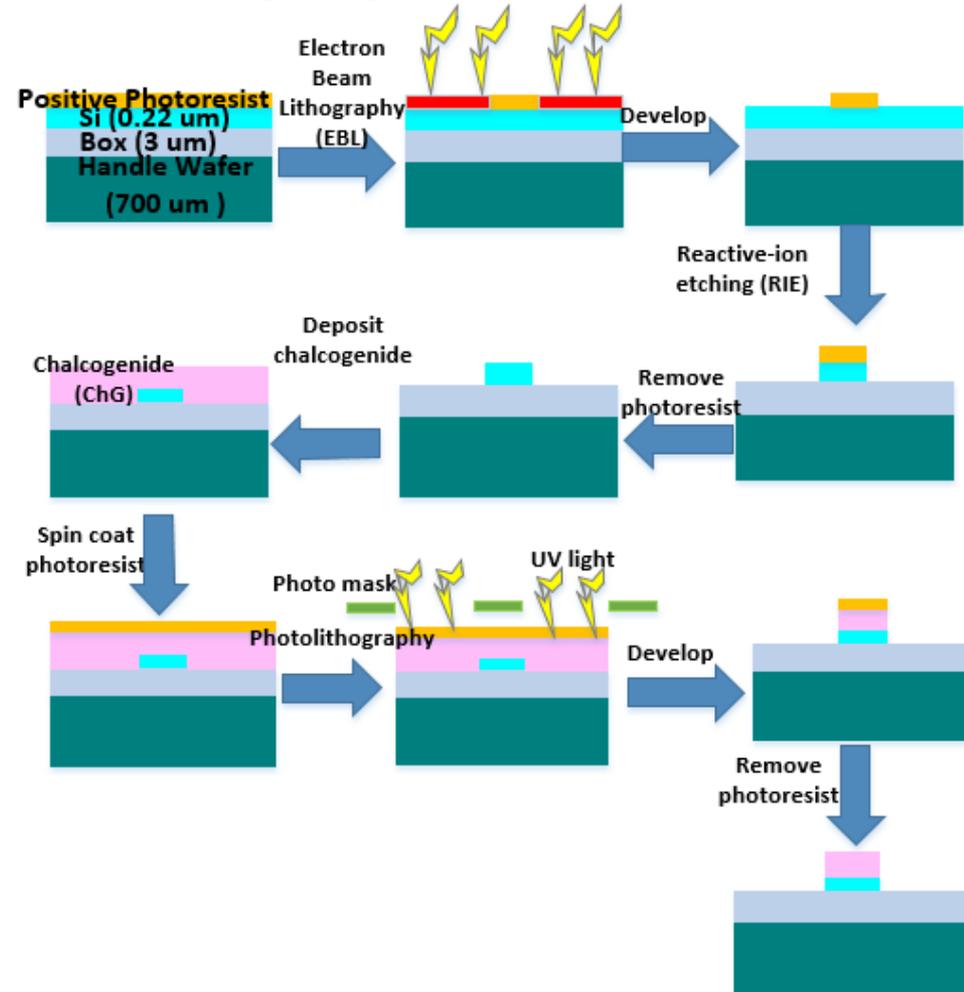
Process flow for fabricating Hybrid Silicon:ChG Waveguide based Plasmonic Temperature Sensors

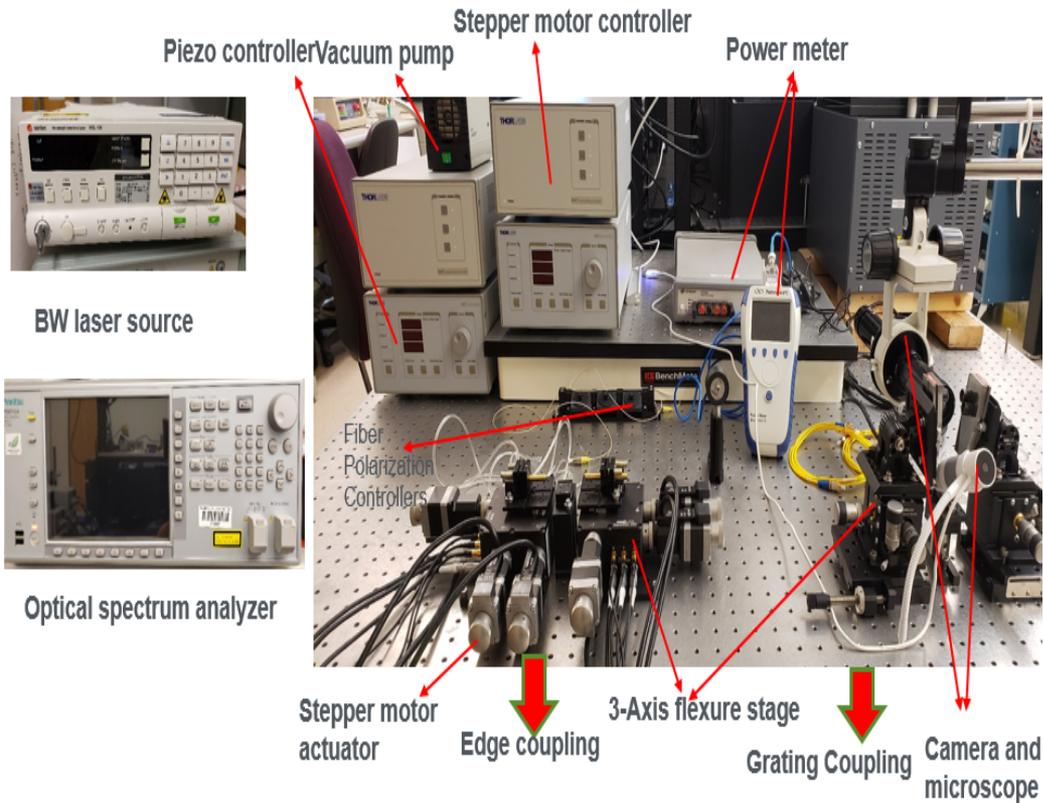
- The device is characterized with the grating coupler set up at Boise State University.

Waveguide characterization setup at Boise State University

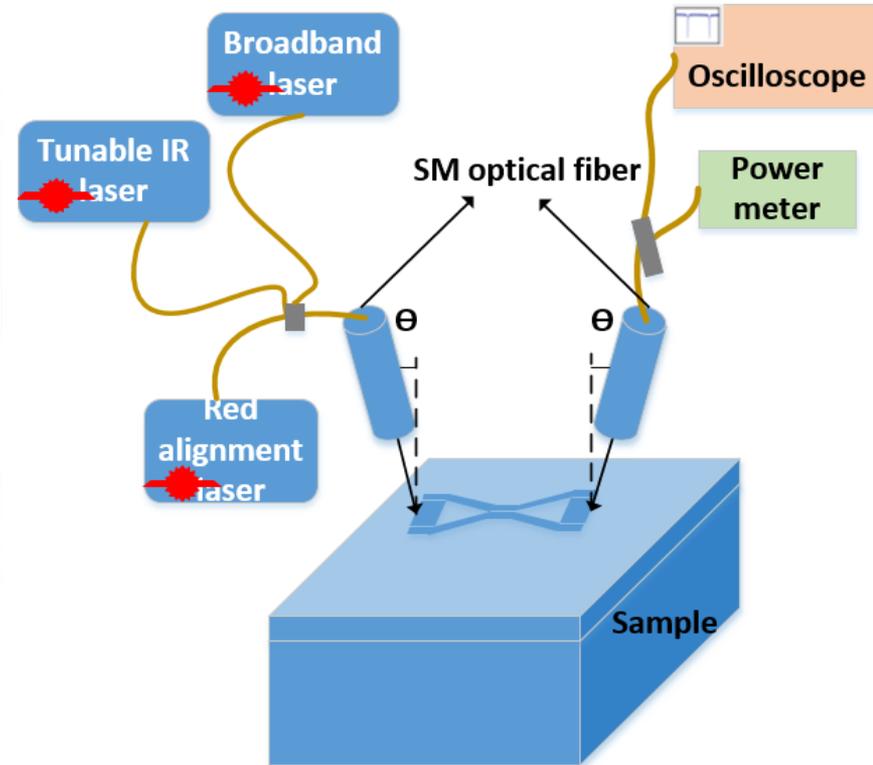
Waveguide testing setup schematic

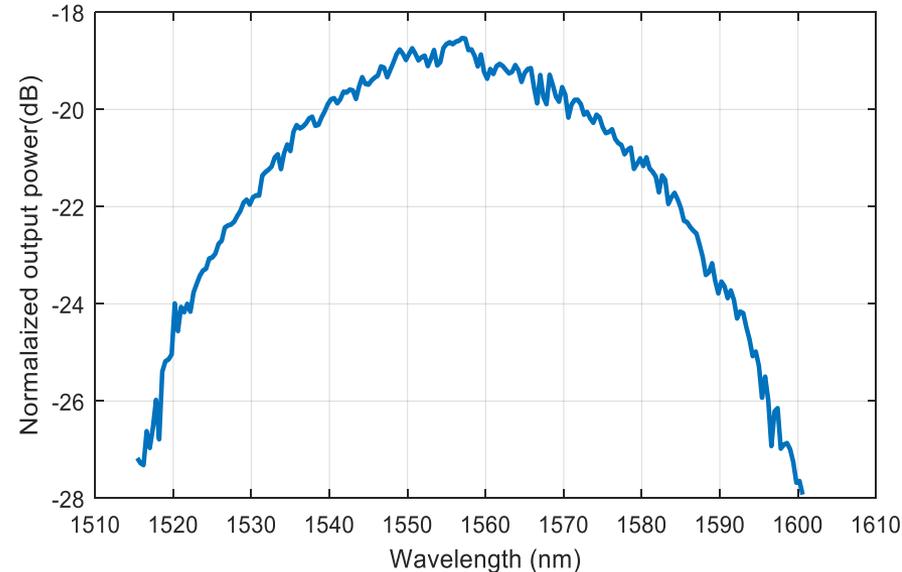
- Measured maximum transmission is -18.53 dB.
- Each grating coupler has  $\sim 8$  dB loss by considering negligible loss in taper and waveguide loss.
- The 1 dB and 3 dB bandwidths are 24 nm and 51 nm, respectively
- Peak wavelength is shifted from 1550 nm wavelength to 1557 nm due to fabrication error during patterning with EBL.
- The fabrication yield is very low due to random spots at different locations (beam blanker leakage) and some devices shows very high loss.

Normalized measured transmission spectrum

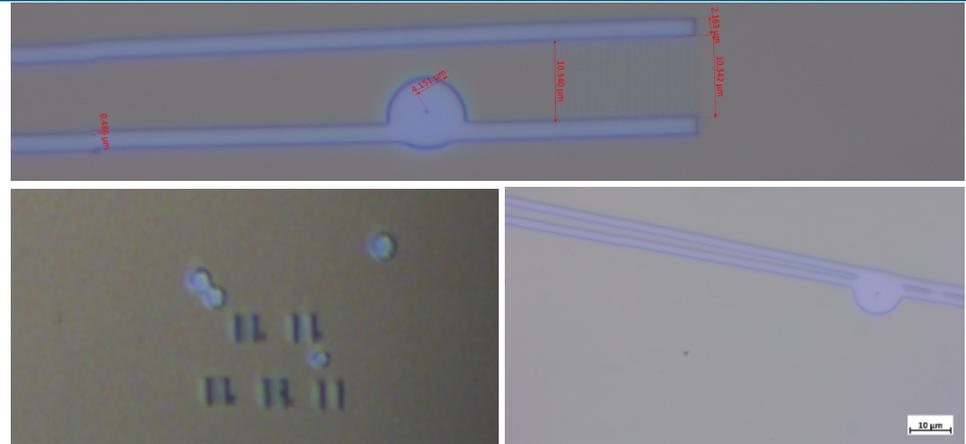
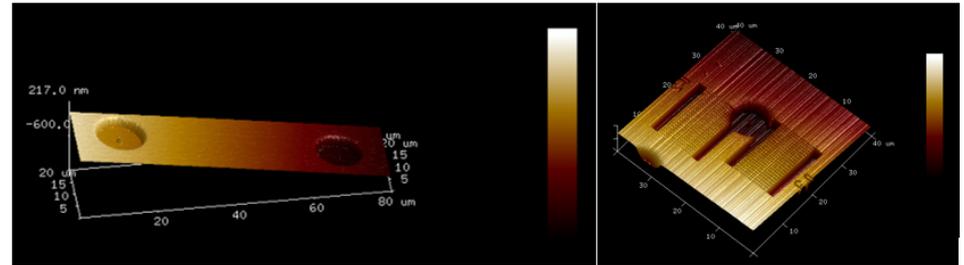
- Since our SEM did not have a fast blanker, the idle time during exposures caused extra exposure dots at the endpoints of every pattern.
- During patterning, unwanted beam spots occurred on the pattern as shown in AFM image.

Beam blanker causes extra beam spots during idle time of the exposure.

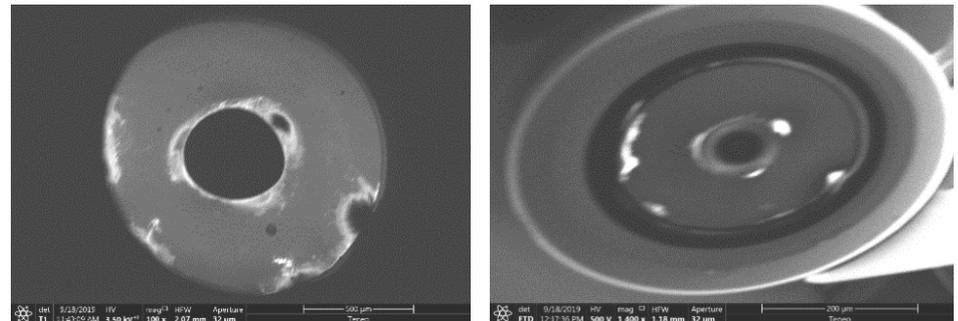
- Heavy contamination/corrosion of the T1 and T2 detectors in the pole piece in FEI TENE0.
- Contaminations will shift the beam and affect the fields in pole pieces.

Heavy contamination in T1 and T2 detectors
