Geology and Groundwater Investigation Many Devils Wash, Shiprock Site, New Mexico

April 2011

LMS/SHP/S06662
ESL-RPT-2011-02

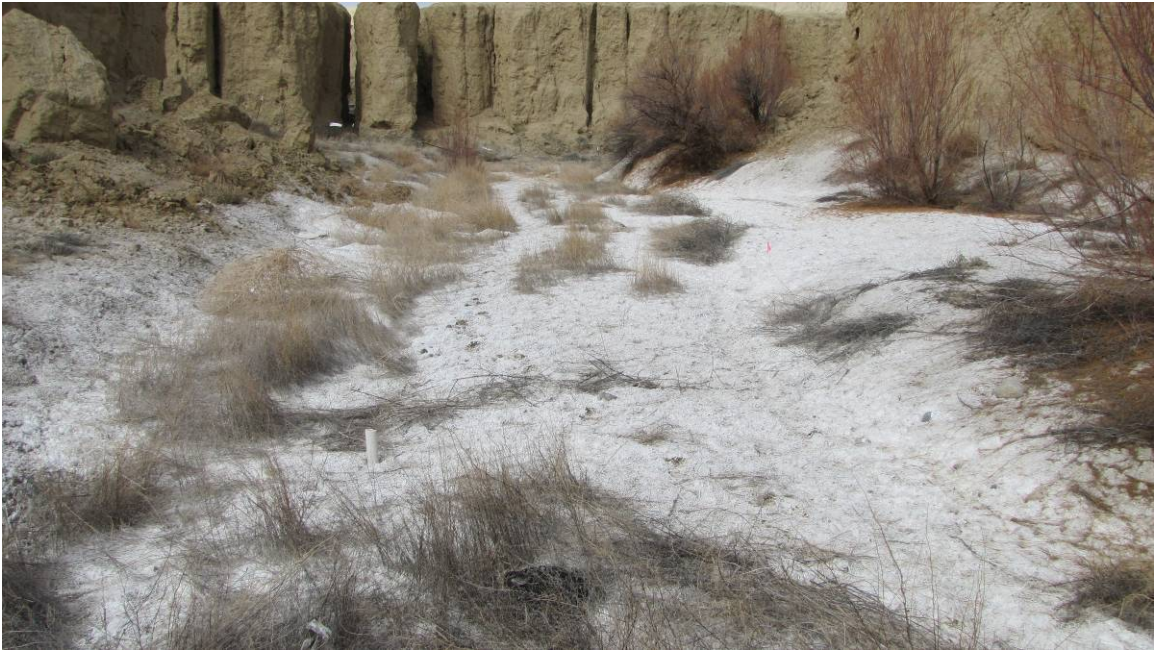
Figure 5. Efflorescence in East Fork
(Looking west, sampling point EF-10 in foreground)

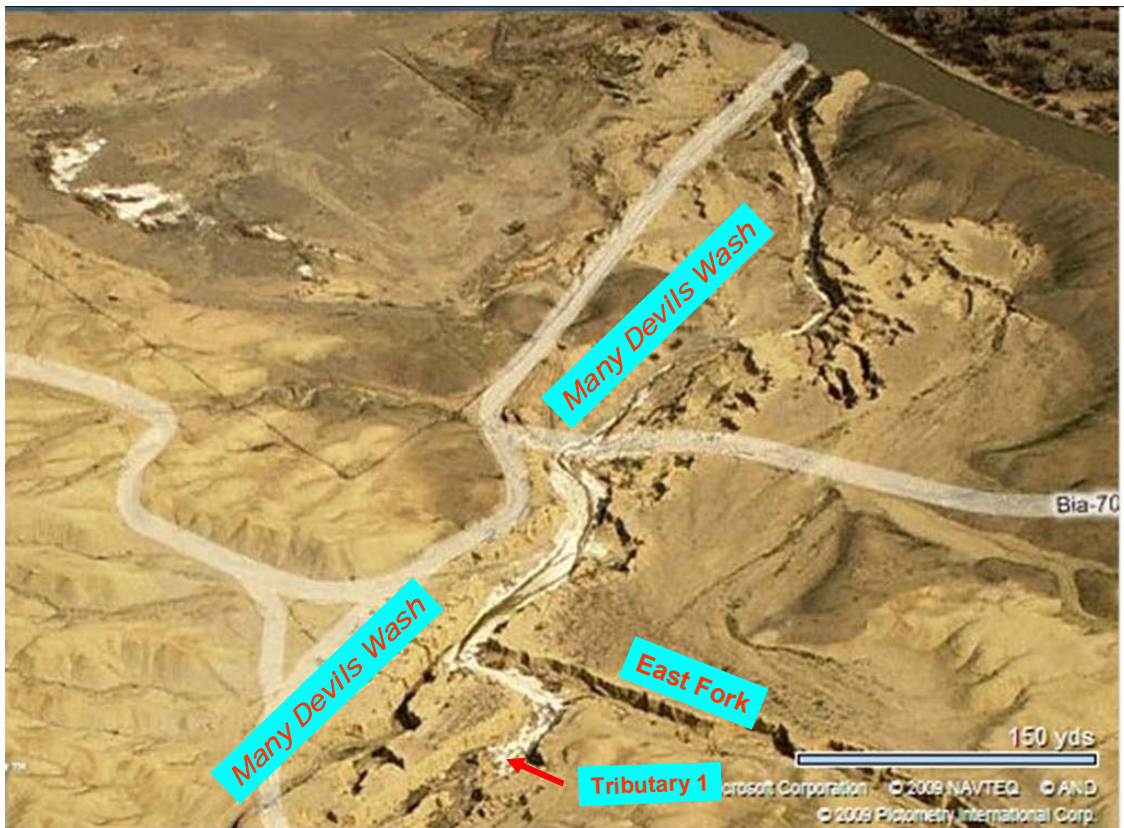
Figure 6. Oblique Air Photo of Project Area Showing Efflorescence Extending from
Tributary 1 to the Mouth of Many Devils Wash
(Farthest upstream efflorescence is at the tip of the Tributary 1 arrow.
Photo base is from the Microsoft Bing website.)

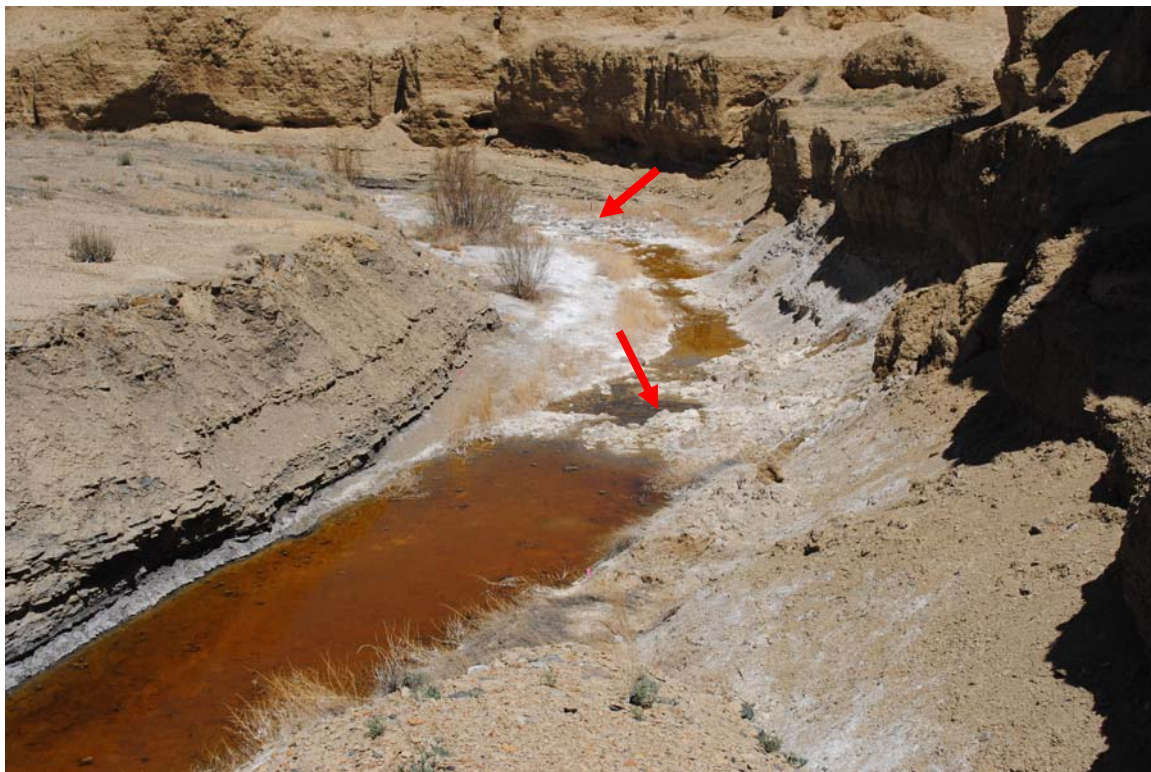
Figure 7. Standing Pools of Red-Colored Water are Typical of Many Devils Wash. Cobbles (arrows) placed to cover the standing pools of water have mostly been washed downstream. Photo is taken about 400 ft downstream of the knickpoint seeps, looking north.

Pools of yellow- to red-colored water are common in the stream channel of Many Devils Wash (Figure 7). The color of the water depends on its depth. Where the water is less than several inches deep, it is light yellow, but where the depth is more than about 1 ft, the color is deep red. The source of the yellow and red colors has not been determined. The pools contain high concentrations of nitrate, selenium, sulfate, and uranium, which are constituents found as groundwater contaminants near the former mill site. These same constituents are detected in groundwater that feeds a line of seeps along the eastern side of Many Devils Wash below the knickpoint seeps. Because these constituents are found at the former mill site, DOE considers Many Devils Wash to have been contaminated by the milling operation and is accordingly engaged in remediation of the wash (DOE 2000, 2002, 2004).

To limit access to the surface water in Many Devils Wash, two interim actions were conducted in the summer and fall of 2000. The wash was fenced to prevent access by cattle, and a cobble blanket was used to cover contaminated pools. In July 2001, flooding caused major removal of the cobble blanket, rendering it relatively ineffective for access control (Figure 7). In

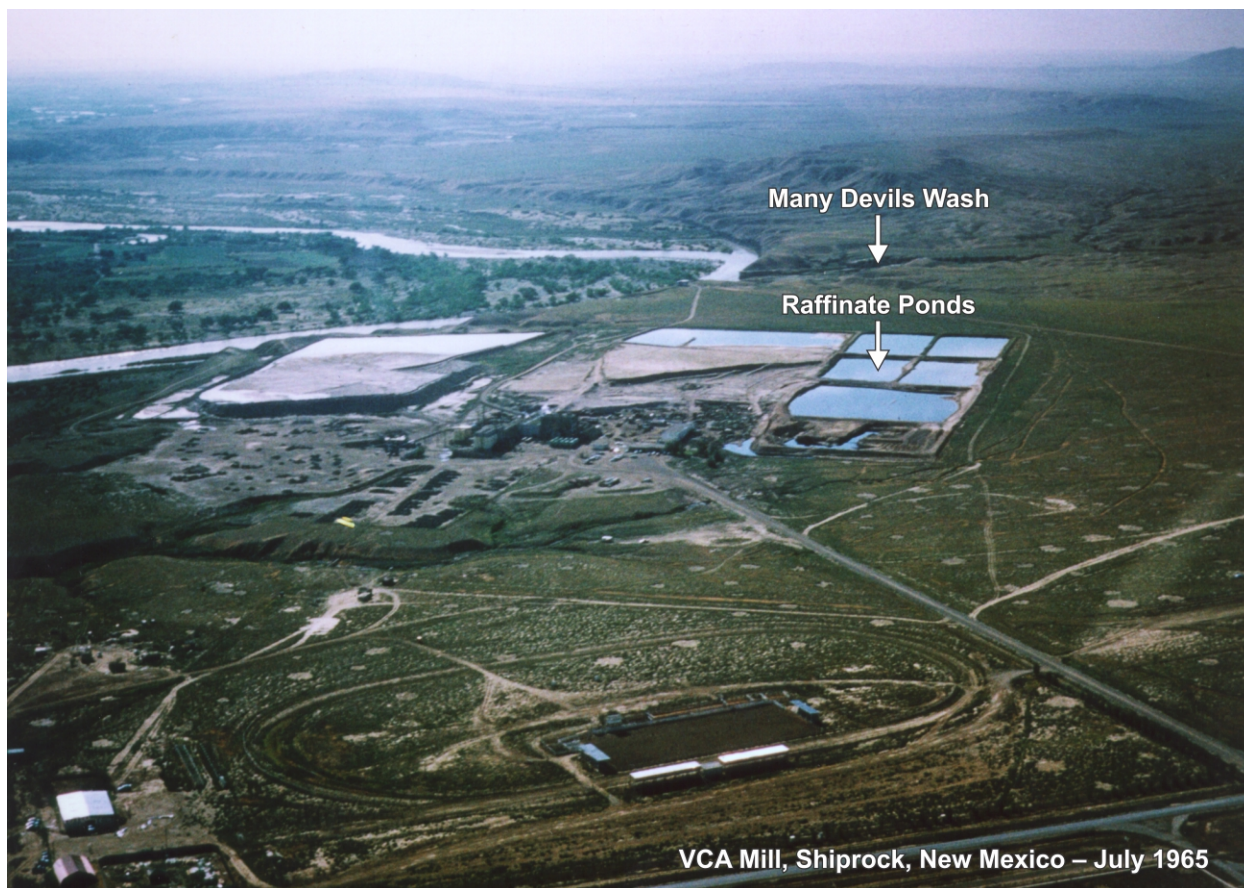
Figure 8. 1965 Aerial Photo of Mill Site Looking East and Showing Locations of Raffinate Ponds and Many Devils Wash

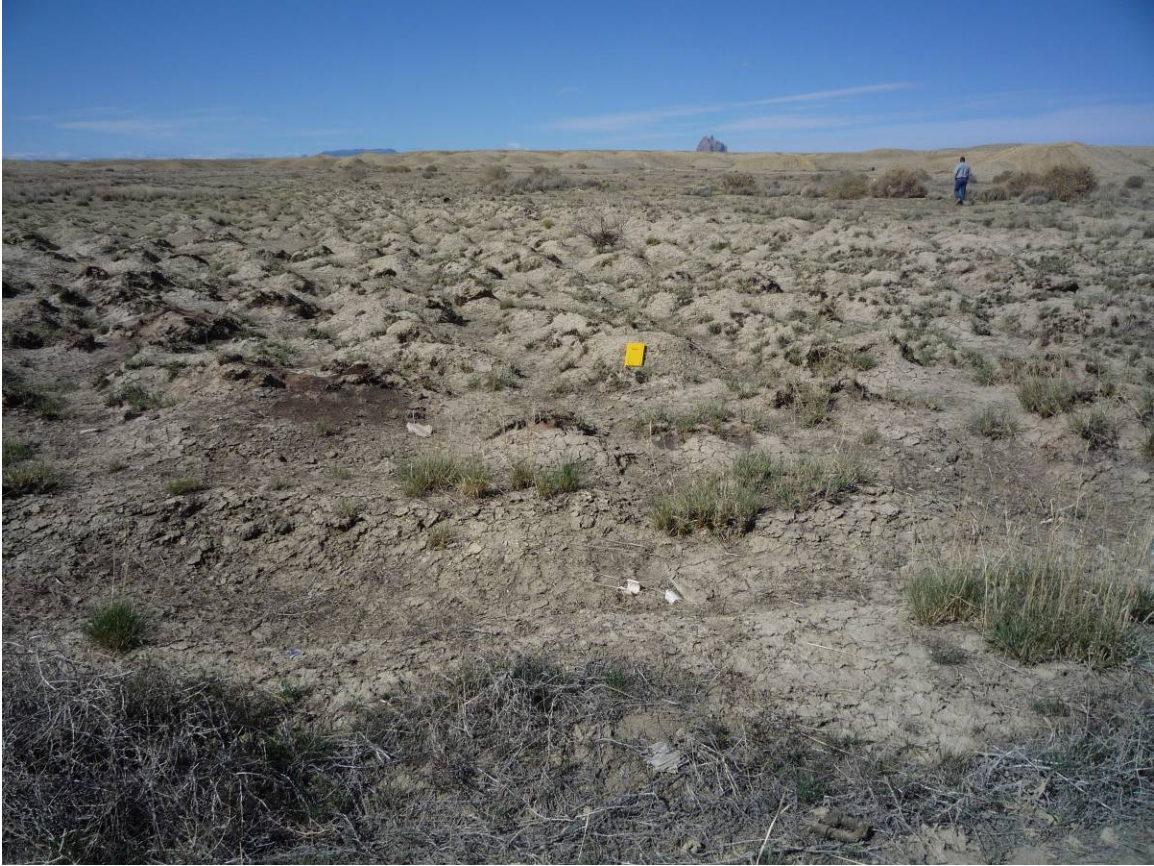
Figure 13. Mounded Surface about 250 ft South of the Head of Incision of Many Devils Wash

Approximately 250 ft south of the head of incision in Many Devils Wash (immediately southwest of the rf unit on Figure 10), where the loess-filled valley is wide and flat, is a several-acre area that contains small, roughly circular mounds 1 to 2 ft high and about 2 ft across (Figure 13). The mounds often have vegetation growing on them indicating that they form by differential erosion around the vegetation. Preliminary field reconnaissance suggests that occurrences of this feature coincide with headward erosion of deeply incised channels in the loess formed by the sapping process.

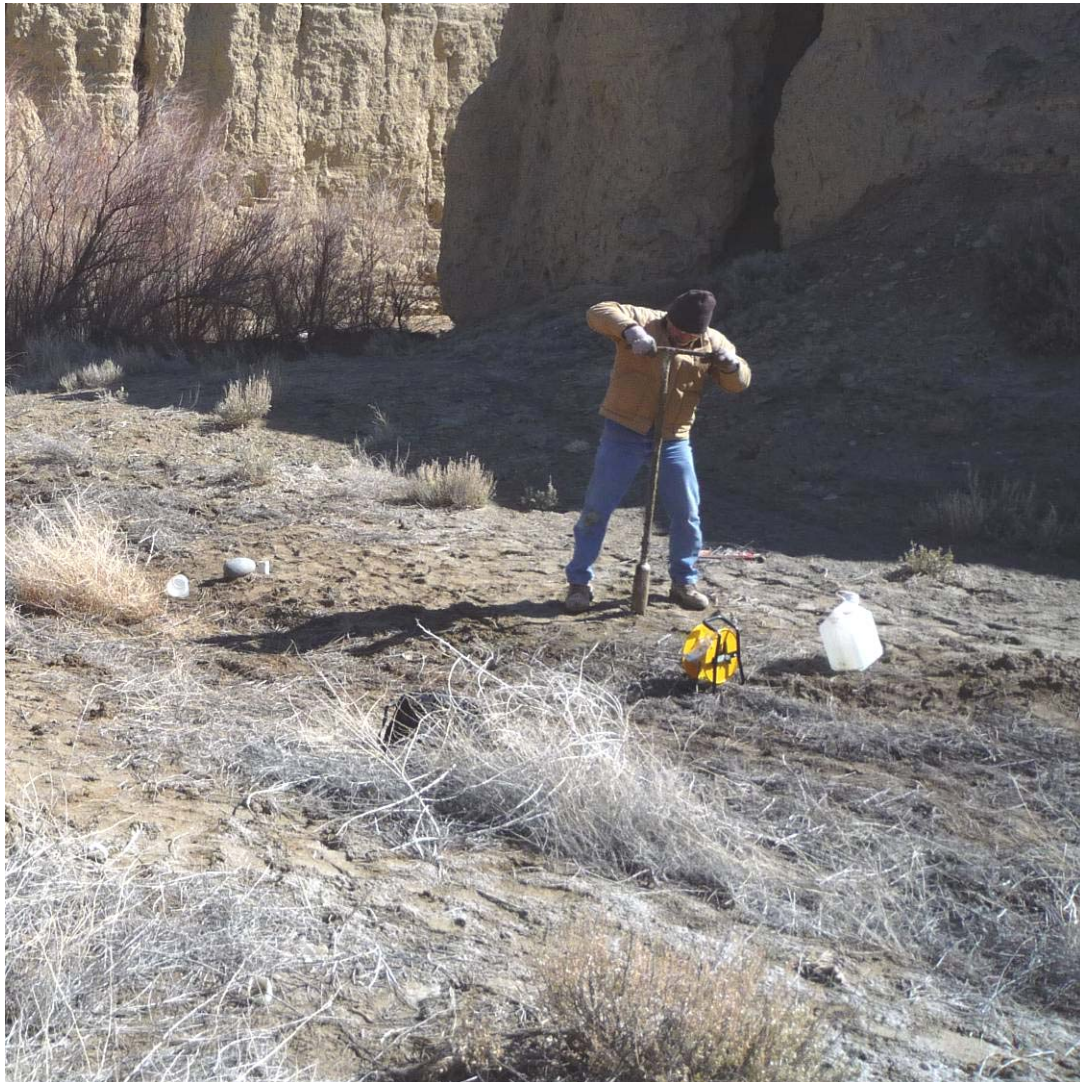
Figure 14. Sample Point Being Installed in Tributary 1 Using Hand Coring Device

Sampling points, mapped in Figure 3 and Figure 4, were installed with a hand-held coring tool (Figure 14). At the desired depth, the coring tool was removed, and a 2-inch-diameter PVC pipe with 1 ft of slotted casing near the bottom and a cap was pushed into the hole. In most cases, the hole remained open and the pipe could be pushed to the full depth that was cored. Hand coring is limited to depths of about 10 to 15 ft in these soils. Sand was poured into the annulus and the upper 1 ft was packed with native soil. U.S. Silica Company natural silica 20- to 40-mesh well sand was used in most completions; however, Home Depot–grade "play sand" was used as a substitute when well sand was not available. There did not appear to be a correlation between production rate and the type of sand used.

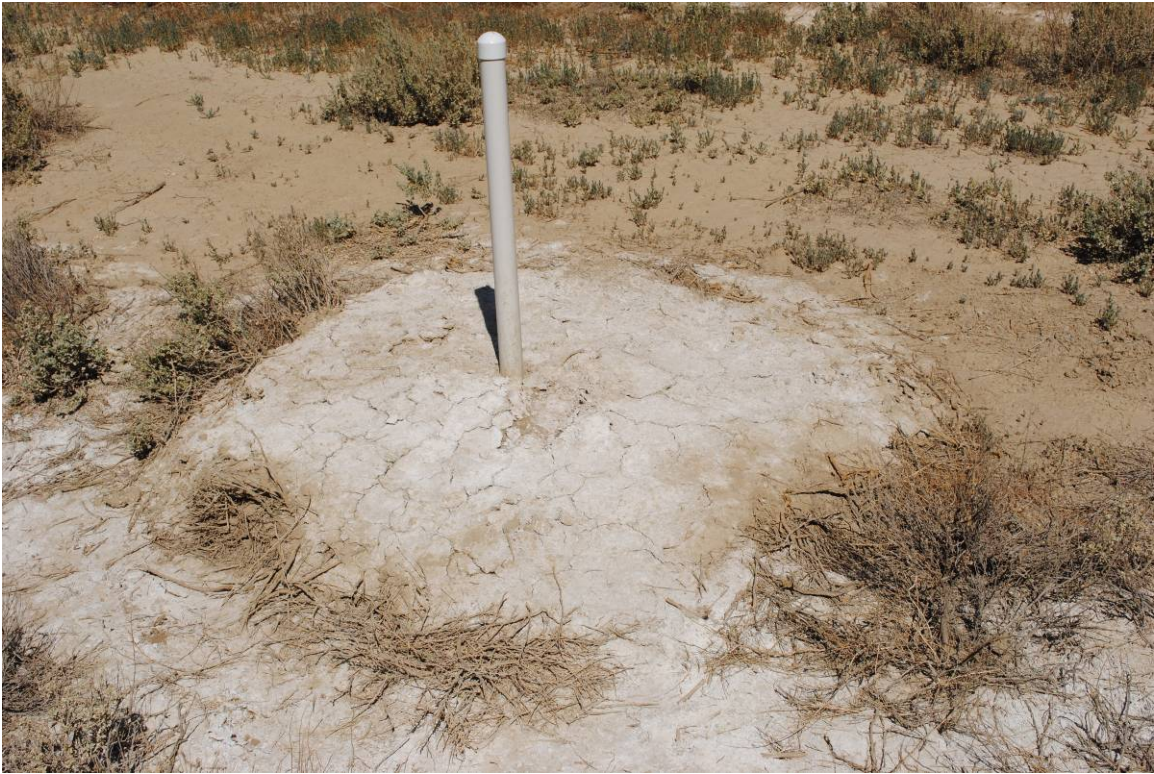
Figure 15. Sampling Point EF-19 Showing Mound Covered by Efflorescence on Ground Surface

Groundwater occurred in Tributary 1 as far south as sampling point EF-19 (see Figure 3). At 0.211 gallon per minute (gpm), sampling point EF-19 had one of the highest water production rates (Table 3). A boring (AH-04) about 80 ft southwest of EF-19 tagged Mancos Shale at about 5.2 ft below ground surface but did not encounter groundwater. Sampling point EF-19 was unusual in that it was bored in the tributary floor on a circular mound about 0.5 ft high covered by efflorescence (Figure 15).

The farthest south sampling point (EF-19) had one of the highest groundwater production rates, suggesting that the southern terminus of groundwater saturation was not reached. Of interest, EF-19 was located on a small (5-ft-diameter) mound of loess caked with efflorescence referred to as a blister. Although not certain, it seems like the formation of this mound is related to the high groundwater surface, perhaps caused by swelling clays. Other features resembling these mounds are found in East Fork between the mouth of Tributary 1 and Many Devils Wash, and in a broad "mounded" area about 400 ft south of the incised channel of Tributary 1 (Figure 13). These features may be related to erosion features formed by groundwater sapping as described by Leopold et al. (1964). Groundwater sapping involves the undercutting of steep-walled arroyos by shallow groundwater and may explain the deeply incised loess channeling in Many Devils Wash and its tributaries. Thus, groundwater in the EF-19 area may originate from percolation through the upgradient loess deposits, movement along the loess-Mancos Shale contact, and emergence in this region of headward erosion of the tributary channels. Alternatively, some or all of the groundwater at EF-19 could be entering from below through fracture flow in the Mancos Shale. For this groundwater to be derived from the tailings area, it may travel deep within the Mancos Shale through fractures and resurface along vertical fractures at unpredictable locations; one such vertical fracture may intercept the loess in Tributary 1. Once the groundwater is in the loess it travels along the loess – Mancos Shale contact to the seepage areas in Many Devils Wash.

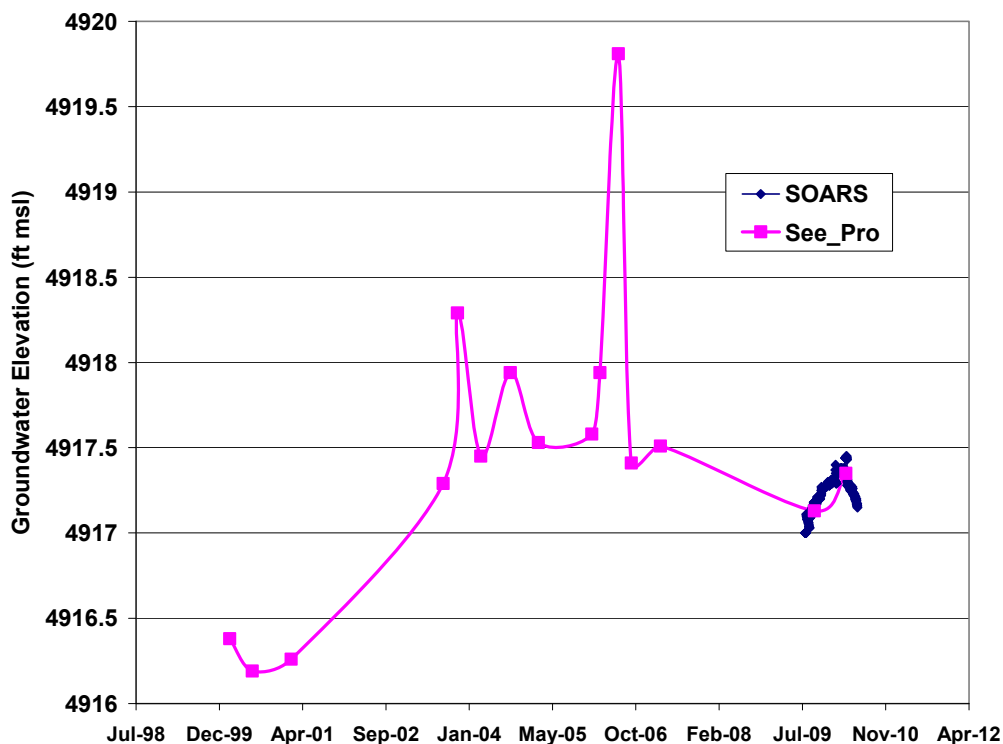
Figure 17. Groundwater Elevations in Well 1049

(Manual measurements are from LM's SEEPro database, datalogger measurements are from SOARS)

Well 1049 is located about 90 ft southeast of the knickpoint seeps; thus, the groundwater level likely correlates with the amount of water flowing at the seeps. Maximum variation in groundwater levels since February 2000 is 3.6 ft (Figure 17). Other than one high value measured on June 27, 2006, the maximum variation is 2.1 ft, and since the SOARS system was installed in July 2009, the levels have varied by less than 0.5 ft. The high value on June 27, 2006, is not associated with a rain event; thus, it may have been a measurement error.

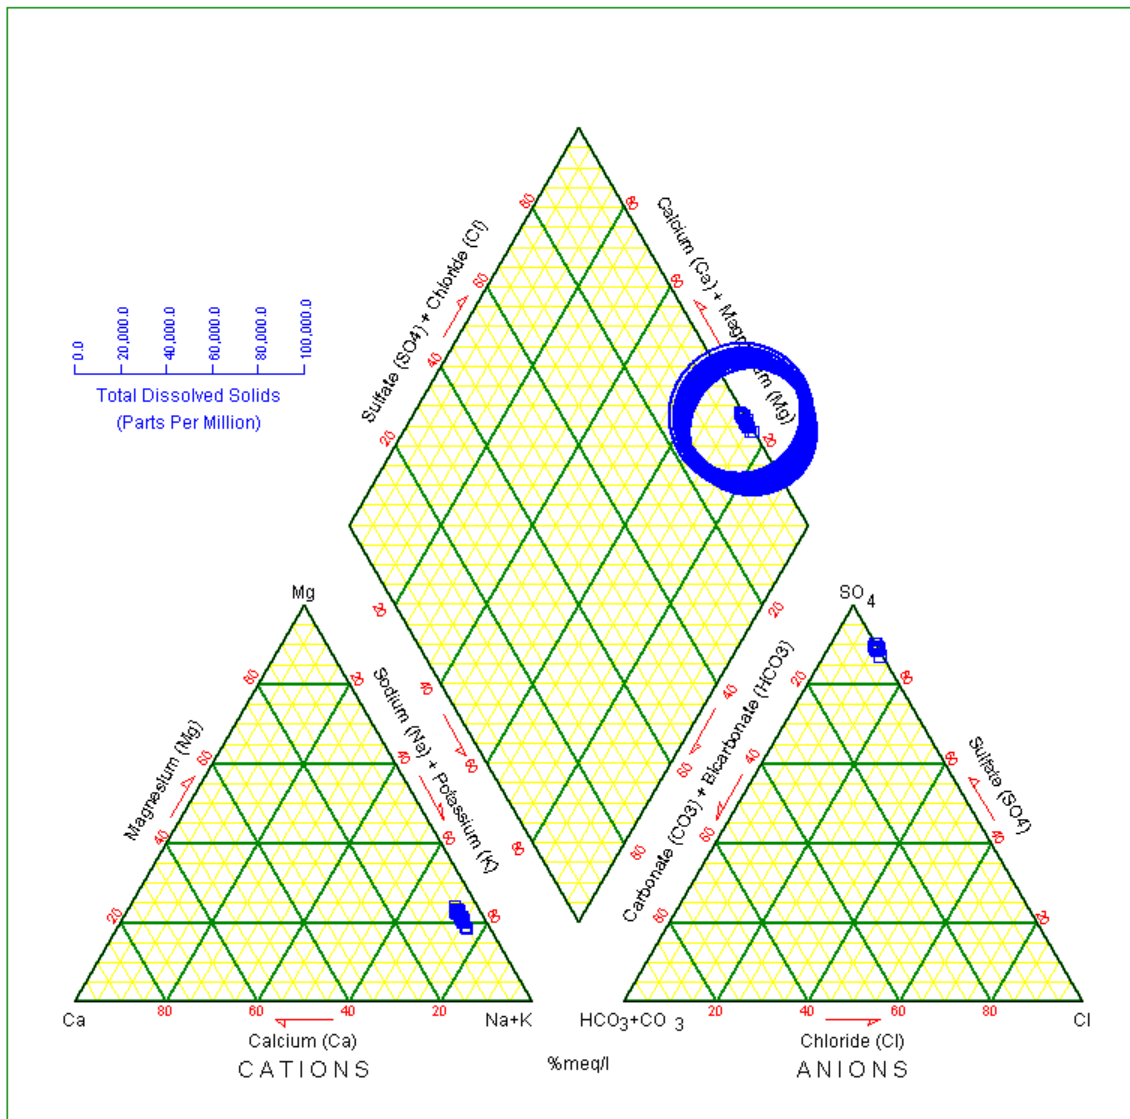
Figure 22. Piper Diagram of Groundwater from EF and MD Points Sampled April 27 and 28, 2010 (The radii of the blue circles on the diamond portion of the diagram display the total dissolved solids content.)

Samples were collected from the EF and MD sampling points on April 27 and 28, 2010, and a complete set of analytical data is provided in Appendix A. The samples were remarkably similar in composition with only a few exceptions. Selenium concentrations ranged from 370 to 1,800 $\mu\text{g/L}$ with a mean of 1,228 $\mu\text{g/L}$ (Figure 18). Most values were near or slightly higher than the mean except at five points along the east side of Tributary 1 with values less than 850 $\mu\text{g/L}$. Uranium concentrations ranged from 133 to 165 $\mu\text{g/L}$ with a mean of 147 $\mu\text{g/L}$ (Figure 19). There is little variability in the distribution of uranium, and few points were more than one standard deviation (8 $\mu\text{g/L}$) removed from the mean. Nitrate (as NO_3) concentrations ranged from 2,157 to 3,087 mg/L , with a mean of 2,494 mg/L (Figure 20). The nitrate concentrations are fairly uniform, with the lowest and the highest values occurring in the same general area of East Fork. Sulfate concentrations ranged from 16,524 to 20,315 mg/L with a mean of 17,318 mg/L (Figure 21). The distribution of sulfate is also rather uniform. The similarity of major ion chemistry is demonstrated on a Piper diagram (Figure 22). The groundwater data from all the

sampling points plot in a small area on the Piper diagram. The groundwater is dominated by sodium sulfate with a mean total dissolved solids content of 27,796 mg/L.

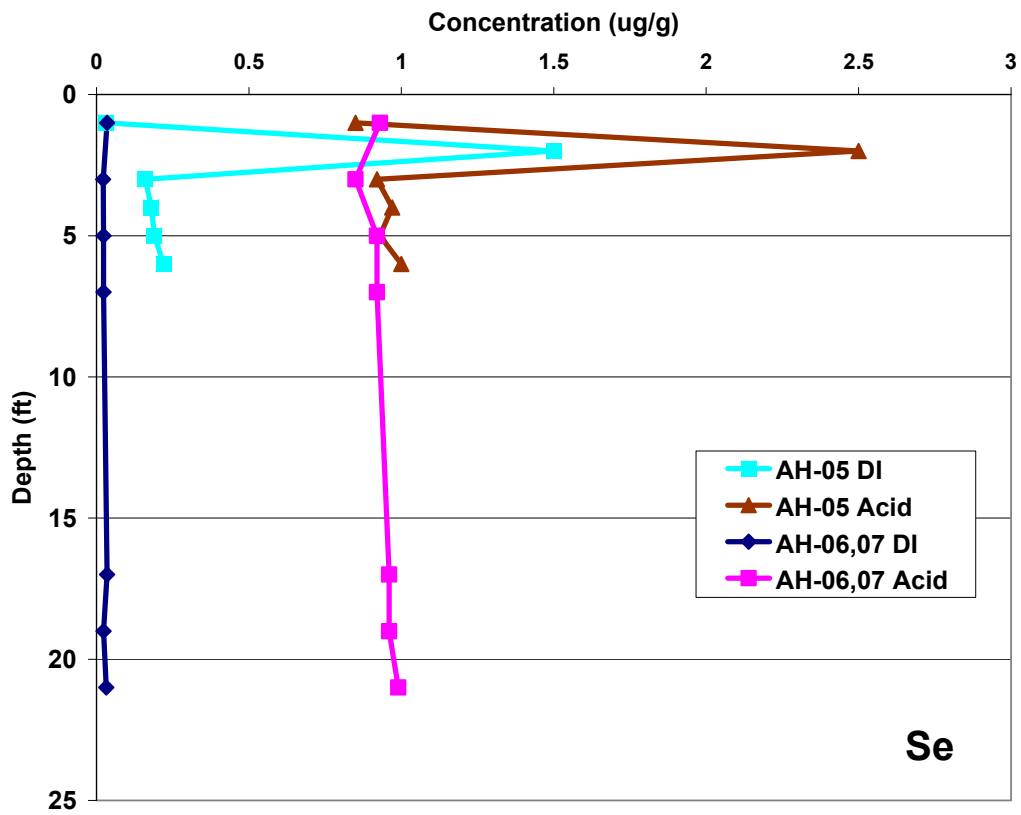
Figure 23. Selenium Concentrations with Depth in Loess at Locations AH-05 and AH-06,07 (DI - deionized water extraction, Acid = nitric acid microwave digestion)

Selenium concentrations in the loess samples ranged from 0.022 to 2.5 $\mu\text{g/g}$ with a mean of 0.62 $\mu\text{g/g}$. In all samples, more selenium was extracted using nitric acid than deionized water (Figure 23). Only one sample, AH-05 at 2 ft, had a selenium concentration that exceeded 1 $\mu\text{g/g}$. The highest selenium concentrations were in samples from boring AH-05, located near the knickpoint seeps. Concentrations of selenium were less than 1 $\mu\text{g/g}$ at all depths in borings AH-06,07, which are located upstream of any known contamination.

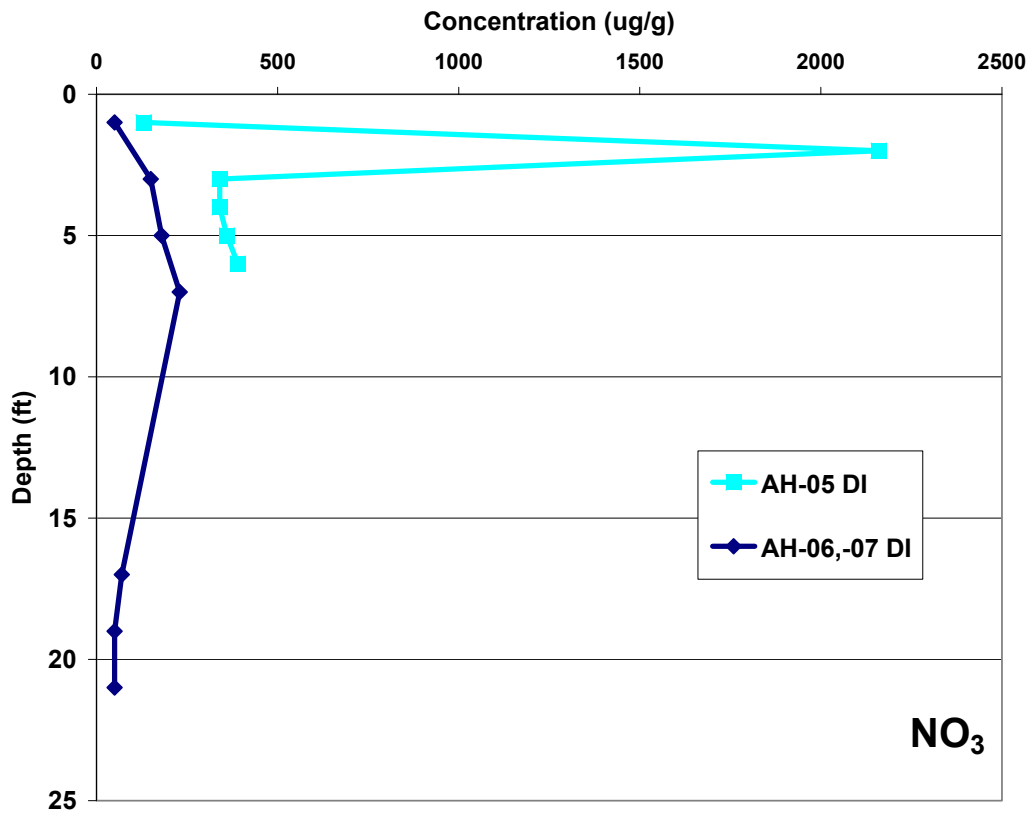
Figure 24. Nitrate Concentrations with Depth in Loess at Locations AH-05 and AH-06,07 (DI - deionized water extraction)

Nitrate (as NO_3) and sulfate were analyzed in the deionized water extractions but not in the nitric acid digestions. Nitrate concentrations ranged from 130 to 2,160 $\mu\text{g/g}$ (Figure 24) and sulfate ranged from 1,910 to 29,090 $\mu\text{g/g}$ (Figure 25) in loess samples from borehole AH-05. Concentrations were lower in samples from upstream locations AH-06,07; nitrate ranged from 50 to 230 $\mu\text{g/g}$, and sulfate ranged from 270 to 12,600 $\mu\text{g/g}$.

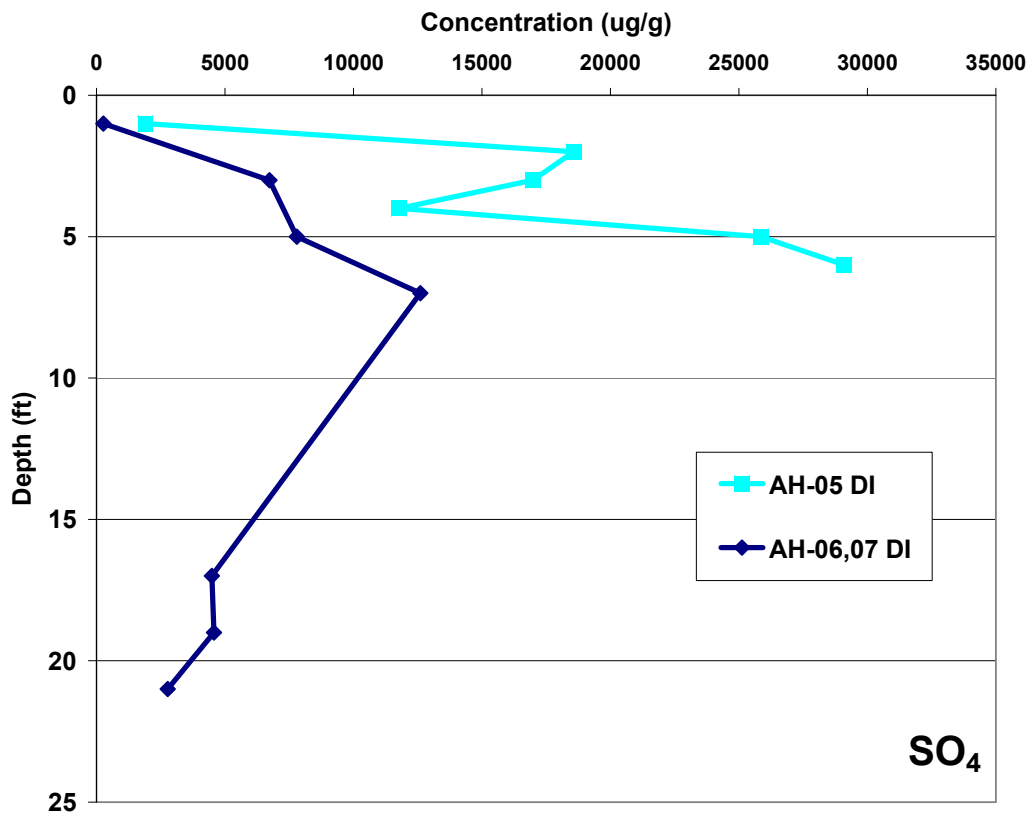
Figure 25. Sulfate Concentrations with Depth in Loess at Locations AH-05 and AH-06,07 (DI - deionized water extraction)
