PNNL-21692

Nondestructive Examination (NDE) Detection and Characterization of Degradation Precursors

Technical Progress Report for FY 2012

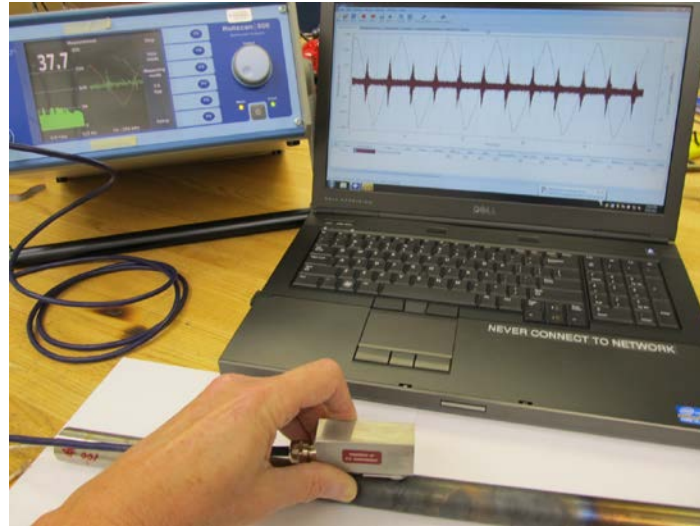
Figure 3.3. Stresstech Model 300 Rollscan with Microscan 600 Controller Software

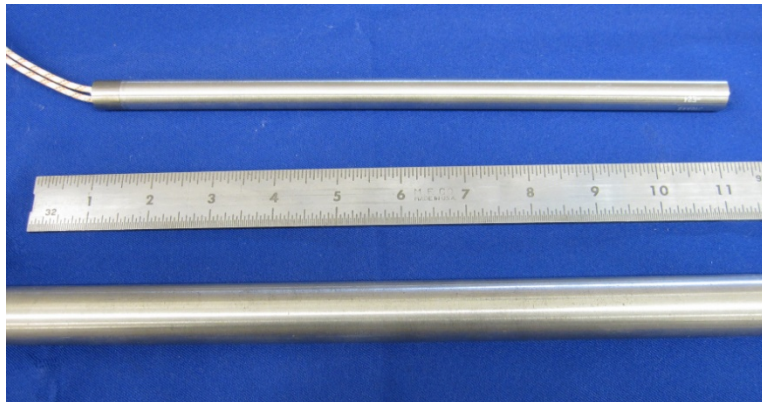
Figure 3.5. Example of Tubular 304SS Specimen and Cartridge Heater

As indicated earlier, thermal fatigue was chosen as the other degradation mechanism in the initial phase of this project. Tubular specimens (Figure 3.5) were selected to obtain a bench-scale thermal fatigue setup that also enabled relatively easy online nondestructive monitoring. The tubular specimens were heated from the inside with periodic cooling on the outside. Heating was accomplished by means of a cartridge heater on the inside of the hollow specimen (Figure 3.5), while cooling using the water spray was from the outside. The resulting thermal stresses initiate a crack (thermal fatigue crack) on the outside surface of the hollow specimen, providing easy access for both online (either continuously or in interrupted test mode) and offline (i.e., by removing the specimen from the test setup) NDE measurements as well as planned destructive analysis of the specimens.

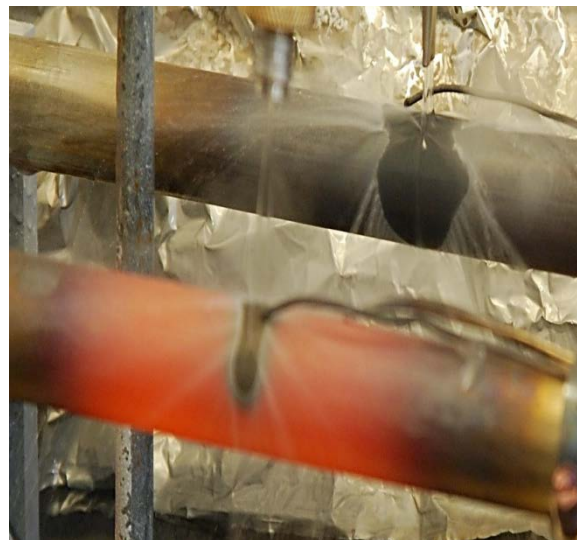
Figure 3.7. Thermal Fatigue Setup Operation. The upper sample has cooled below the visible thermal temperature while the lower sample has just started the cooling cycle and is still red hot. The shape of the water jets can be seen in this photo, most clearly for the upper sample.

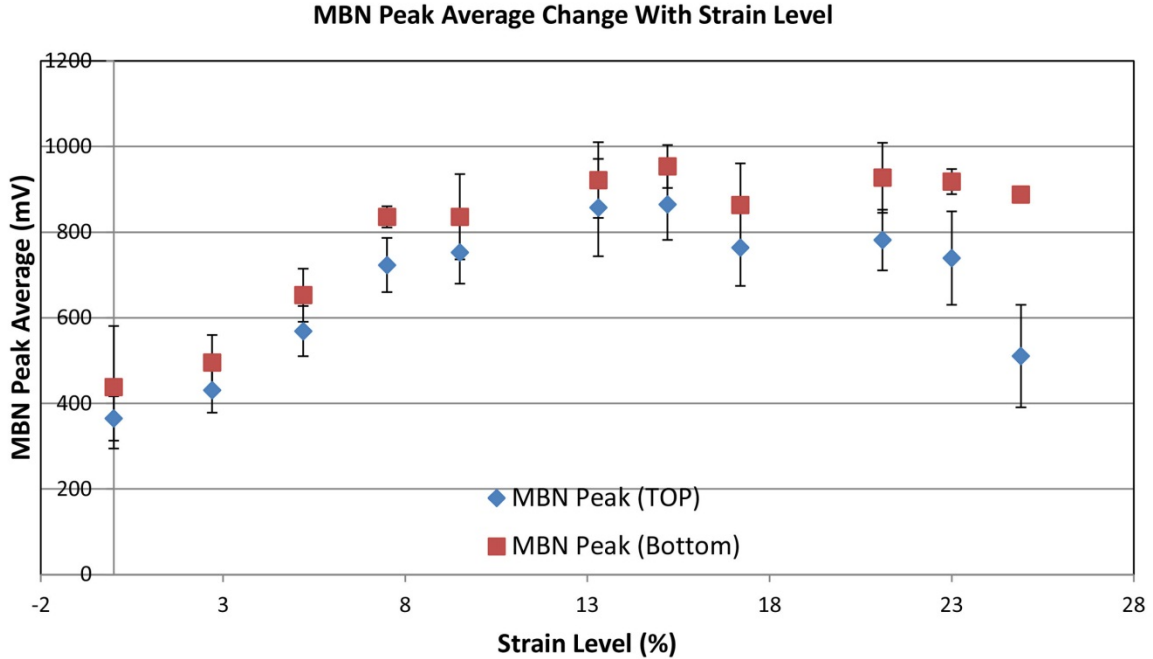
Figure 4.1. MBN Peak Average (in mV) as a Function of Strain Level in 410 Grade Steel. Magnetization direction was parallel to applied strain direction.

Figure 4.1 presents the averaged peak voltage from the magnetic Barkhausen measurements on a single specimen, at the TOP and BOTTOM locations, as a function of the strain level. The magnetization direction was parallel to the applied strain direction. The specimen failed shortly after the last measurement taken at 24.9% strain. The table also lists the standard deviation at each location (computed from the three measurements at that location), which is a measure of experimental noise.

Figure 4.1 also indicates that the measured MBN voltage increases initially during the elastic strain regime (and perhaps into the plastic strain regime), before decreasing as plastic deformation increases. The table also shows that the measurements from the two locations are generally not similar (within one standard deviation of each other), except at very early stages of degradation. This could be an indication of variability in specimen microstructure and localized variations in processing. It is also likely that variability in the measurement process (manual probe placement) contributed as well. Figure 4.2 shows the average difference between the top and bottom measurements, as well as the mean damage index (DI), which is the average difference normalized to a value between 0 and 1. The normalized differences are also used to compute the standard deviation in the damage index, which is also listed in Figure 4.2.

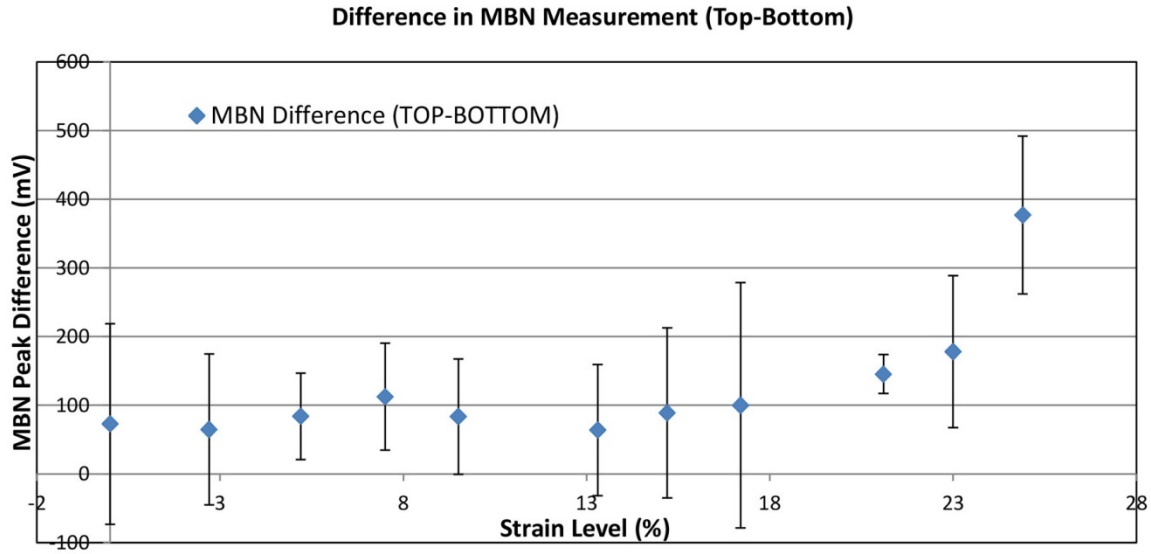
Figure 4.2. Difference in MBN Measurements at TOP and BOTTOM Locations on Single Specimen, as a Function of Strain Level

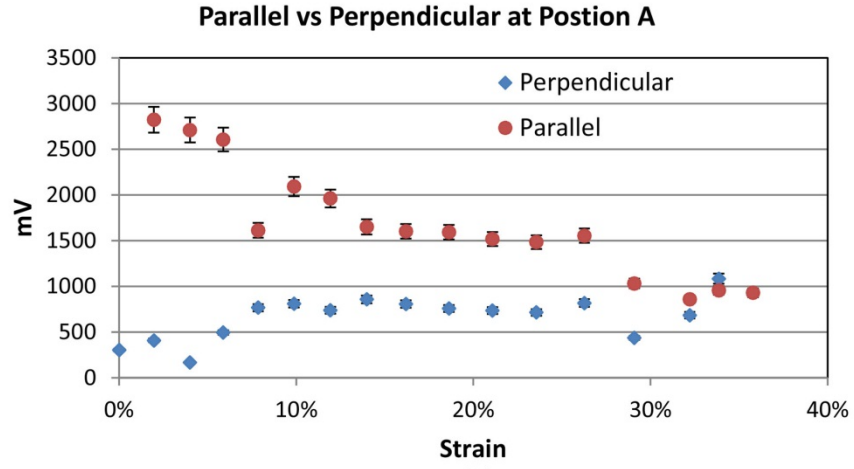
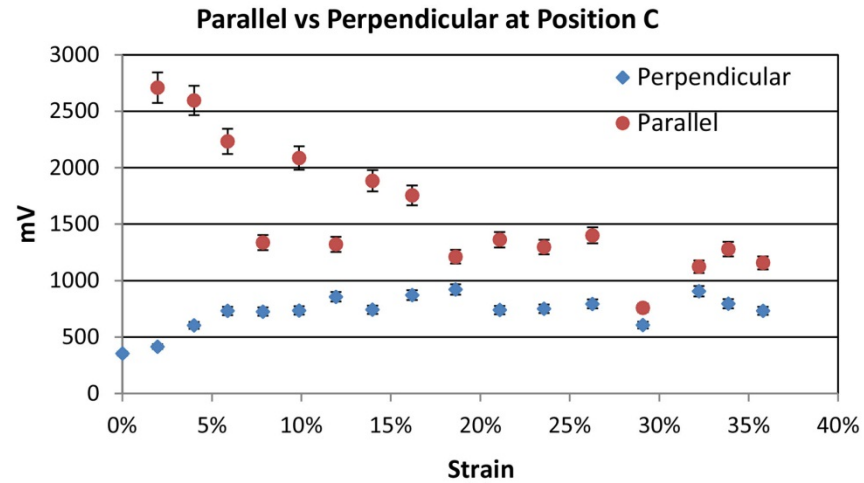
Figure 4.3. Impact of Magnetization Direction Relative to Strain Direction on MBN Measurements, as a Function of Applied Strain Level at Three Locations: (a) TOP, (b) CENTER, (c) BOTTOM

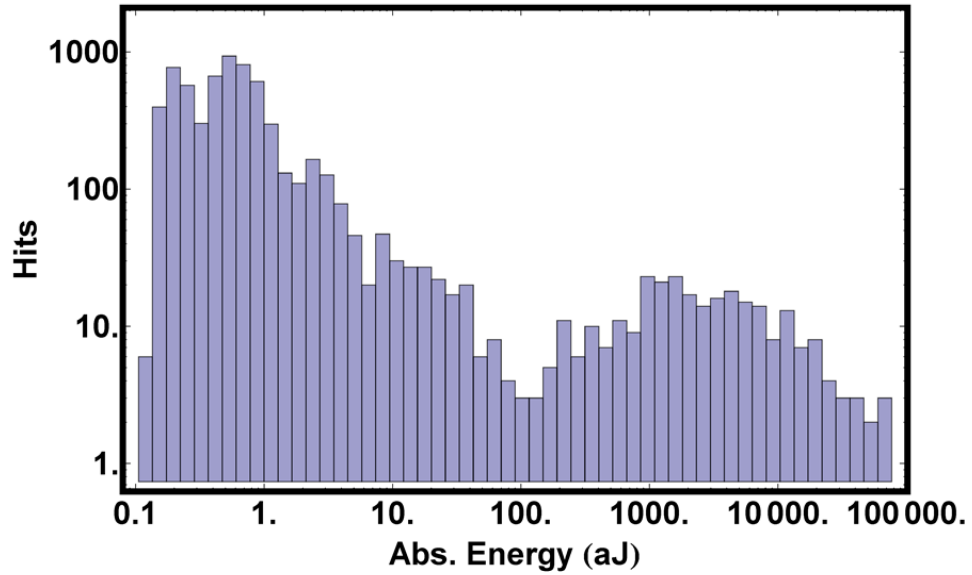
Figure 4.12. Energy Spectrum of Background Signals (< 190 kHz) Collected During Interval 1

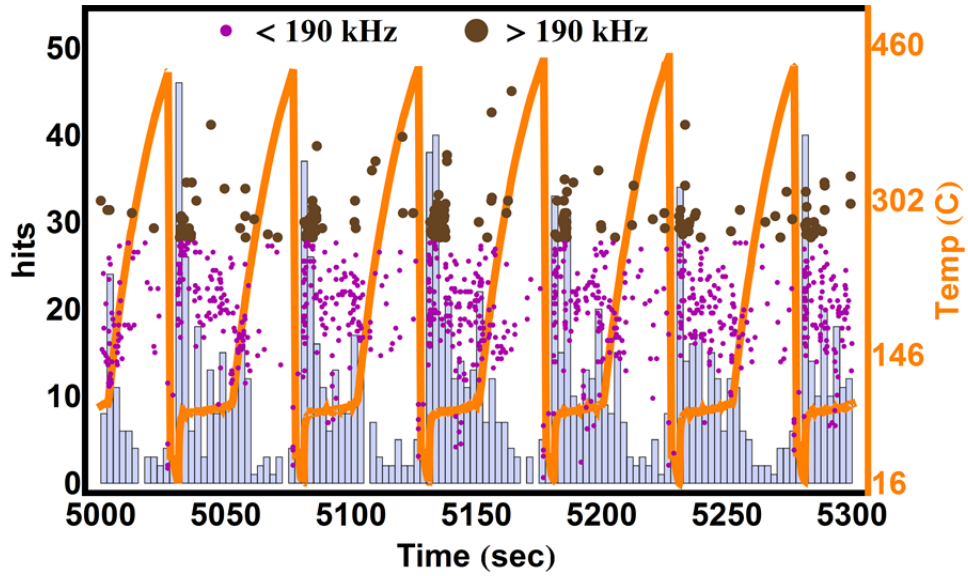
Figure 4.14. AE Activity Collected Over Six Thermal Cycles During Interval 9 Along with a Plot of the Thermocouple Signal During These Cycles; Signals with Centroid Frequency Greater Than 190 kHz are Highlighted Using Enlarged Dots

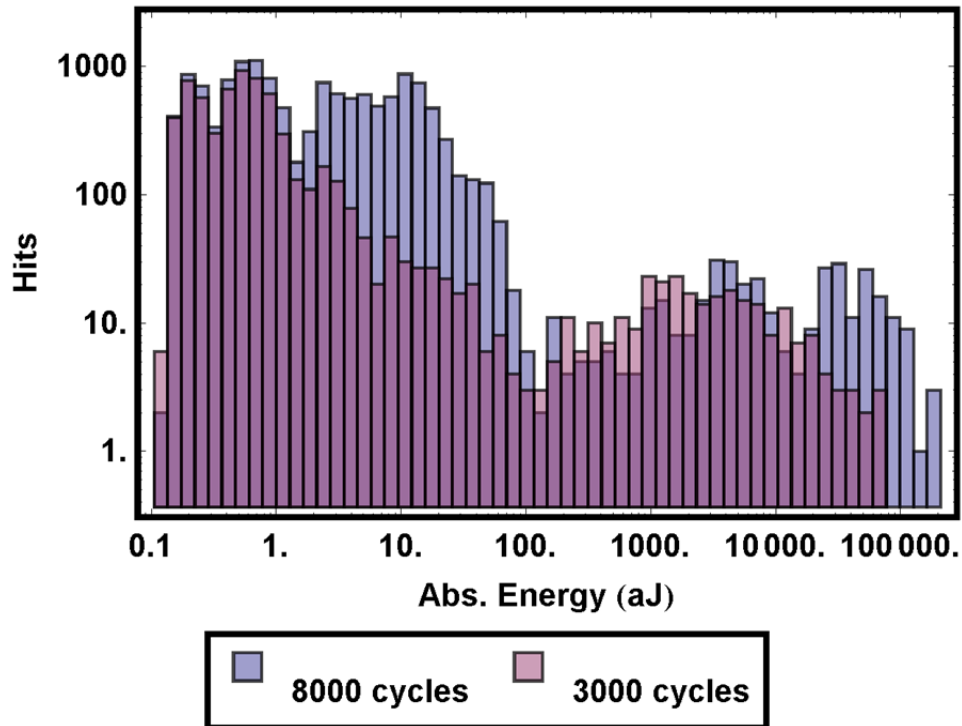
Figure 4.16. Energy Spectrum of Signals with Centroid Frequency Greater Than 190 kHz for Intervals 1 and 10

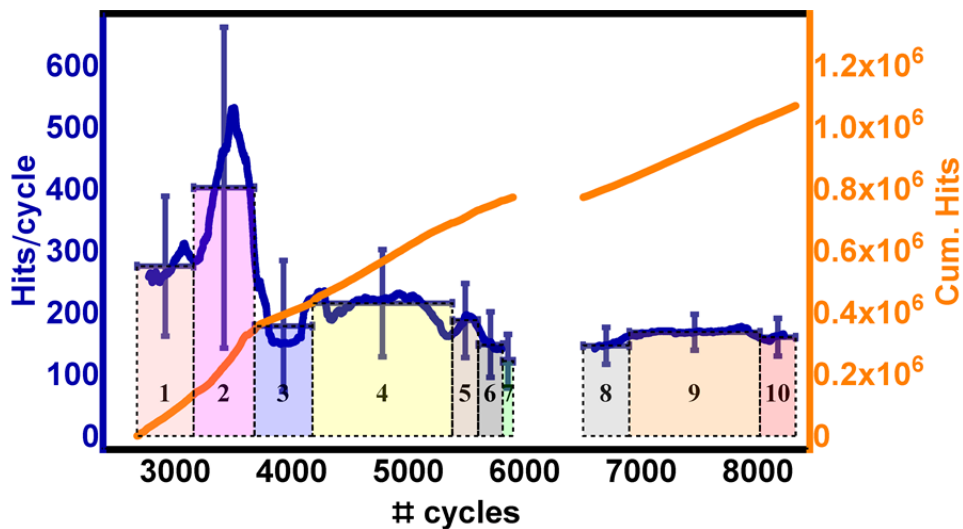
Figure 4.20. AE Activity of the Remaining Signals in Interval 1 to Interval 10 After Removing Signals with Centroid Frequencies Greater Than 190 kHz and Energies in the Range of 5 aJ–100 aJ
