**INDUSTRIAL WASTEWATER CLOSURE MODULE FOR THE
LIQUID WASTE TANKS 18 AND 19
F-AREA TANK FARM, SAVANNAH RIVER SITE**

Industrial Wastewater Construction Permit No. 17,424-IW

Prepared by: Savannah River Remediation LLC
Closure & Waste Disposal Authority
Aiken, SC 29808

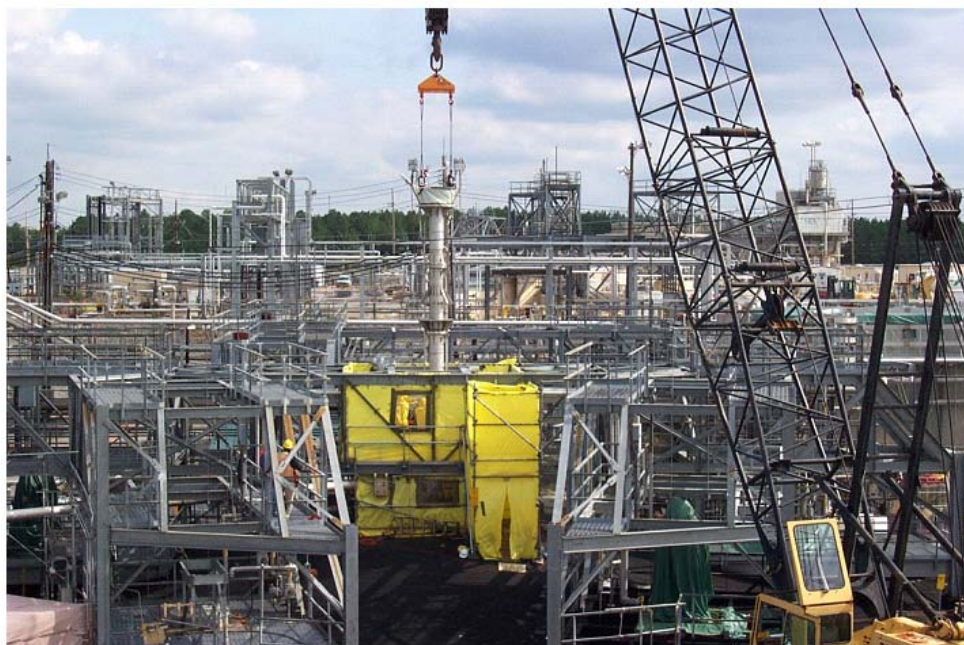
Figure 2.1-3: Examples of Structural Steel Support Systems

A structural steel support system was later added to both Tank 18 and Tank 19 to support equipment used in their respective waste removal campaigns (Figure 2.1-3). [SRS-REG-2007-00002]

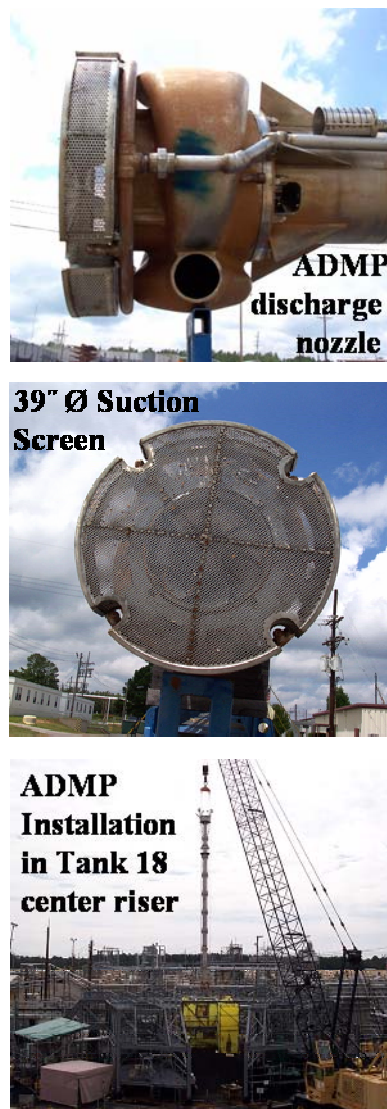
Figure 3.2-7: ADMP Technology

operations, the ADMP, one centrifugal transfer pump, a dewatering pump, and a transfer system completed over 1,000 hours of mixing and six transfers of material out of Tank 18 into Tank 7. [U-ESR-F-00014]

The heel removal strategy consisted of adding well water (total of 800,000 gallons), mixing with the ADMP, and transferring the sludge slurry to Tank 7. The ADMP was turned off when the Tank 18 liquid level reached 43 inches to prevent aerosolization of waste, a radiological release hazard. [WSRC-TR-2004-00036] This sequence of adding well water, mixing, and transferring, continued for six transfers until a point of diminished effectiveness was reached, i.e., waste was no longer being effectively transferred. [CBU-LTS-2003-00158] The amount of solids removed from Tank 18 during transfers was compared with the time of ADMP operation. Comparing the gallons removed per cycle with the time of mixing per cycle indicates that solids removal per hour of mixing decreased significantly in the final three cleaning cycles. [WSRC-TR-2003-00472]

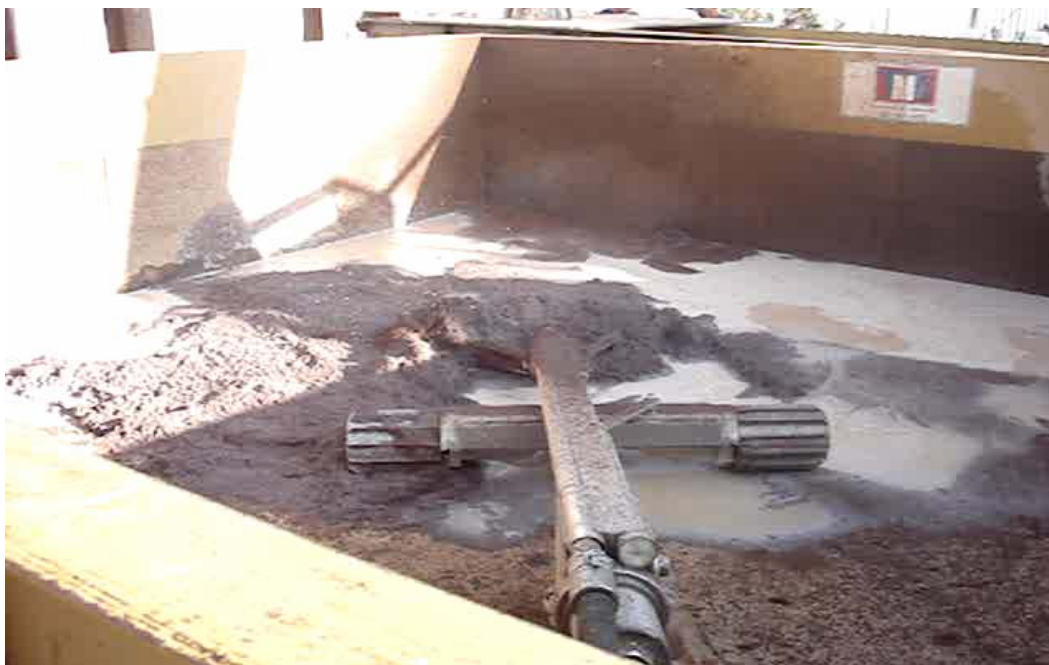
Figure 3.3-1: Full Scale Demonstration Test Waste Tank Operation

The “Full Scale Demonstration” was held at the TMR facility in Lakewood, Colorado on March 11 - 12, 2008. This demonstration was a full-scale test with the actual equipment that ultimately was used for heel removal from Tanks 18 and 19 (Figure 3.3-1). The Mantis used forward/downward spray nozzles to slurry the solids and blades were installed on the front of the crawler to push the waste into piles during testing. The test was successful with a few key deficiencies that required additional modifications to optimize effectiveness of waste removal. TMR was able to demonstrate that the Mantis was able to be deployed, deal with obstacles and break up, and transfer simulant. The pump and control systems all supported operation adequately. The Mantis functioned well at the beginning of each run but debris in the water supply, which had not been adequately flushed prior to the testing, plugged the eductor nozzles. In addition, the dump valve at the bottom of the grinder became obstructed with settled material and required manual intervention to clear. After these and other deficiencies were corrected, a follow-up demonstration was performed on April 7-11, 2008. During the follow-up demonstration, corrections to deficiencies that had been identified in the initial “Full Scale Demonstration” were satisfactorily demonstrated. [LWO-LWE-2008-00185, LWO-LWE-2008-00065]

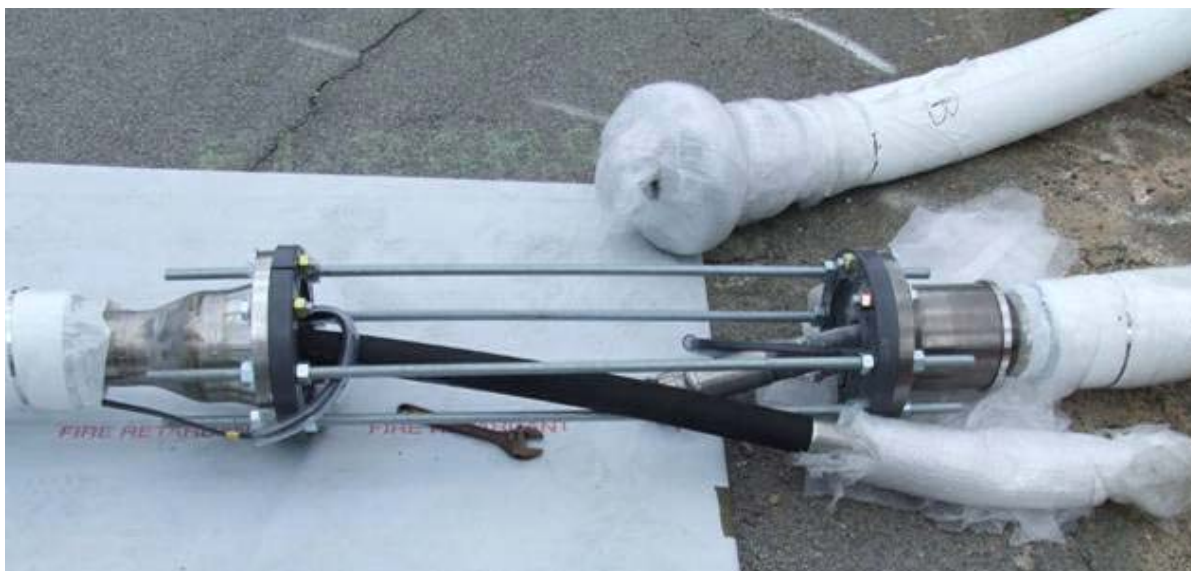
Figure 3.3-6: Waste Mixing Chamber

The WMC (Figure 3.3-6) contained flush water lines, waste lines, thermocouple and particle size reduction equipment (a grinder). The grinder, located in the bottom of the WMC where the transfer lines discharge waste, was designed to grind up and reduce solid waste particles to a particle size of less than 38 microns. The particle size reduction was needed so that the waste particles could be more easily suspended and removed from Tank 7 when further heel removal is performed on that waste tank. The grinder continually re-circulated the waste material until it was light enough for displacement upwards in the WMC. Above the grinder, openings were located in the WMC sidewall that allowed the waste particles, once they became small enough, to float out of the WMC into Tank 7.

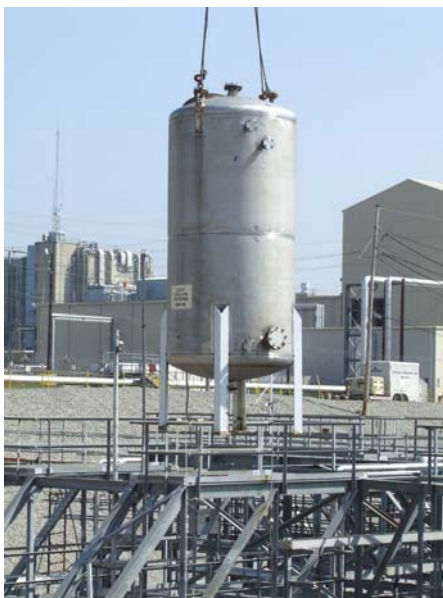
Figure 3.3-8: Removal of the Existing Tank 19 Center Riser Plug

Tank top modifications were required for installation of the Mantis in Tank 19 because of obstructions in all existing risers. The center riser was selected for Mantis installation in Tank 19. Modifications on Tank 19 included removal of an abandoned water tank (which had been used to support earlier phases of waste removal on both Tank 18 and 19) from the structural steel above the center riser (Figure 3.3-7), removal of the existing center riser plug (Figure 3.3-8), and installation of a new center riser cover with a riser designed for installation of the mechanical cleaning equipment and Toadstool (Figure 3.3-9).

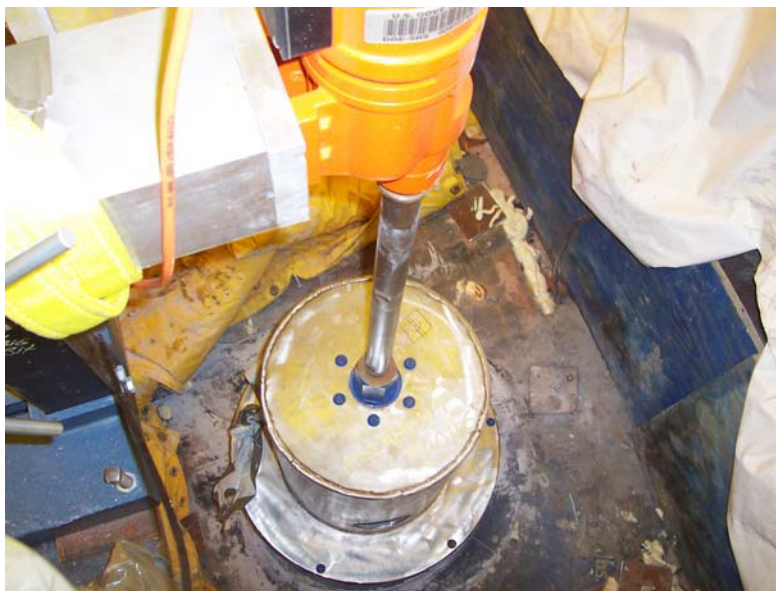
Figure 3.3-15: Core Drilling of New Mechanical Cleaning Riser in Tank 18

The Tank 18 MWRS equipment was installed in the new mechanical cleaning riser on Tank 18 on January 9, 2009. The HIHTL was installed from Tank 18 to Tank 7. A radiation monitoring system was installed over the temporary shielding on the transfer line from Tank 18 to Tank 7. The system used EPDs equipped with radio transmitters linked to a computer monitor and logging system. The computer used Viewpoint monitoring software. An additional EPD was installed at Tank 18 inside of the temporary shielding with the antenna outside the shielding to transmit the signal. This EPD signal was recorded as a means of assessing the solid waste transfer process.

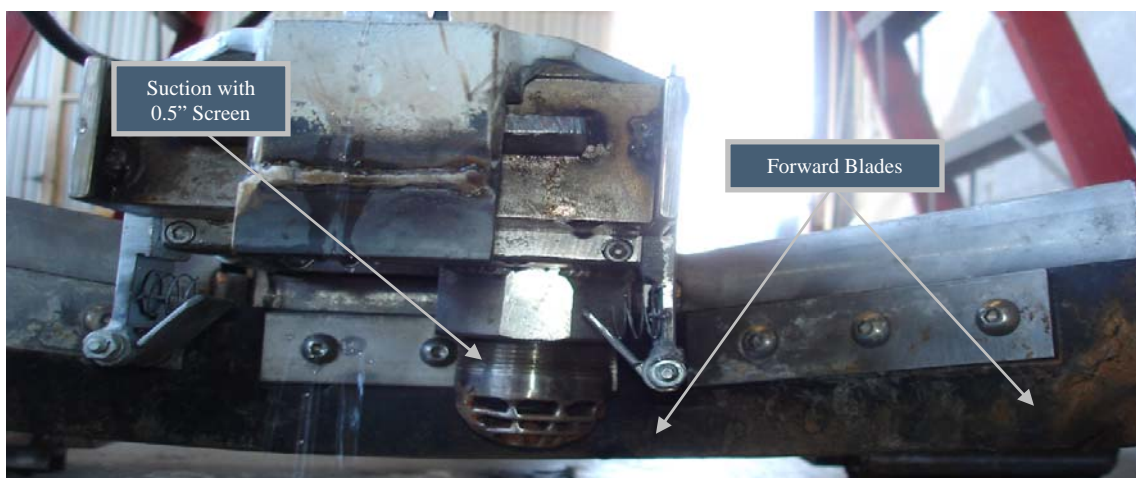
Figure 3.4-3: Mantis Suction Head Screen and Blades

The installation of the screen resulted in a 0.5-inch air gap between the bottom of the waste tank and the Mantis suction inlet. This air gap limited the Mantis ability to remove waste below the 0.5-inch level in the tank. To remove the waste effectively, this suction head configuration depended on the use of the forward blades (rubber squeegee devices), located just behind the suction head, to corral or pile the waste up into the suction head. The suction head and blade configuration are shown in Figure 3.4-3. The forward blades were most effective in corralling the waste in areas of the tank floor with mounds. The effectiveness of the forward blades was diminished in areas of the tank floor with thin layers of waste due to the interference by physical obstacles (primarily lifting plates) in the tank. The floor of each Type IV tank has sixty-nine 1-foot by 1-foot by 0.5-inch high lifting plates, which are remnants of tank construction (arrayed in a grid pattern across the floor). These physical features interfered with the blade's ability to push the material and also contributed to deterioration of the blades after extended operations.

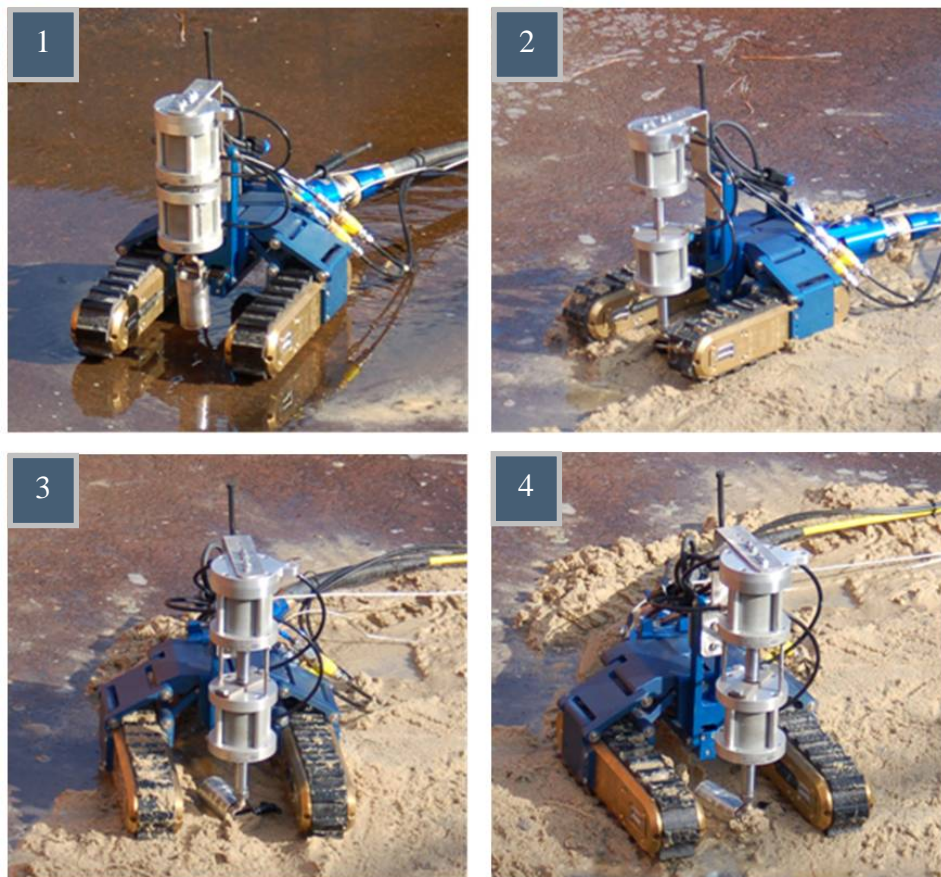
Figure 4.2-1: Waste Tank Floor Sampling Process During Mock-Up Testing

Between January 5, 2010, and February 4, 2010, the residual waste on the Tank 18 and Tank 19 floors was sampled at the designated locations using the modified robotic crawler-sampling device. Figure 4.2-1 provides photographs taken during mock-up testing of the device. The crawler was lowered to the waste tank floor (Panel 1) and then driven to the sample location. Upon arrival at the sample location, several scrape samples were taken while moving the robotic crawler forward or backward and lowering the sample cup (Panels 2 and 3). Once the sample cup was filled (Panel 4), the crawler was driven to a location under the riser where it was hoisted to the waste tank top. A new sample cup was attached and the process was repeated. [SRR-LWE-2010-00059]

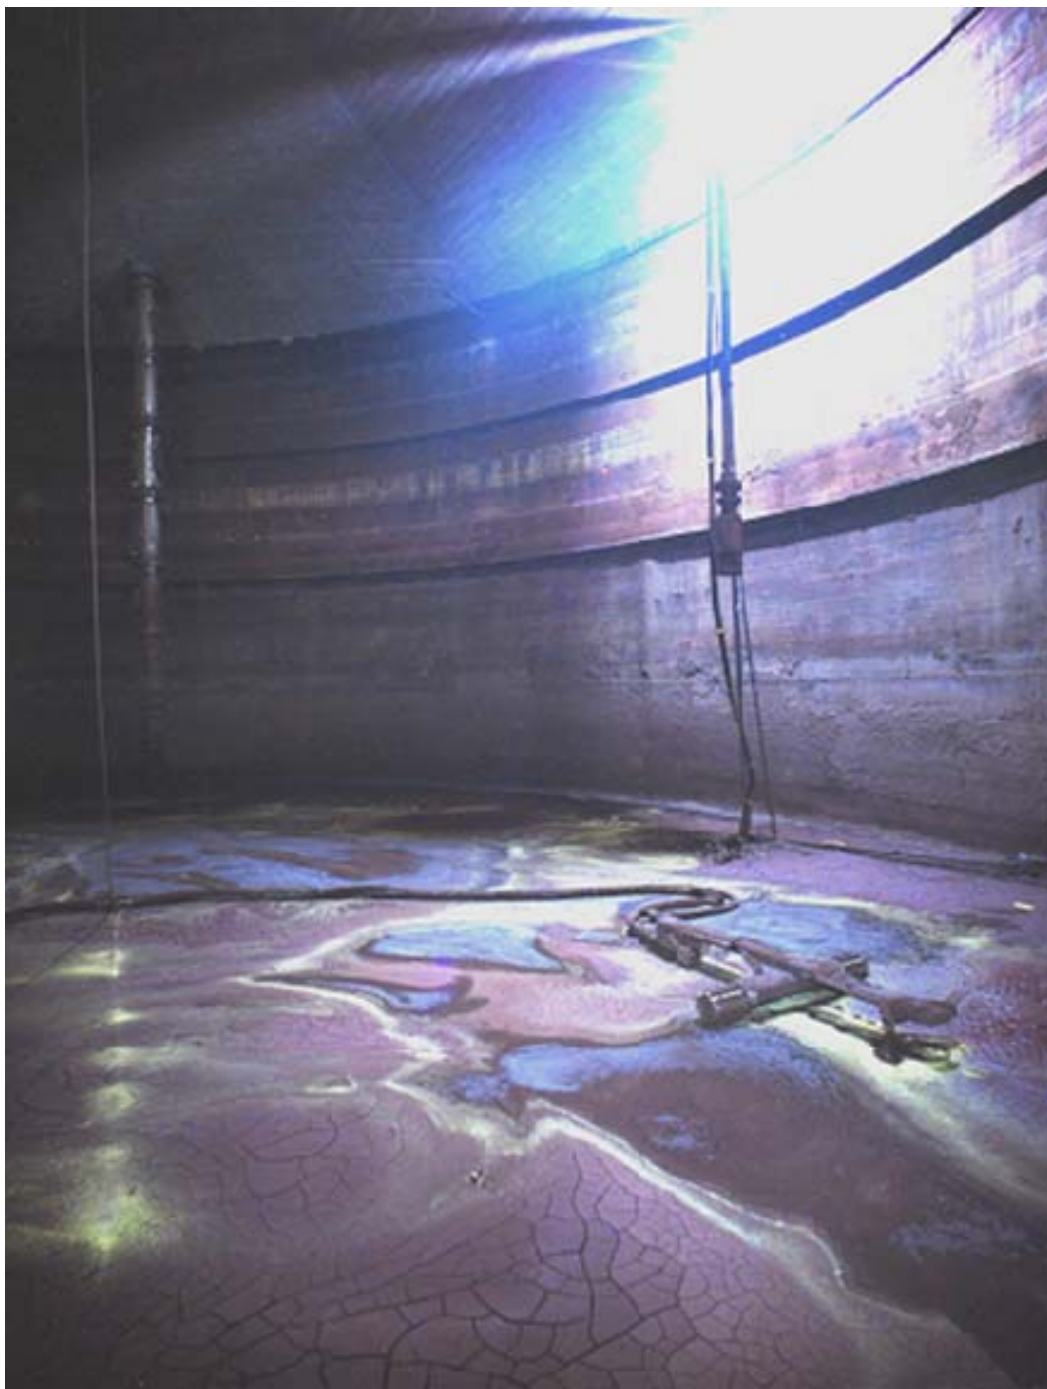
Figure 9.0-3: Tank 18 after Completion of Mantis Operations

- Visual Observation – Visual inspections of the tanks indicated that there was a significant reduction in residual material volume resulting from the Mantis operations. Figure 9.0-3 and Figure 9.0-4 show Tanks 18 and 19, respectively, after the completion of Mantis operations (Section 3.4.1).

Visual inspections of the tanks indicated that there was a significant reduction in residual material volume resulting from the Mantis operations. Mounds of residual material that had existed prior to heel removal using the Mantis were no longer present. Tank 18 has 4,000 gallons of residual solids (3,900 gallons on the floor and approximately 100 gallons on the wall) while Tank 19 has 2,000 gallons of residual solids on the floor with no appreciable wall scale. Figure 3.4-1 and Figure 3.4-2 show Tanks 18 and 19, respectively, after the completion of Mantis operations.
