U.S. DEPARTMENT OF
ENERGY

2015 Annual Site Inspection and Monitoring Report for Uranium Mill Tailings Radiation Control Act Title II Disposal Sites

November 2015

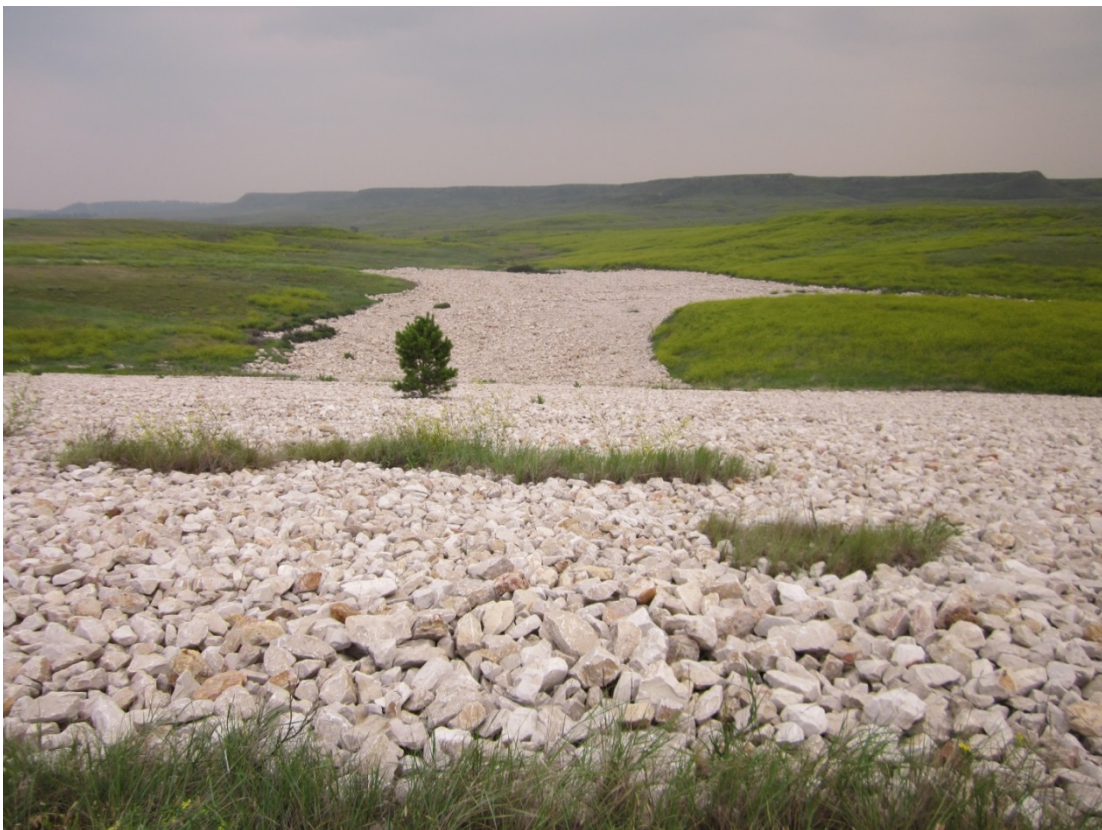
EDG 7/2015. PL-4. Tailings embankment, looking southeast.

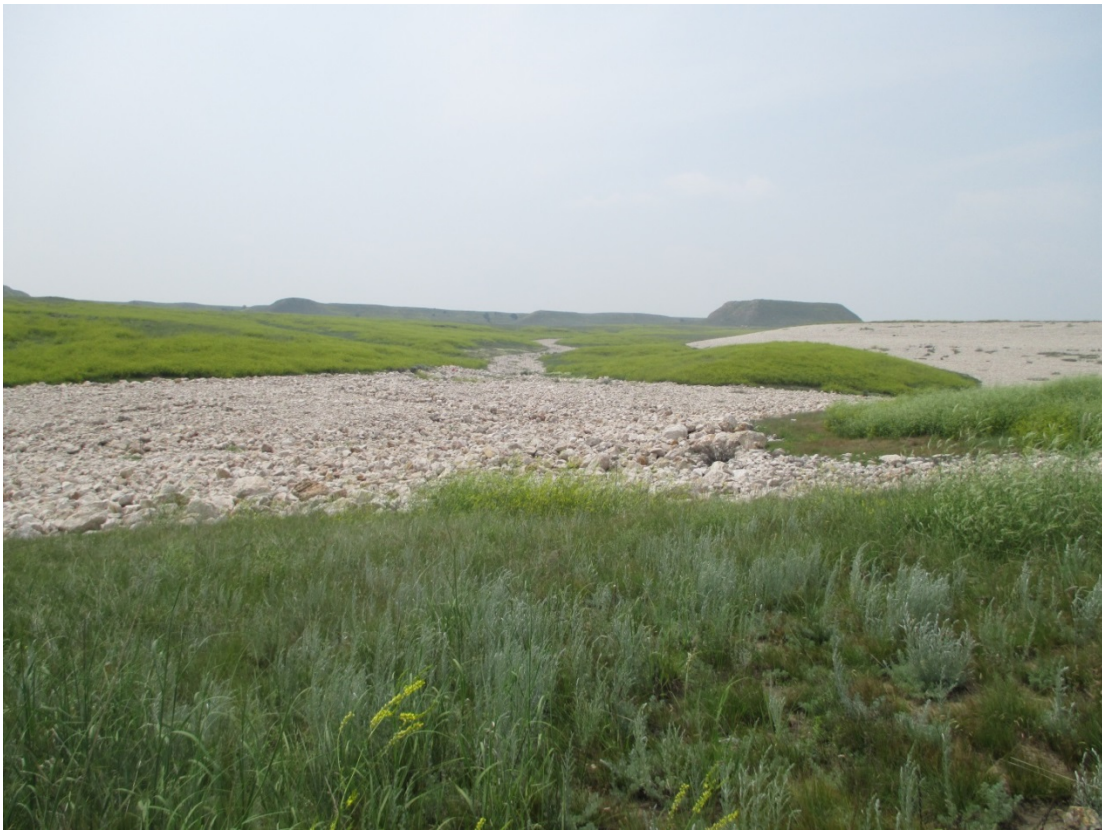
EDG 7/2015. PL-5. Drainage channel and west diversion channel.

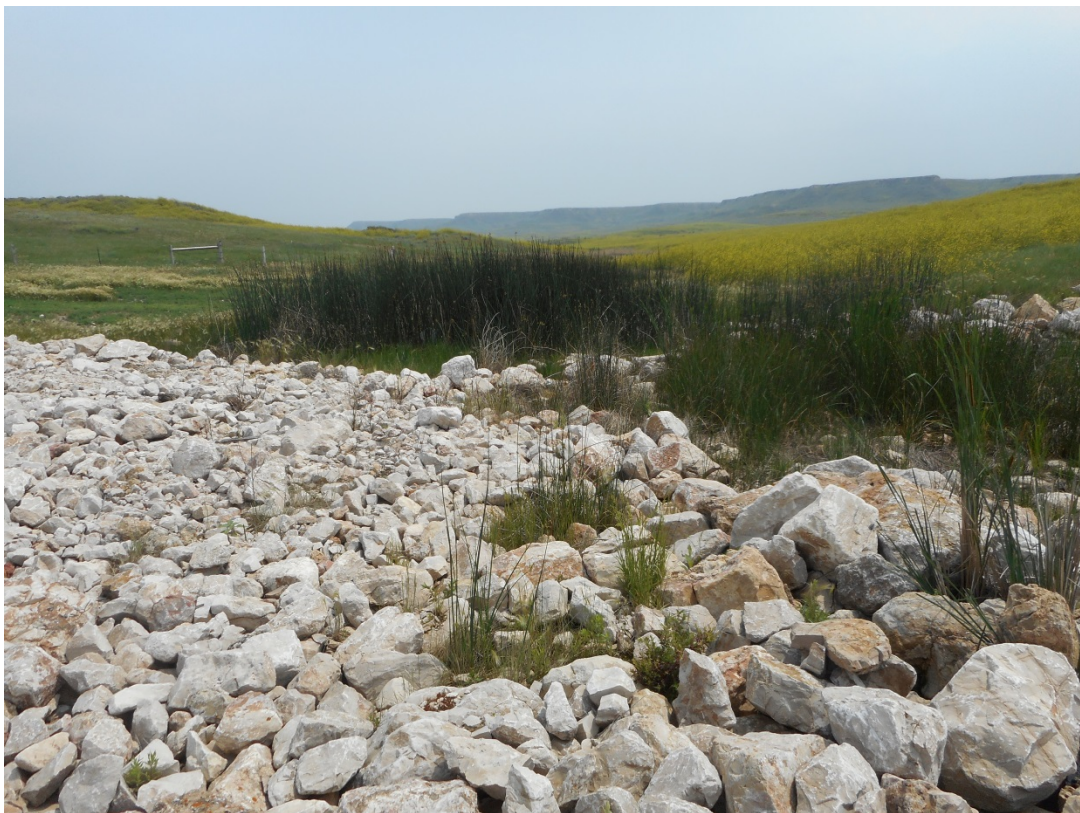
EDG 7/2015. PL-6. Wetland vegetation at base of embankment.

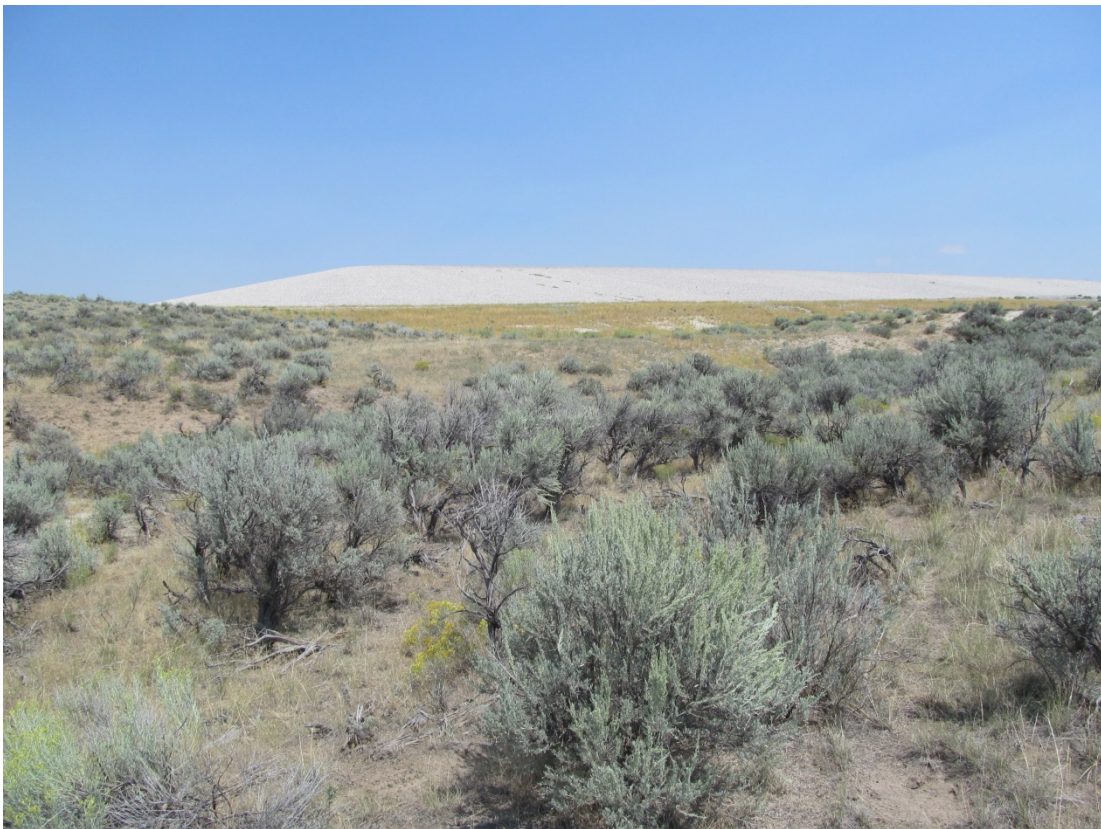
MAW 8/2015. PL-5. Southwestern portion of the site; disposal cell in background.

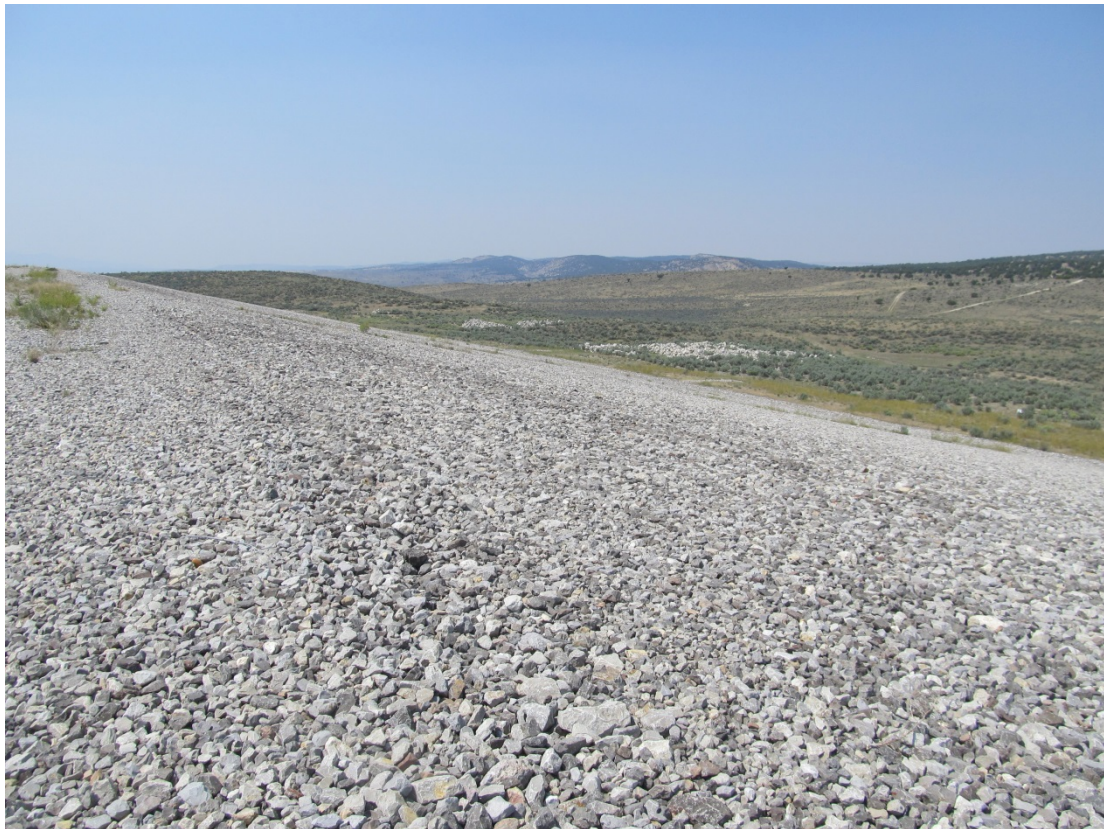
MAW 8/2015. PL-7. Northeast side slope of the disposal cell.

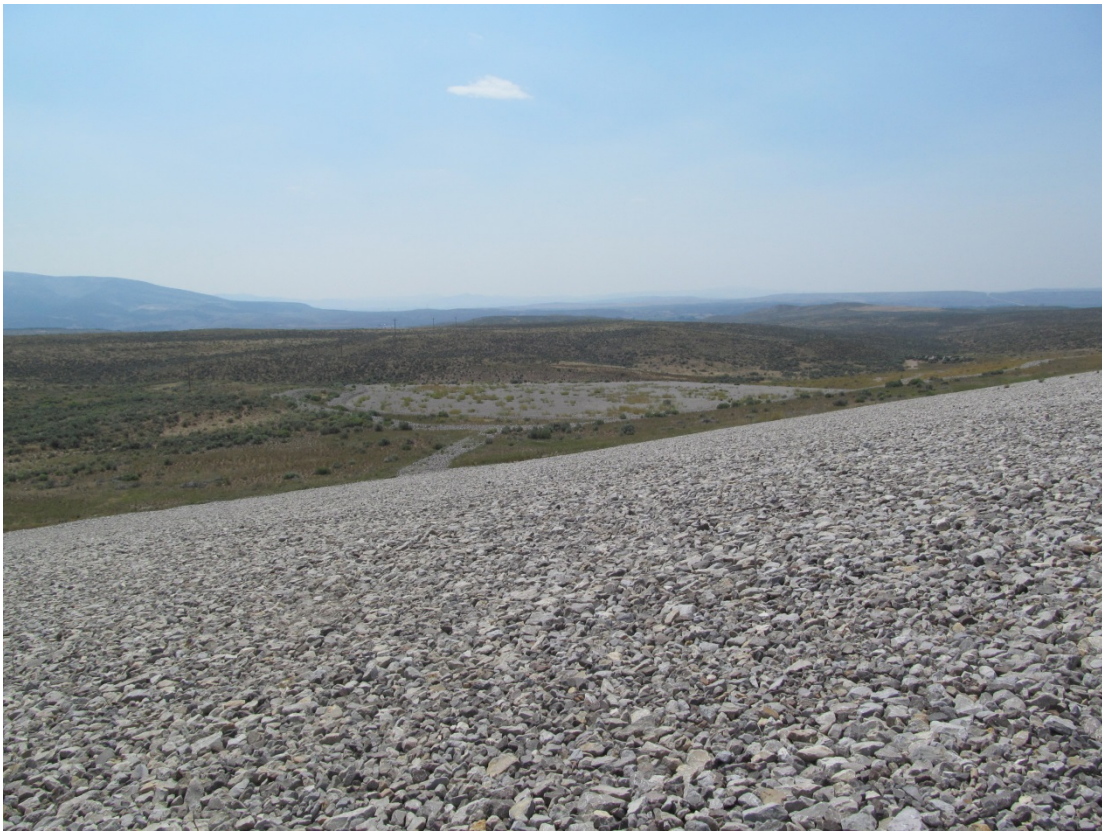
MAW 8/2015. PL-8. South side slope of the disposal cell; ancillary cell in the background.

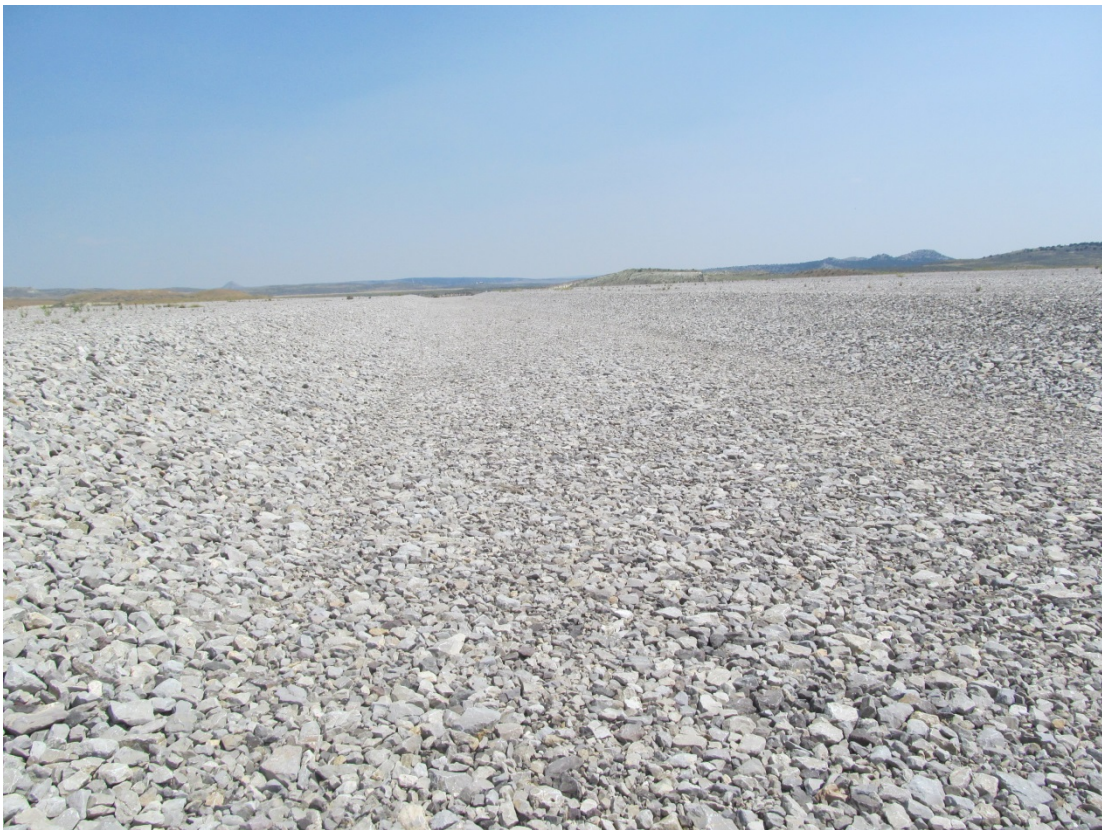
MAW 8/2015. PL-9. Diversion Channel No. 1; view downslope.

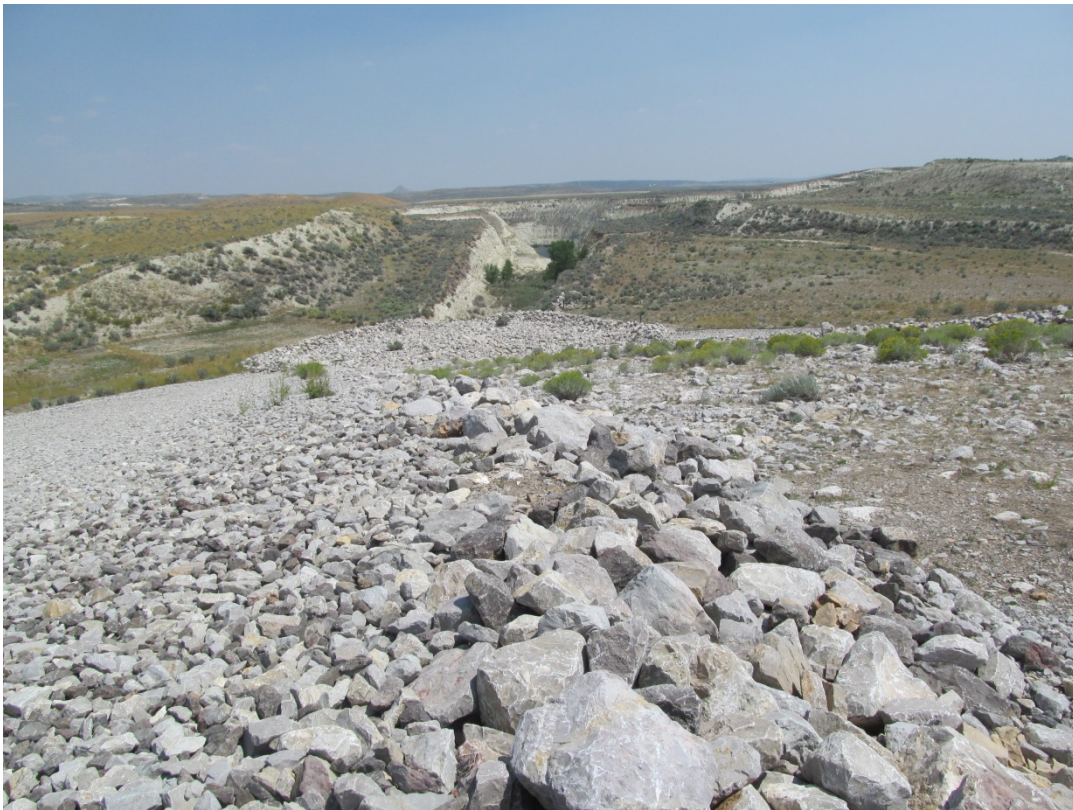
MAW 8/2015. PL-10. Diversion Channel No. 1 outlet into the launch rock erosion protection basin on the east side slope of the disposal cell; Rob Pit in background.

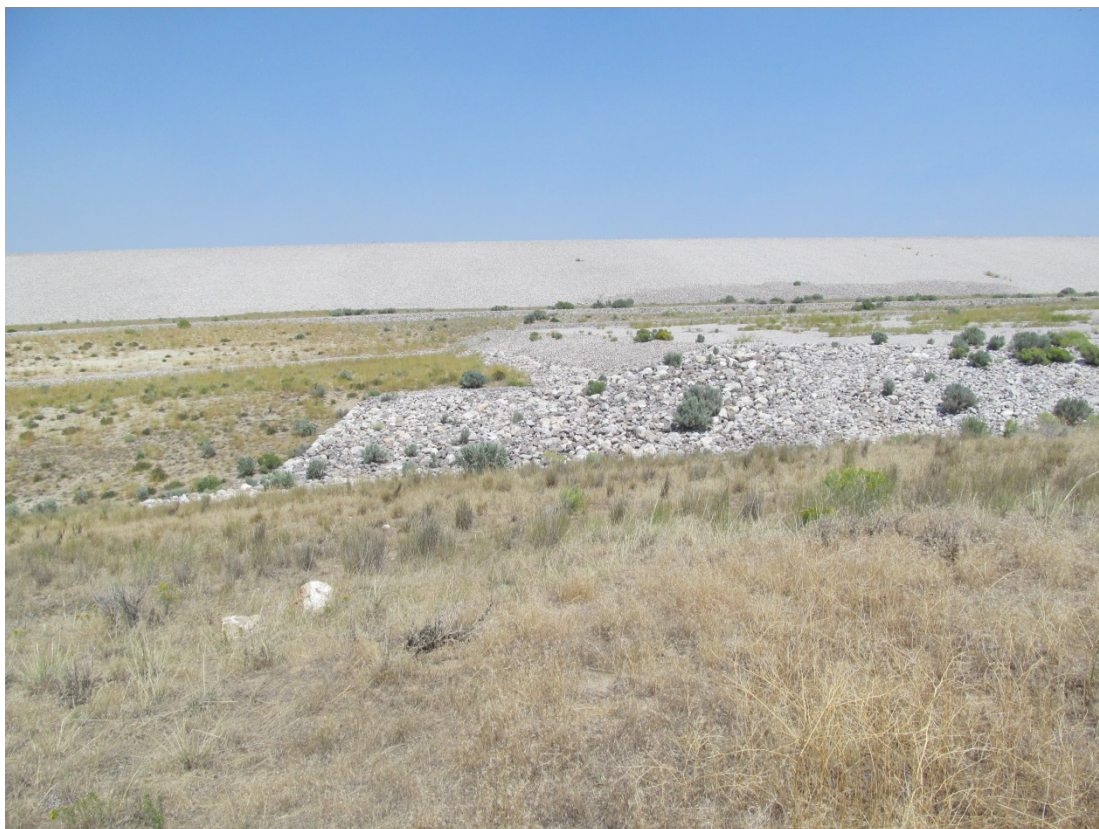
MAW 8/2015. PL-11. Diversion Channel No. 2 outlet and ancillary cell; main disposal cell in background.

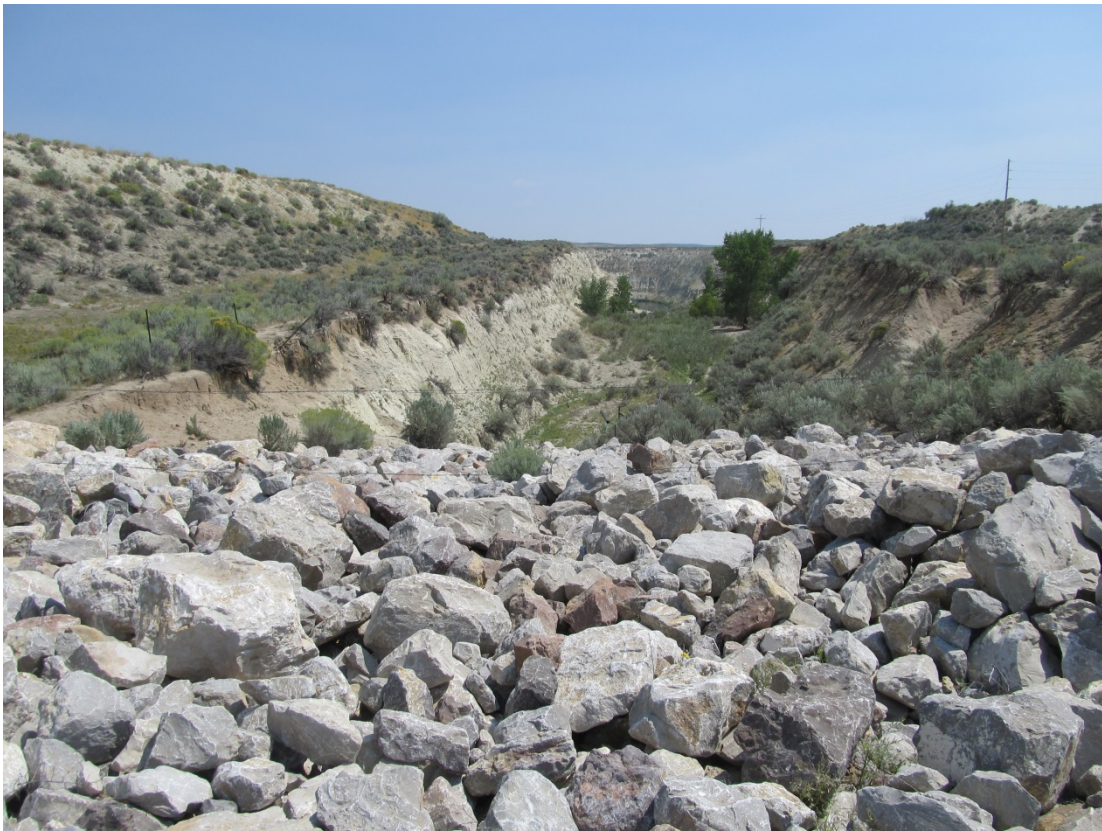
MAW 8/2015. PL-12. Diversion Channel No. 1 outlet channel; Rob Pit in background.

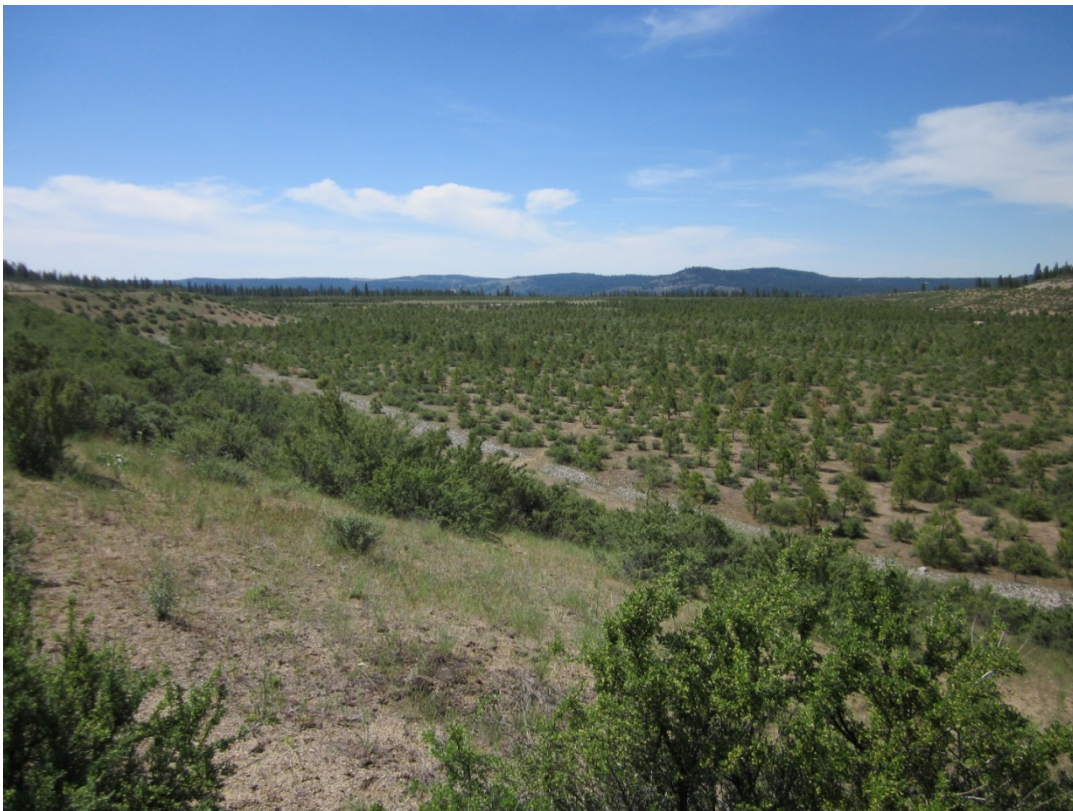
SHE 4/2015. PL-4. Disposal cell surface from dike road, view to south-southwest.

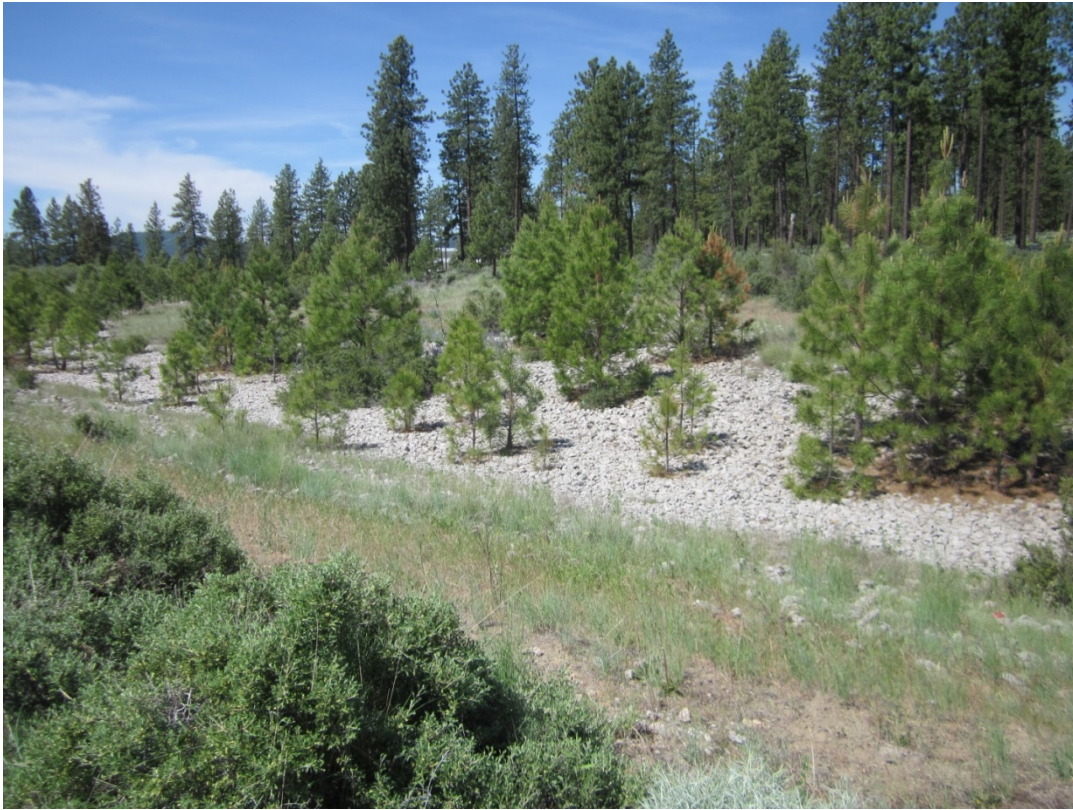
SHE 4/2015. PL-5. 5/2015. Diversion channel, west side of dike road.

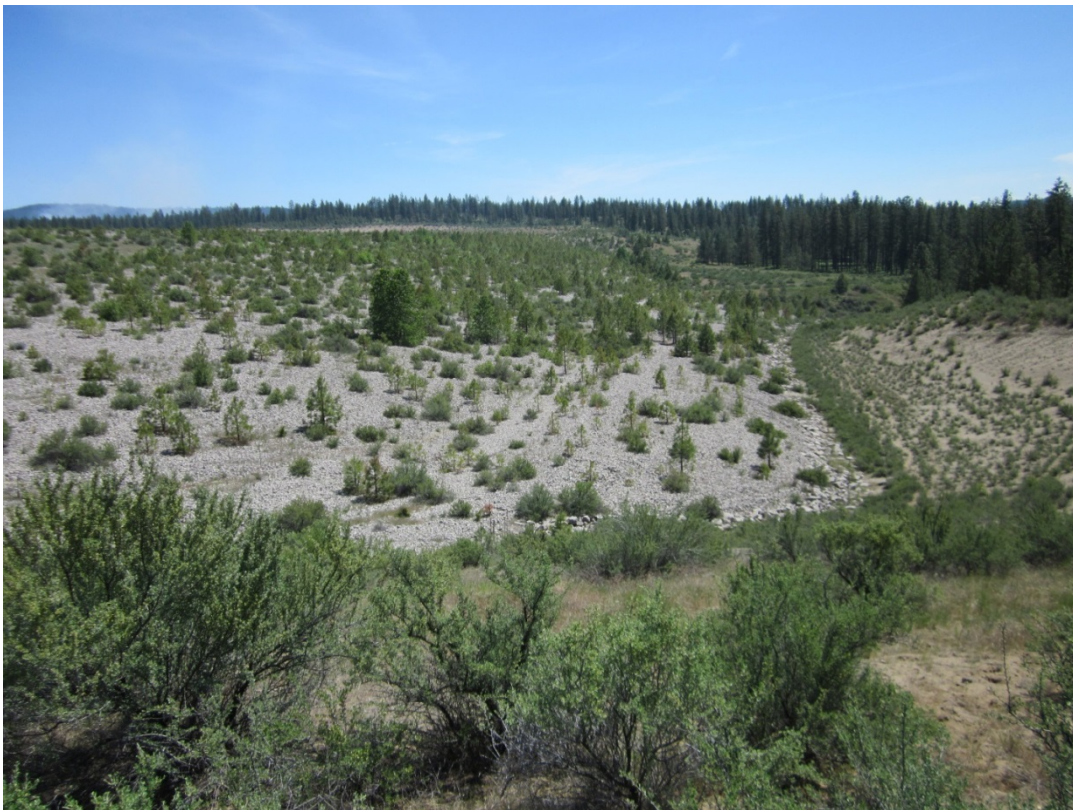
SHE 4/2015. PL-6. 5/2015. Face of tailings dam, view to east.

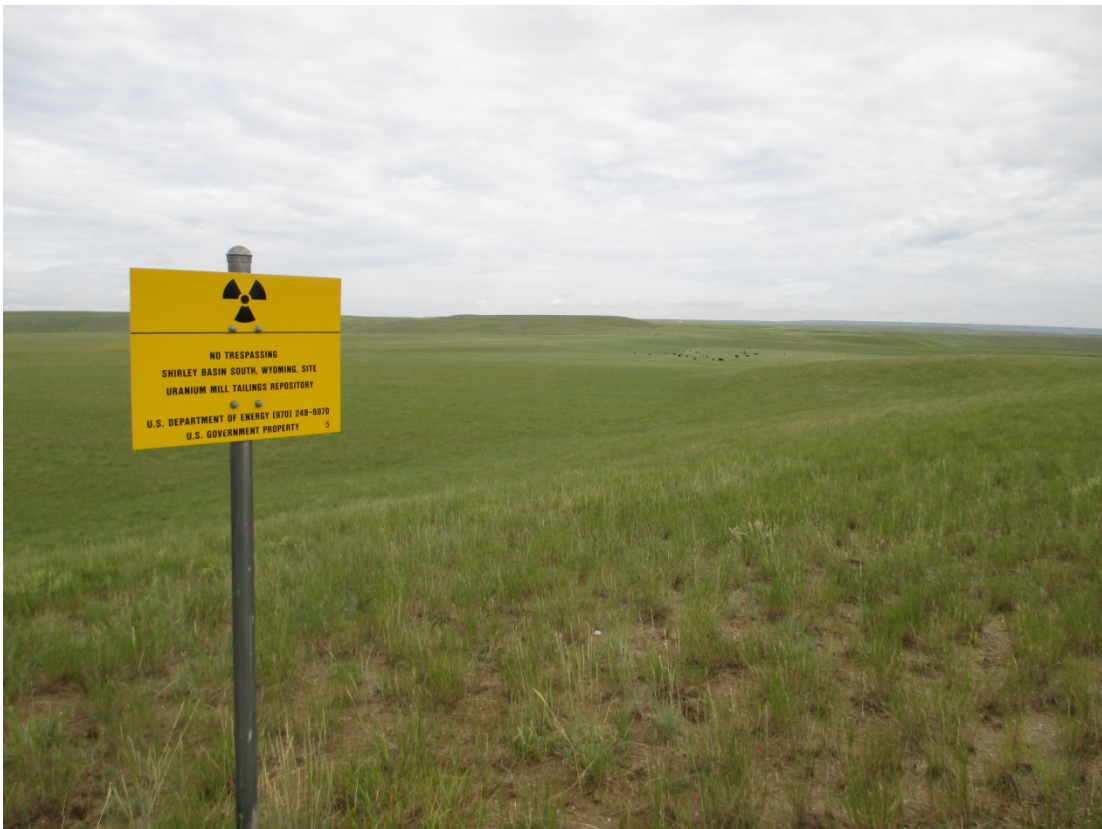
SBS 7/2015. PL-2. View toward east drainage basin from perimeter sign P5.

Nine perimeter signs (warning/no-trespassing signs) are along the site perimeter at likely points of access, and another 25 signs are positioned around the disposal cell (PL-2). Other than perimeter signs P1, P2, P23, and P33, which have bullet holes in them, the signs were in excellent condition.
