# SITE 9920

## ACCIDENT INVESTIGATION BOARD REPORT

January 2014

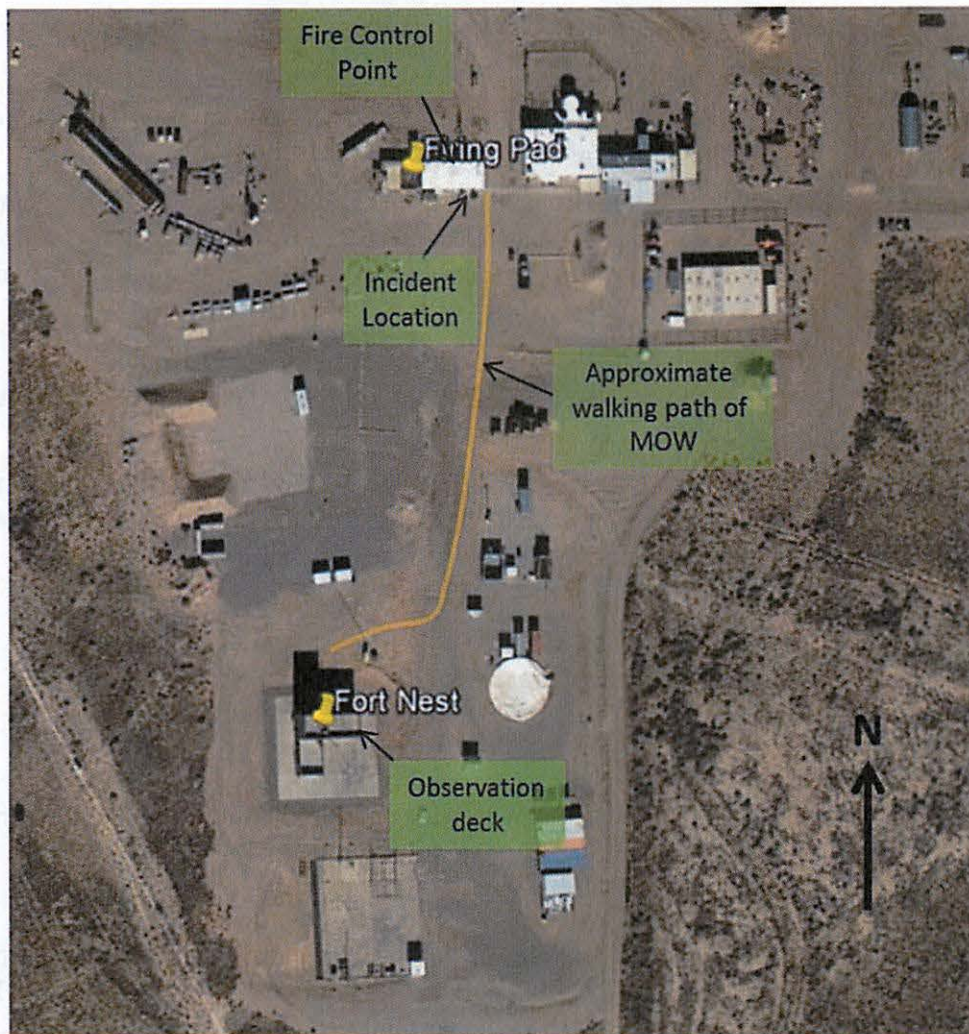
Figure 1: Aerial view of Site 9920

Site 9920, the Explosives Applications and Containment Training Facility (Fig. 1), is located in SNL's Coyote Test Field, east of Tech Area 3. Since 1958, engineers and technicians have used the site to design, assemble, and test explosive experiments in support of Labs-wide programs.
