**U.S. Department of Energy
Office of Health, Safety and Security**

Accident Investigation Report

**Accident Investigation of the June 1, 2013
Stairway Fall Resulting in a Federal Employee
Fatality at DOE Headquarters
Germantown, Maryland**

August 6, 2013

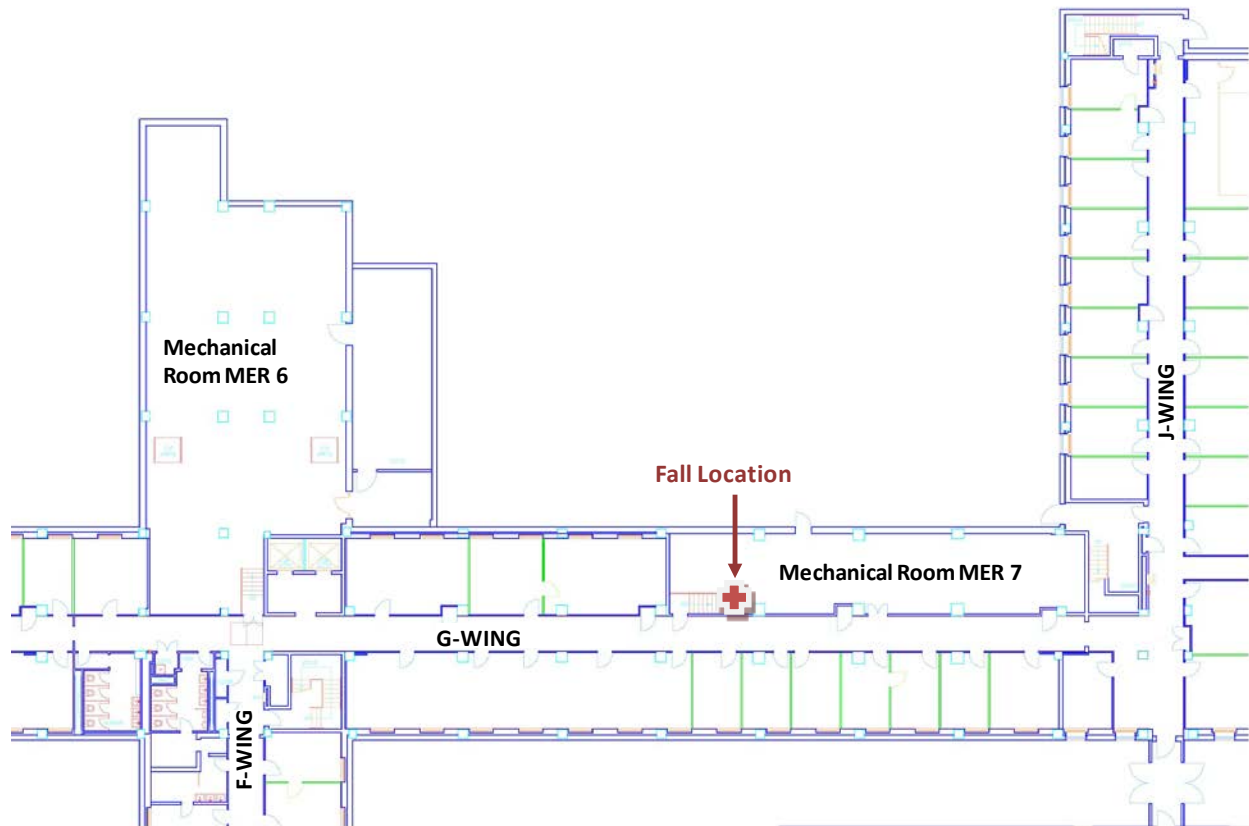
Figure 2: Germantown Building G-Wing Floor Plan

The staircase involved in this accident is located in Mechanical Equipment Room (MER 7) in the G-Wing, ground level of the DOE Germantown Headquarters facility (see Figure 2). The staircase is the single access point to MER 7.
