2025 ANNUAL SITE INSPECTION AND MONITORING REPORT FOR

# Uranium Mill Tailings Radiation Control Act Title II Disposal Sites

DECEMBER  
**2025**

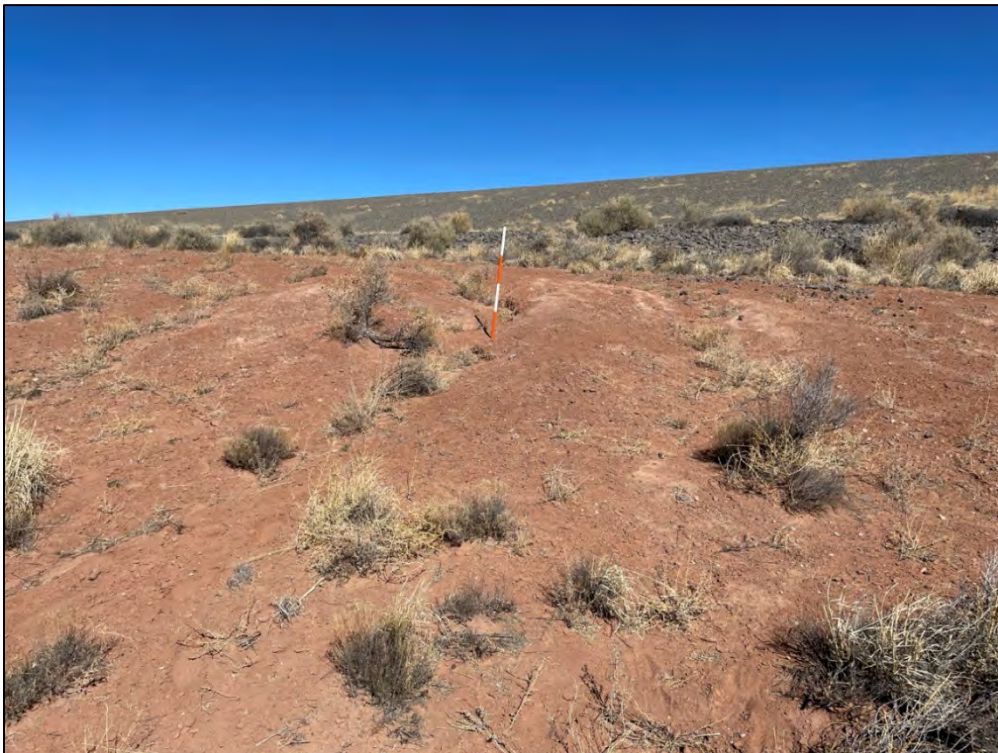
*PL-14. Rill Formation at the Base of the South Bench near Perimeter Sign P24 (MT-08)*

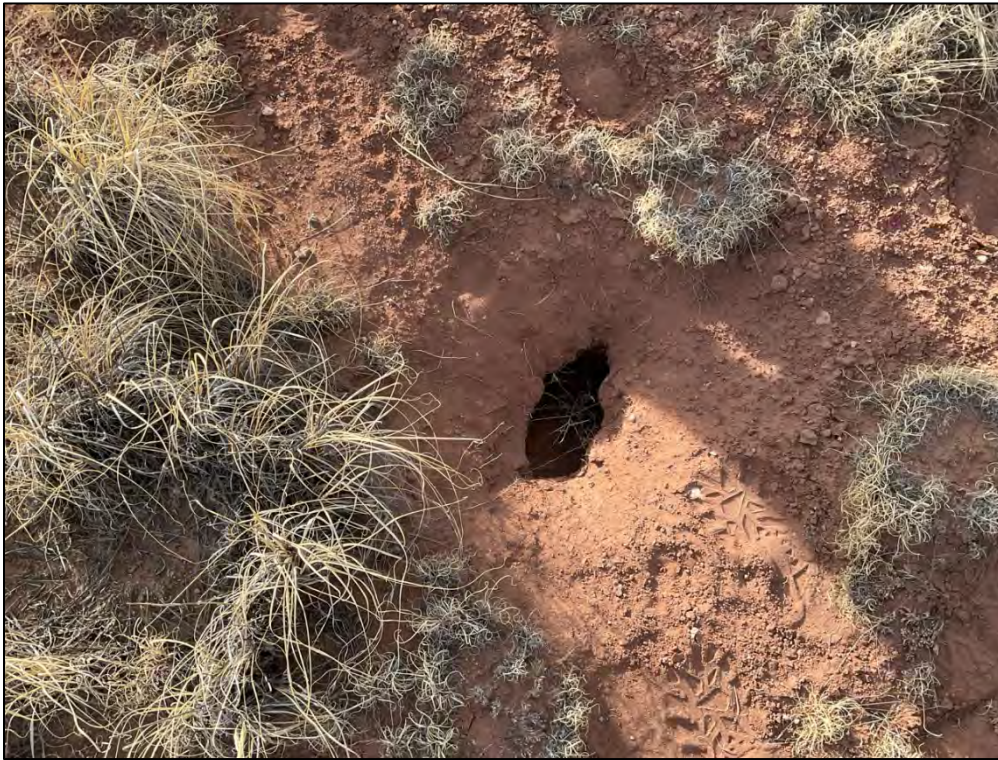
*PL-19. East Dump Soil Piping*

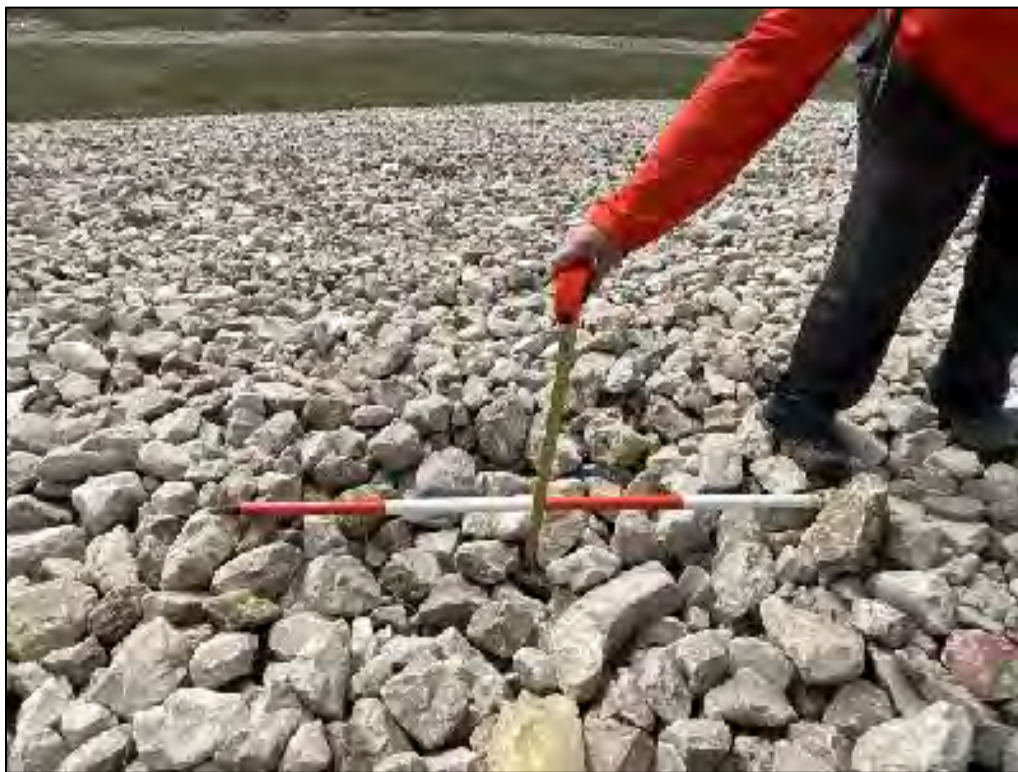
*PL-3. Depression No. 2, Measuring Depth*

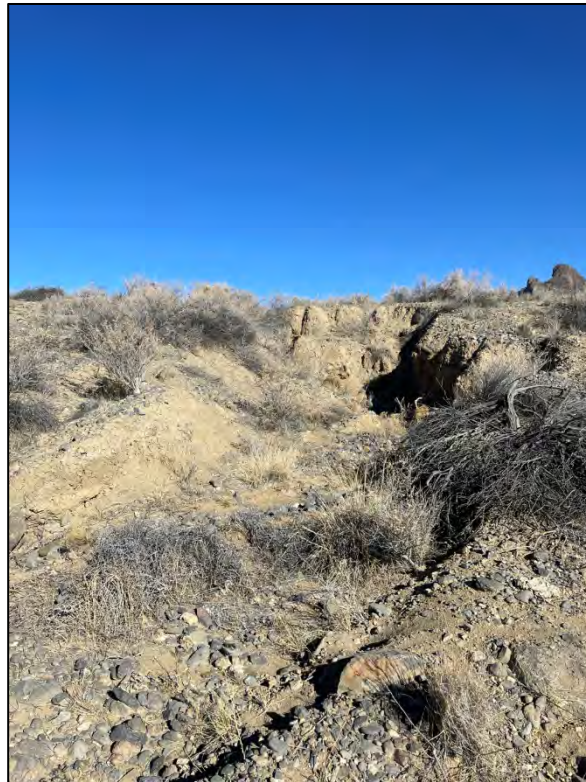
*PL-8. Slope Erosion near Perimeter Sign P26*

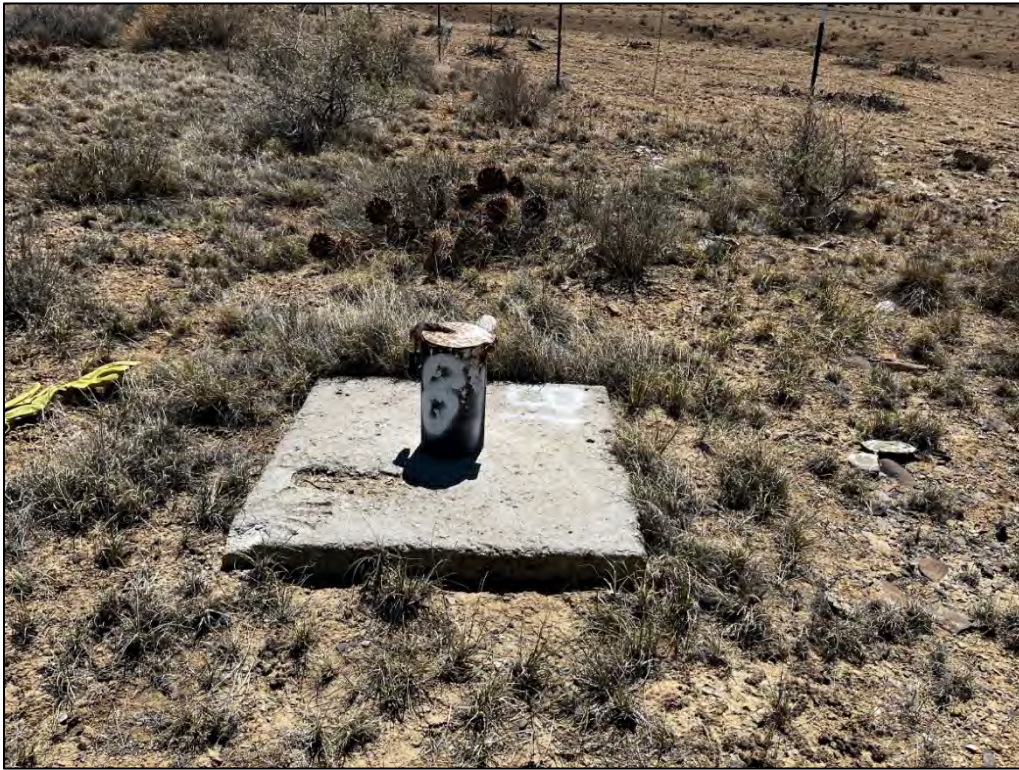
*PL-13. New Paint at Monitoring Well 81*

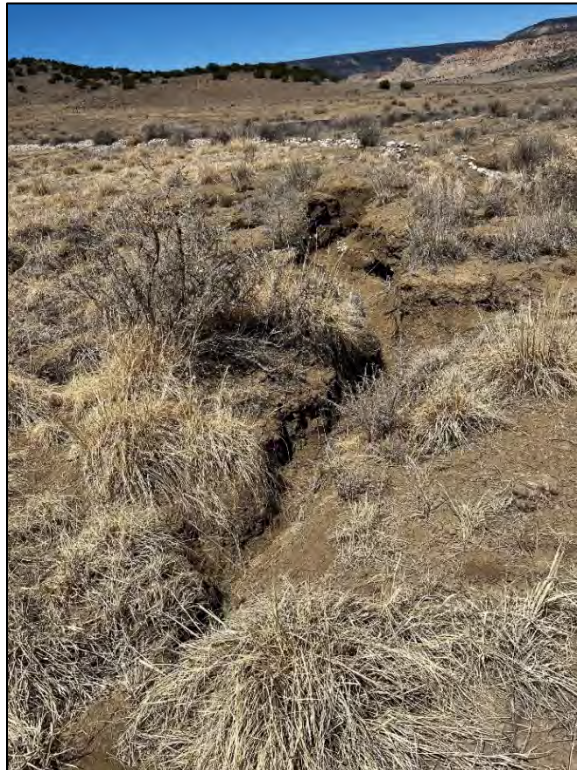
*PL-19. Erosion near Runoff Control Structure A*

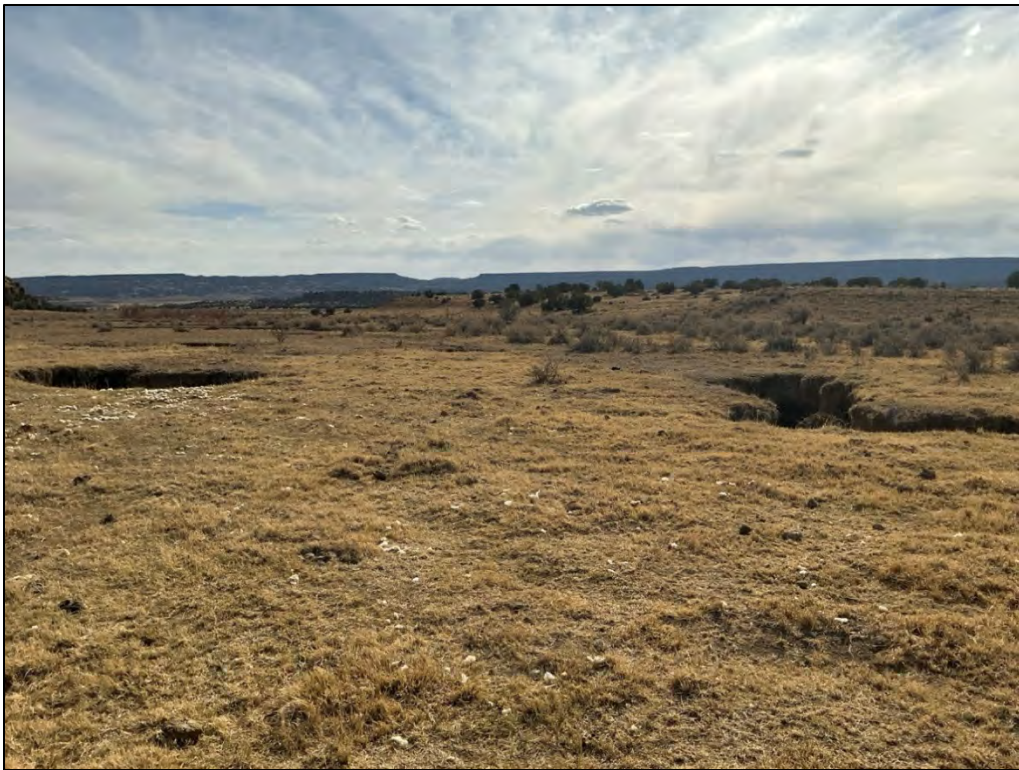
*PL-22. Northern Extent of Southwest Gully Erosion*

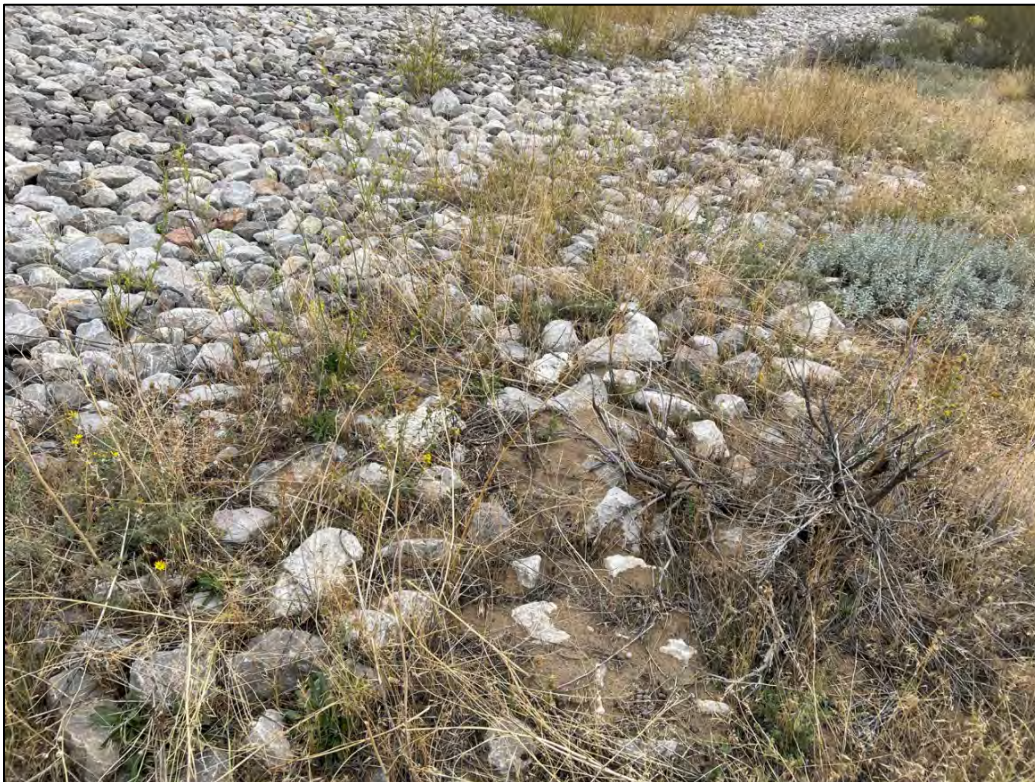
*PL-8. Sediment Accumulation at Toe of Side Slope*

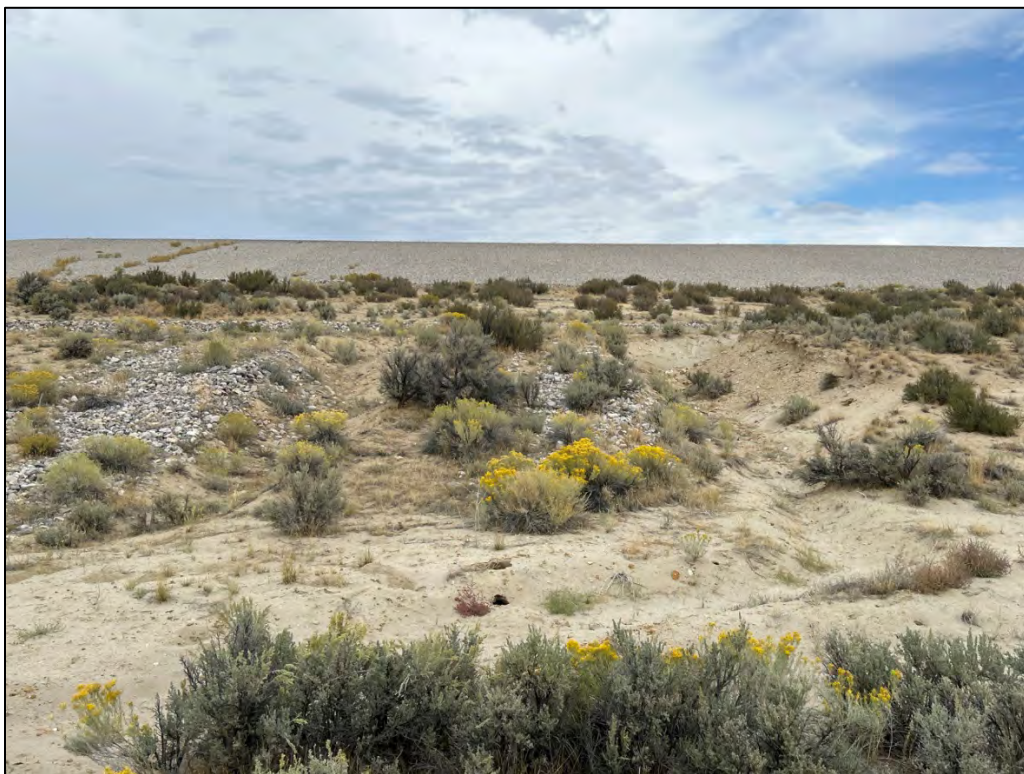
*PL-12. Gullies South of Disposal Cell*

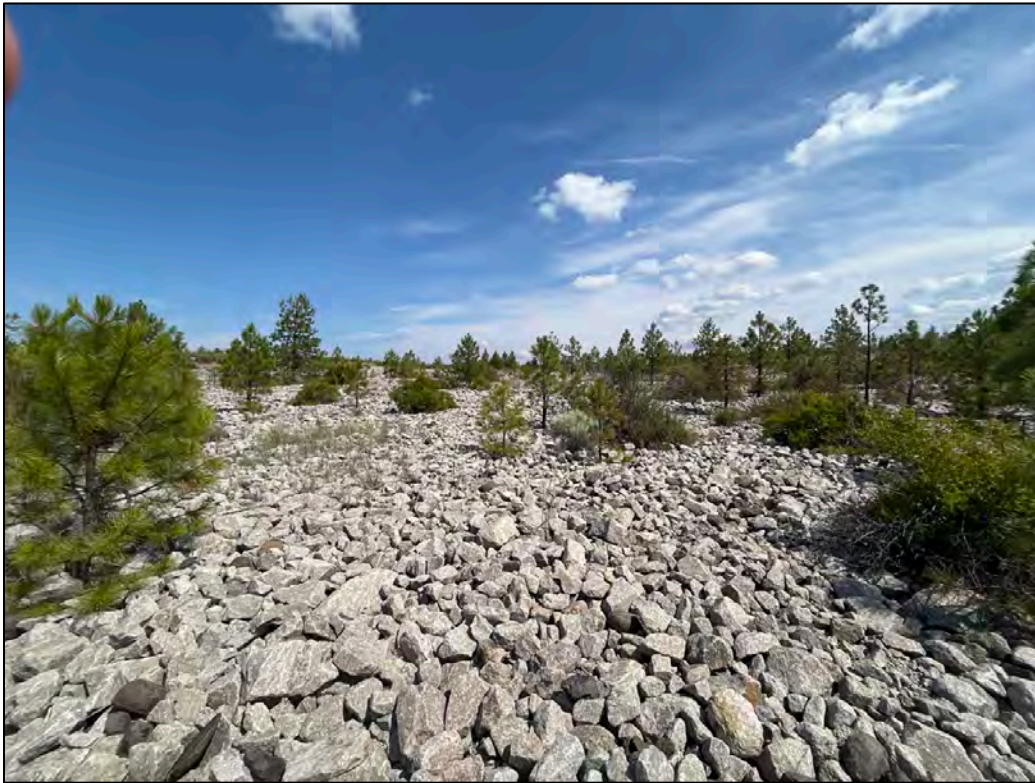
A small, shallow runoff channel near the southeast corner of the disposal cell discharges water into a riprap-armored swale east of the containment dam (PL-5). The channel is stable and is not above the tailings impoundment. In previous inspections, rilling was found below the riprap-armored swale. These features will continue to be monitored to ensure that they do not affect the integrity of the disposal cell.

*PL-5. Riprap-Armored Swale*

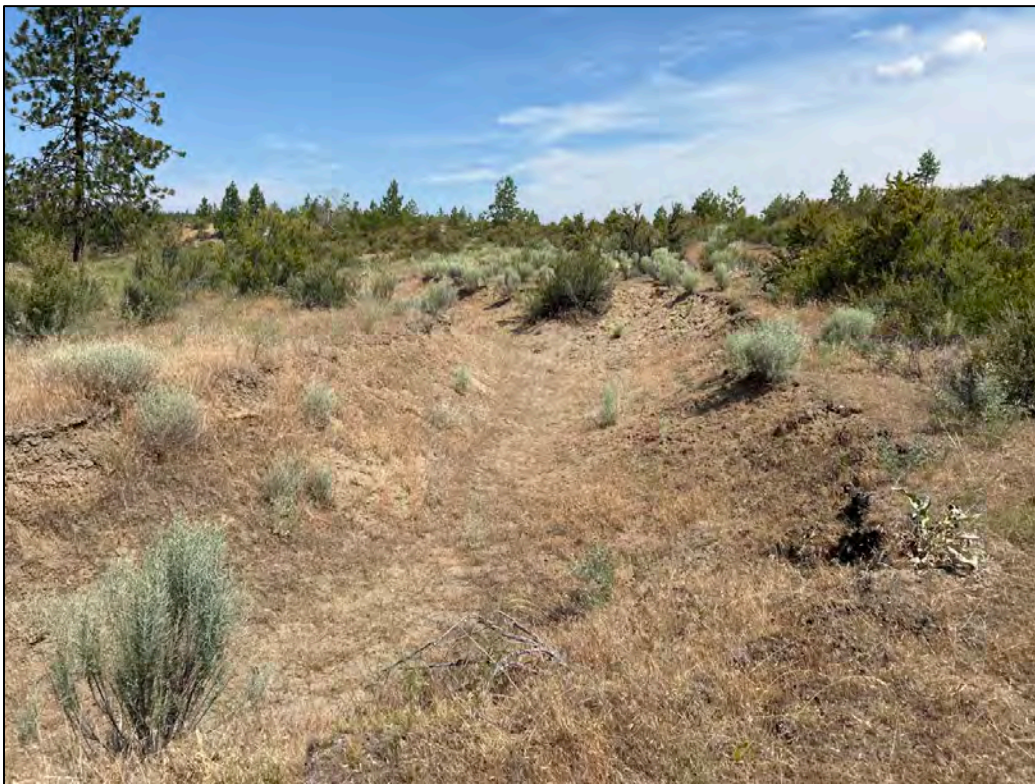
*PL-6. Gully near Perimeter Sign P1*

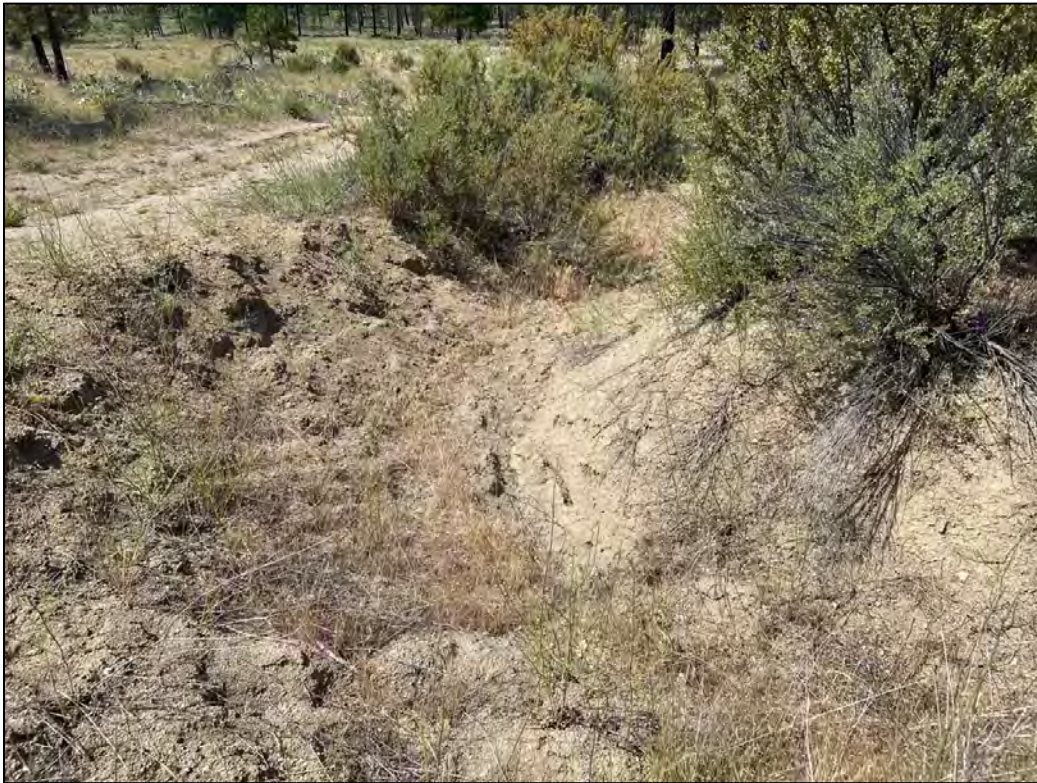
*PL-7. Gully near Perimeter Sign P2*

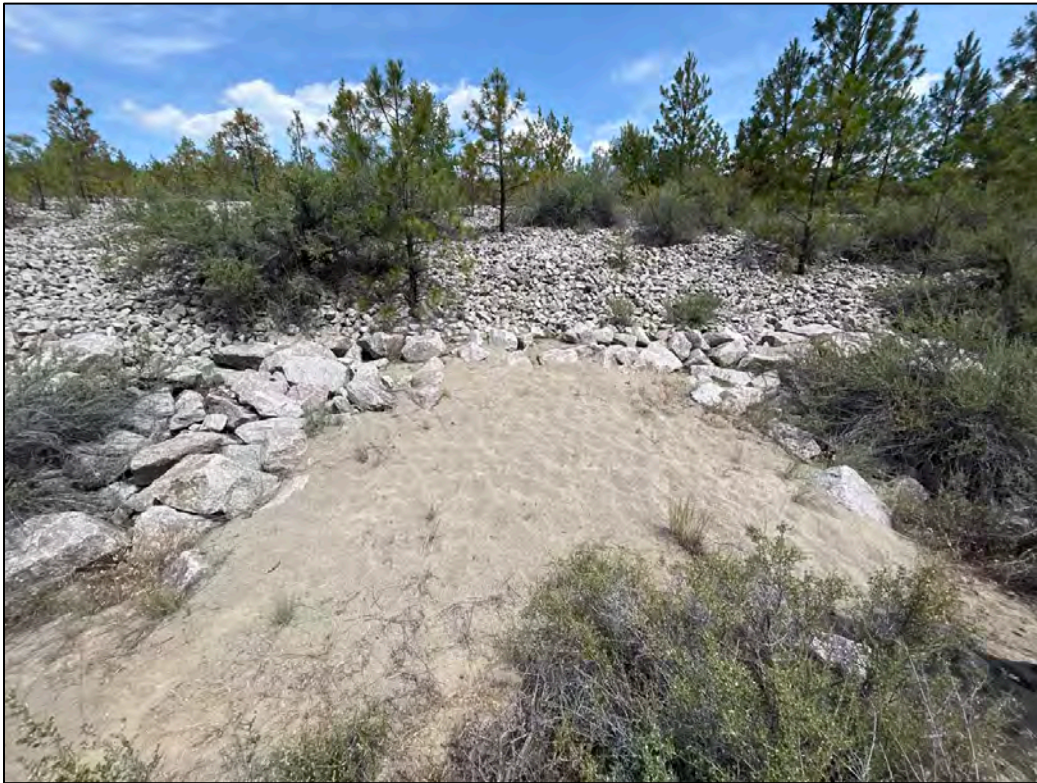
*PL-9. Large Sand Deposit at Base of Containment Dam Face*

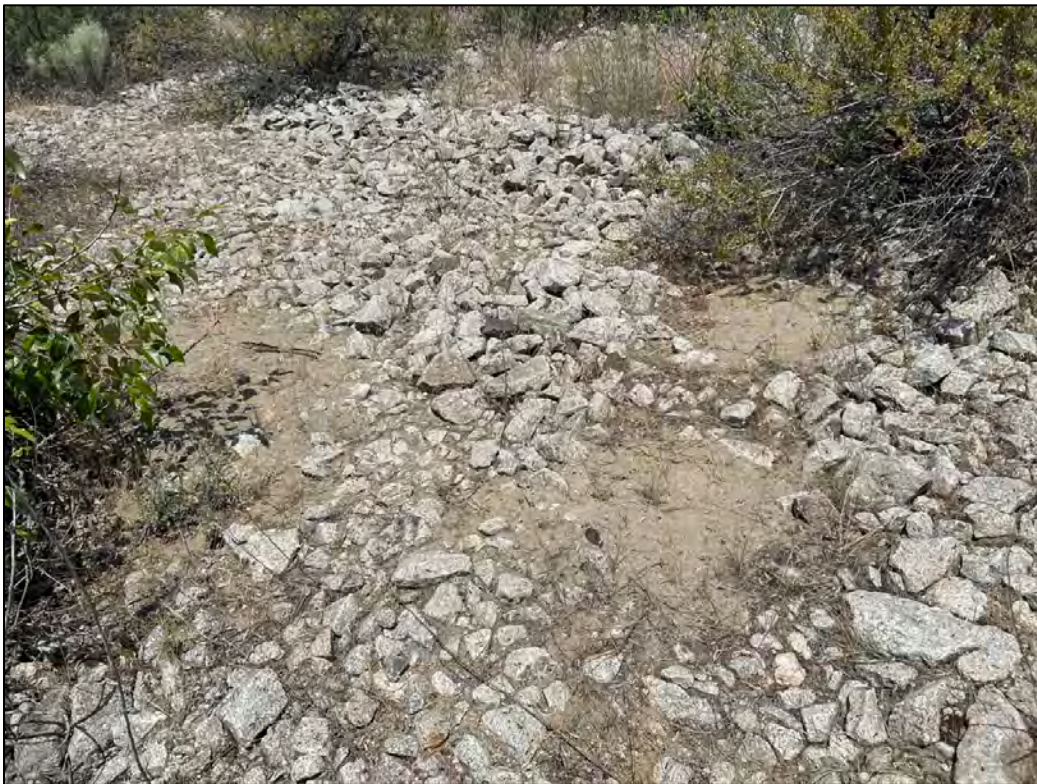
*PL-10. Small Sand Deposits on Dam Face*

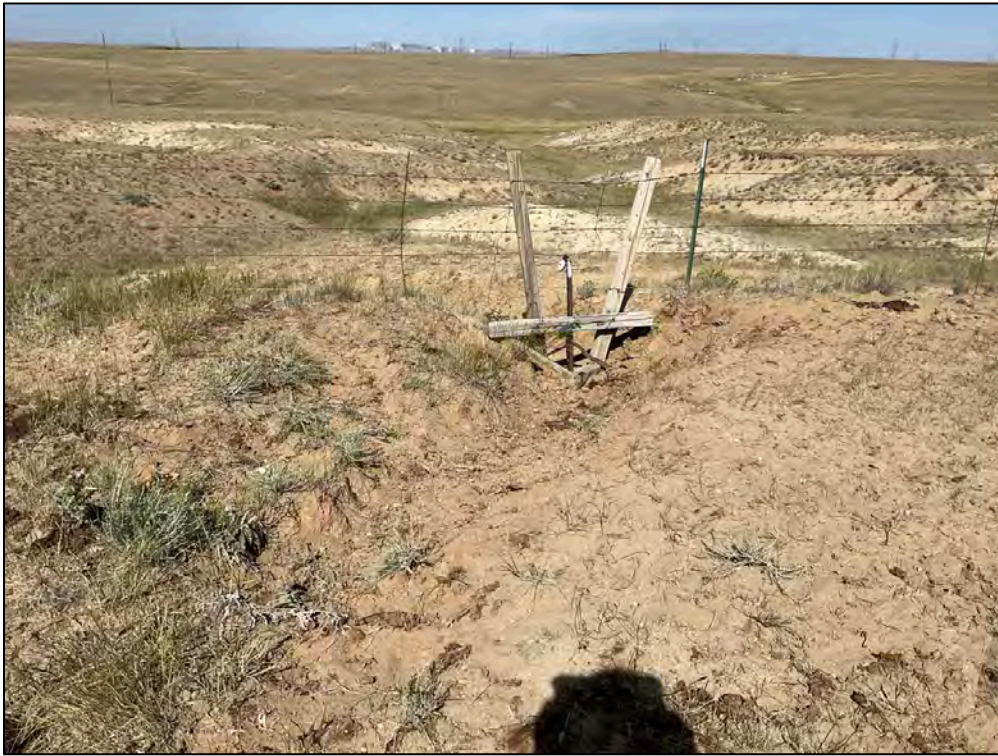
Two gullies have formed perpendicularly beneath the boundary fence by the southwestern corner (PL-1). The grazing licensee has modified and repaired the fence in these sections to deter cattle from going under the fence. All fence posts appeared stable during the time of the inspection and will continue to be monitored. No maintenance needs were identified.

*PL-1. Erosion Gully Under Fence Line*

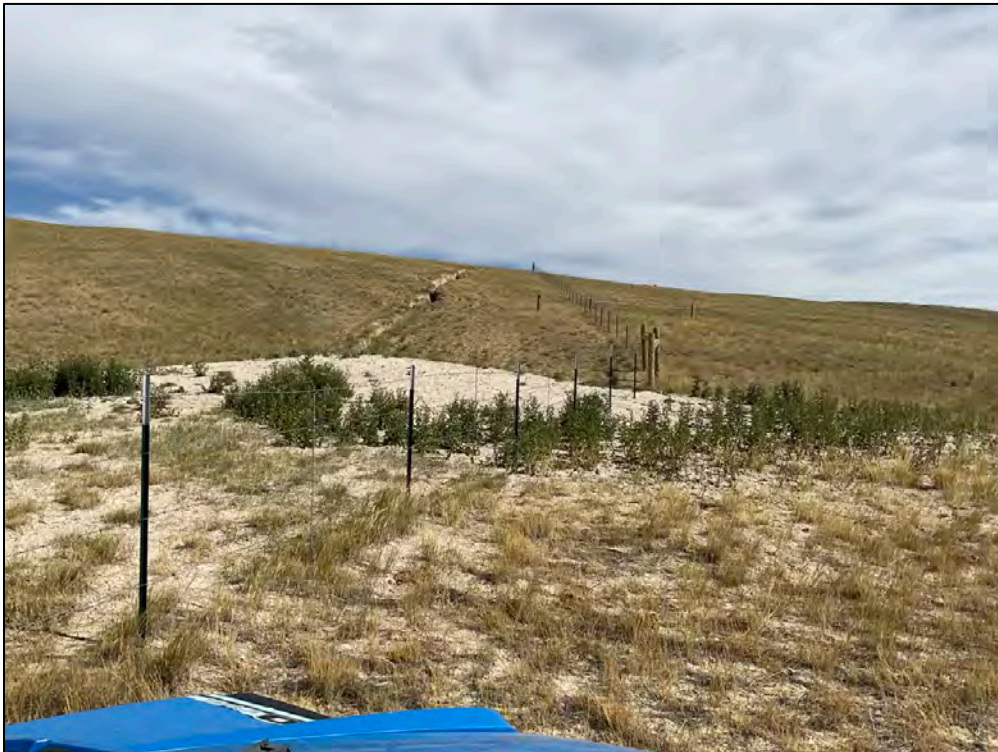
An arroyo formed beneath the fence on the southern portion of the west boundary in 2023. The arroyo formed in line with the fence, damaging several sections. Sediment from the erosional event was deposited below the slope break (PL-2). The damaged fence was removed, and the

perimeter fence was realigned approximately 30 feet (ft) east and away from the arroyo in October 2023. A similar arroyo is forming north of the one previously observed and addressed. A significant rain event could cause the sediment to damage the fence similarly to the previous arroyo from 2023. This feature will continue to be monitored. No maintenance needs were identified.

*PL-2. Sediment Deposition Along Western Boundary*

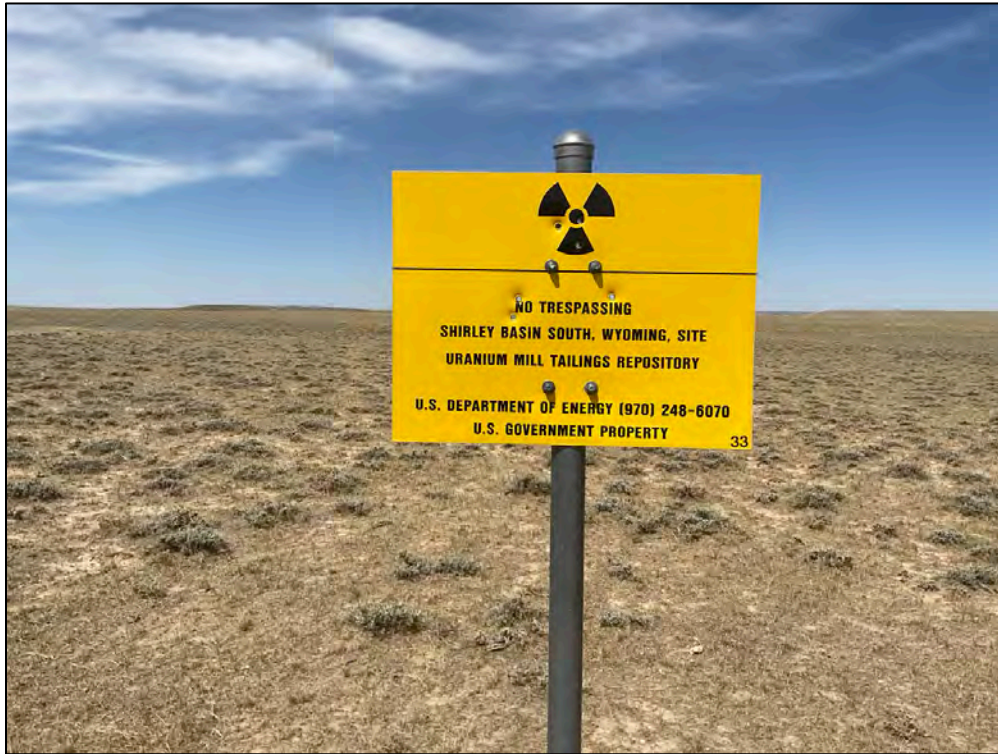
*PL-3. Perimeter Sign P33 Showing Bullet Holes*

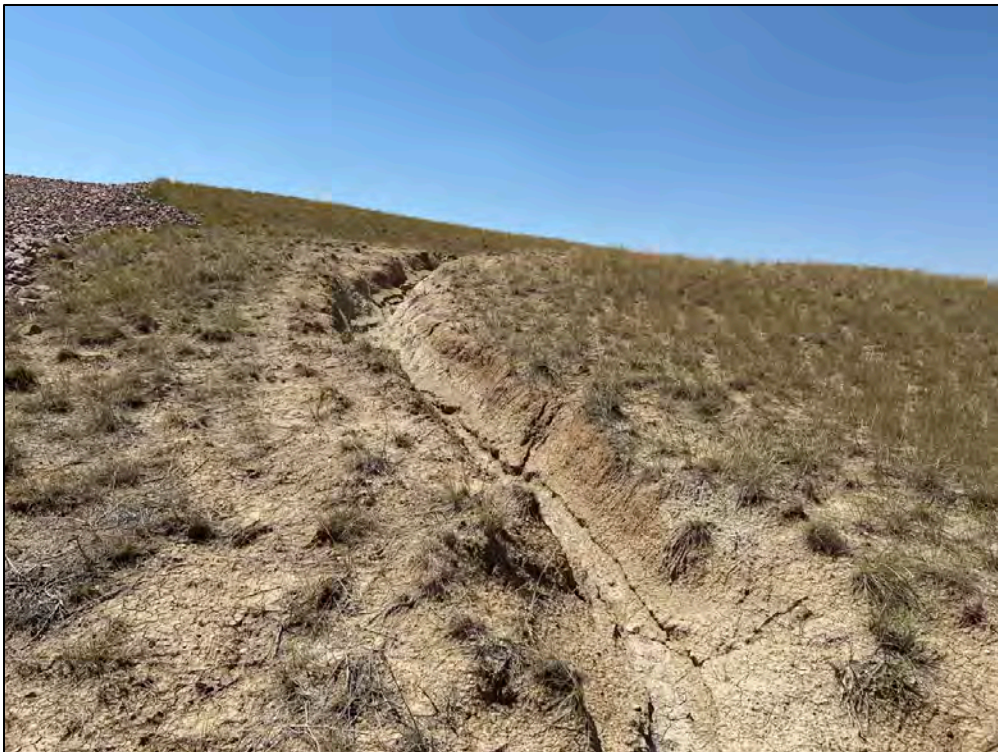
*PL-8. Erosion Parallel to Riprap in Pit 4 Area*

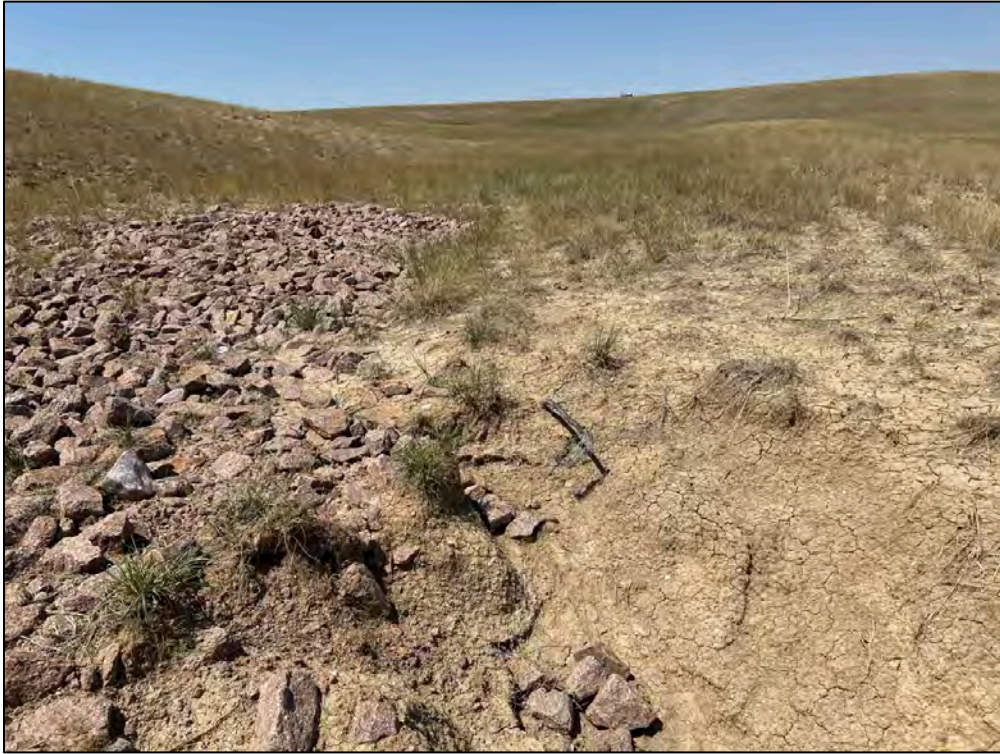
*PL-9. Exposed Wire at Top of Erosion Gully*

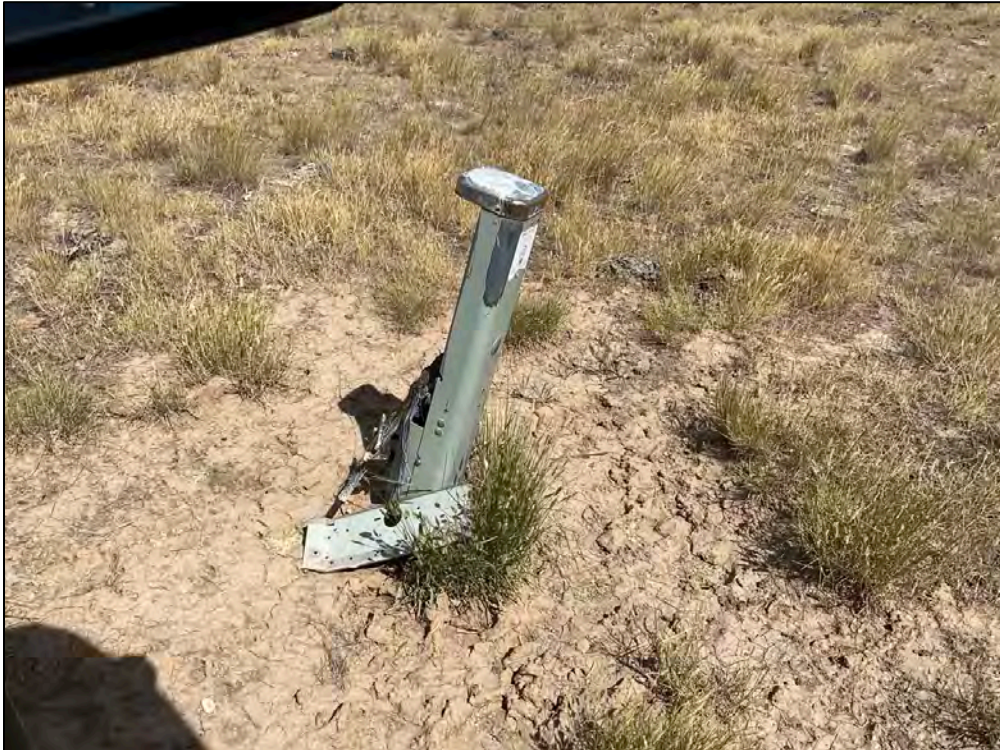
*PL-10. Old Phone Box with Exposed Wires*

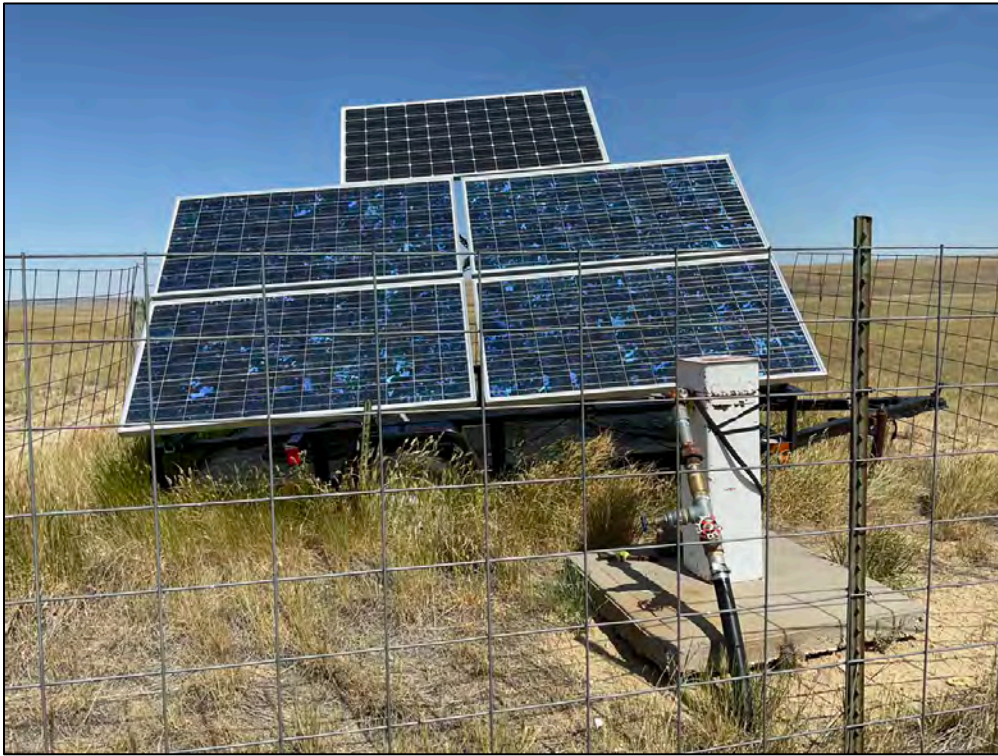
*PL-11. K.G.S #3 Pump Well and Solar Panel*

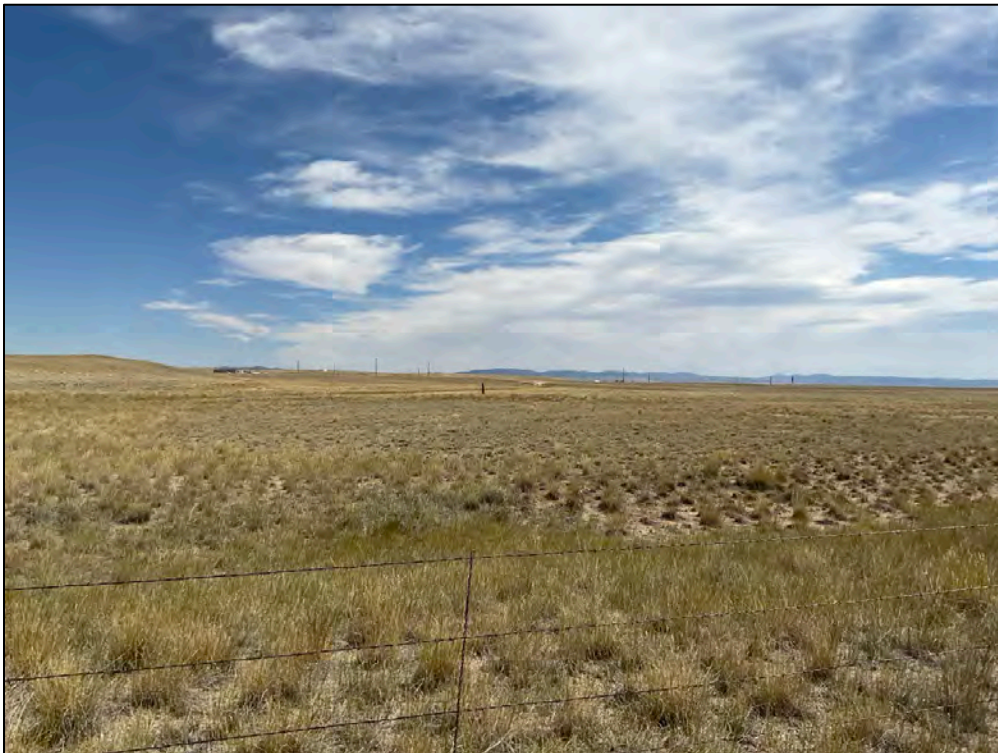
*PL-12. Office Construction for In Situ Recovery North of Site*

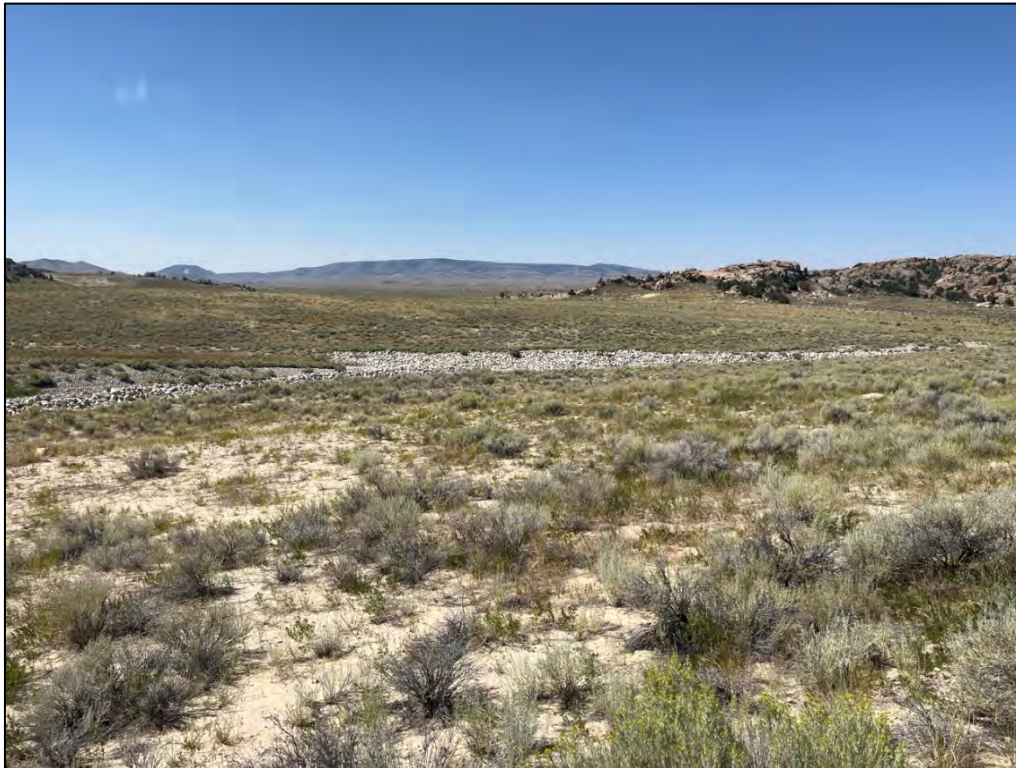
*PL-11. Brush and Shrubs on Disposal Cell Side Slopes*

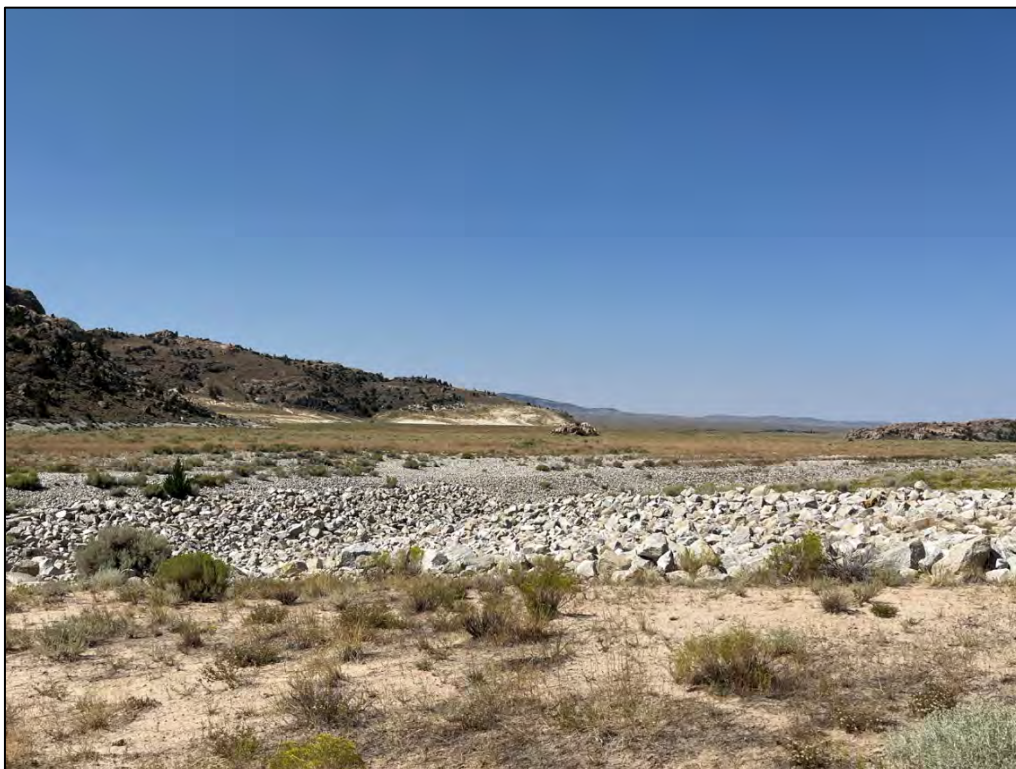
Since construction and before the site transitioned to LM, deep-rooted vegetation has established in the stormwater diversion system (DOE 2023). Inspectors noted volunteer growth of deep-rooted species within the stormwater diversion system; however, no negative performance impacts have been identified from their presence (PL-18). No maintenance needs were identified.

*PL-18. Deep-Rooted Vegetation in Diversion Channel*

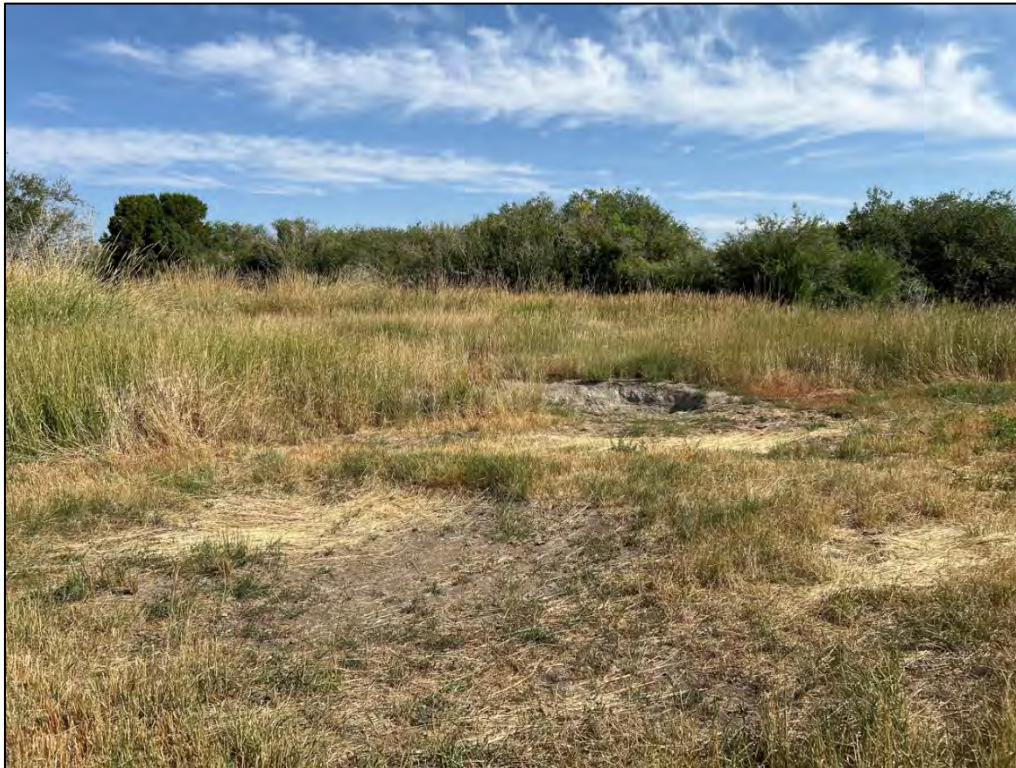
*PL-21. Signs of Disturbance in Northern Hay Field*
