OFFICE OF  
ENVIRONMENTAL  
MANAGEMENT

# Individual Permit Corrective Actions Update

March 5, 2025

**N3B** Los  
Alamos

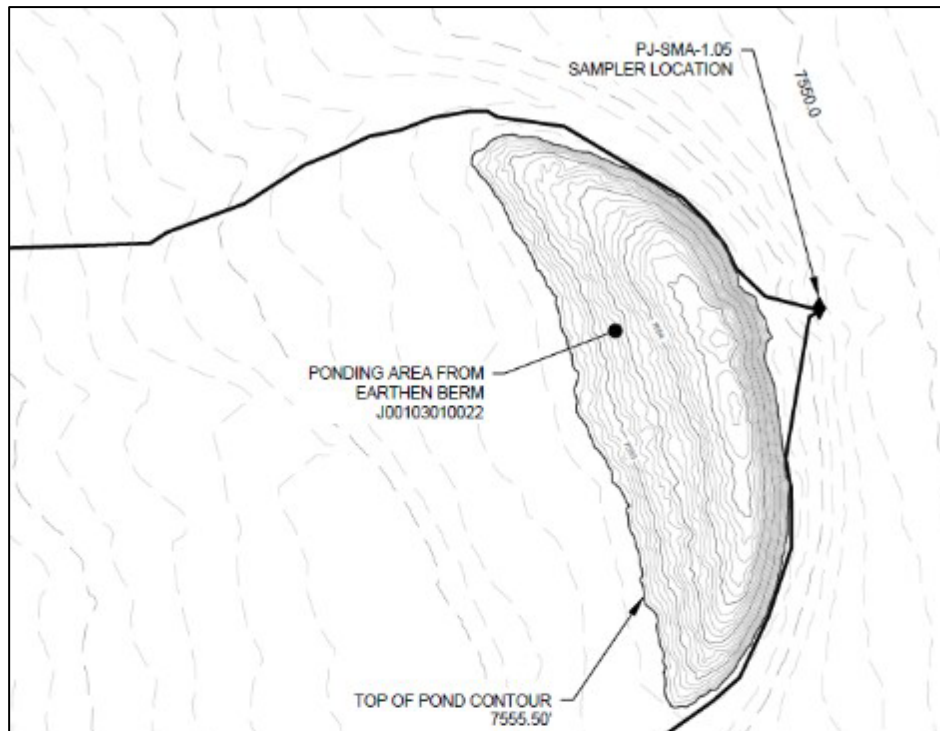
# 3-year, 24-hour Retention Certifications Scheduled for 2025 – PJ-SMA-1.05, S-SMA-3.51, and STRM-SMA-5.05

| <u>Earthen Berm</u> | <u>3-year, 24-<br/>hour Storm<br/>Runoff<br/>Volume (ft<sup>3</sup>)</u> | <u>Pond<br/>Retention<br/>Volume (ft<sup>3</sup>)</u> | <u>Volume<br/>Difference<br/>(ft<sup>3</sup>)</u> | <u>Maximum<br/>Allowable<br/>Sediment<br/>Accumulation<br/>Stage (ft)</u> |
| J00103010022 | 450 | 2,717 | 2267 | 2.0 |
