Well MIDDLE-2051 Investigation and Results

Presentation to Citizens Advisory Board

Idaho Cleanup Project

October 26, 2017

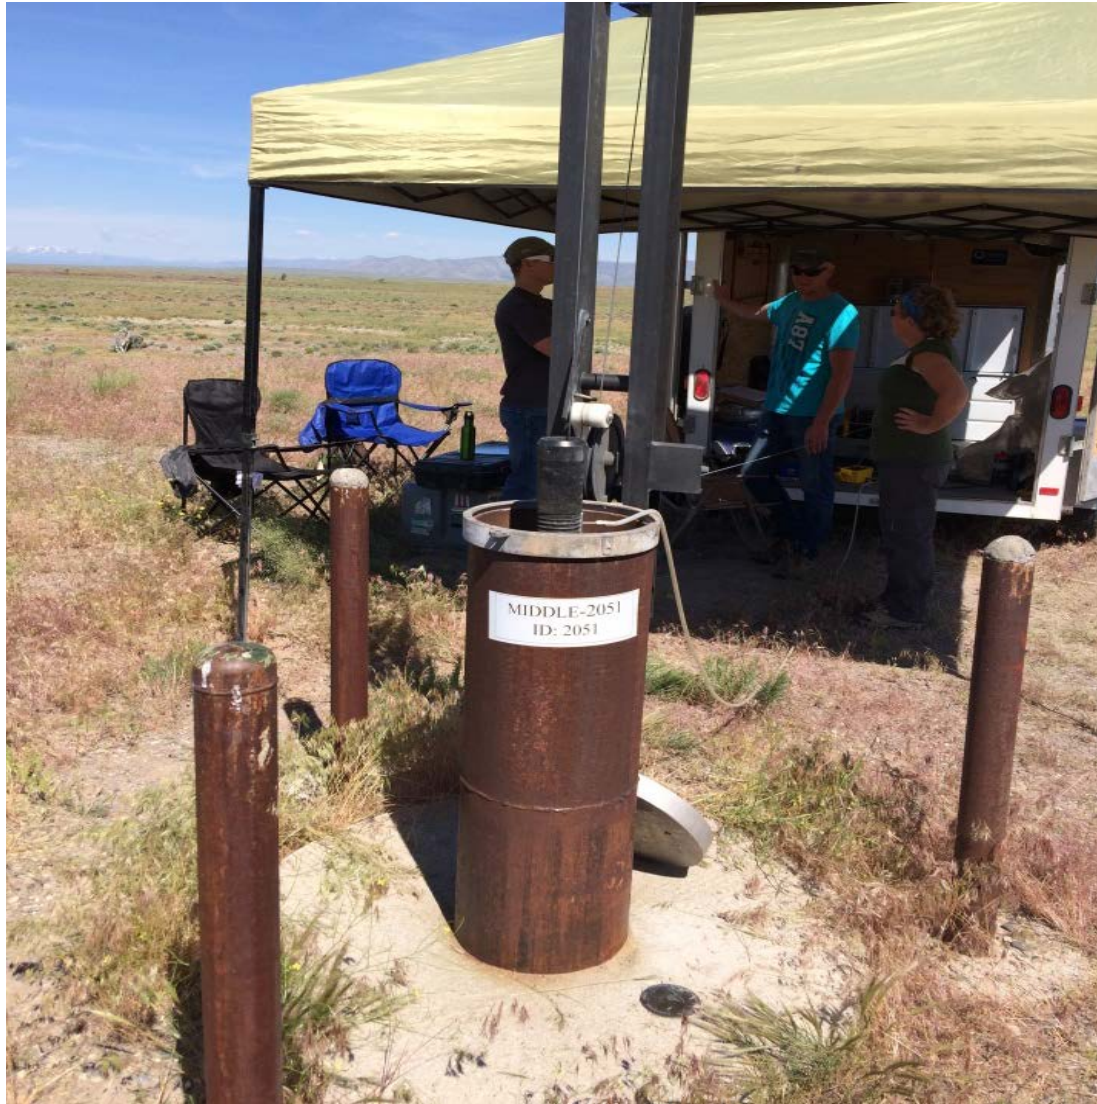
Well MIDDLE-2051

- In November 2015, the solvent perchloroethylene (PCE) was detected in water samples from well MIDDLE-2051
- Follow-up sampling demonstrated that the Westbay well tubing fluid was contaminated with PCE – **but PCE was not present in the aquifer** (outside the well)
- The agencies agreed to implement the New Site Identification process from the Operable Unit 10-08 ROD to further investigate the nature and extent of the problem.
