# Hooper Bay Housing Analysis and Energy Feasibility Report

Prepared for:  
Sea Lion Corporation  
Main Airport Road  
Hooper Bay, AK  
99604

December 30th, 2012

Prepared by:  
Cold Climate Housing Research  
Center  
1000 Fairbanks, AK 99708  
907.457.3454  
[www.cchrc.org](http://www.cchrc.org)

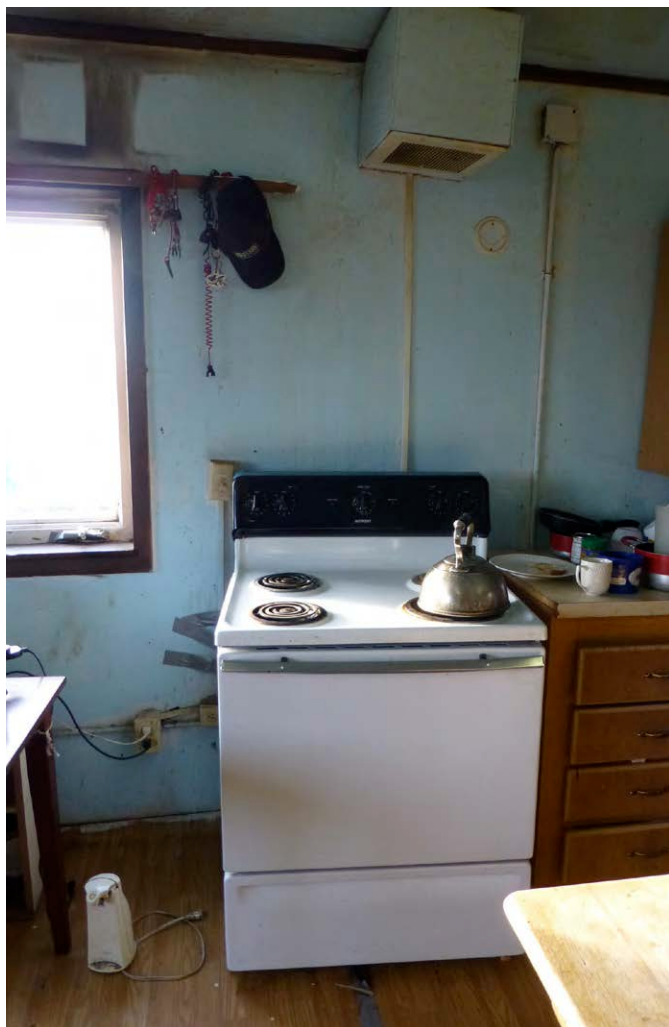
Ventilation fan installed above stove.
