Type B Accident Investigation Board Report Employee Burn Injury at the D Area Powerhouse

September 23, 2009

October 2009
U.S. Department of Energy
Savannah River Site

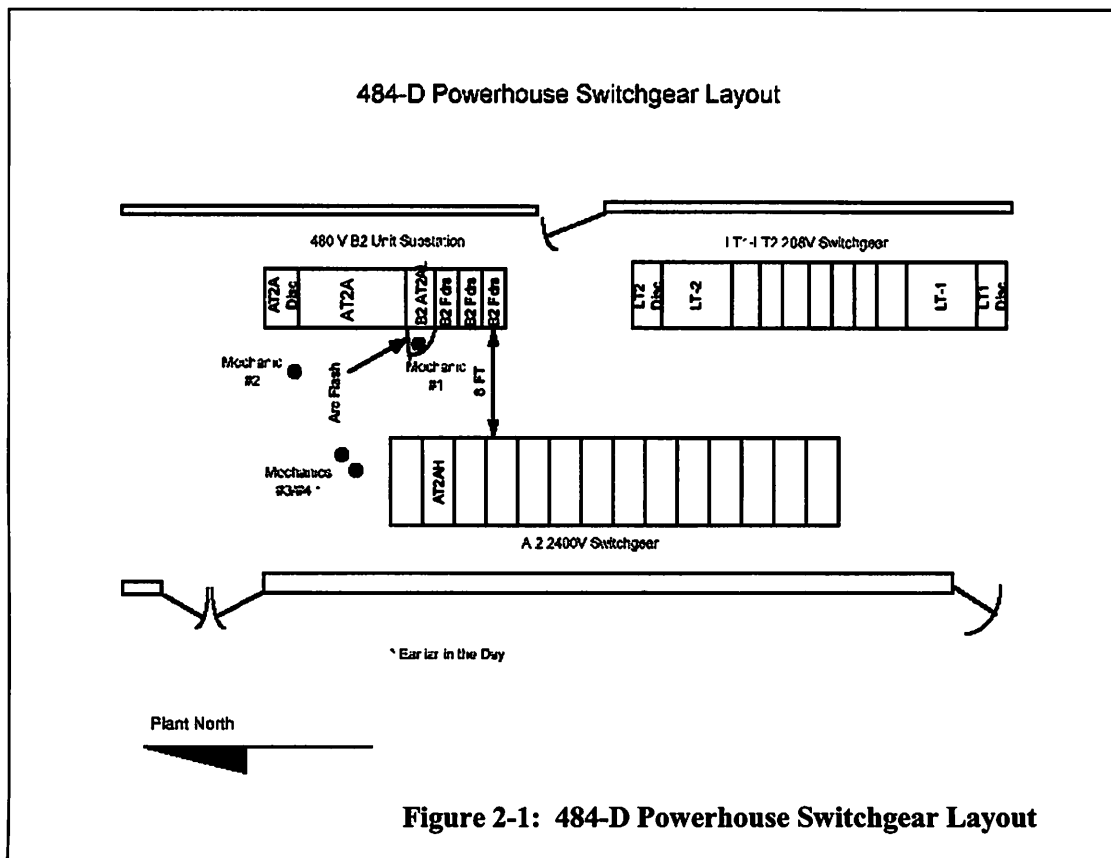
At 1246 hours on September 23, 2009, an electrical and instrumentation (E&I) mechanic (E&I Mechanic #1) received second and third degree burns to his arms and first and second degree burns to his face when a metal tool (9-inch torpedo level) contacted the energized "A" phase of a 480 volt breaker, causing a direct short to ground and an arc flash event. At the time of the accident, two E&I mechanics were troubleshooting/repairing the breaker and cubicle because the breaker would not close. During earlier attempts to close the breaker, the mechanics concluded the problem was related to an un-level track resulting in breaker misalignment in the cubicle. The level was placed in the energized cabinet by E&I Mechanic #2 to determine the extent of "adjustments" needed to position the breaker within the cabinet. The level fell from the top of the arc chute down the left side of the breaker (when facing the breaker) and is suspected to have lodged between the "A" phase breaker moving contact and the breaker support brace, causing the arc flash. The arc flash severely damaged the left side of the breaker, generated excessive heat, and resulted in splattering of material within the cubicle and surrounding area, including evidence of slag embedded in the electrical equipment approximately ten feet away. E&I Mechanic #1 was positioned at the front of the breaker cabinet without an arc flash suit or flame-retardant coveralls. He recognized the level was falling and positioned his arms horizontally to protect his head and face. He experienced second and third degree burns to his arms and first and second degree burns to the right side of his face. E&I Mechanic #2 had stepped away from the cabinet and was outside the effect of the arc flash. Based on the condition of the circuit breaker and cubicle, the Board determined the fault current was interrupted before the short was able to develop a plasma arc cloud which would have made the event a fully engulfed arc flash, creating more extreme consequences including more serious injuries to the workers.
