ARIZONA STATE UNIVERSITY  
**PHOTOVOLTAIC RELIABILITY LABORATORY**

## **Failure and Degradation Modes of PV modules in a Hot Dry Climate: Results after 12 to 26 years of field exposure**

**Mani G. Tamizh-Mani  
Joseph Kuitche  
&  
Research Students of ASU-PRL**

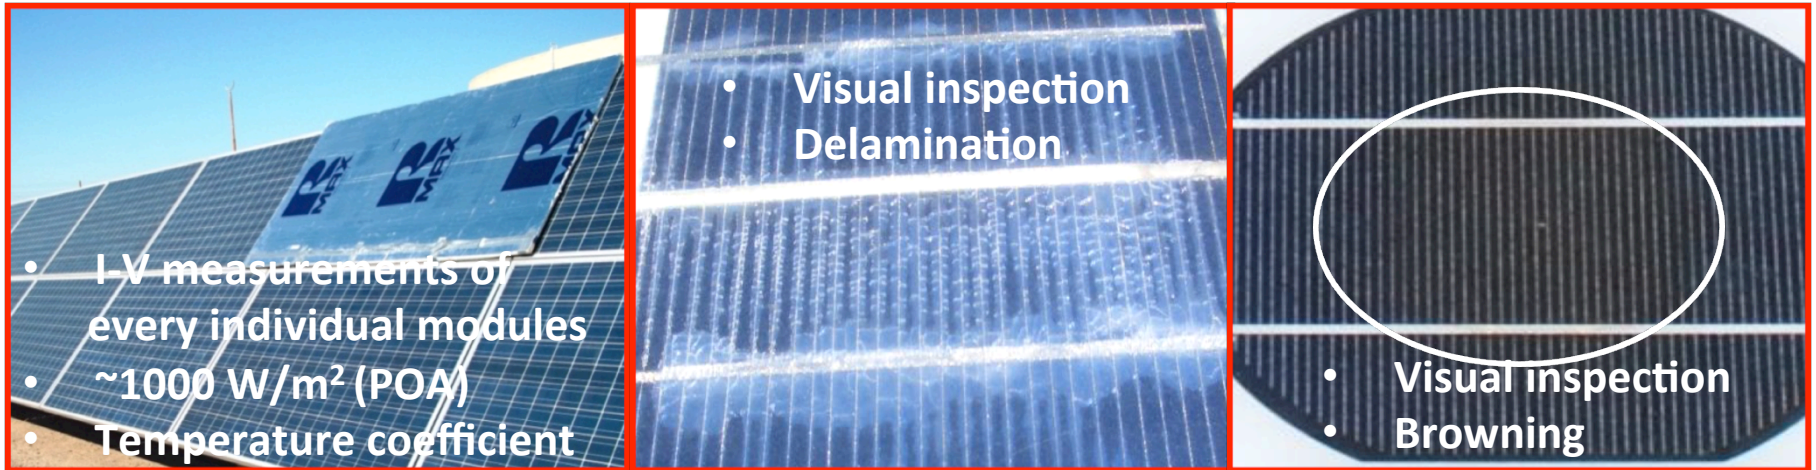
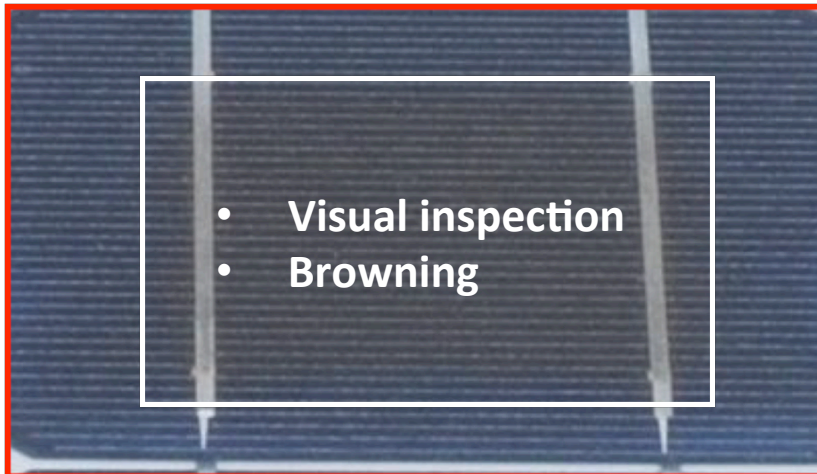
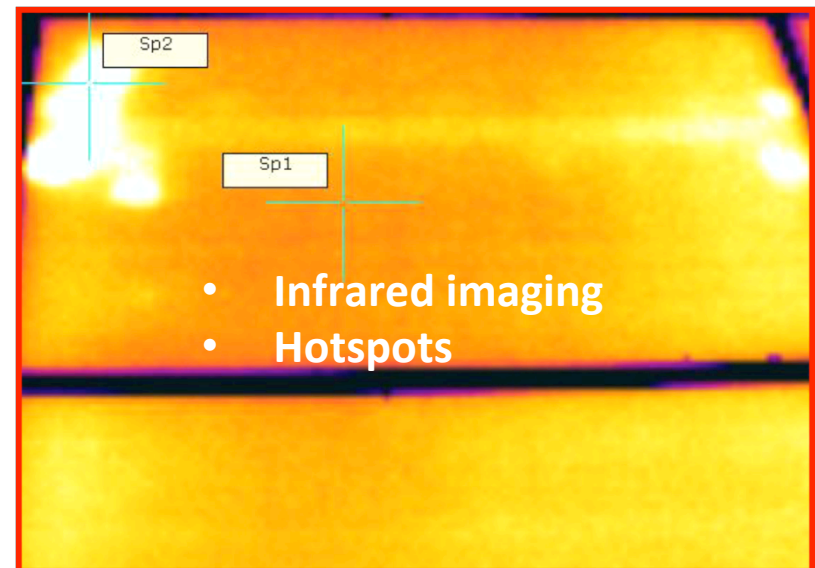
## Site 1: Characterizations – Visual Inspection, IR Imaging & I-V Curves

Power degradation appears to be primarily due to **current drop (encapsulant browning)** and **fill factor drop** (series resistance increase due to **thermo-mechanical fatigue of solder bonds**)

Modules with hotspot issues seem to degrade at higher rate than the non-hotspot modules. Periodical IR scanning may be useful for the early identification and potential removal of the hotspot modules from the power plants to mitigate future module mismatch issues.

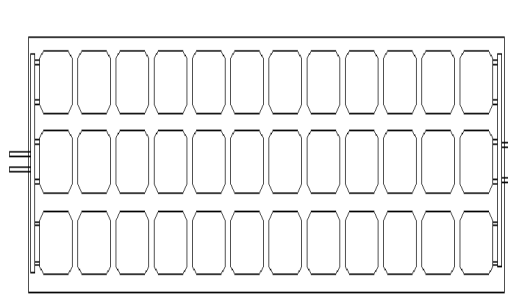
**Note: OUTDATED CABLIG METHOD**

- **No module cable**
- **No module connector**
- **Non-cell interconnect ribbons are directly welded on inter-panel busbar**

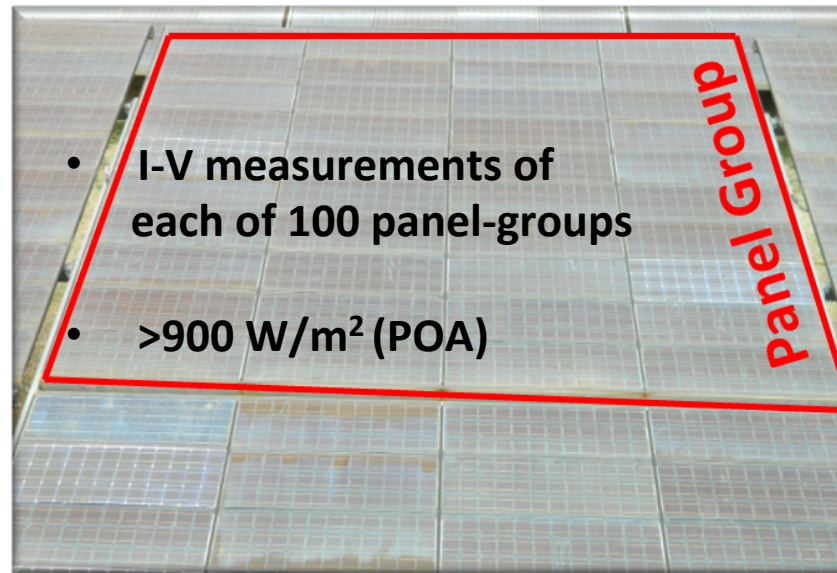
## Site 2: Characterizations – Visual Inspection, IR Imaging & I-V Curves

- Infrared imaging
- Hotspots

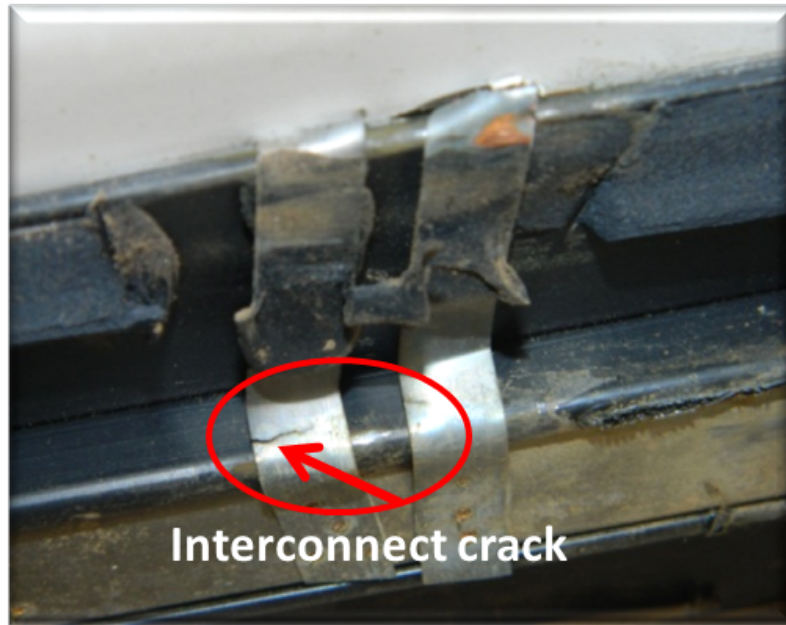
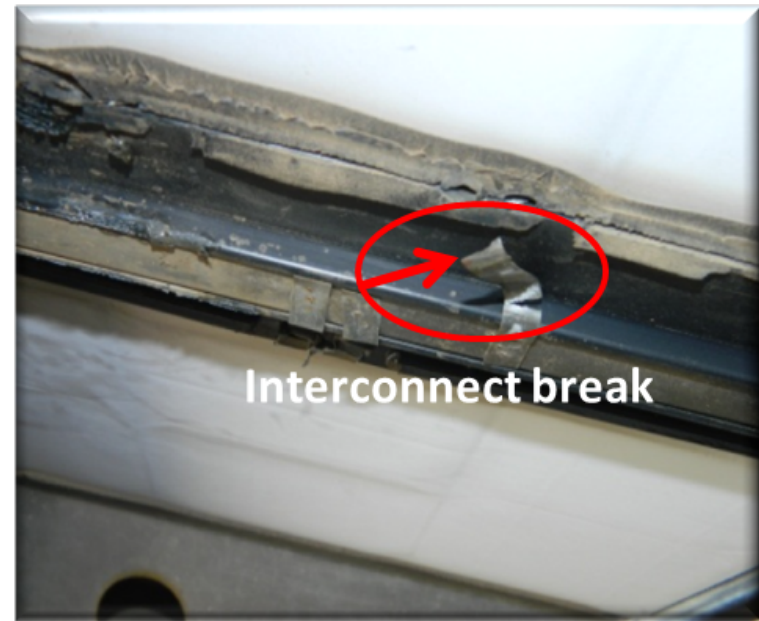
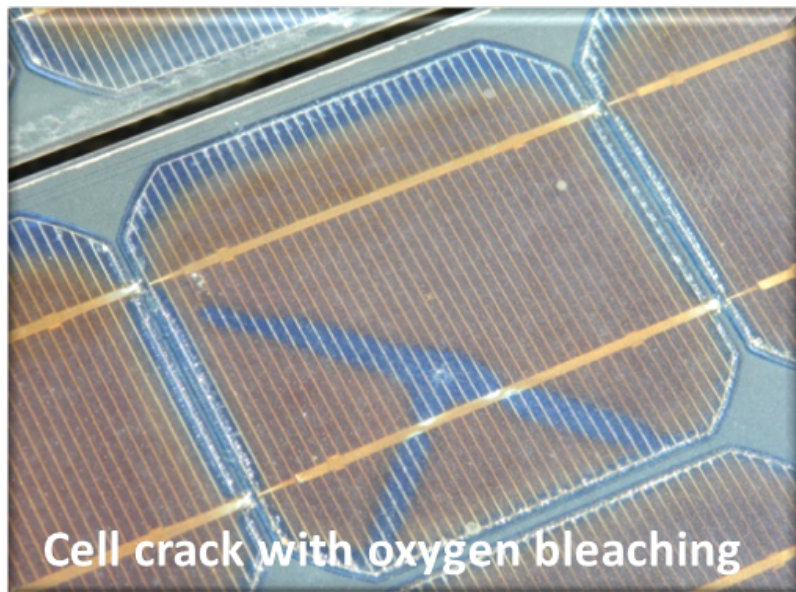
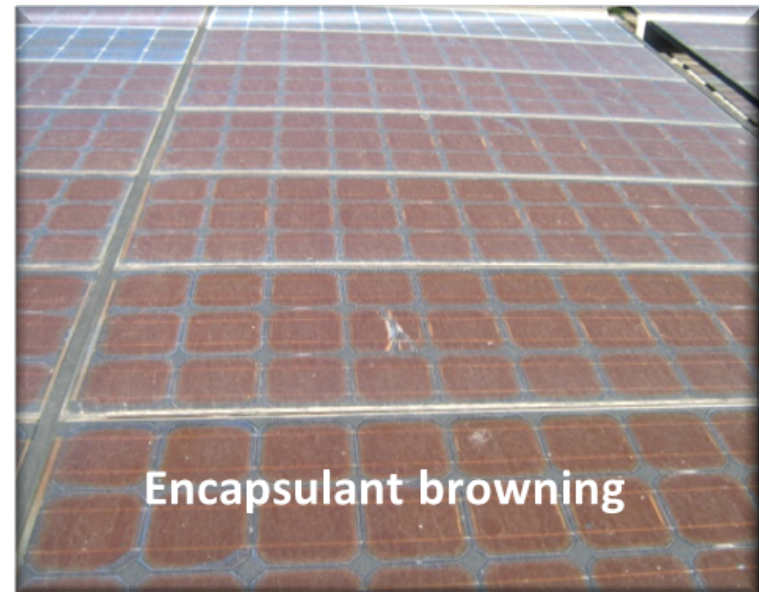
## Site 2: Characterizations – Visual Inspection, IR Imaging & I-V Curves

**Primary degradation modes in hot-dry climatic sites appear to be encapsulant browning and solder bond fatigue. These degradation modes turn to become failure modes when the performance degradation exceeds the warranty limit, e.g., > 20%.**
