Delamination failures in long-term field-aged PV modules from point of view of encapsulant

Tsuyoshi Shioda

Mitsui Chemicals, Inc.

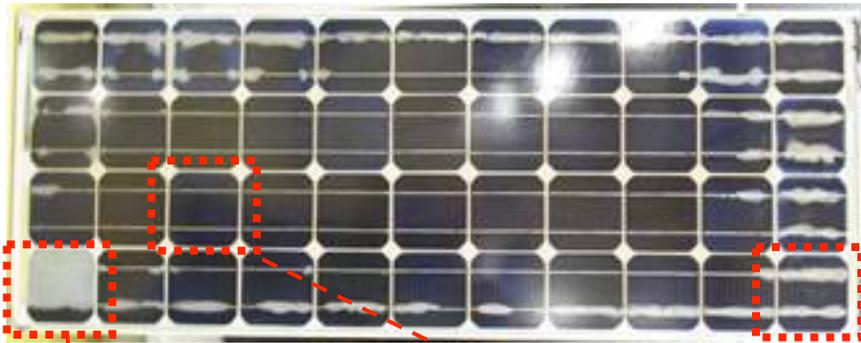
partial delamination

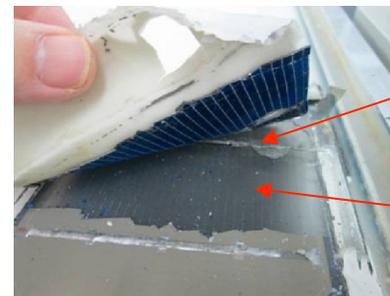
ribbon

Delaminated portion

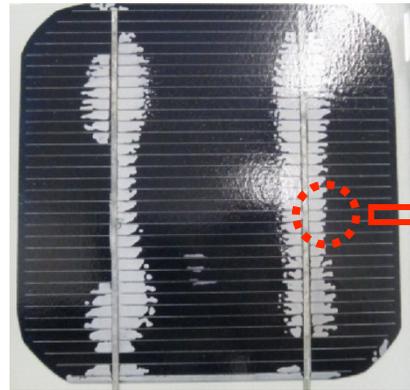
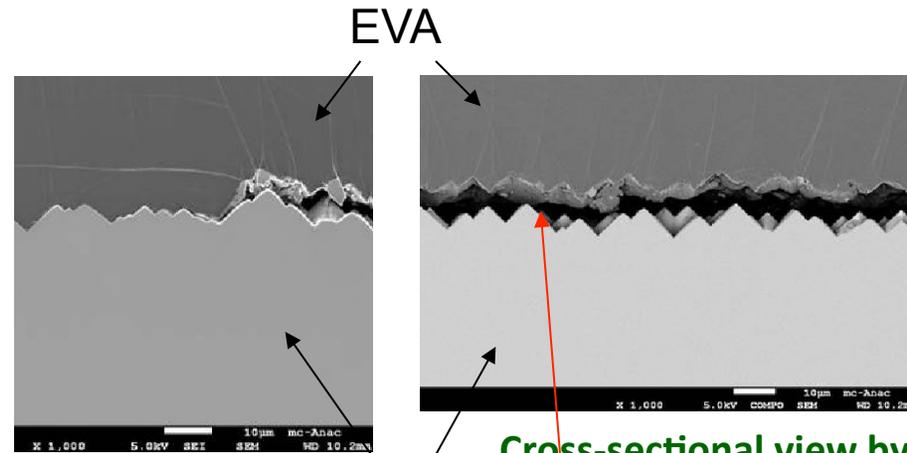
Cross-sectional view by SEM

We confirmed that the surface layer of the cell was **TiOx** deposited as an AR-coating of the cell using XPS measurement.

Delamination was observed at the interface between EVA and TiOx.

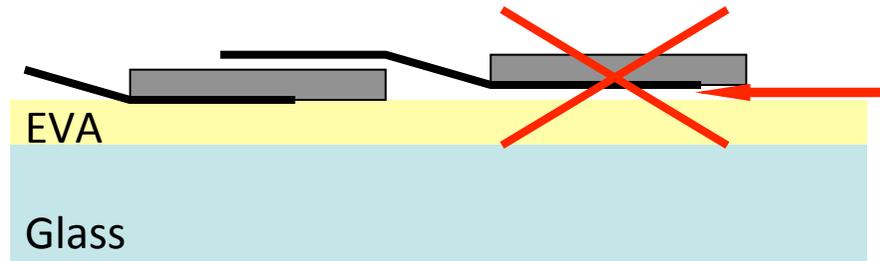
When we attempted to separate a cell from EVA/Glass, a cell broke into bits due to brittleness of a cell.

- ✓ To separate a cell from glass side EVA at the **X** is **easier** than that at the **Y**.
- ✓ The stress at the **X** is **higher** than that at the **Y**, because the **X** is **outer** position as compared to the **Y** in a plane of the PV module.

- ✓ We speculate that delamination is induced by weakening chemical adhesion (led by use of TiOx) and high strain at the interface.
- ✓ We should confirm change of performances of EVA encapsulant.

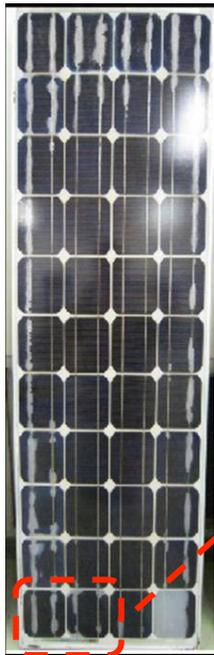
closeup picture

Patina

Severe degradation of copper

A solder layer disappeared.

A part of Copper ribbon disappeared.
= No electrical conduction

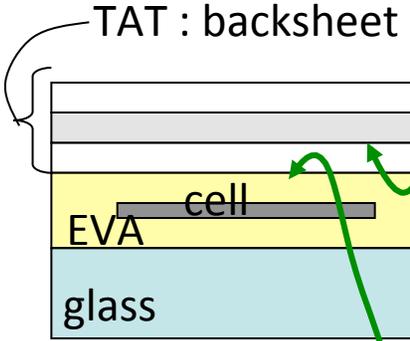
✓ Adhesion strength among inner layers of the backsheet "TAT" was extremely low.

TAT : backsheet
EVA
cell
glass
