Mexican Hat, Utah, Disposal Site Disposal Cell Evaluation Information Sheet

This information sheet provides information about observed disposal cell conditions and anomalies of the **Uranium Mill Tailings Radiation Control Act of 1978 Title I processing site at Mexican Hat, Utah**. This site is managed by the **U.S. Department of Energy Office of Legacy Management**.

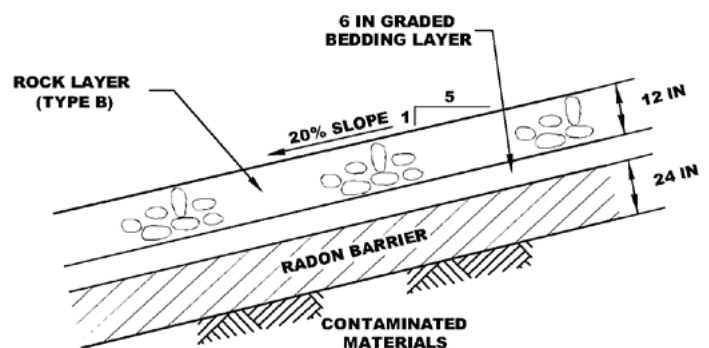
SCHEMATIC - NOT TO SCALE

Bentonite is an engineered material commonly used in radioactive waste management because it reduces hydrologic permeability, swells, and self-seals when saturated, and results in diffusion as the dominant transport mechanism (Sellin et al. 2013). A 6-inch bedding layer was placed on top of the radon barrier consisting of sandy gravel with a few fine aggregates. The

bedding layer acts as a filtering system and provides additional protection against erosion of the radon barrier. On top of the bedding material is a 12-inch layer of larger riprap (rock) keyed together to reduce lateral and horizontal water movement and further protect against erosion.
