Level I Accident Investigation Report

Fatal Fall Dworshak-Taft # 1 500 kV Line, September 20, 2012

**Report Date:
November 30, 2012**

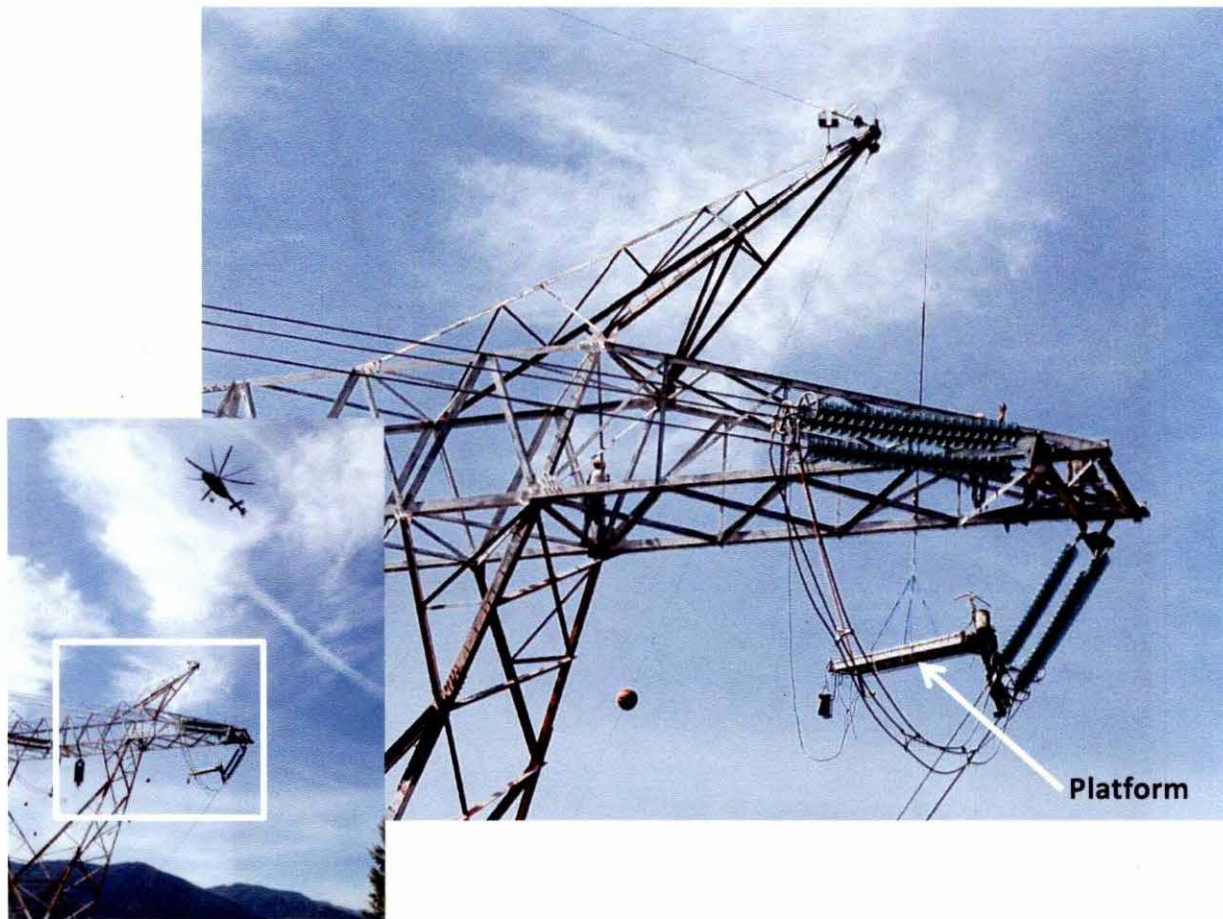
Figure 2: Similar Work Performed on a Different Type of Tower

On September 20, 2012, a combination of two work crews, the Bell crew (Spokane, WA) including LM-1, and the Kalispell crew (Kalispell, MT), were scheduled to begin the work of replacing aging dead-end insulators on the Dworshak-Taft # 1 500 kV transmission line at mile 83 structure 4 (83/4). (Figure 1) This line was de-energized and a work clearance was issued from Dittmer Control Center (Dittmer). The work plan was to use a BPA helicopter to fly dead-end platforms, tools, and materials to men working in the tower. Figure 2 shows similar work performed on a different type of tower.
