Accident Investigation Report

Fall Injury Accident at the Savannah River Site on July 1, 2011

August 8, 2011

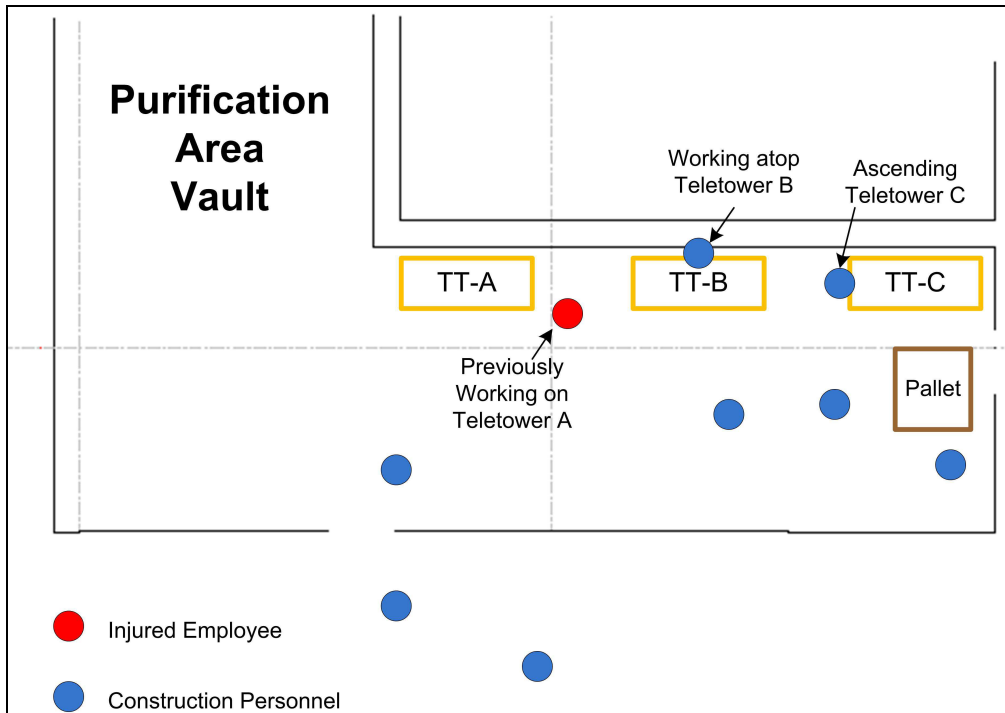
Figure 2-33: PAV Accident Scene Layout

To provide access to the elevated work location, the workers elected to use Tele-Tower[®] Adjustable Work Platforms (scaffolds) Model 1101. The Tele-Towers[®] were adjustable from 2’ to 11’ in six inch intervals. An extension may be added to provide a working platform height from 12’ 6” to 17’ 6”. Two of the Tele-Towers[®] used by the workers (unit B and unit C) had the vertical extensions installed. One (unit A) did not. The static load rating of the scaffold was 550 lbs. without the extension installed with a weight restriction of 400 lbs. with the extension installed.
