Type B Accident Investigation Board Report

**October 9, 2009
Employee Injury at Building 1005H
Upton, New York**

December 2009

**Brookhaven Site Office
U.S. Department of Energy**

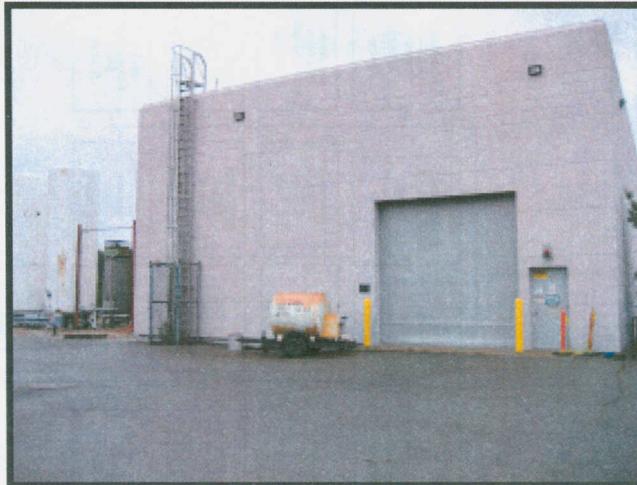
Figure 1-3. Building 1005H, west side

The injury occurred outside of the RHIC Compressor Building 1005H (Figure 1-3). Building 1005H is a one-story, high bay, steel framed, masonry construction building. It is approximately 10,800 square feet in floor area with a volume of about 200,000 cubic feet. It houses the helium compressors and their associated equipment. It is located just to the northwest of the Cryogenic Building 1005R. Access is through 12-foot roll-up doors or man-doors around the building.

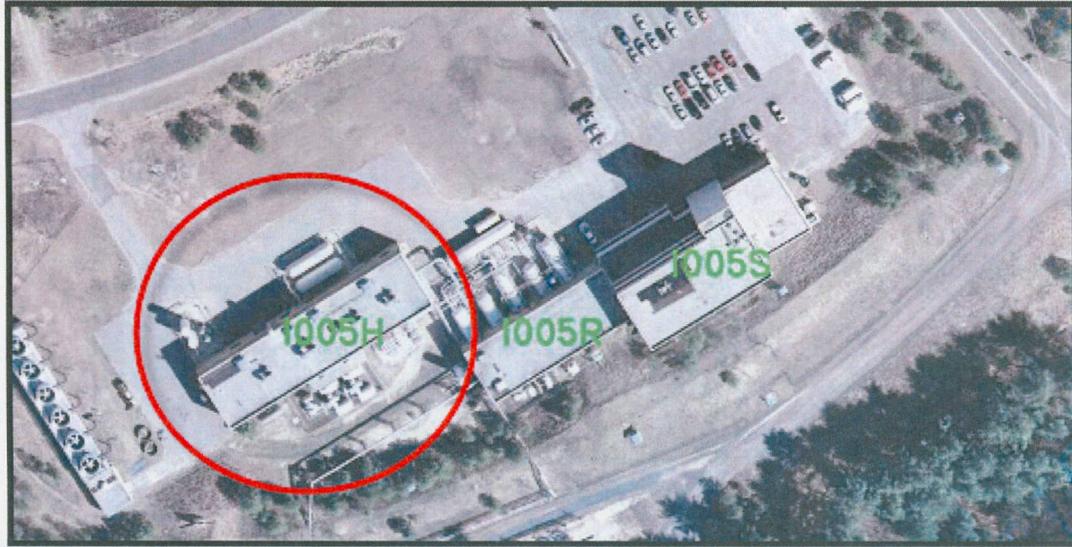
Figure 2-2. BNL North Campus

The Lead Rigger then walked to the north side of the building and proceeded east toward the north doors and the Cryogenic Control Room in Building 1005S (Figure 2-2). As he turned the corner, he passed under two external vent lines (Figure 1-4) for the purification system located inside of the building.
