Type B Accident Investigation Board Report
Employee Puncture Wound at the F-TRU Waste Remediation Facility
June 14, 2010

September 2010
U.S. Department of Energy
Savannah River Site

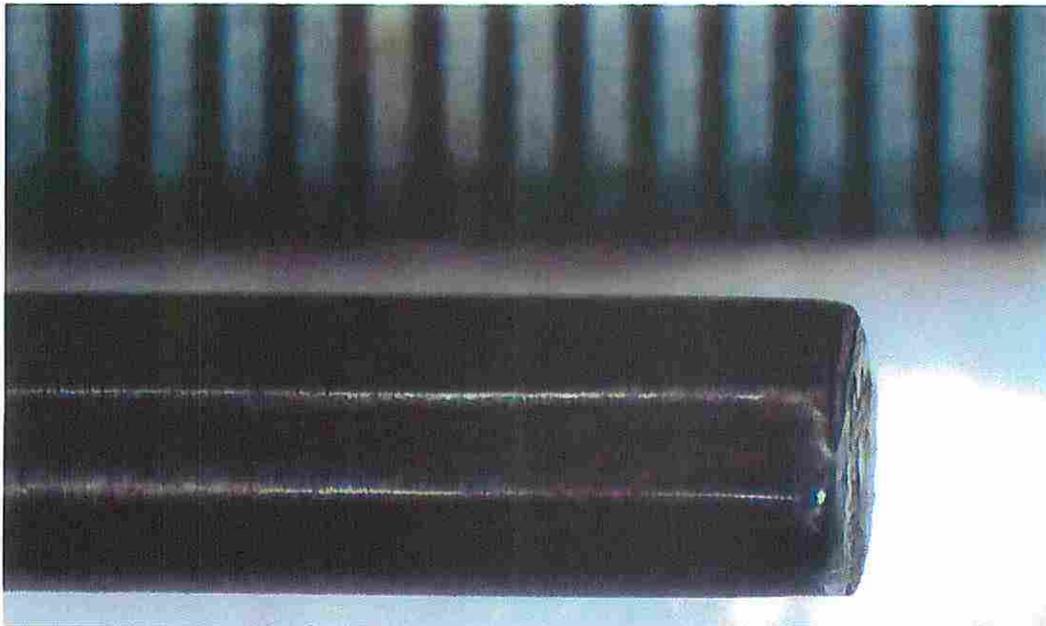
Figure 7. End of typical landscape flag, showing flat surface square to the wire axis. Approximate size 0.066 inch diameter, scale marks 1/64" apart.

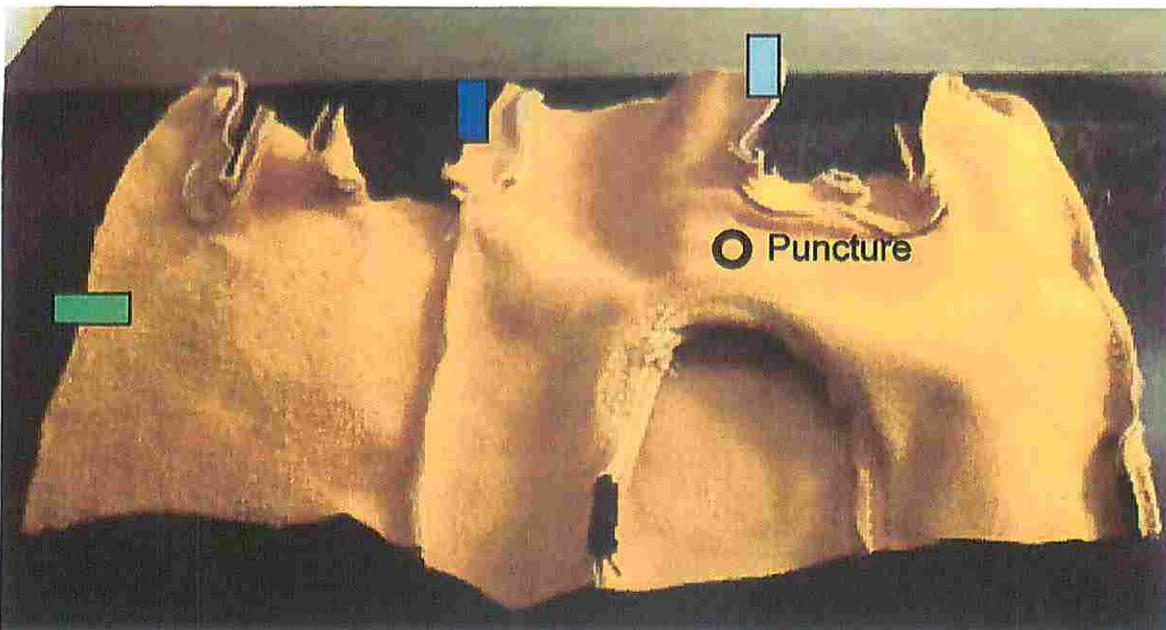
Figure 9. Main region of punctured glove following sectioning, showing 3 areas (at boxes) where the thickness was measured.

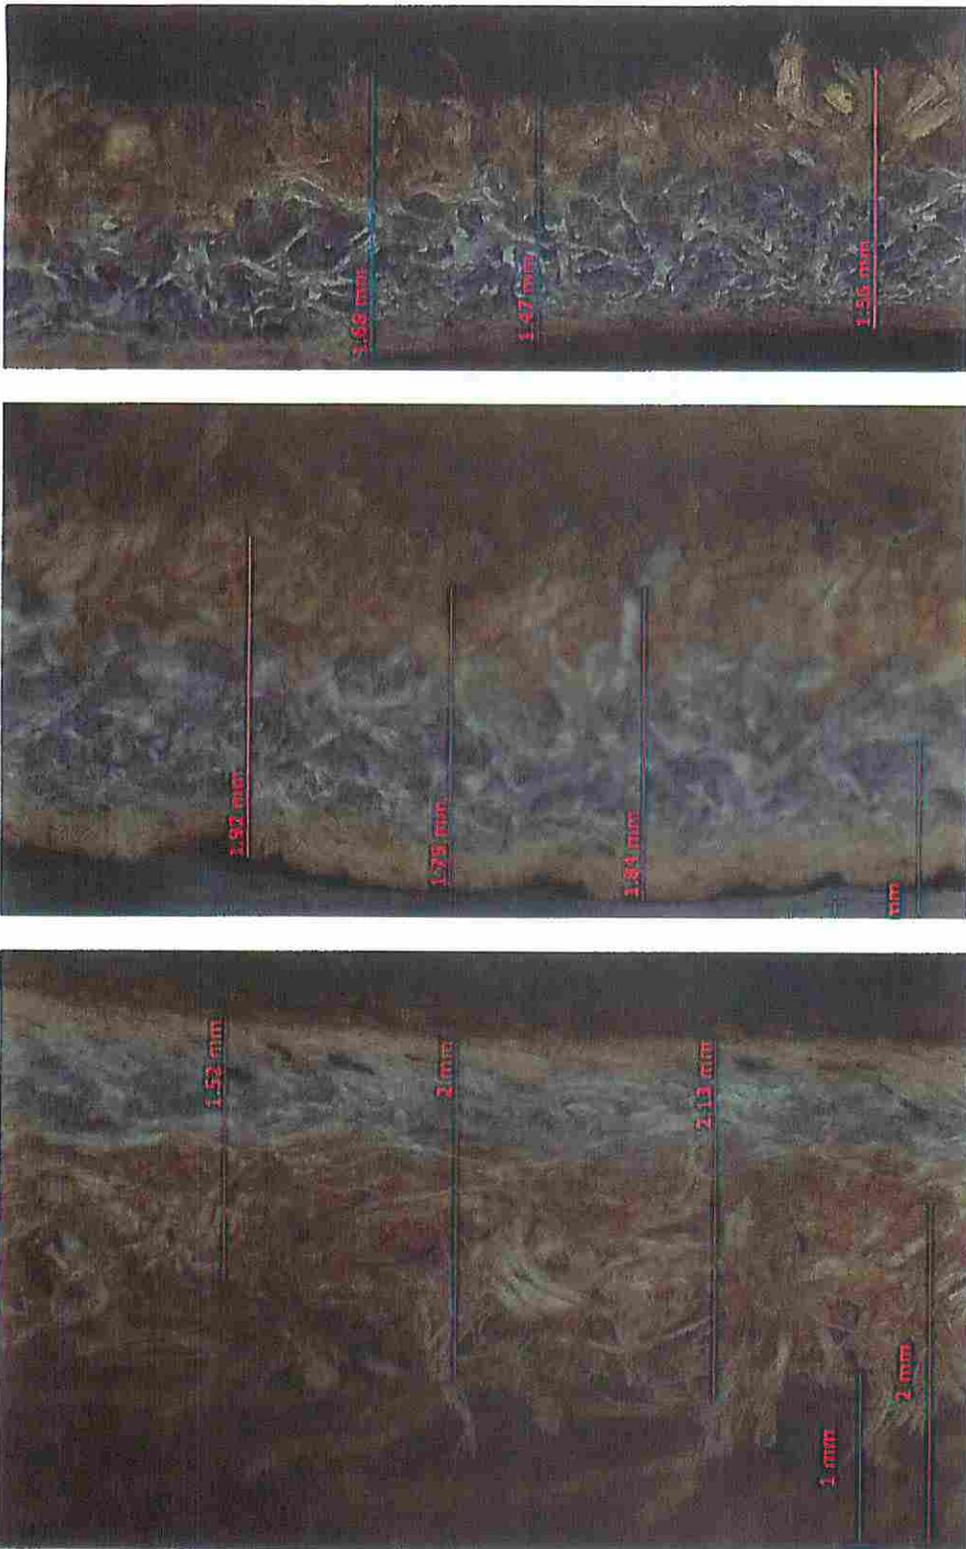
Figure 10. Glove thickness measurements performed at 3 locations around the cut edge of the punctured glove

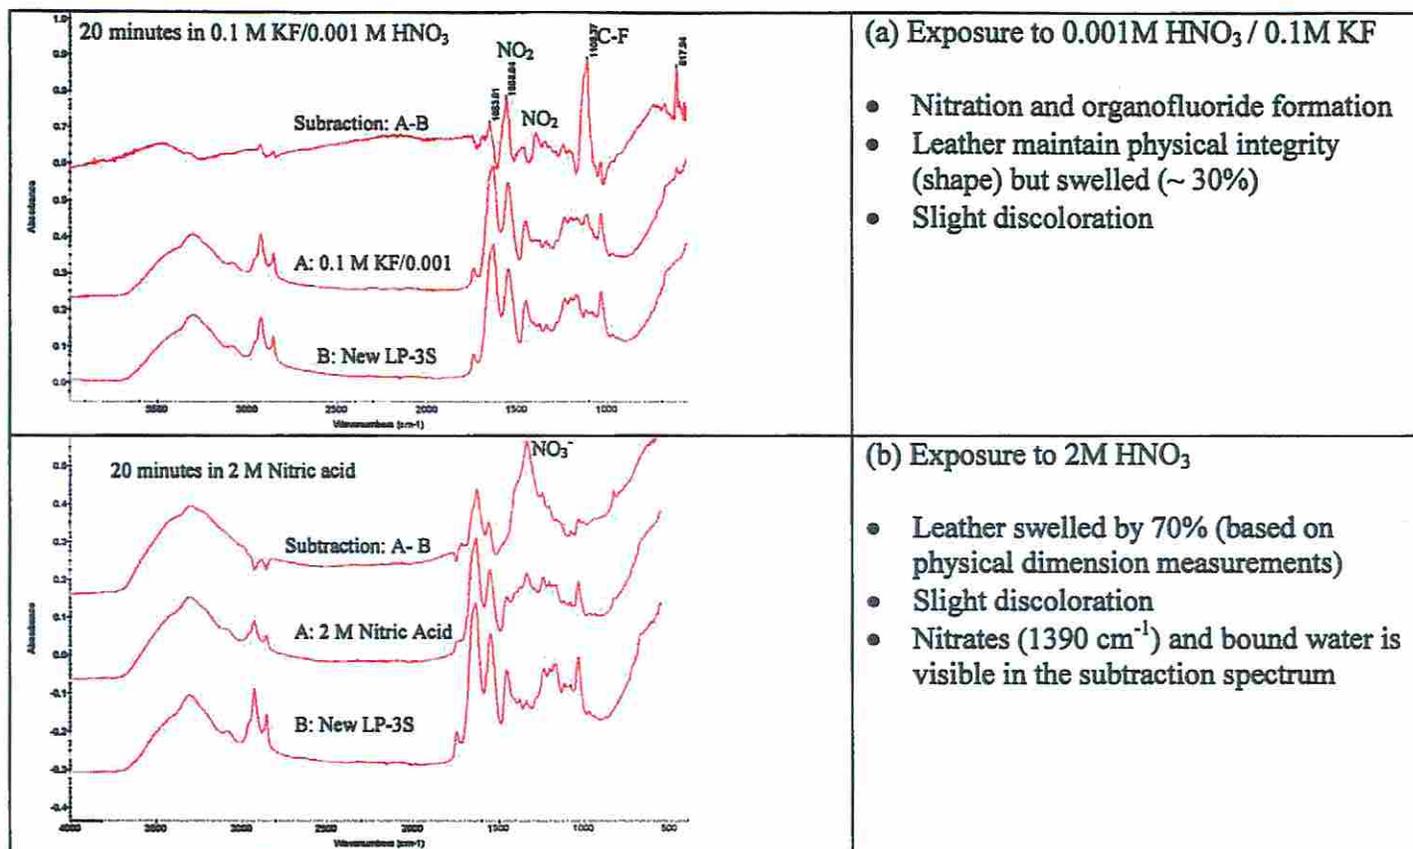
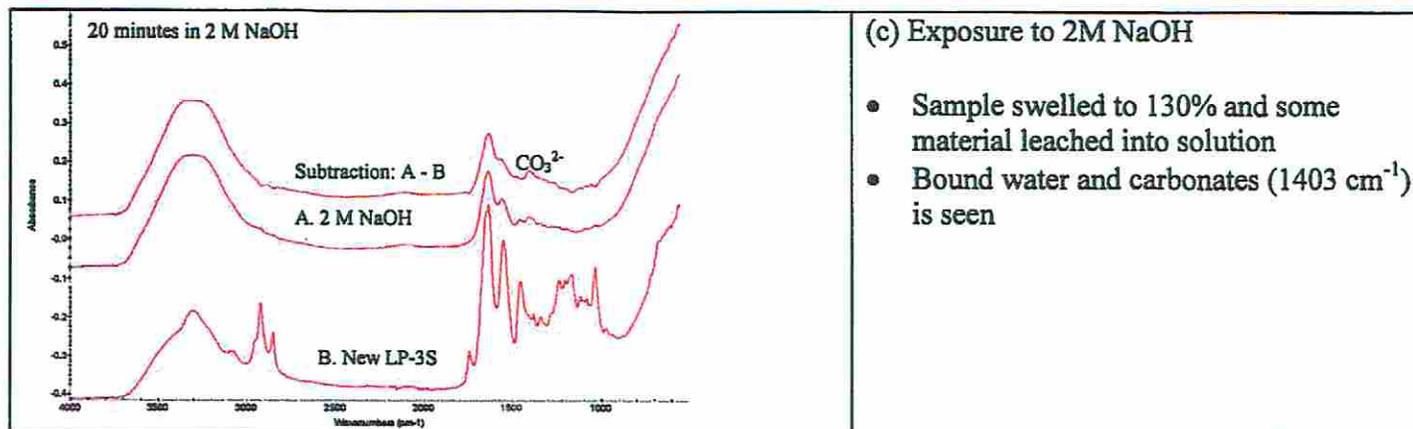
Figure 12 shows the impact of the chemical exposure to a new glove. Short-term (2 hour) exposure to a mixture of 0.001M nitric and 0.1M hydrofluoric acid showed incorporation of fluoride into the organic structure (as evidenced by appearance of peaks at 1100 cm^{-1} wavenumbers) as well as nitration of the organic (as evidenced by appearance on peaks at 1550 cm^{-1} wavenumbers). (Review of literature spectra for pure KF and NaF solutions [6] shows no peak occurs at 1100 cm^{-1} wavenumbers indicating that the new features are not simply from deposition of KF crystals on the dried leather surface.) Also, visual inspection of the leather surface indicated “dimpling”.

Figure 12. Chemical degradation: exposure to (a) combined nitric (0.001 M) and hydrofluoric acid (0.1 M), (b) nitric acid (2 M), and (c) caustic solution (2 M).

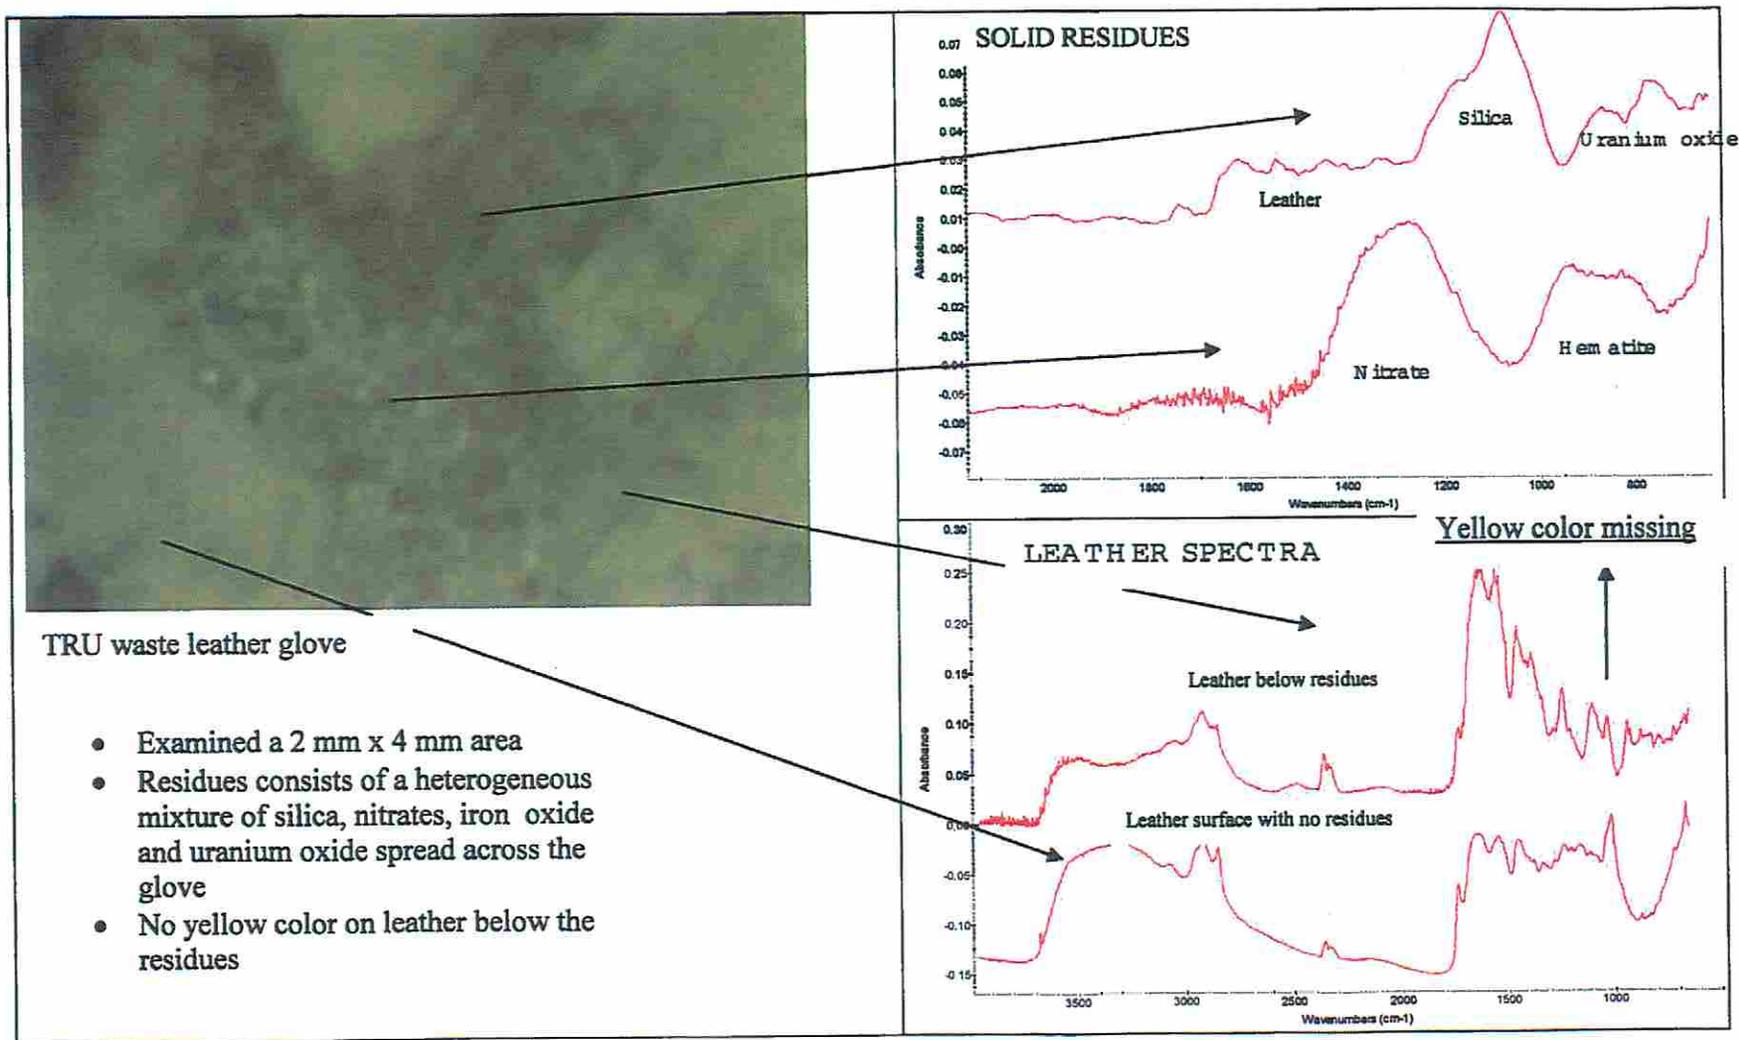
Figure 13. FTIR Analysis of a TRU-waste containing glove

The FTIR analysis of the overglove (see Figures 13 and 14) from the TRU Drumline did not show similar features. There is a slight broadening of the native peak near 1100 cm^{-1} wavenumbers but no evidence of nitration.

Exposure of a new glove to either 2M nitric acid or caustic (for periods of 20 min) showed obvious swelling of the leather with discoloration. These exposures also resulted in the incorporation of new chemical moieties into the leather as evidenced by peaks in the FTIR spectra. Figures 13 and 14, of the contaminated overglove, do not show these features nor does the microscopic imaging show evidence of swelling for the leather.

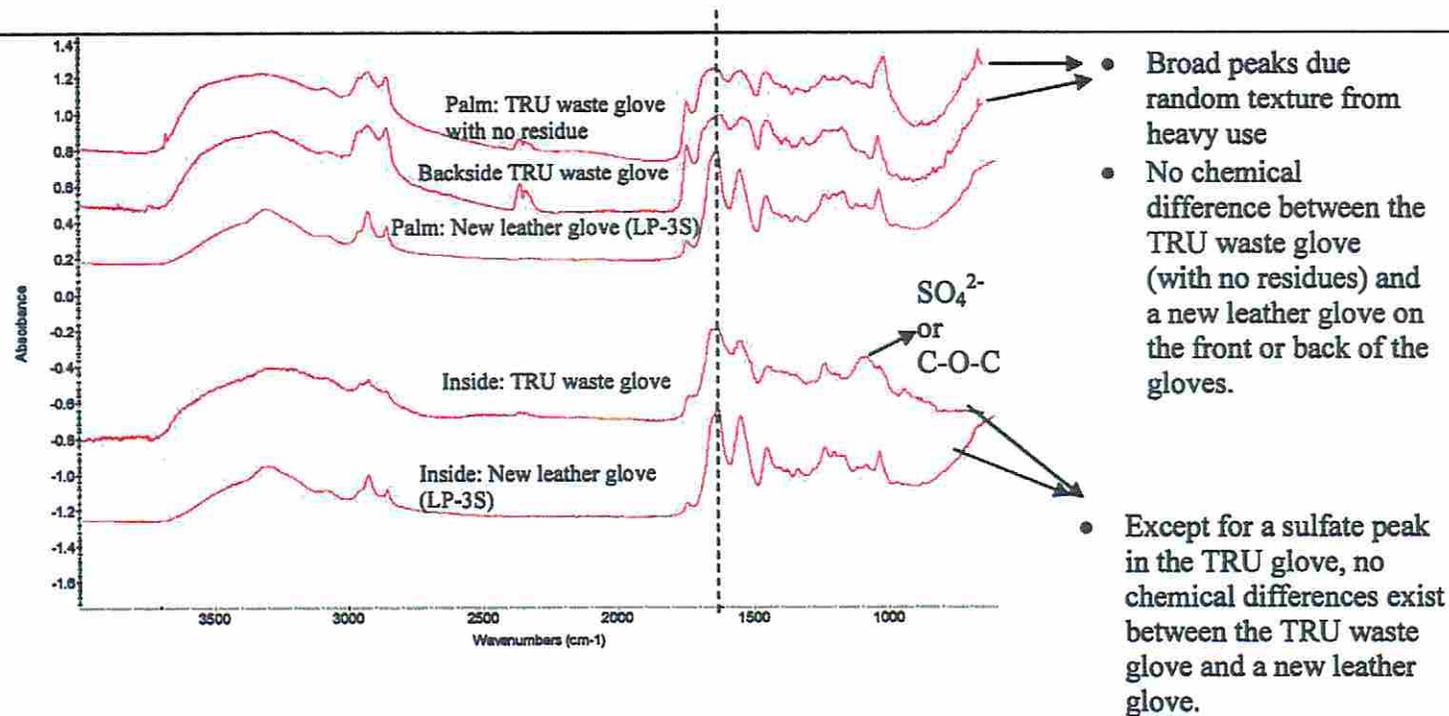
Recent studies have linked the degree of degradation of parchment – or leather – to changes in features of the FTIR spectra [8, 9]. Leather is composed in part of collagen and this particular leather has distinctive FTIR spectral features designated as the Amide I (near 1650 cm^{-1} wavenumbers) and Amide II (near 1540 cm^{-1} wavenumbers) regions. Leather (and collagen) deteriorates through three prime means: denaturation, hydrolysis and oxidation [8]. The studies indicate that as these reactions proceed the relative peak areas of the Amide I and II regions and the space distance between the peak centers changes. Figures 14 and 15 show changes in this spectral region when comparing the new glove and the contaminated glove.

Figure 14. Comparison of the FTIR spectra from the TRU waste-containing glove and a new leather glove (LP-3S).

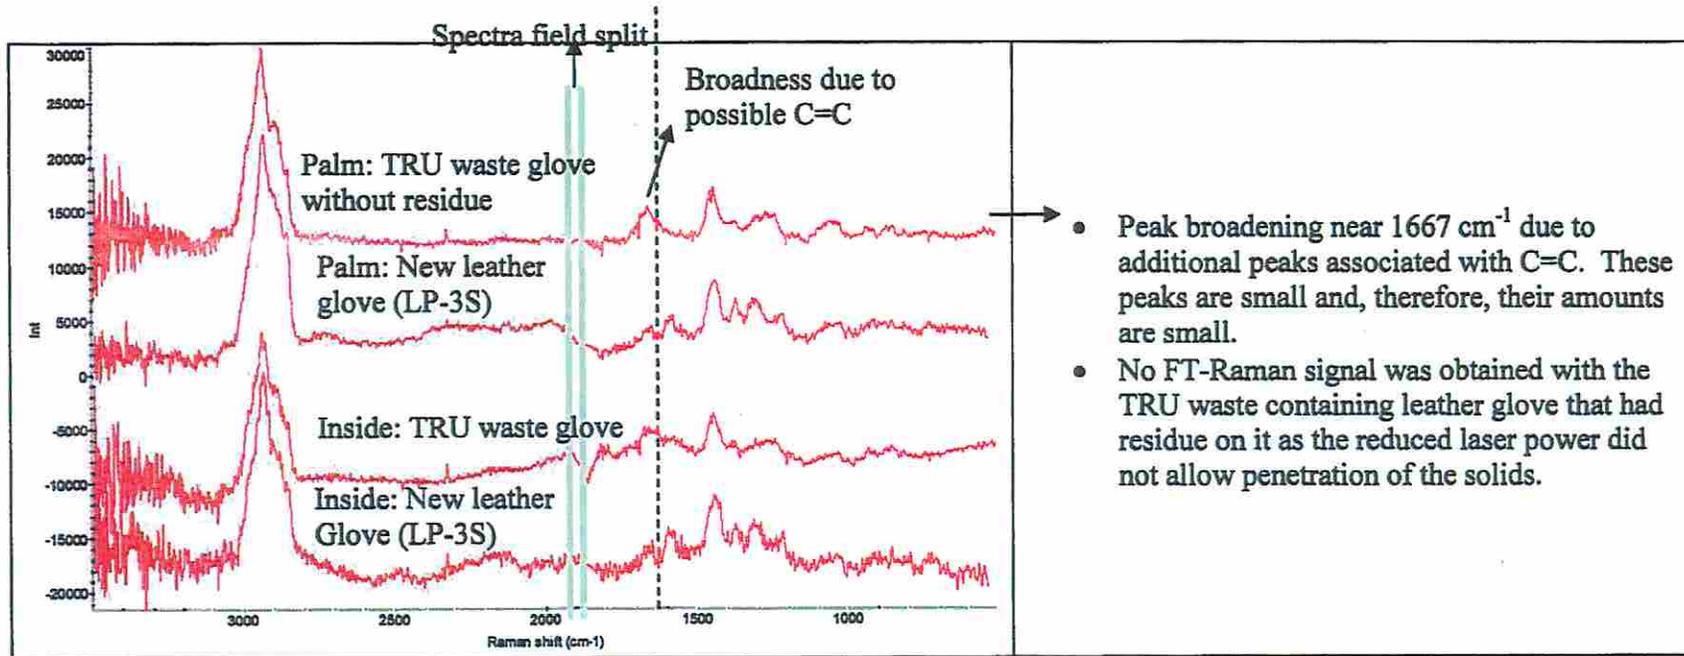
Given that the radiation for the surface deposits is almost exclusively from alpha-emissions, it was reasoned that the best, readily available tool to search for structural changes from radiolytic attack was Raman spectroscopy. This method exclusively looks at the top few microns of the material and stresses the carbon-carbon bonds. In this application, the Raman laser used required reduction to ~25% of power to avoid burning the leather surface and hence penetrated to an estimated depth of only 0.25 microns. Comparing the FT-Raman spectra for the new and contaminated glove (see Figure 15) one notes primarily a change near 1667 cm^{-1} wavenumbers which corresponds to formation of a carbon-carbon double bond ($-\text{C}=\text{C}-$). The magnitude of the change is judged as small. Furthermore, the same shift is not apparent in the corresponding difference FTIR spectra which penetrates ~40-60 microns into the surface. Hence, given the relatively low curie content of the solid deposits and limited evidence of deep formation of the double bond, it is concluded that radiolytic damage is relatively limited and unlikely to impact the bulk property of the glove.

Figure 15. FT-Raman spectra of TRU waste containing glove and a new leather glove (LP-3S).

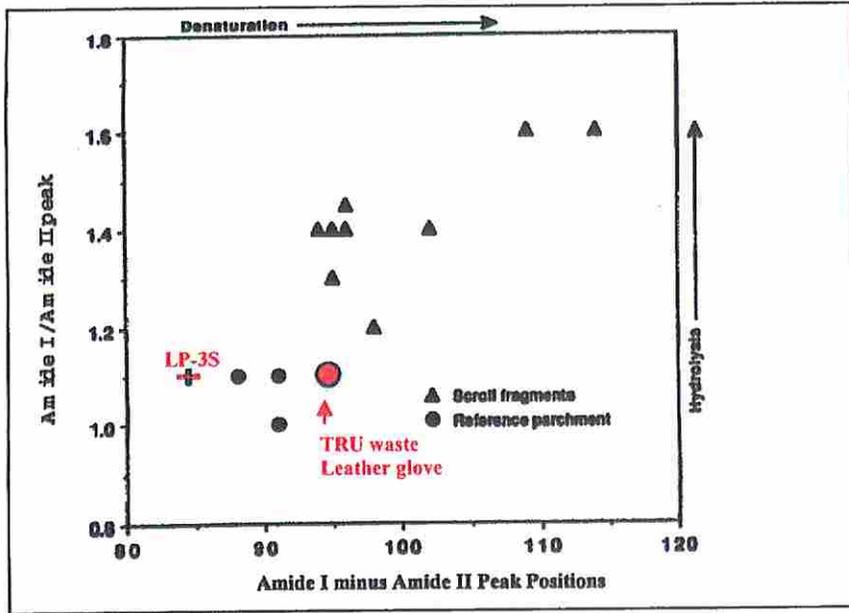
Peak heights and positions were determined from the spectrum of a new LP-3S leather glove and the TRU waste leather glove. After determining peak distance and relative peak height, those data were plotted in Figure 16 (from [9]) to determine the relative degradation of the TRU waste leather glove. Inspection of this figure reveals that the new glove (LP-3S) has relative very little hydrolysis and denaturation (shown in the “+” symbol). The TRU waste leather glove appears to have the same level of hydrolysis but a bit more denaturation (lost of protein order) than the LP-3S. In the same figure, data from the “Dead Sea Scroll” which is leather from 200-100 B.C. are also shown for comparison. The TRU waste leather glove data is in the same grouping as the reference leather data (lower left corner). Unfortunately, the scale in this figure is not directly linked to mechanical properties – such as puncture resistance. In addition, the relevance of these data for leather tanned by modern methods (i.e. chromium tanning) has not been established. Nevertheless, the variance between the new and contaminated glove shows no evidence on

Figure 16. Deterioration as measured by changes in Amide I and Amide II peaks.
