# **Level I Accident Investigation Report**

## **Tice Electric Company Employee Fatality near Patrick's Knob Radio Station, October 1, 2013**

**Report Date:  
November 22, 2013**

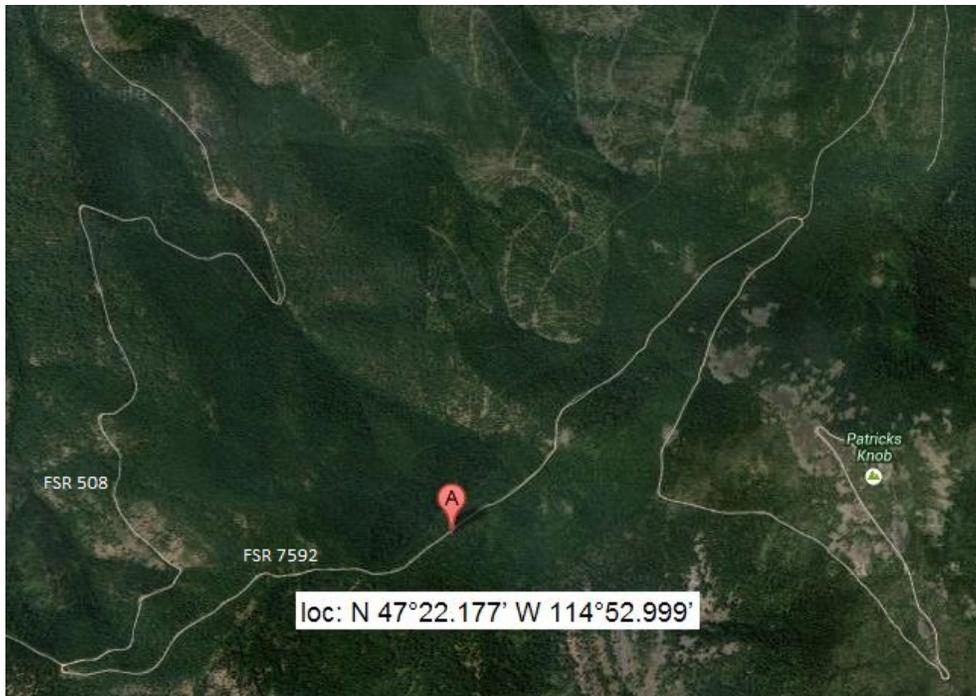
**Figure 4: Location of Accident near Patrick's Knob**

TL witnessed TLE attempt to steer the Gradall back onto the road, which ended with the machine mostly off the road and its right side leaning extremely to the down side of the hill. TL also saw TLE attempt to exit the Gradall from the up-hillside as it rolled off the road edge and out of sight. There was no factual evidence available to the Board to determine if the seat belt was or was not utilized while operating the Gradall prior to going off the roadway, but the Board determined that TLE was not belted in while the Gradall was rolling over.
