# U.S. Department of Energy Office of Environmental Management

## Accident Investigation Report

### Phase 1

## Radiological Release Event at the Waste Isolation Pilot Plant on February 14, 2014

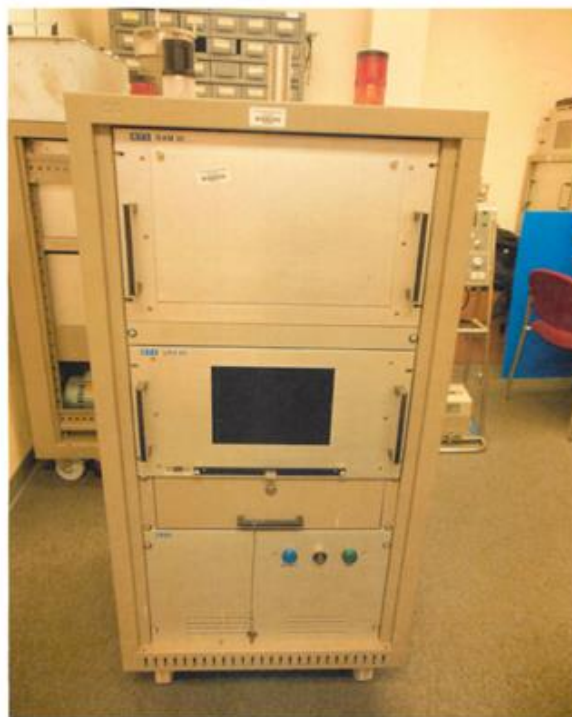
**Figure ES-1: RADOS Continuous Air Monitor**

On Friday, February 14, 2014, at approximately 2314, a "HI HI" radiation alarm was received in the Central Monitoring Room (CMR) at the DOE WIPP facility approximately 27 miles east of Carlsbad, New Mexico. The alarm was triggered from a CAM (Figure ES-1) in the U/G which was monitoring airborne radioactivity levels in air exhausting from Panel 7, an active waste panel where TRU waste was being emplaced for disposal.

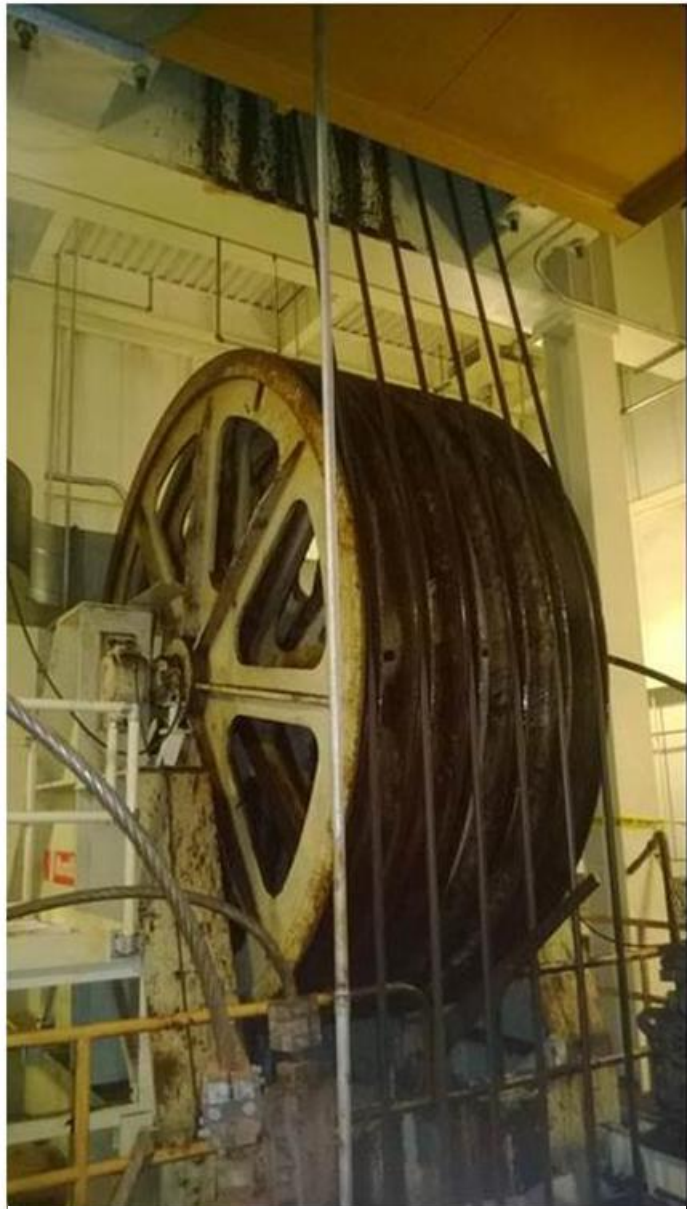
**Figure 10: Waste Hoist Cable**

from credited controls in Revision 2, which included a SAC and DF to TSR/LCO on the brakes and DF in Revision 3 to eventually TSR/LCO on brakes in Revision 4. (Figure 10) Previous revisions of the TSR's had a DF for the waste hoist as its structure was classified as SC but not the current revision.

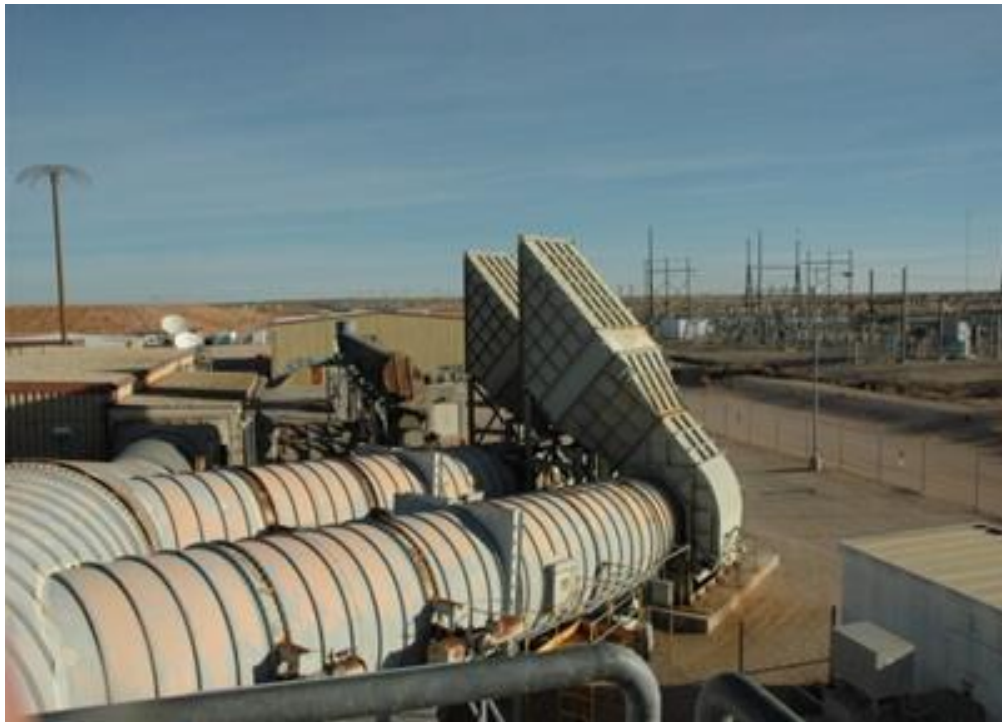
**Figure 19: Ventilation Fans 700A and 700B**

The exhaust fans serving the underground ventilation are located on the surface. A combination of six fans provides airflow for the U/G ventilation system. Three large main (700) fans rated nominally at 260,000 cfm discharge directly to the atmosphere. Three smaller 860 fans, rated nominally at 60,000 cfm, draw ventilation through HEPA filtration and discharge to a small stack monitored for radiological release. The 860 fans can also exhaust the underground directly through a filtration bypass duct. (Figure 18 and Figure 19)

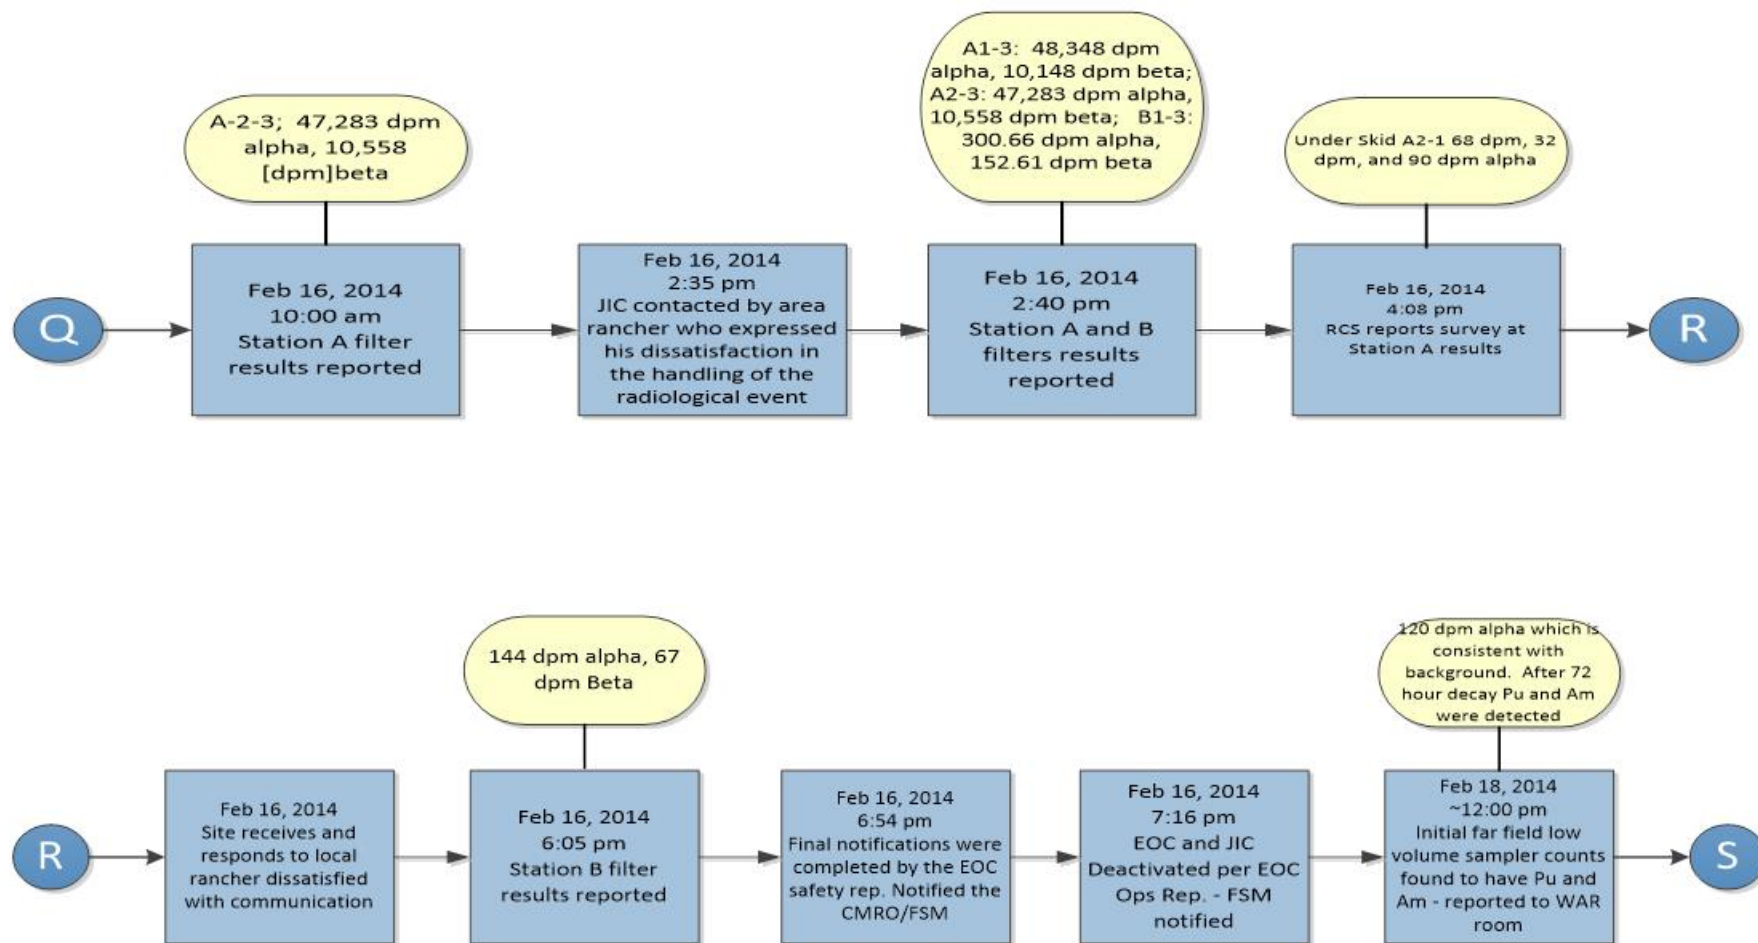
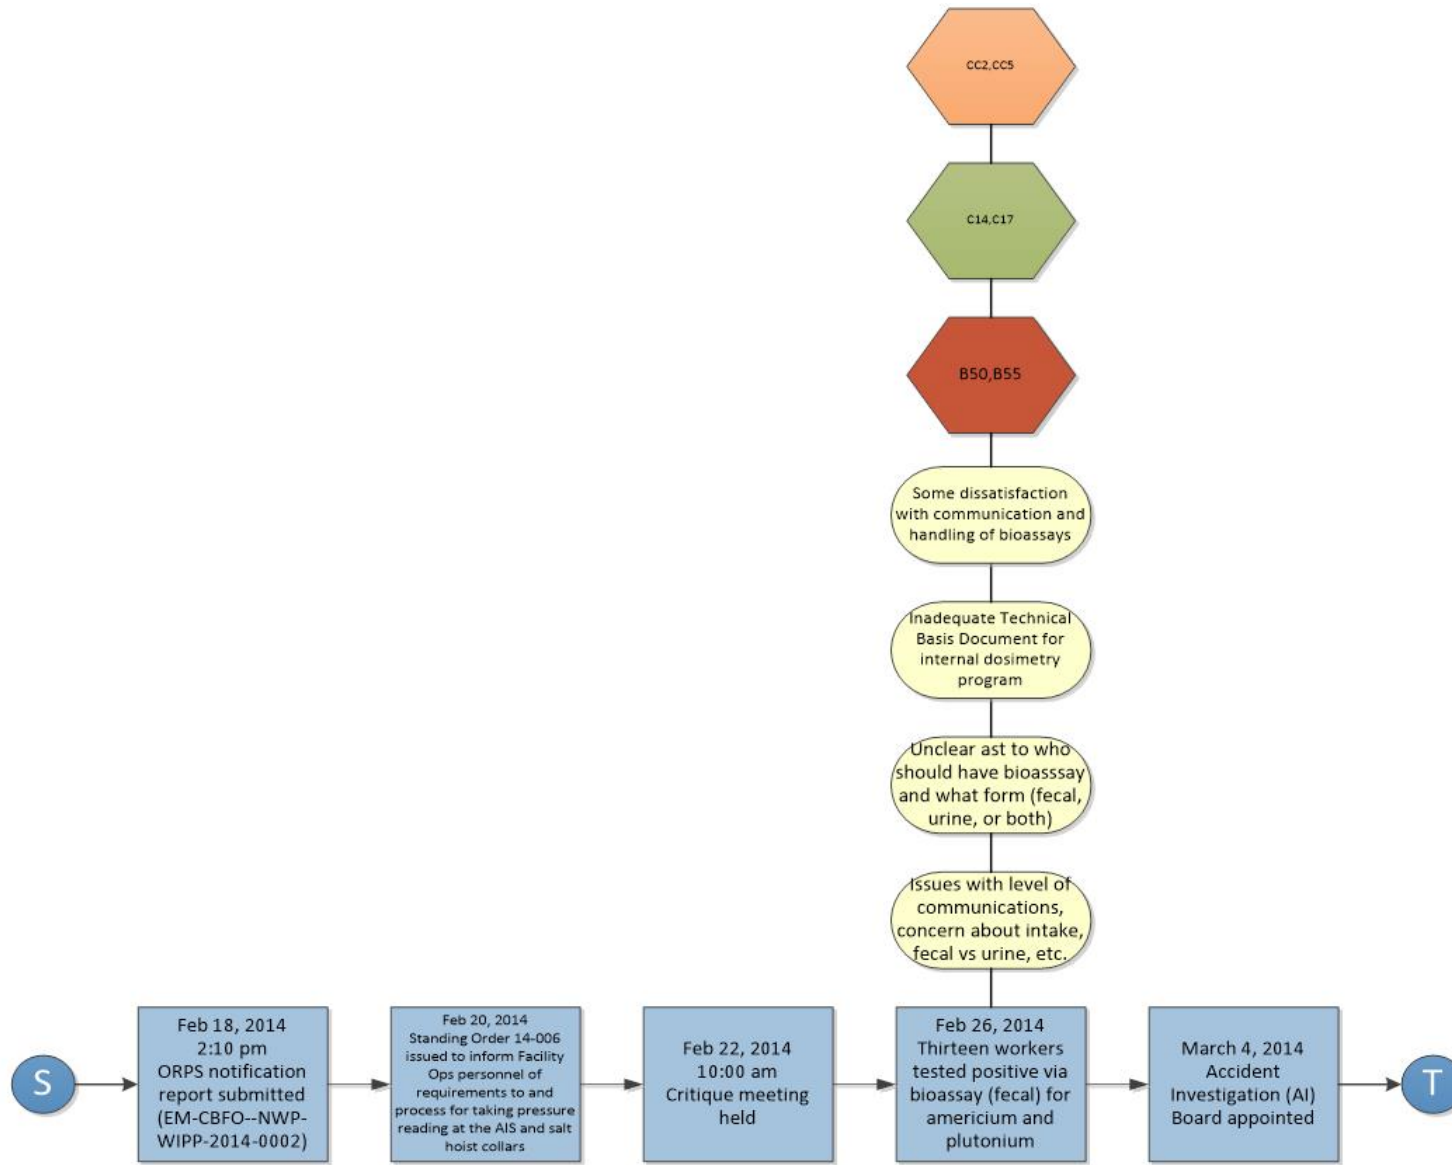
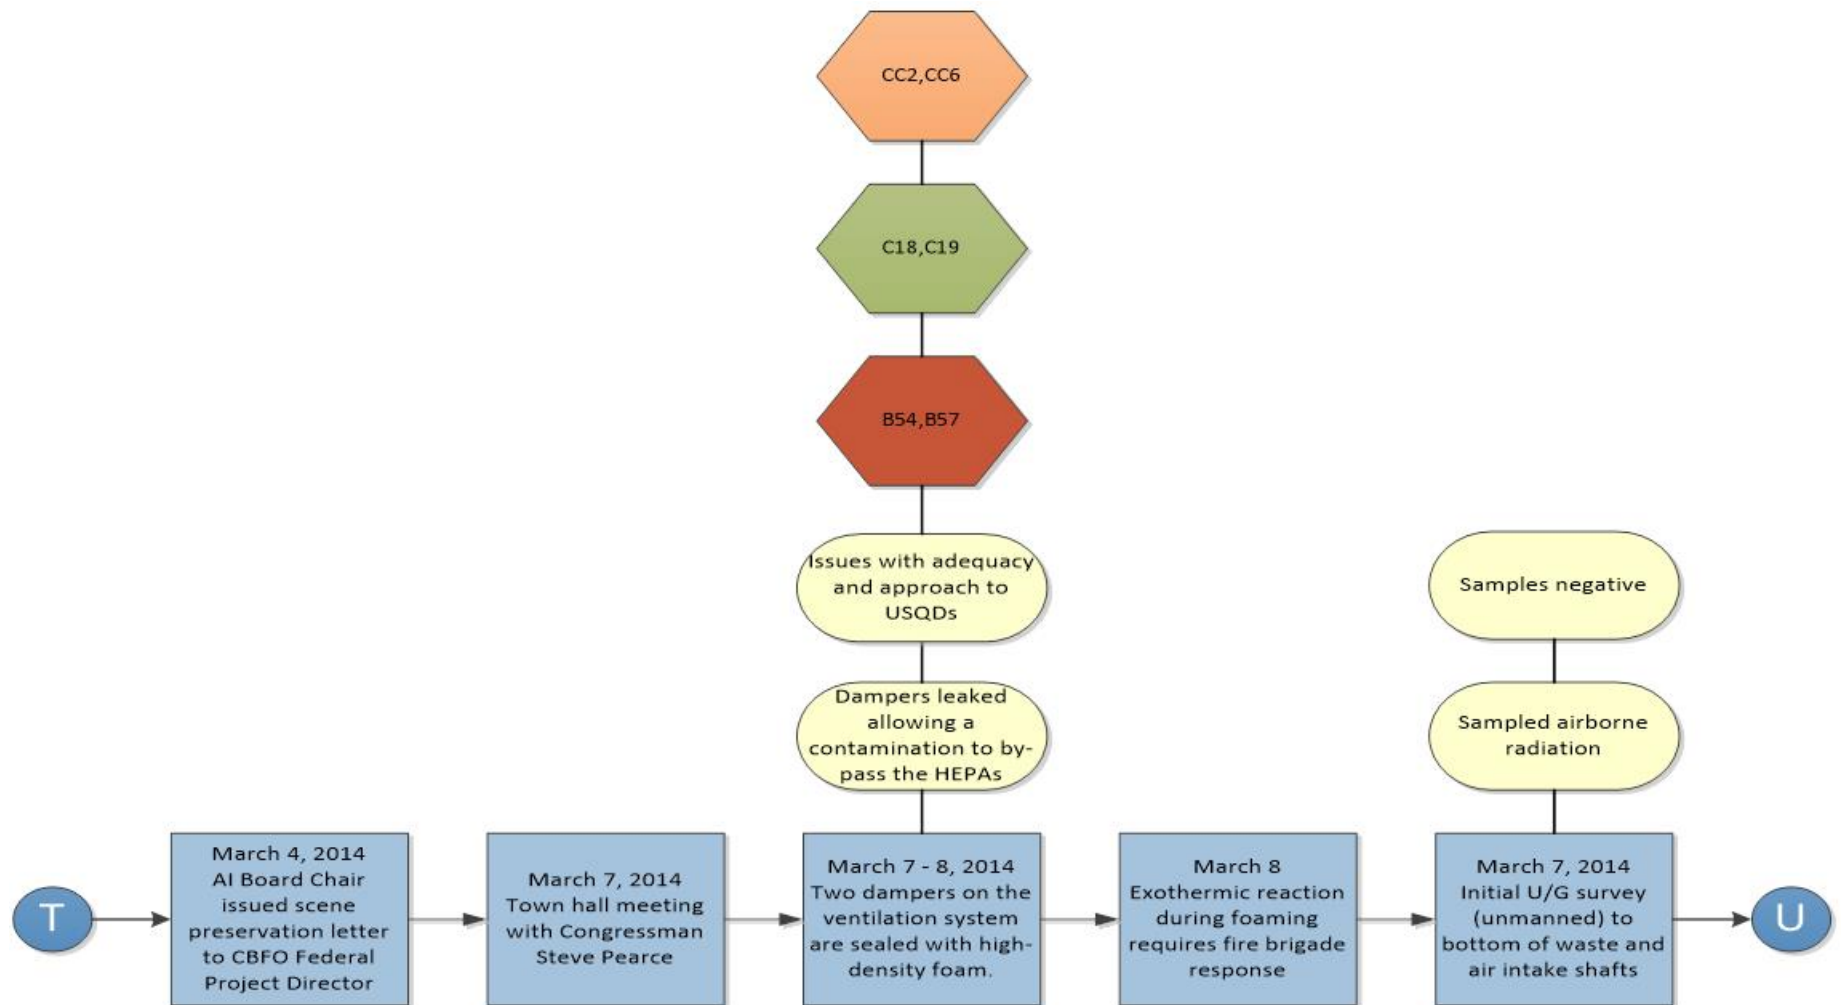
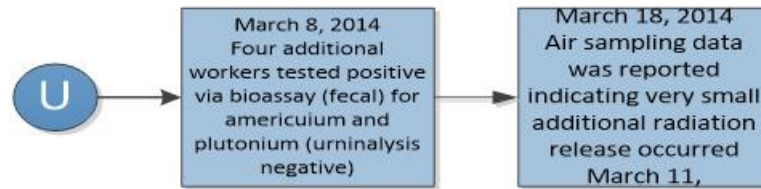
## Radiological Event Primary Events and Causal Factors

An events and causal factors analysis was performed in accordance with the DOE Workbook, Conducting Accident Investigations. The events and causal factors analysis requires deductive reasoning to determine those events and/or conditions that contributed to the accident. Causal factors are the events or conditions that produced or contributed to the accident, and they consist of direct, contributing, and root causes. The direct cause is the immediate event(s) or condition(s) that caused the accident. The contributing causes are the events or conditions that, collectively with the other causes, increased the likelihood of the accident, but which did not solely cause the accident. Root causes are the events or conditions that, if corrected, would prevent recurrence of this and similar accidents. The causal factors are identified in Figure E-1: Events and Causal Factors Analysis.
